## Windscreen removal, maintenance and installation

1991 Alfa 33 1.4 IE

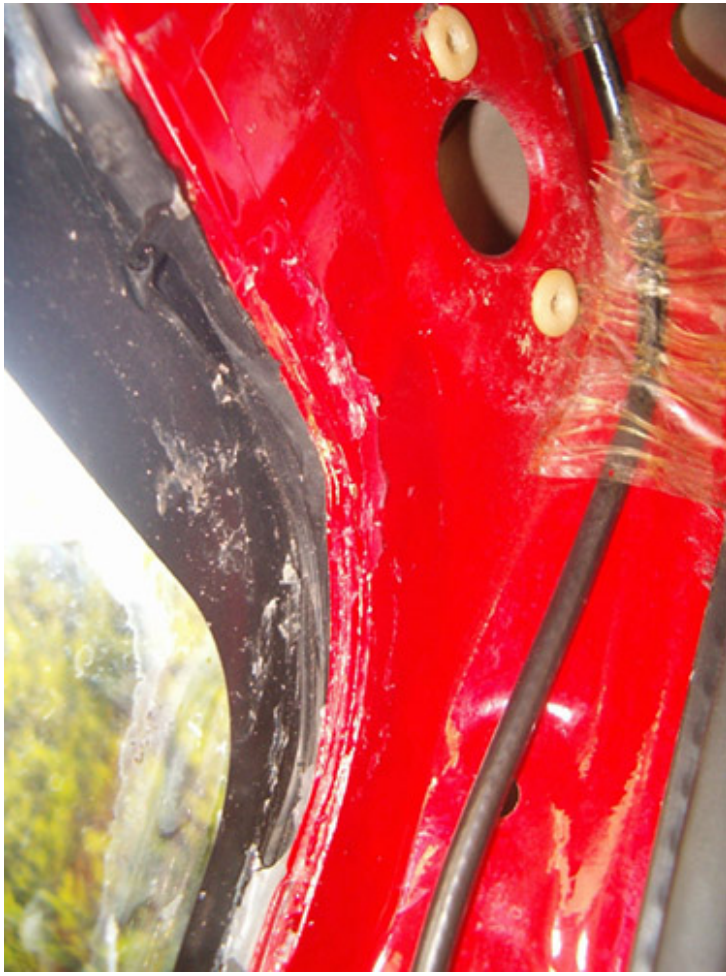
this is the lower right corner of the windscreen ... I think I see brown metal :-)

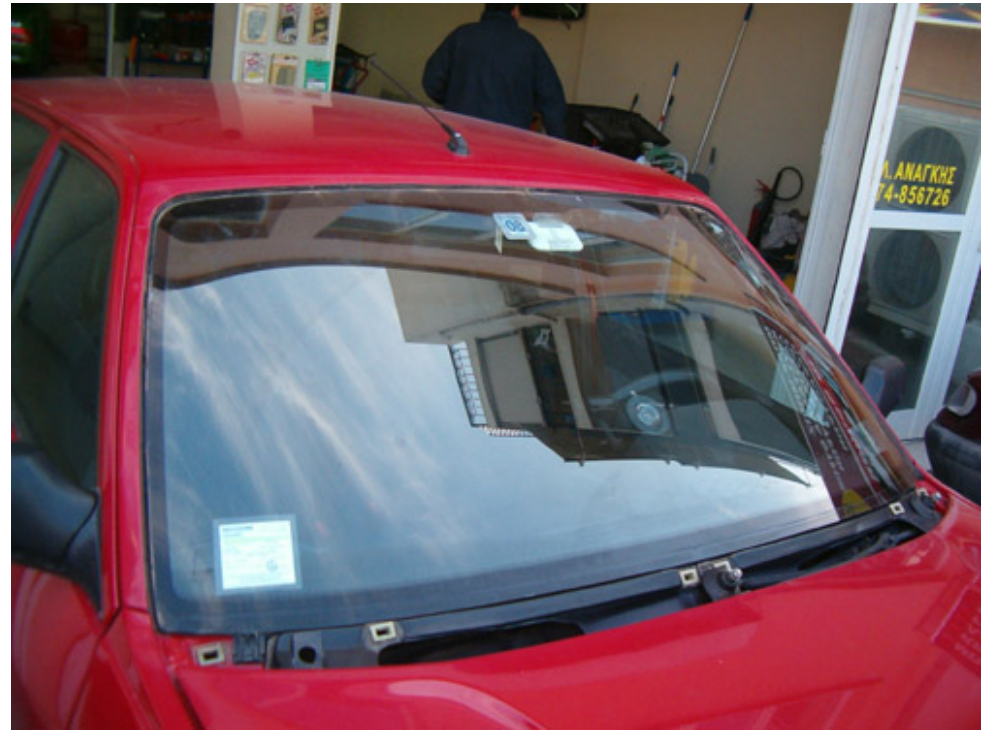
This is the right upper corner of the windscreen area where I think causes troubles ...

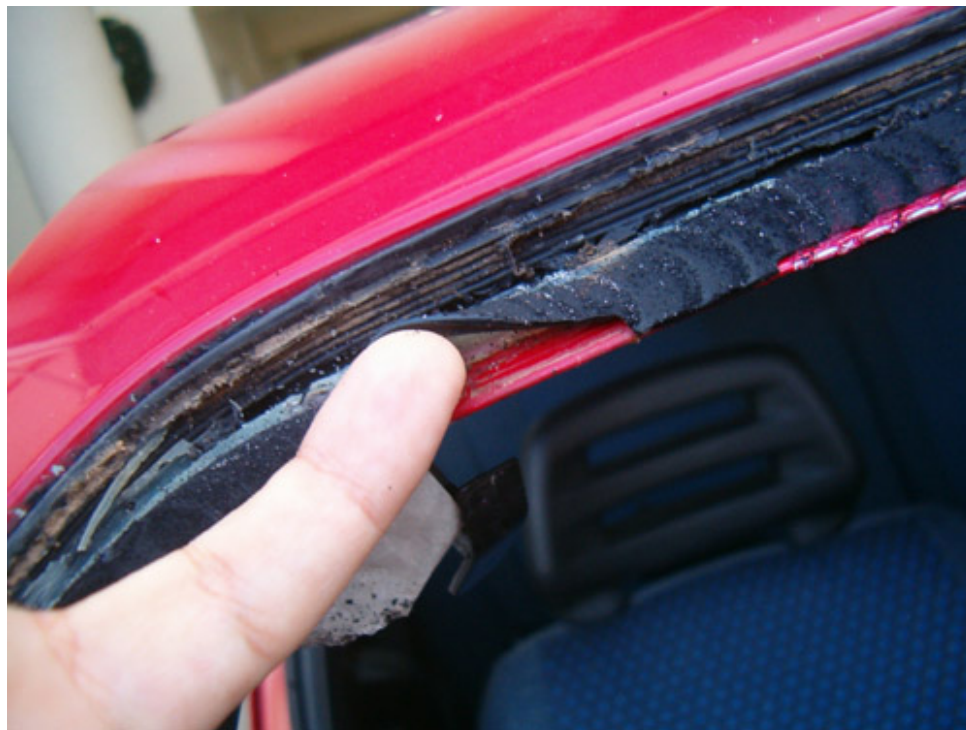
My fears were true ... brown metal in the corner. Looks like water was accumulating in this area causing the corner to develop rust

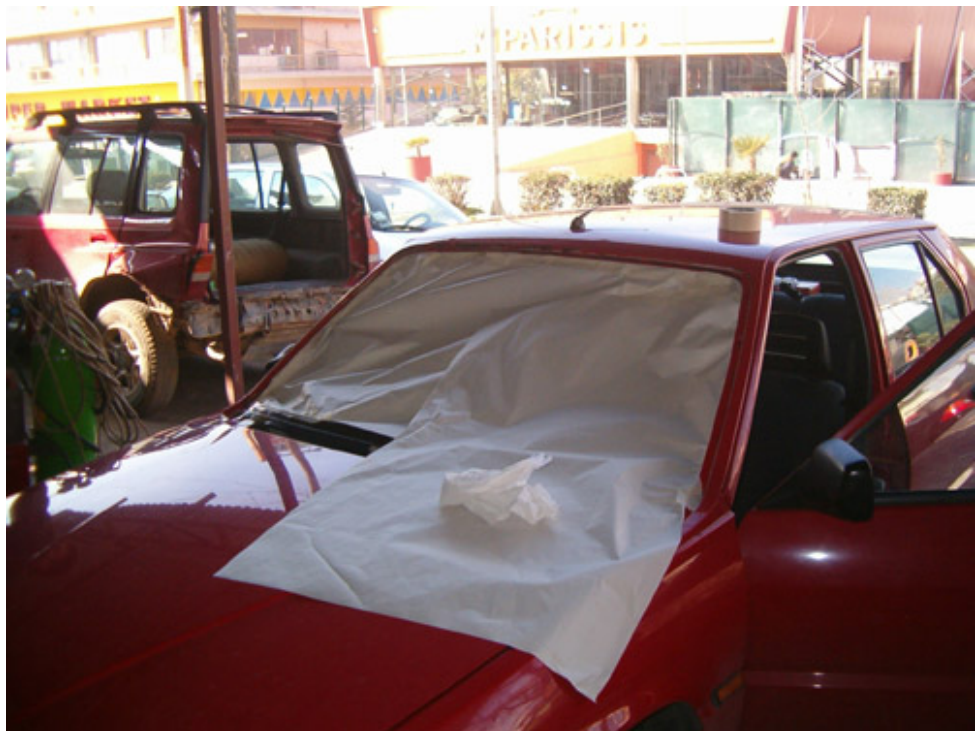
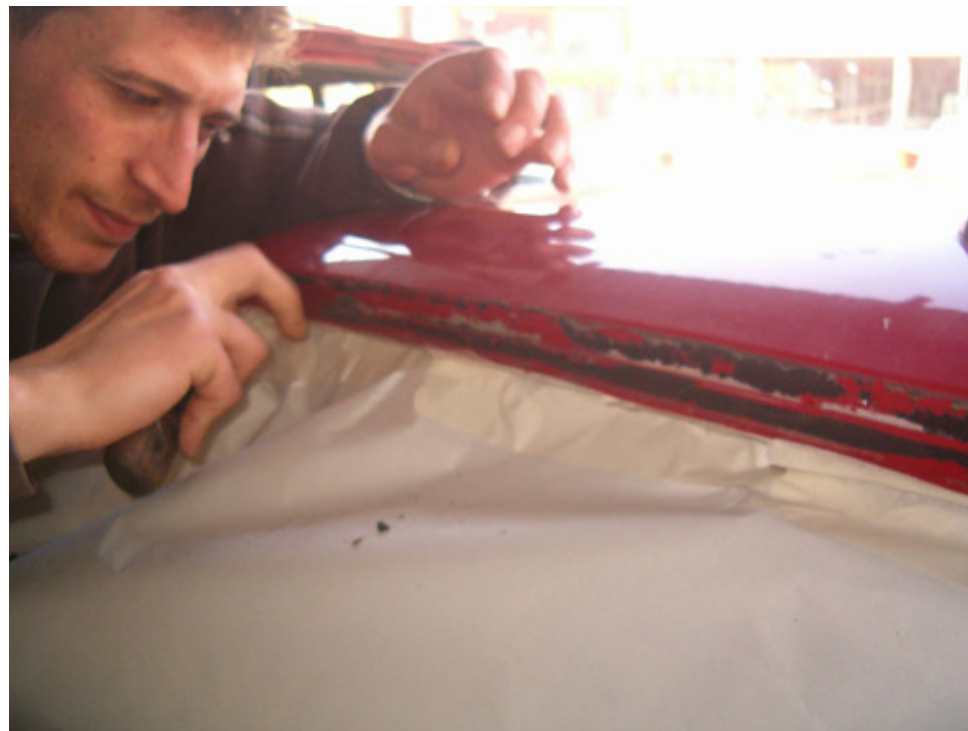
This is the origin of my troubles. The glue has separated from the frame and water found an easy way in

Constantine hard at work removing traces of old glue. According to the words of the pros, the frame should have been treated with special primer intended for bonding windscreen glue to the metal frame. In my case, this was probably ignored as the remaining of the windscreen glue could be easily removed with the fingers...

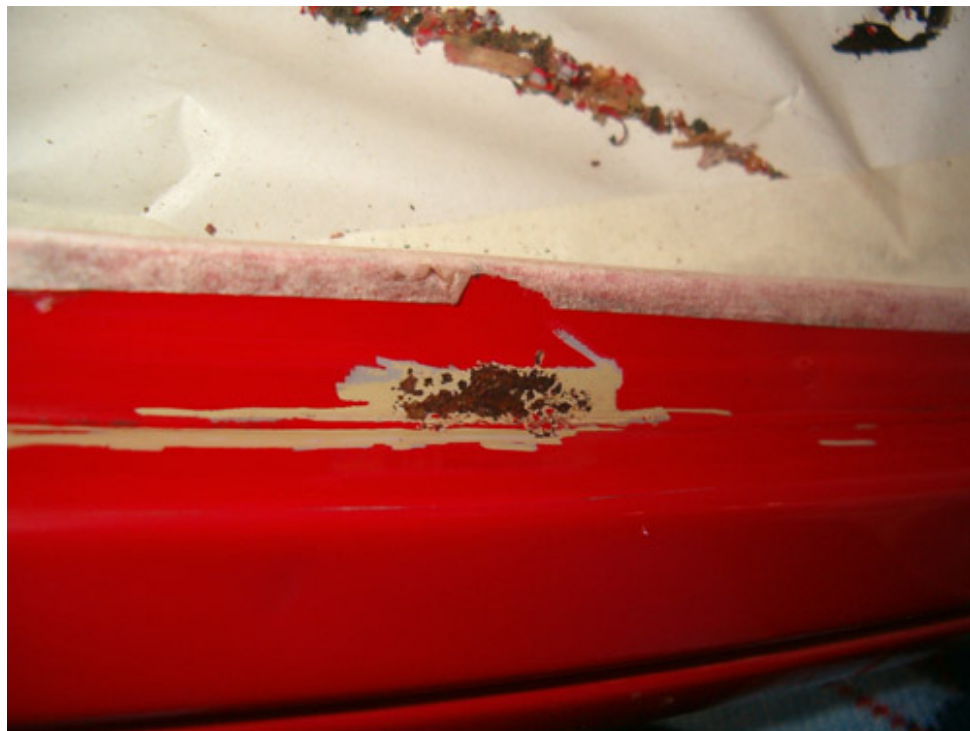
Once everything is cleaned rust spots were revealed on the upper side of the frame.

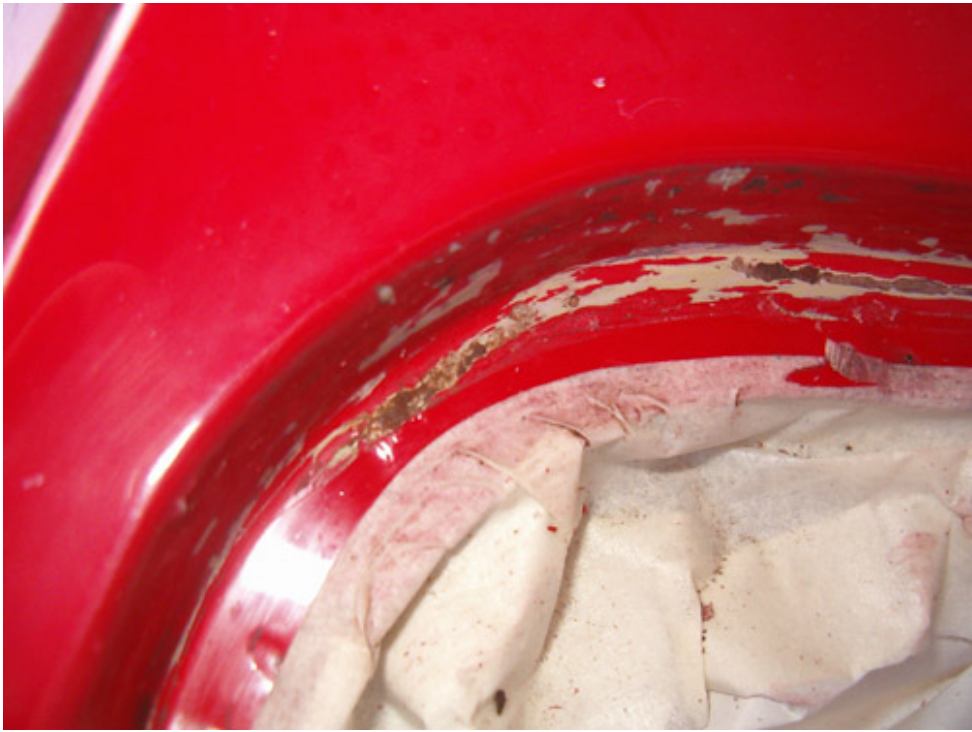
Another rust spot on the A-pillar post

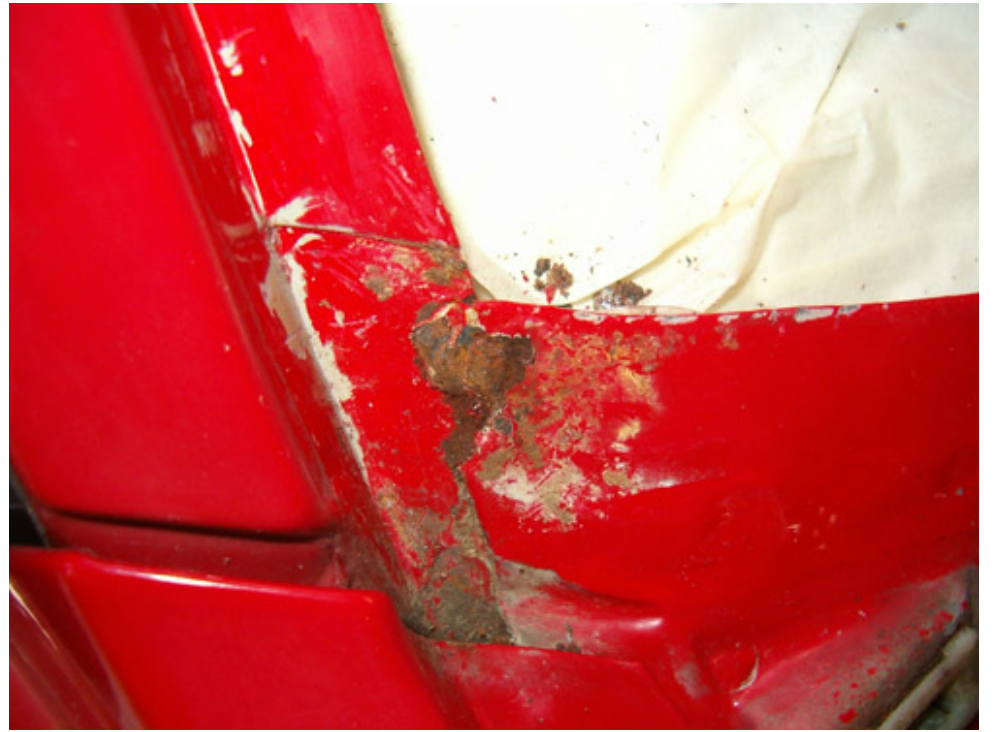
Rust on the upper right corner ...

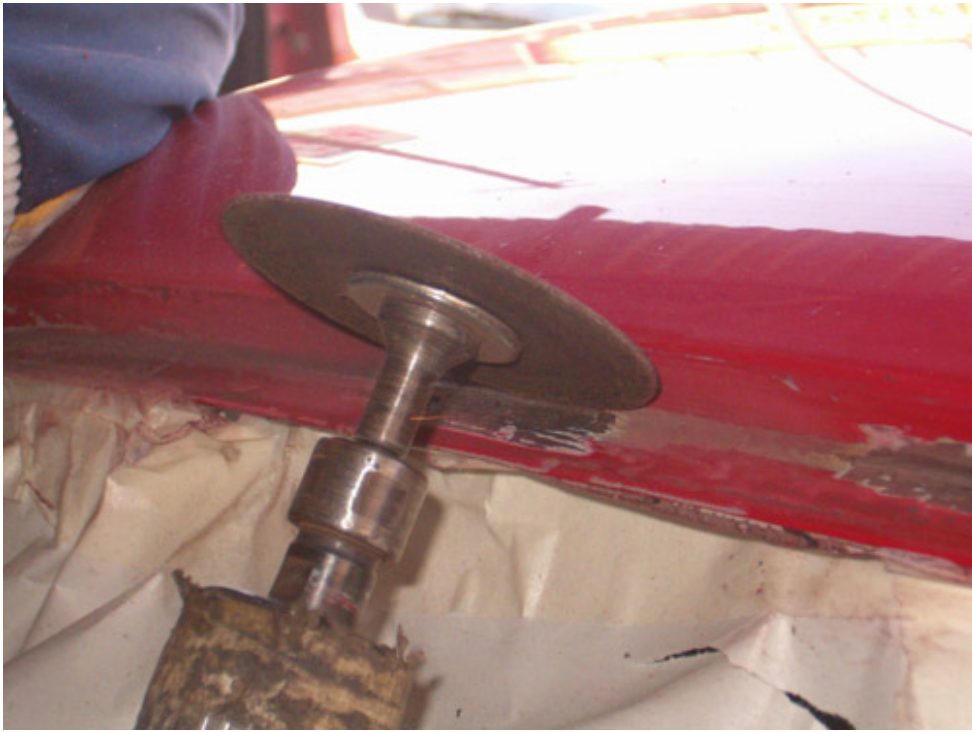
... and worst on the lower corner. Fortunately rust had not eaten away metal and no rust holes were required to fill up
