## **Inner Wheelarches & Luggage Compartment Maintenance**

1991 Alfa 33 1.4 IE

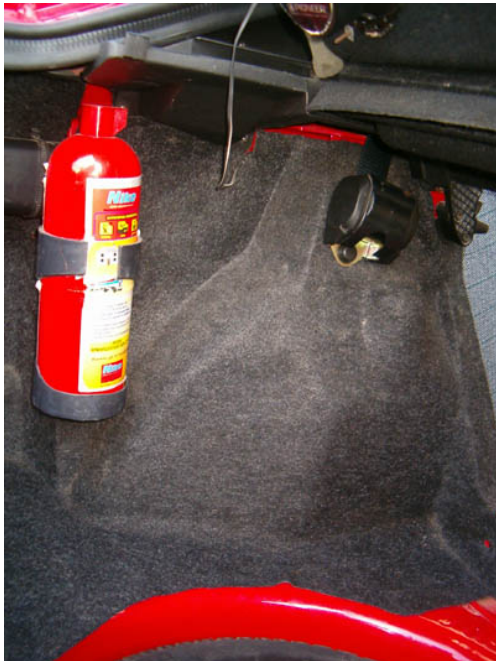
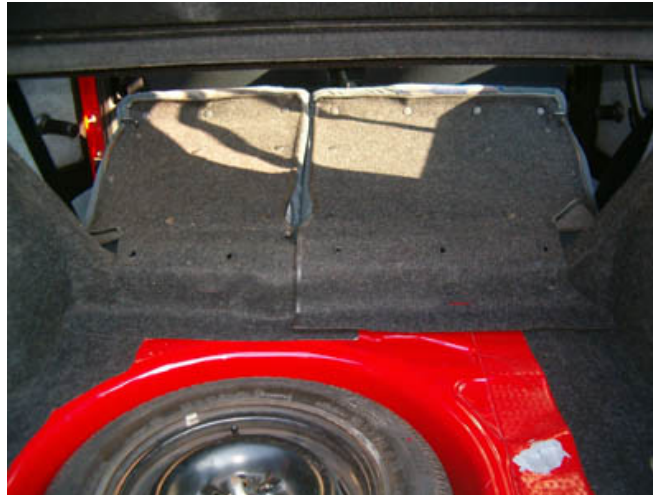
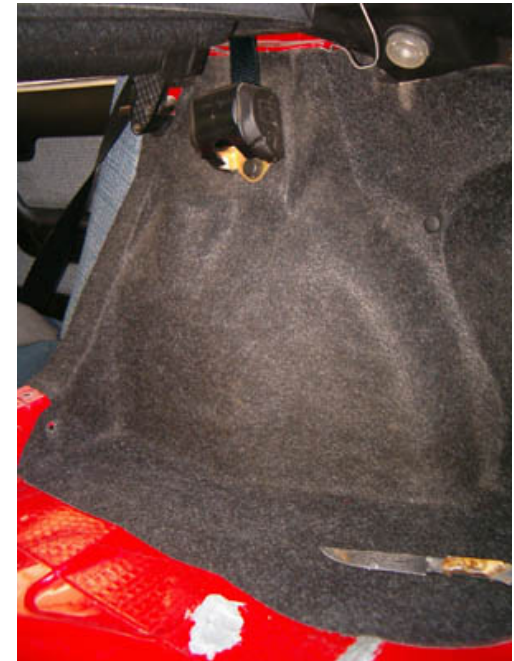
The three pictures above show you the carpets that must be removed. Several plastic taps keep in place the carpet - it is an easy job to remove them provided you have in hand a very simple tool; a knife like the one in the above picture.

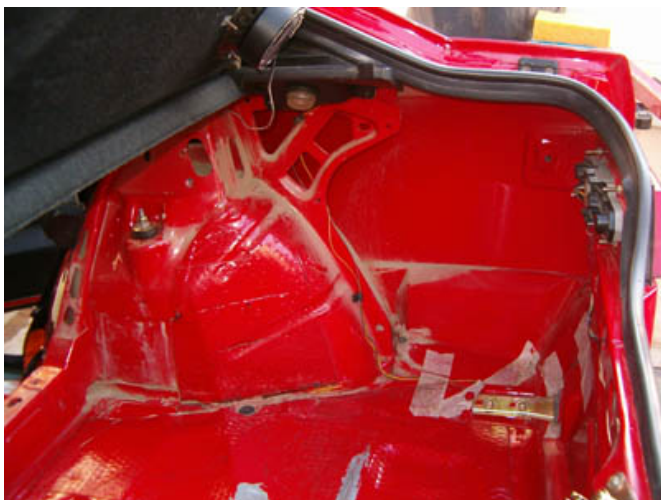
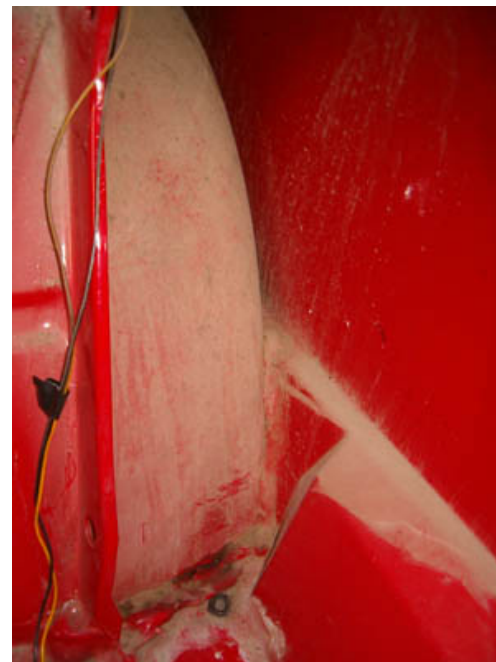
Observe the amount of dust in the hatch. This has accumulated all these years, so it would be wise to clean everything out - use a sponge, some hot water and a small quantity of soap. Strain the sponge thoroughly and apply it several times in order to remove all of the dirt. In case you need to clean a curved area use a toothbrush.

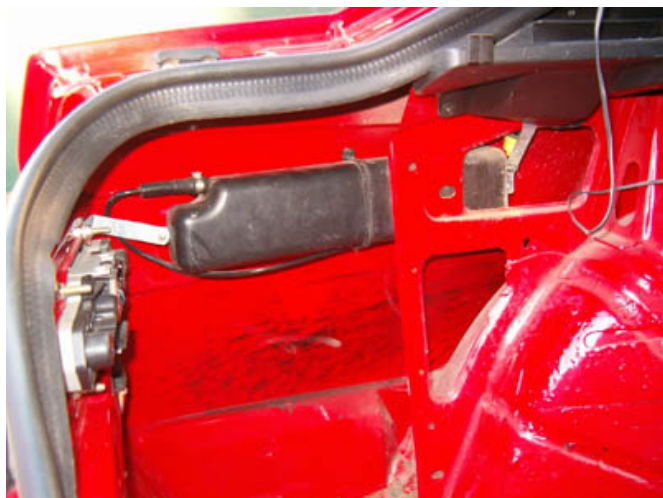
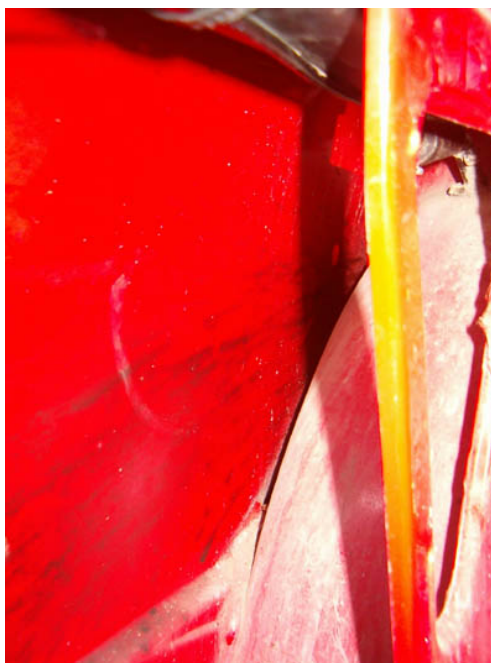
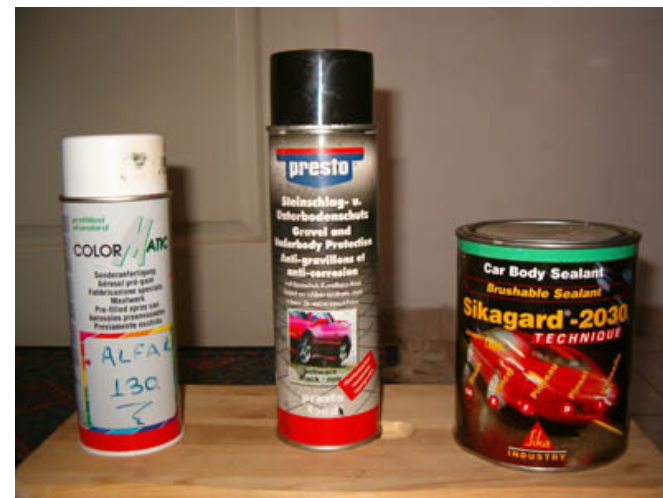
Here you see the left side of the hatch - note the black box here. This is the fuel vapor separator which converts fuel vapor to liquid vapor. Hardly seen in the left part of the filter is the compensation valve in yellow color. This black box is typical in IE catalyst 33s. Again loads of dirt also in the left side. Notice the black color below the vapor filter. It is this magic black material which rust proofs inner panels and it is done at the production line; seems that more than enough quantity was used in my car back in 1991!

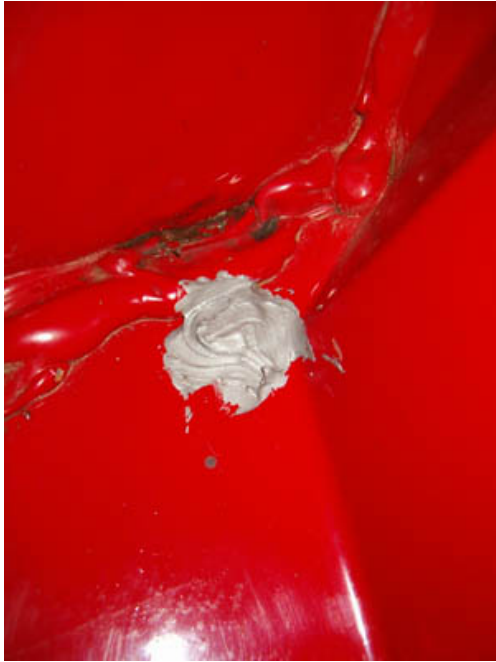
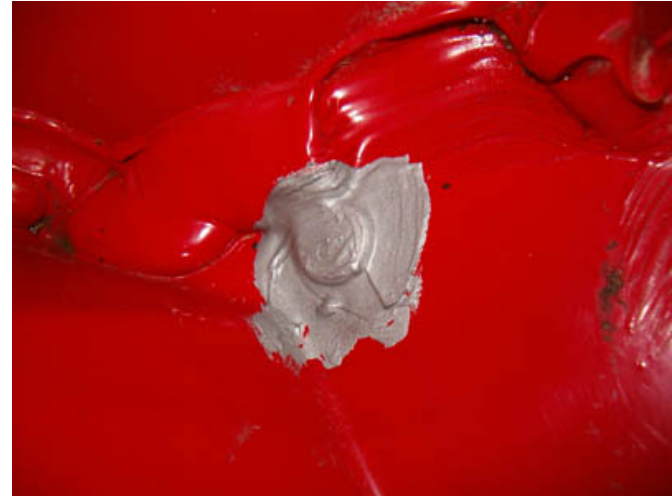
I have decided to seal the above rubber taps (LHD & RHD) in order to avoid dust accumulation and possible water coming in. Sealer was used and when dry it sticks to the metal - note that if needed it can be peeled off rather easily without ruining the rubber since the quantity applied is small.

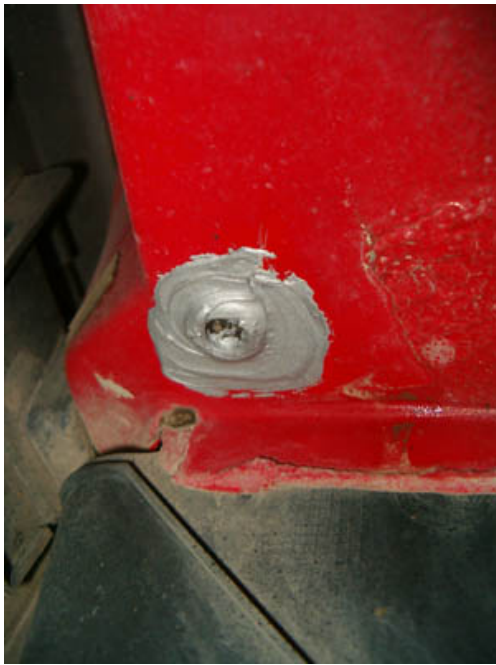
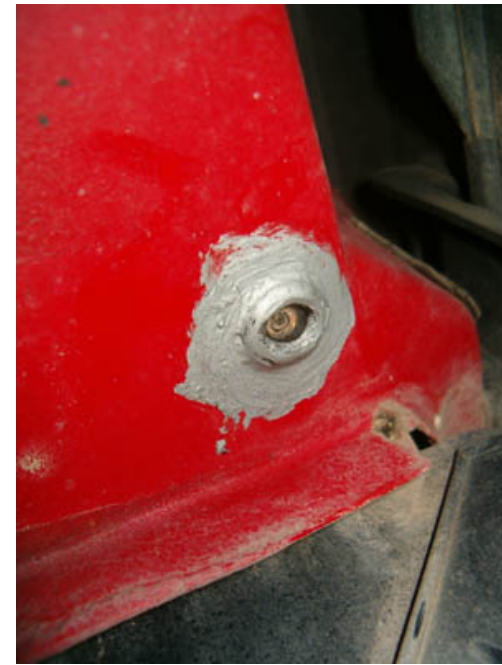
The same taps from the under of the car

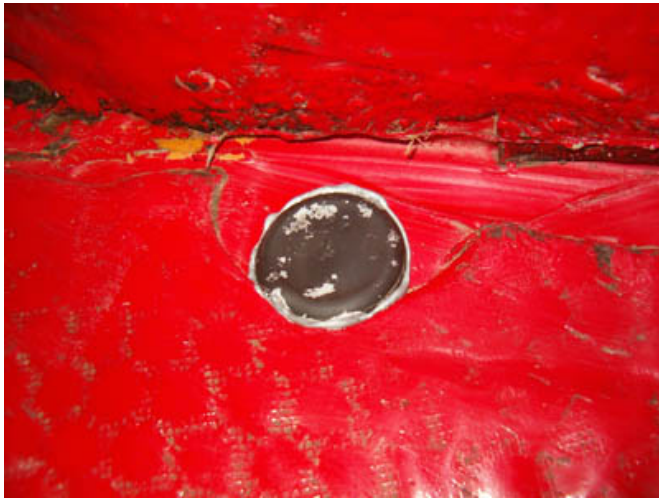
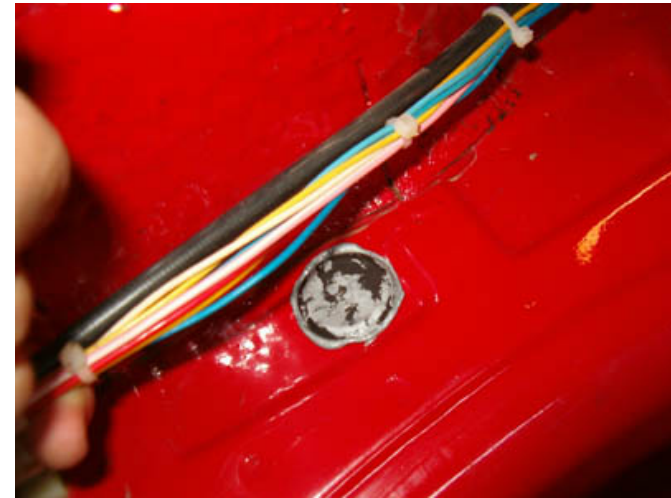
Also those rubber taps seal the metal floor side member that keeps in place the spare wheel well. The first photo shows the RHD and the second the LHD taps; note the wiring harness that passes above the tap and reaches the rear lights and fuel pump. It should be noted that by unveiling the taps, one can see through the member towards the ground; this is done on purpose from the design of the body as possible water entering crucial body parts can easily escape and dry, not resulting in corrosion.

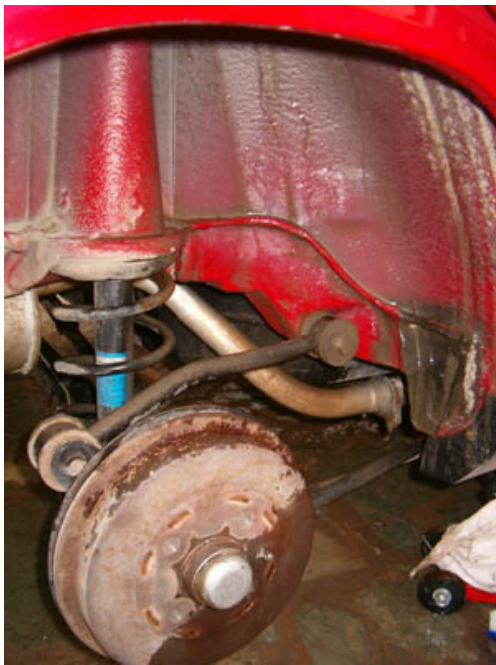
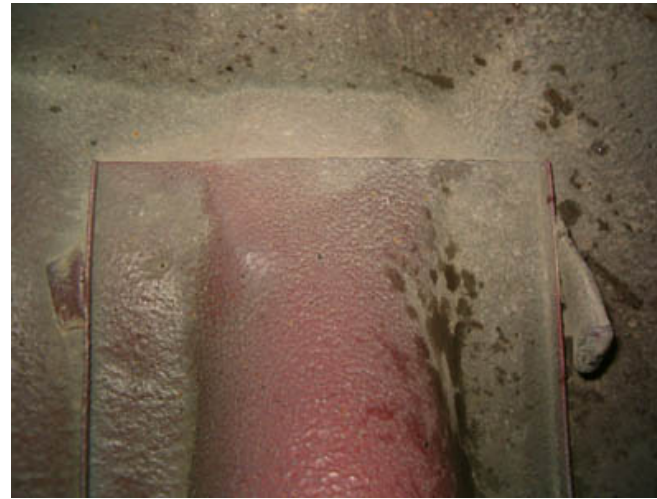
It is now time to clean both wheel arches. It is a job that needs to be done with patience since every bit of dirt must be removed. Again use sponge, brush, toothbrush for the difficult spots and plenty of soap. The middle photo shows the area of problems ... water is coming in from the topmost part of the vertical cylinder and finds its way to the luggage compartment. Note two pieces of rubber material coming out of the upper cylinder part; the left sits much lower compared to the right one. This is the reason of troubles; misaligned factory sealing. This material in excess will be removed and sealed on top.

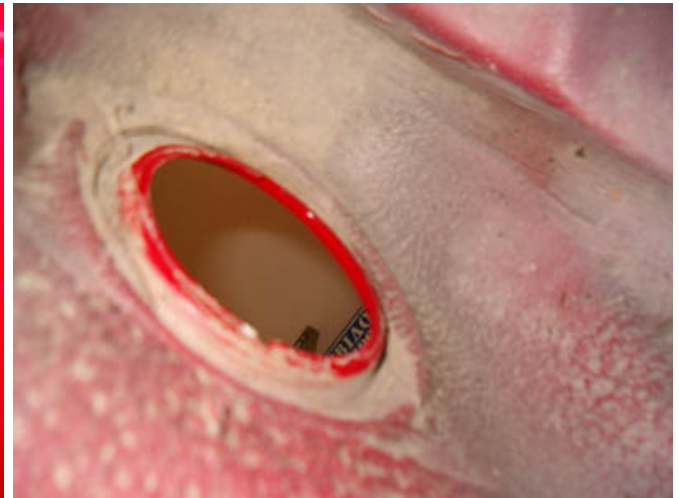
Luckily no signs of corrosion!

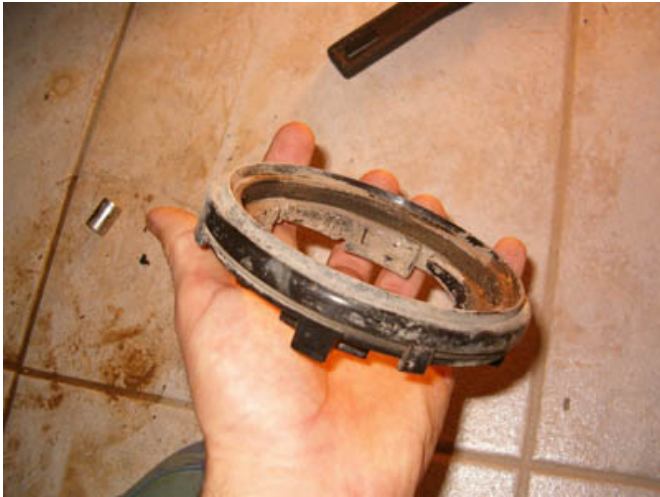
... but loads of residual dirt

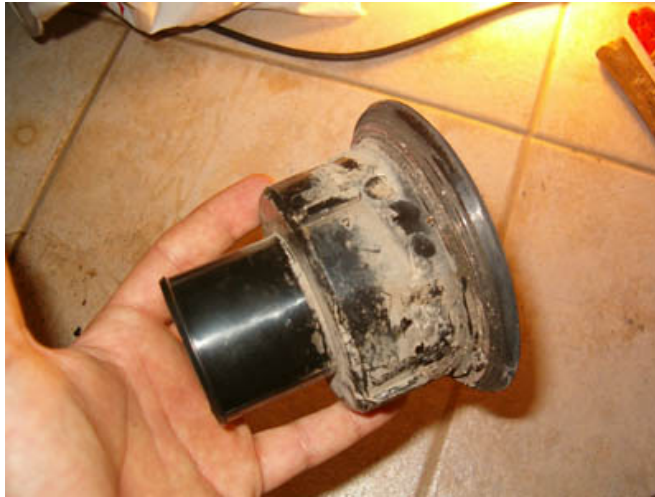
... dirt again

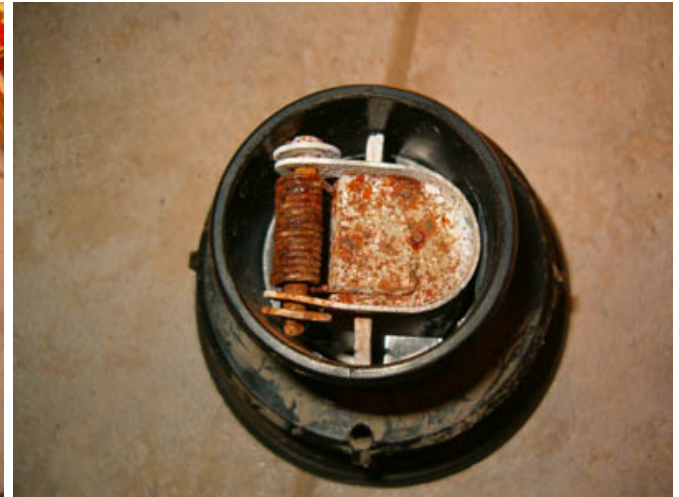
... and rusted inlet. Note that the inlet assembly (spring & door) are NLA items (No Longer Available); so it would be wise to clean out rust and preserve it as much as possible.

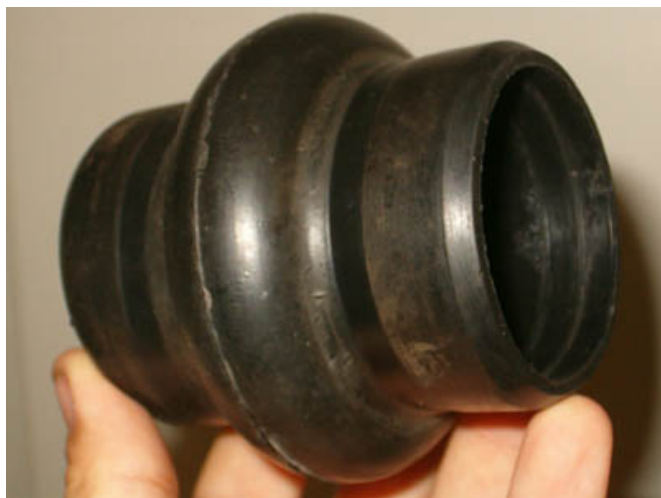
This is the rubber boot connecting the filler neck to the plastic tube of the fuel tank. If yours is worn out replace it with a new one; gas and vapors escape from worn out boots and it's not that good!
