Dial/Dashboard Bulb Replacement

1991 Alfa 33 1.4 IE

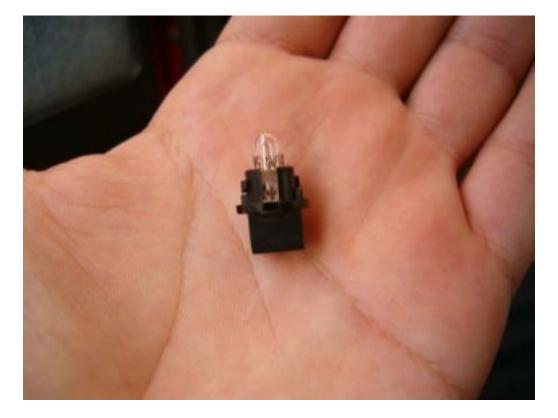
... and this is the burned bulb

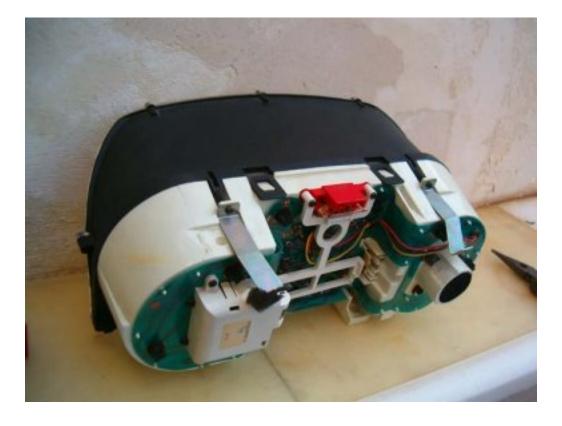
finally got it out!

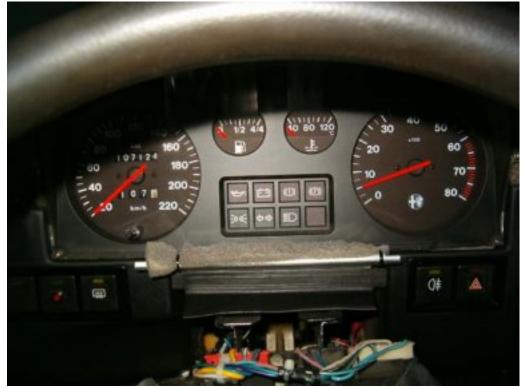
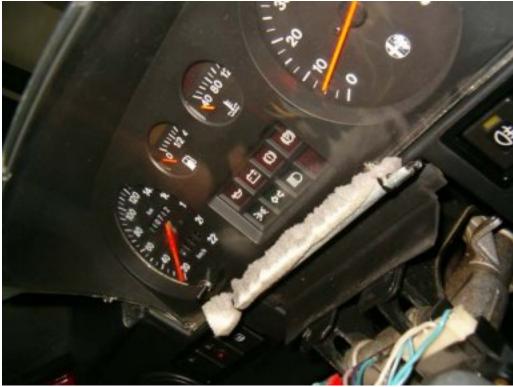
Dash is resting in its position, and foam has been installed on the area below the function checks. This is an annoying source of noise as metal comes in contact with the plastic shell of the instrument panel. Very slim cable ties were used to keep the foam in place. from another angle

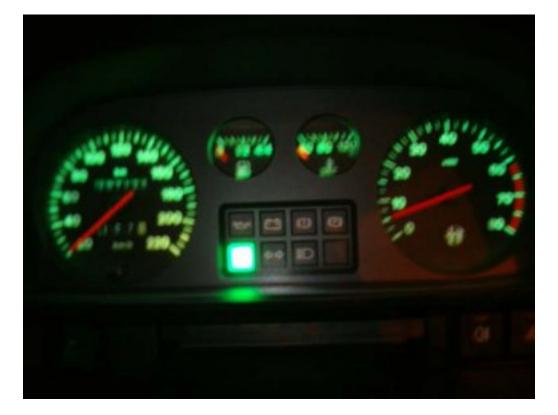
Finally the illumination is back to normal !!!
