Steering Bars Replacement (Alfa 33 Nuova - series 907)

1991 Alfa 33 1.4 IE

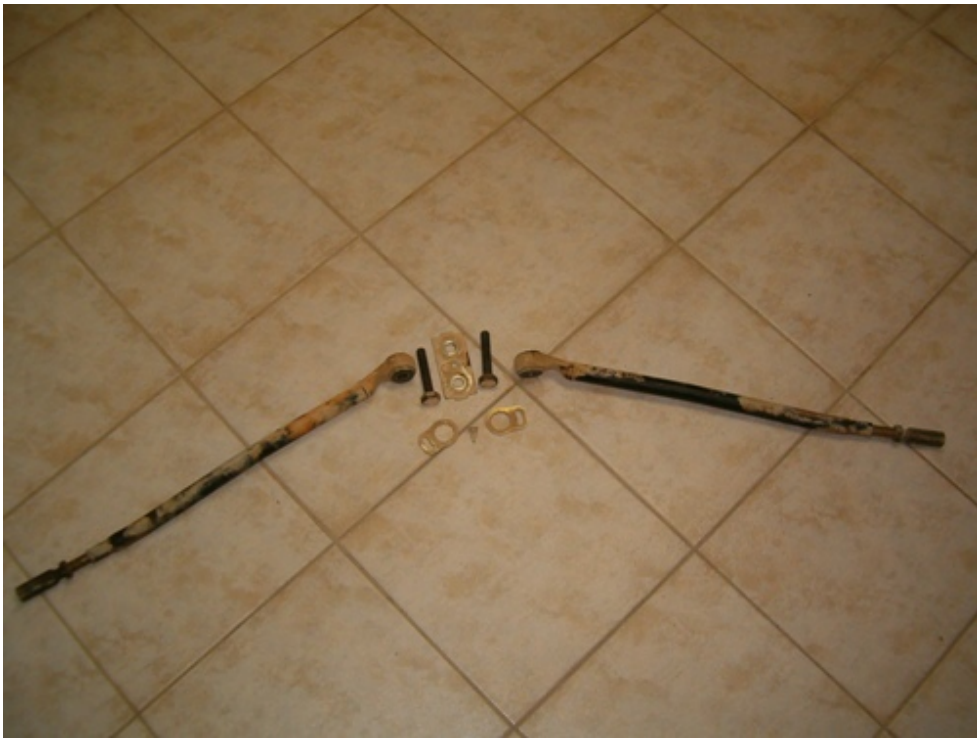
Here you can see the complete set of the steering bars as taken out from the donor car

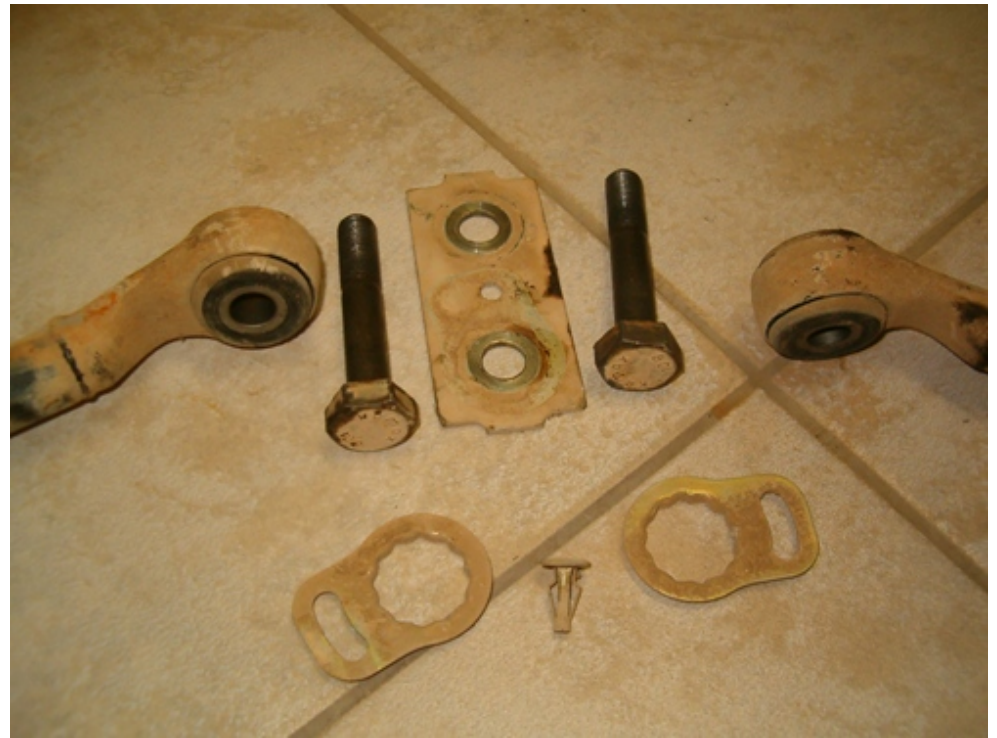
A close up shows the bush side of the bars, the metal plate and 2 x 24 mm bolts that keep the bars firm to the steering box and finally the lock rings that eliminate the possibility of the bolts being unbolted.

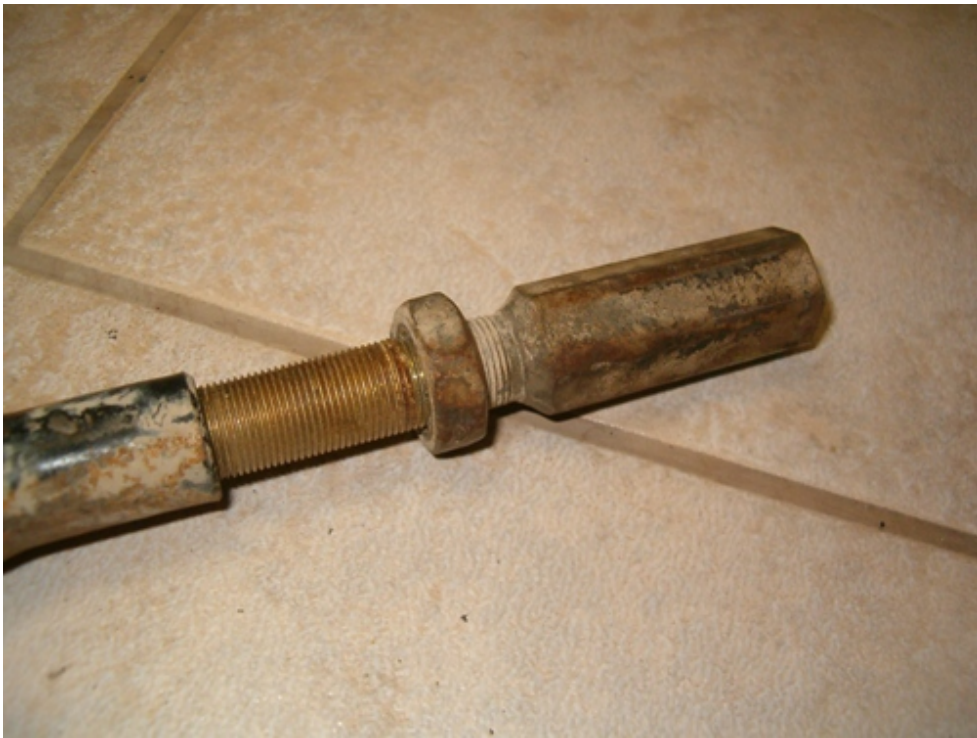
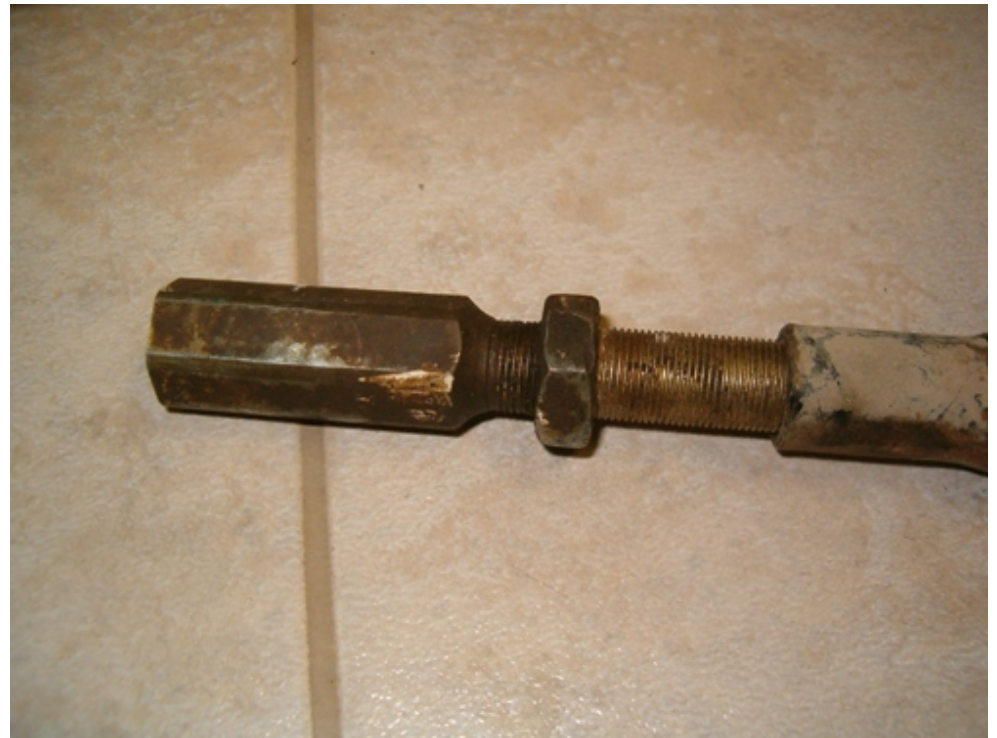
A close up of the adjustable connection. A note here about the threaded part of the connection; it is a reverse thread meaning that the lock nut bolts in CCW and not CW.

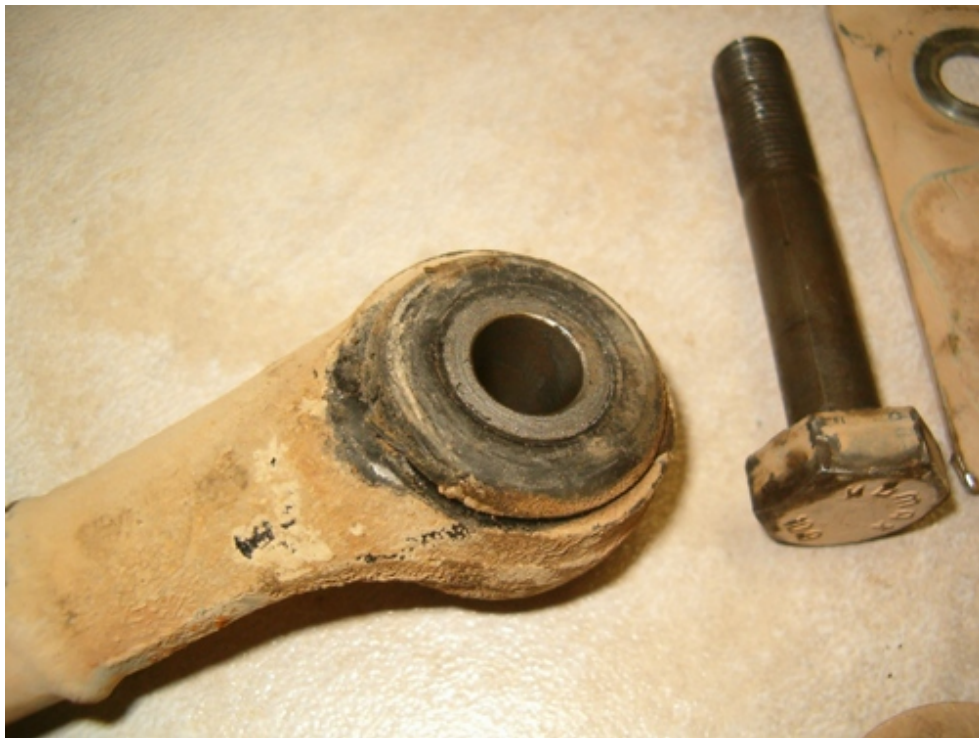
Also a close up of the bush and the 24 mm bolt. Both bushes will be renewed.

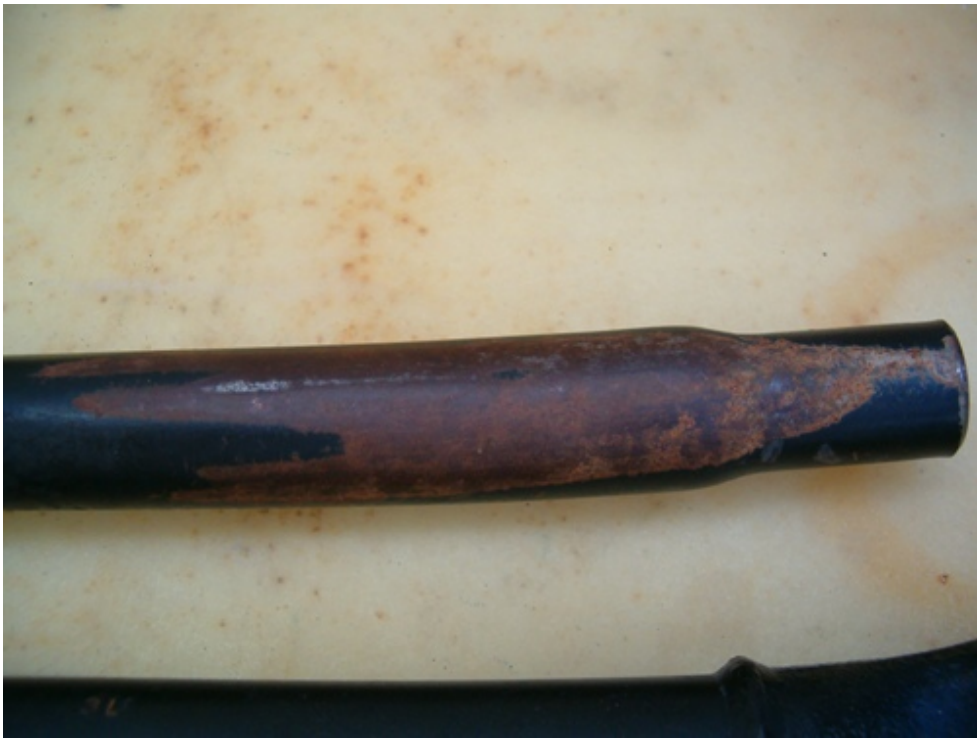
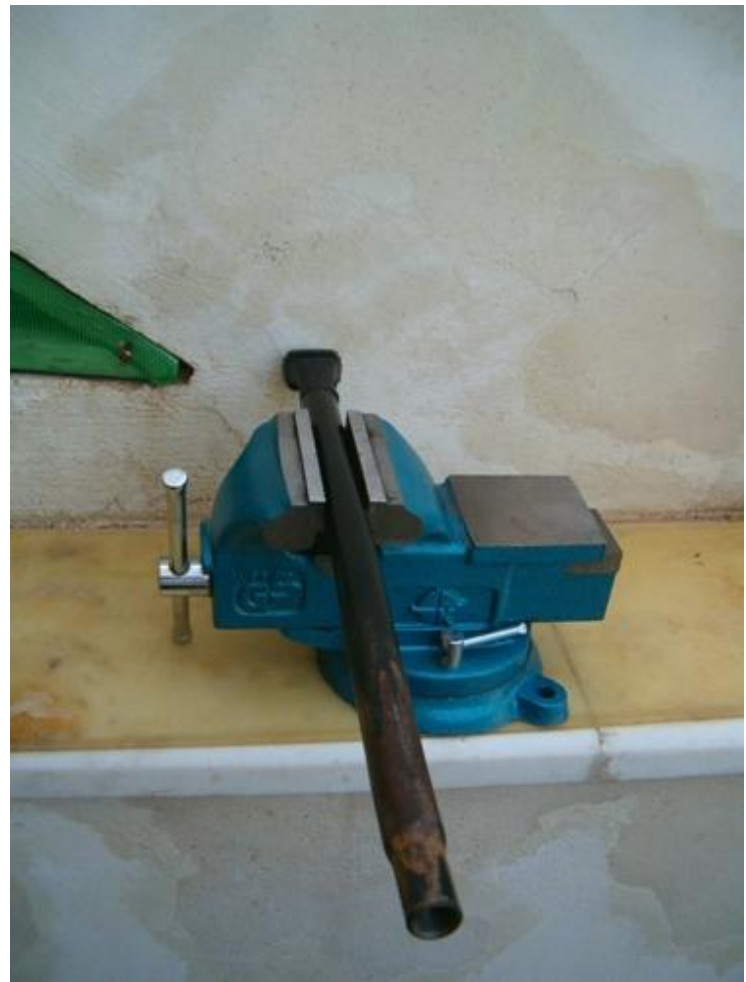
Small amount of rust which will be remove. Rust forms when original paint is rubbing on the protective flaps of the fender well

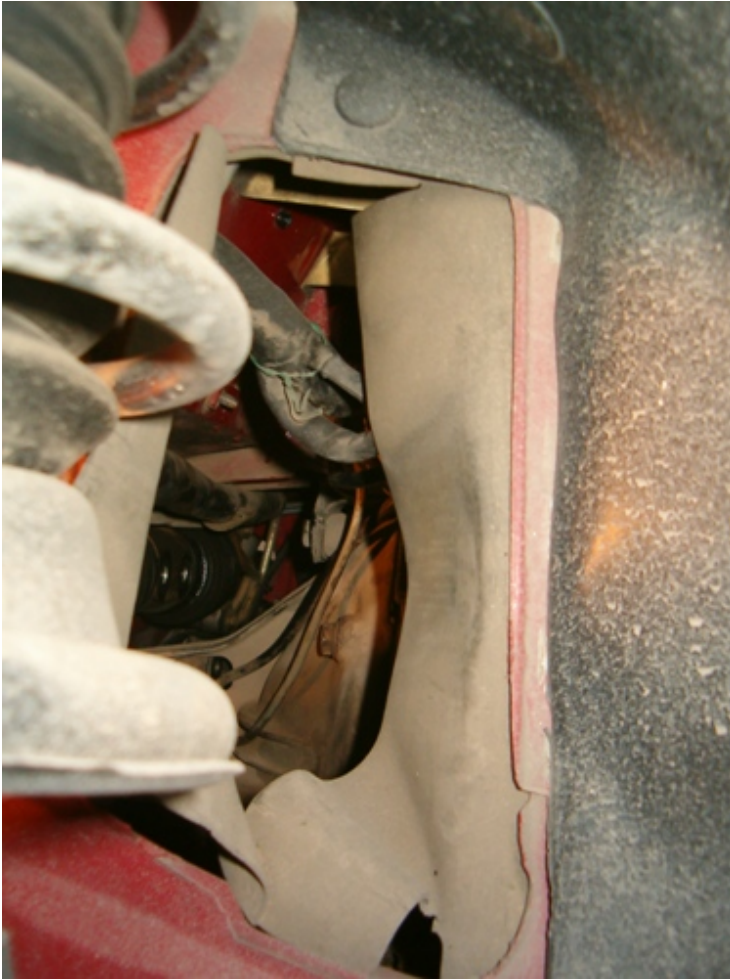
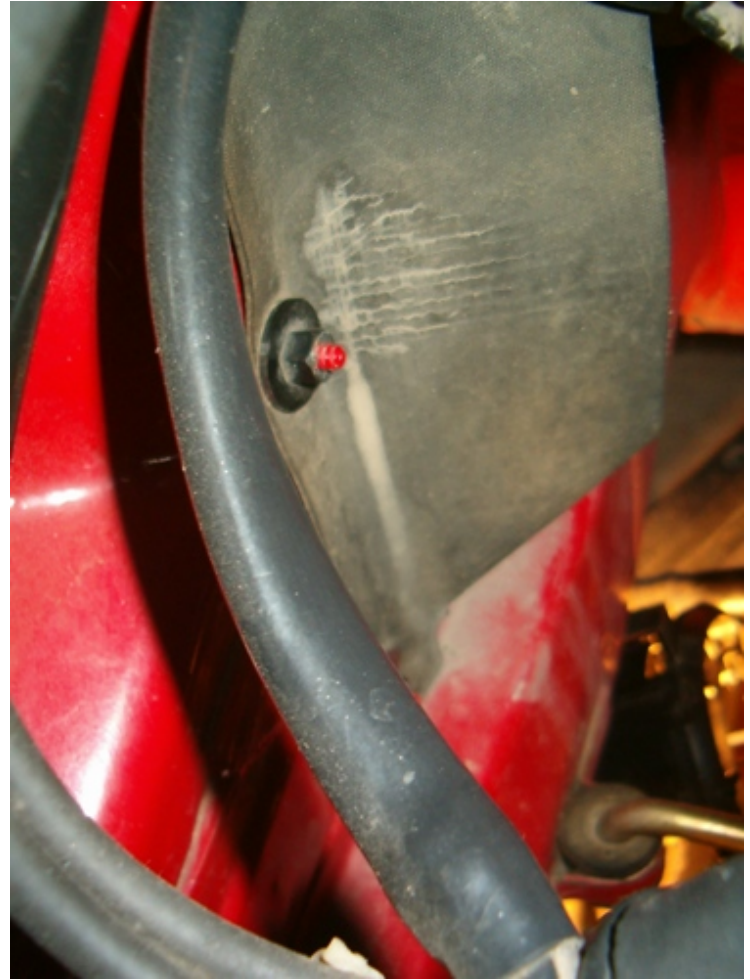
These are the worn out protection pads that will be replaced.

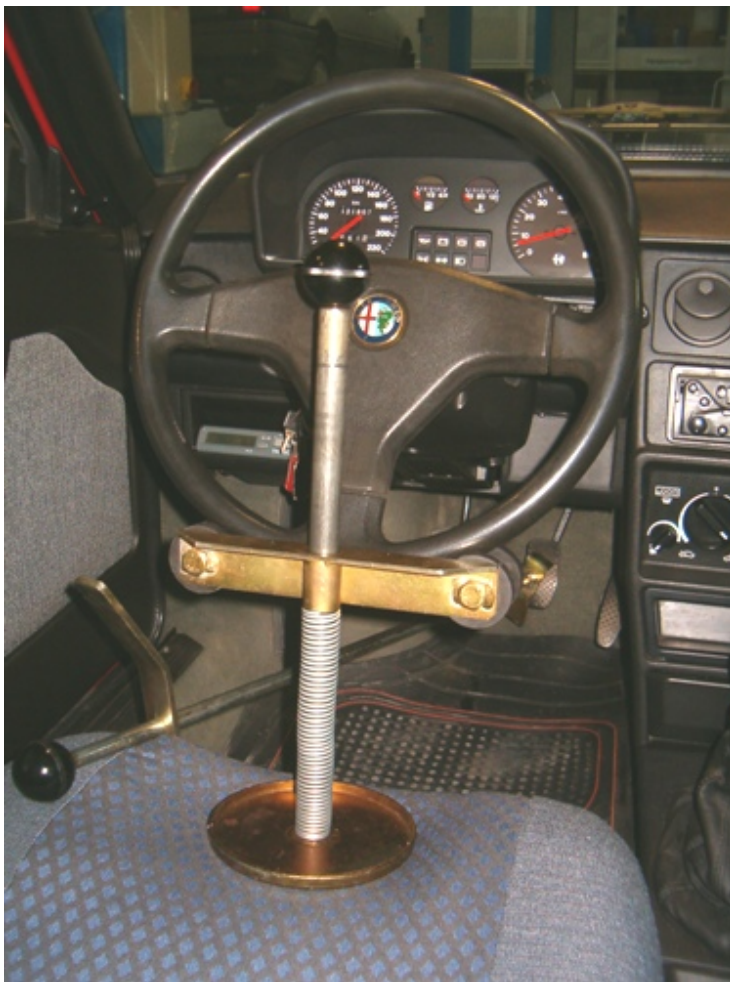
Very important task is to lock the steering wheel on the centre, so that **alignment is done with the wheel on the center**. Otherwise the car will coast straight and the steering will be out of centre. Also notice the bar fully depressing the brake pedal, so that any possible movement of the car is avoided.
