Installation on the vehicle

1991 Alfa 33 1.4 IE

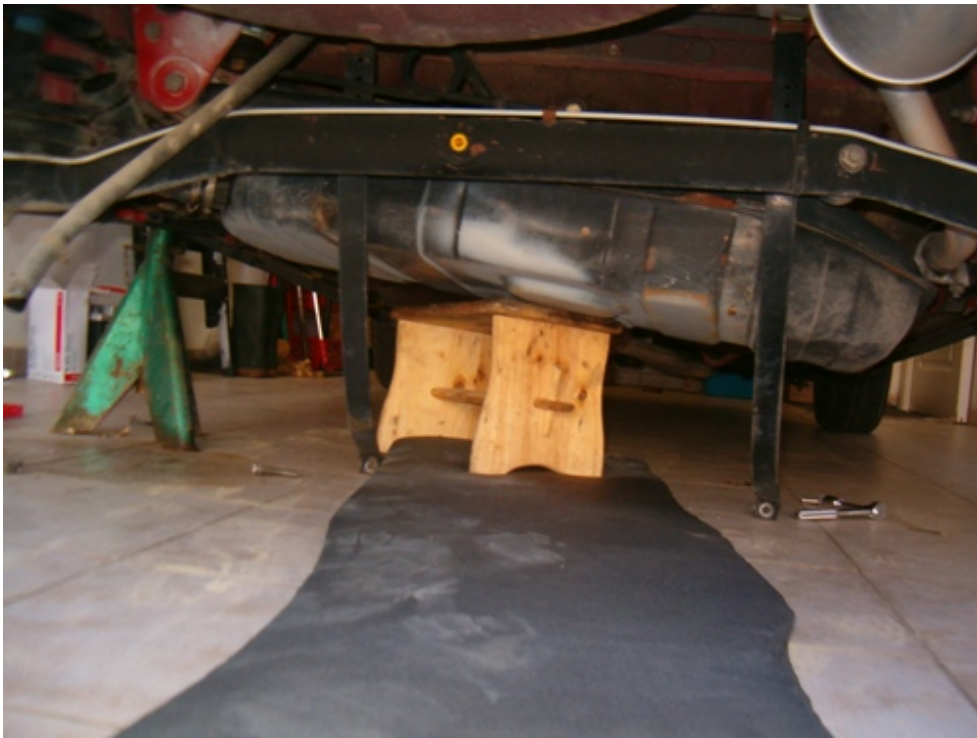
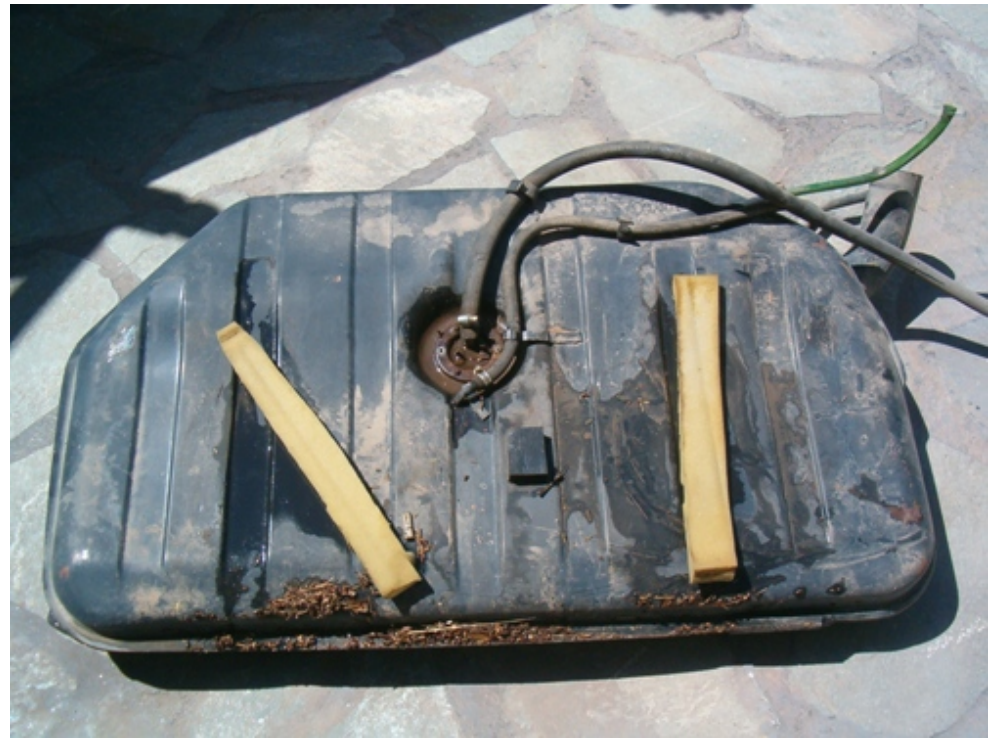
Lets begin by removing the fuel lines along with the plastic fuel filler neck; should it be necessary renew them. Mine showed crack signs so they will be replaced with new ones.

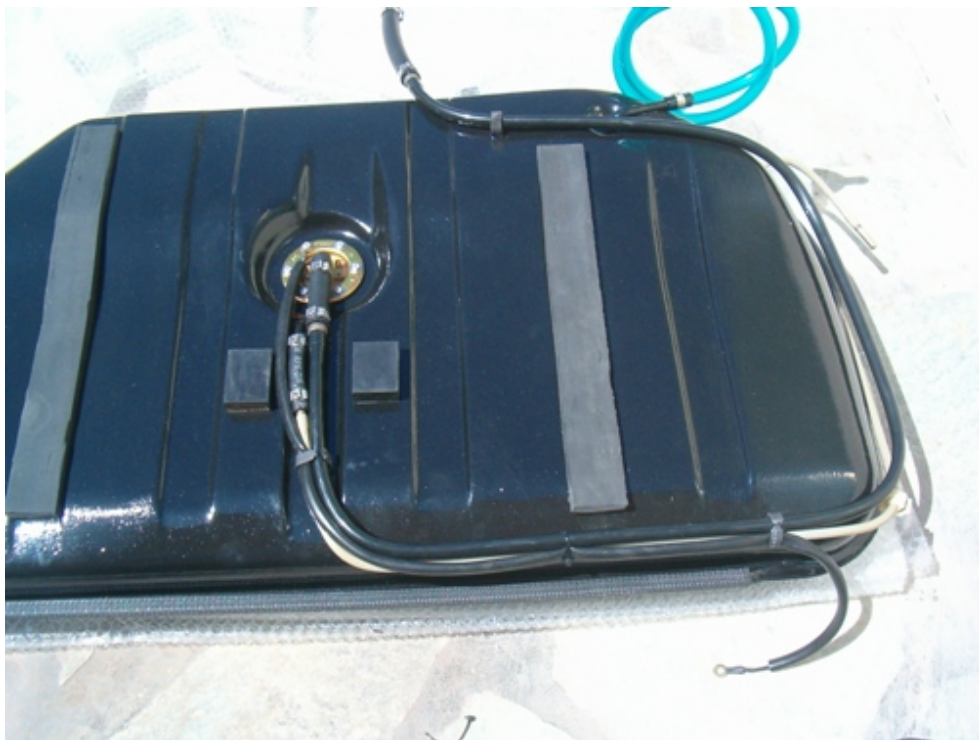
Undo the straps holding the tank in place and remove tank from the car. Notice again the different routing of the temporary tank.

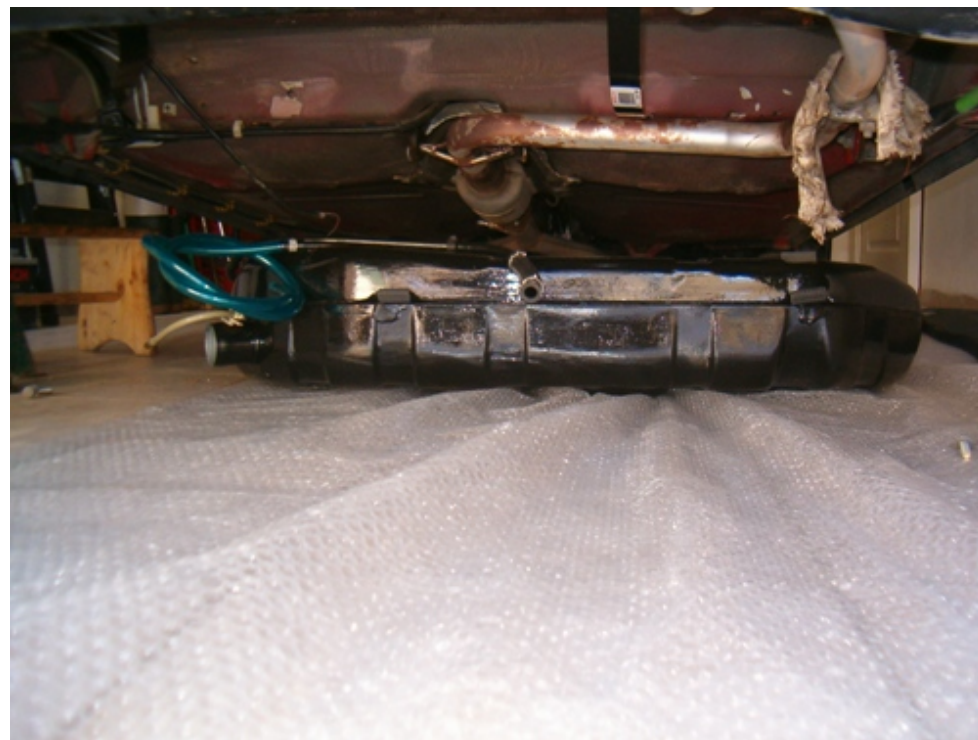
I have integrated the earth lead of the tank to the rife routing. This way I won't have to remove the bolt from the sender unit the next time I remove the tank; I should remove it from the chassis which is far easier.

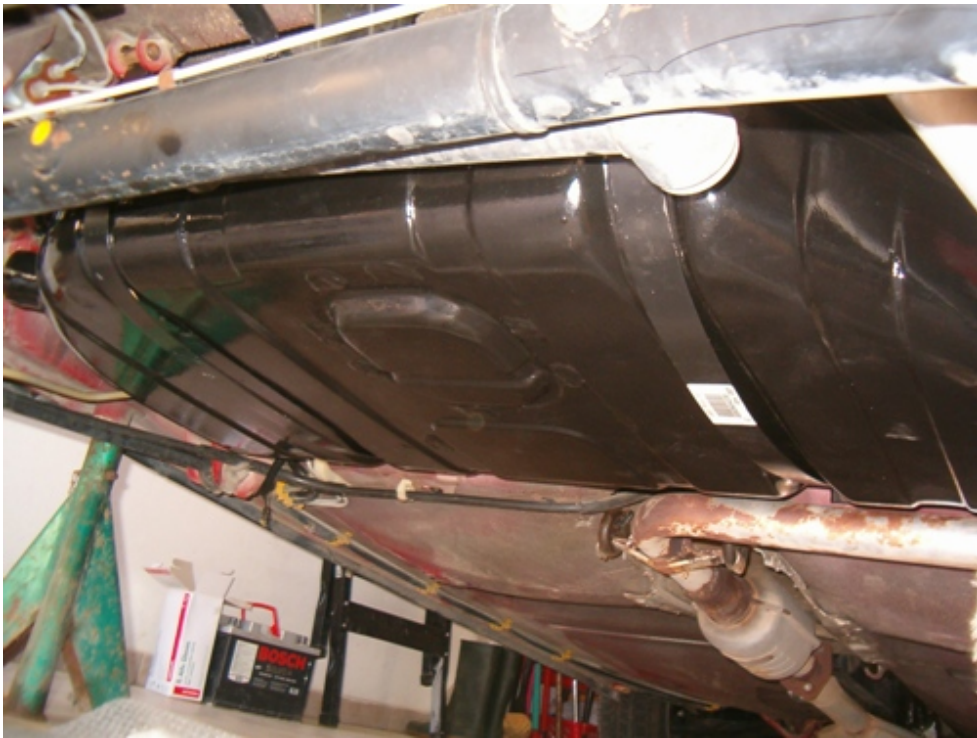
All the underside covered by the tank has been cleaned and new straps are ready to keep the tank in place

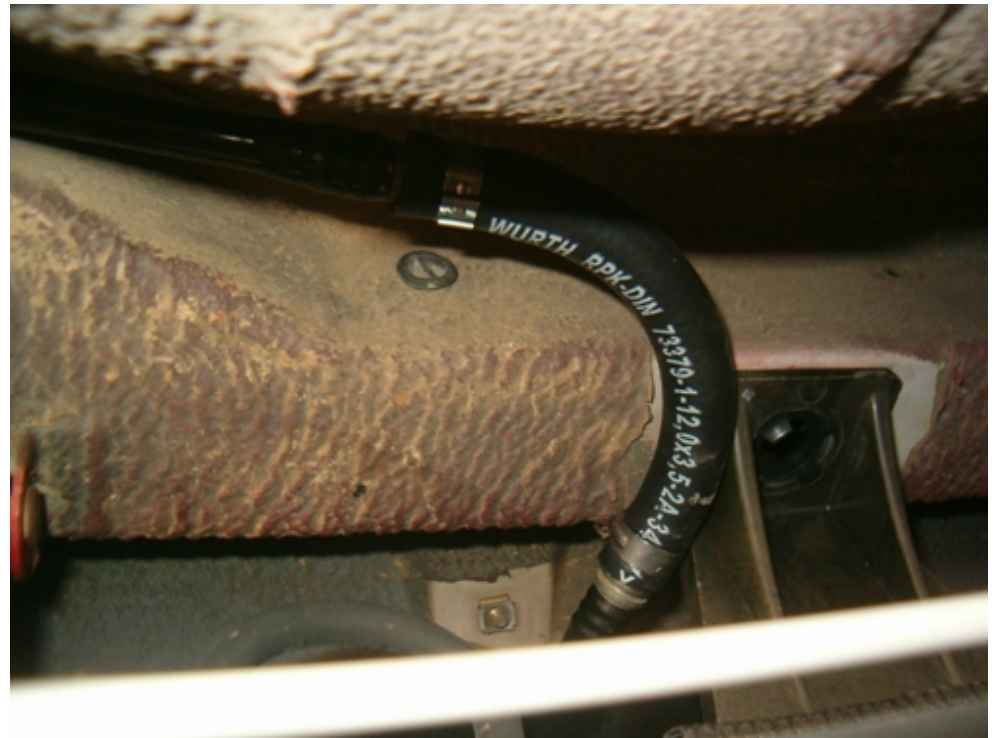
Just seated in place...

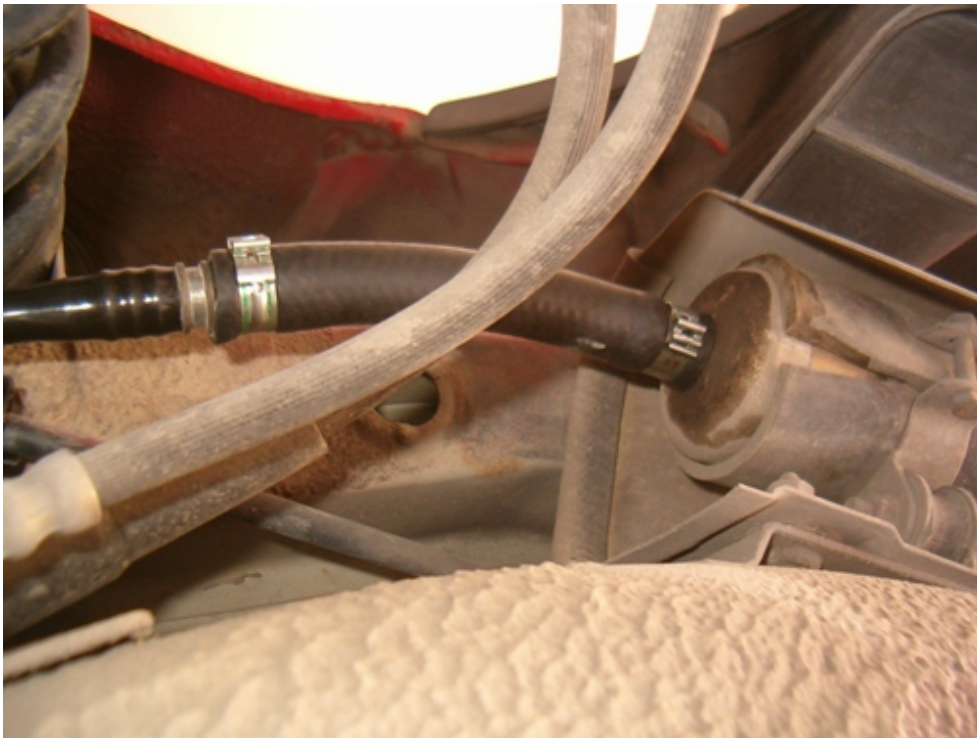
Fuel feed line is attached and properly clamped

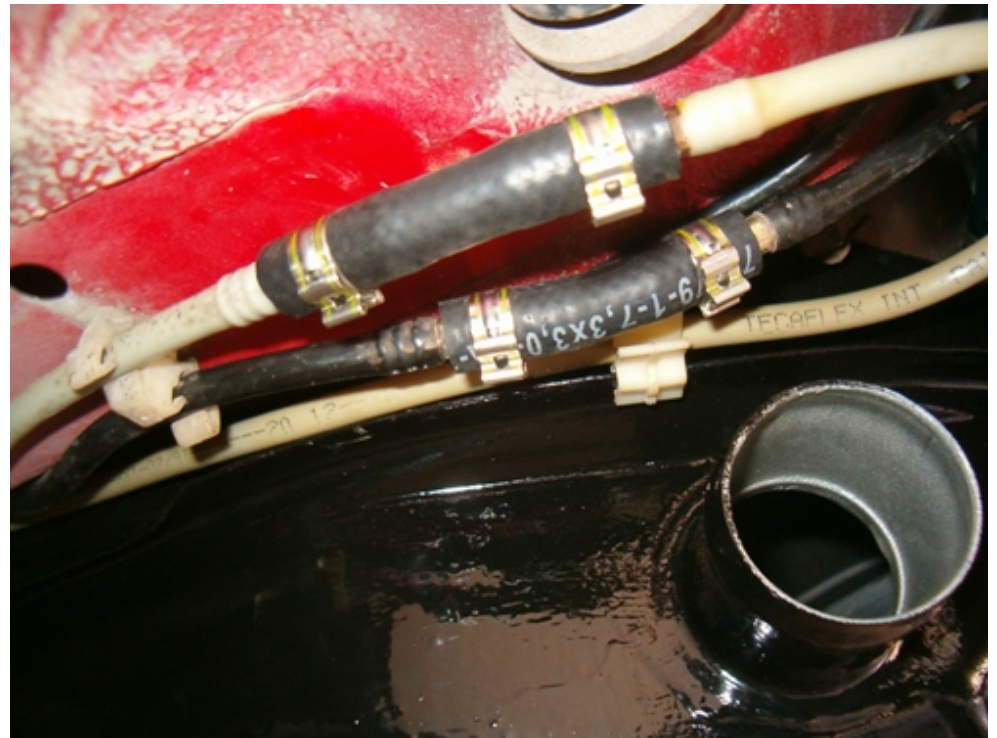
The same done to the fuel pump rubber line

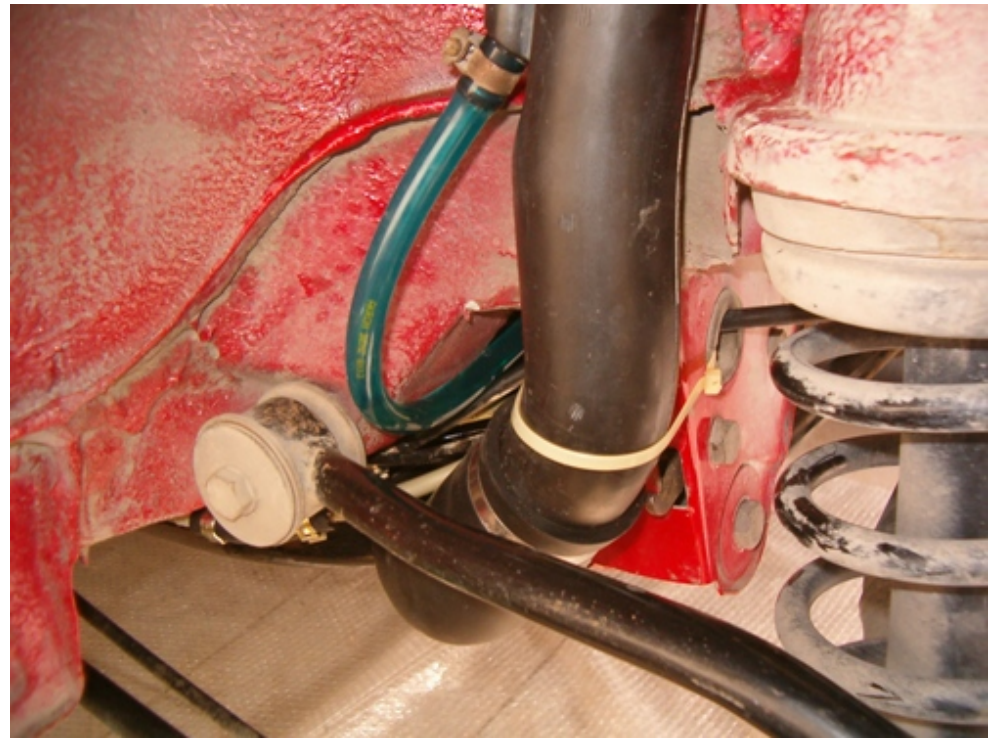
A new fuel filler neck will be used

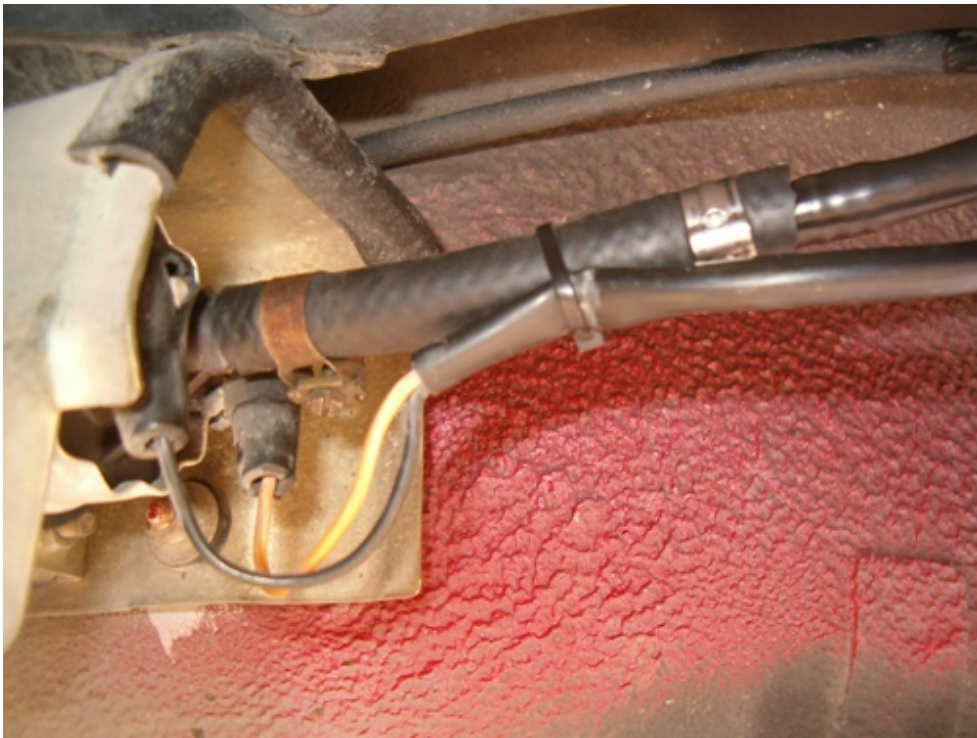
Filler neck is in place with clamps properly tightened, blue relief hose attached to filler tube and properly zip tied.

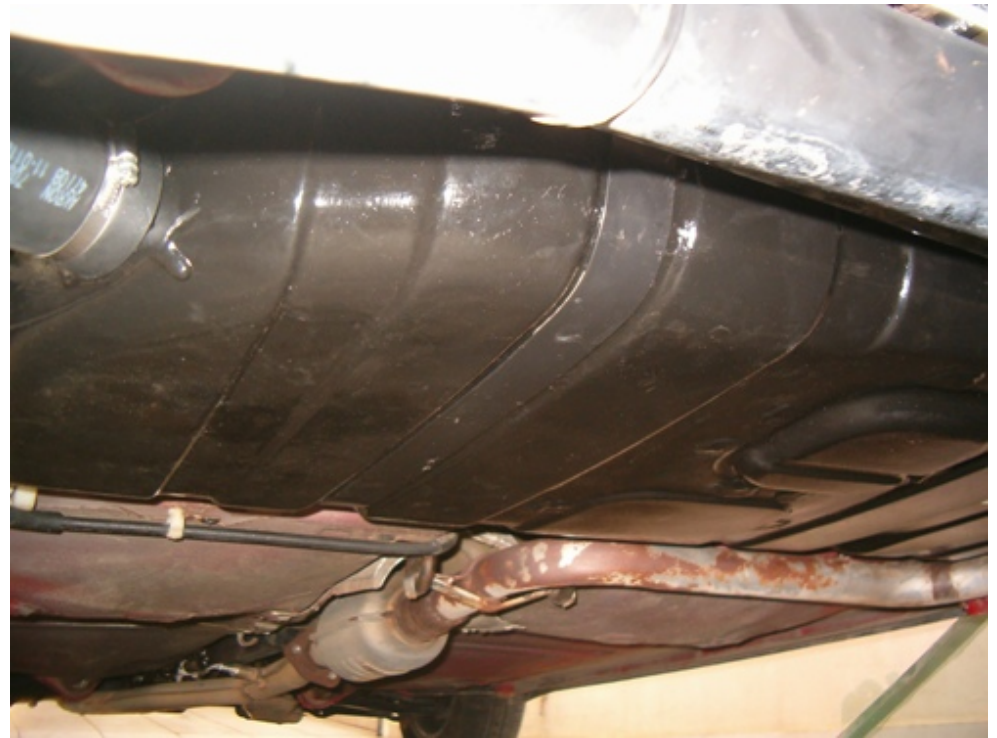
Finally a new hose is also installed to the fuel pump outlet.

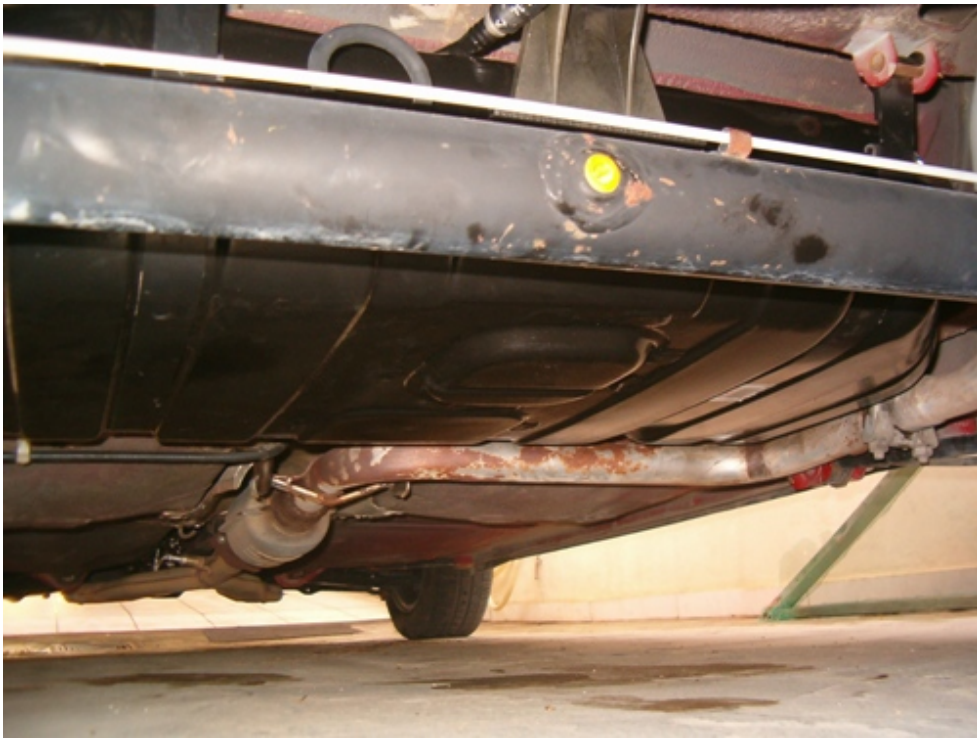
Fuel tank straps are fully tightened.
