Let's start renewing parts. As a first step I chose to deal with the front of the ABS system by rebuilding and restoring front wheel hubs & half-shafts. The main difference compared to the non-ABS version is the teathed CV joints and the ABS wheel sensor bracket on the wheel hub. The rest of the parts like wheel bearings and brake calipers remain the same.

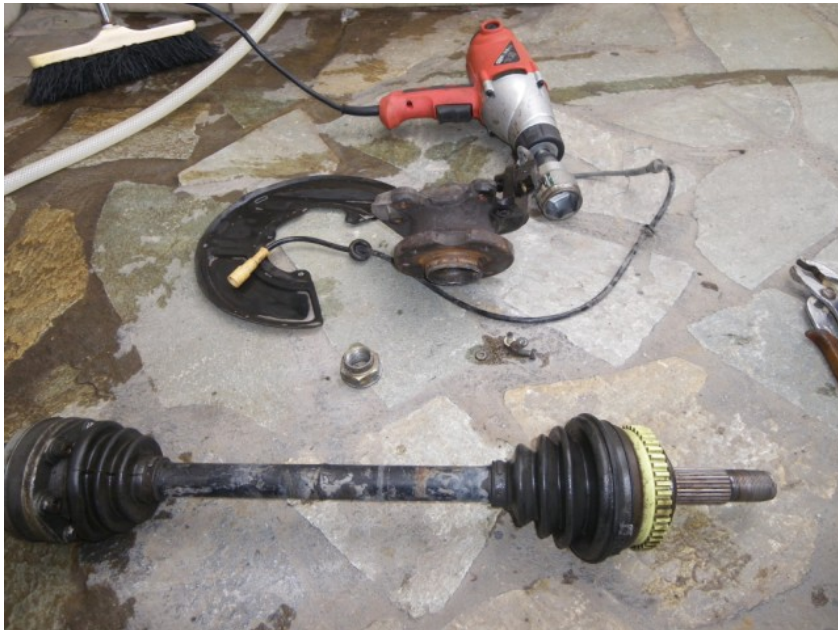
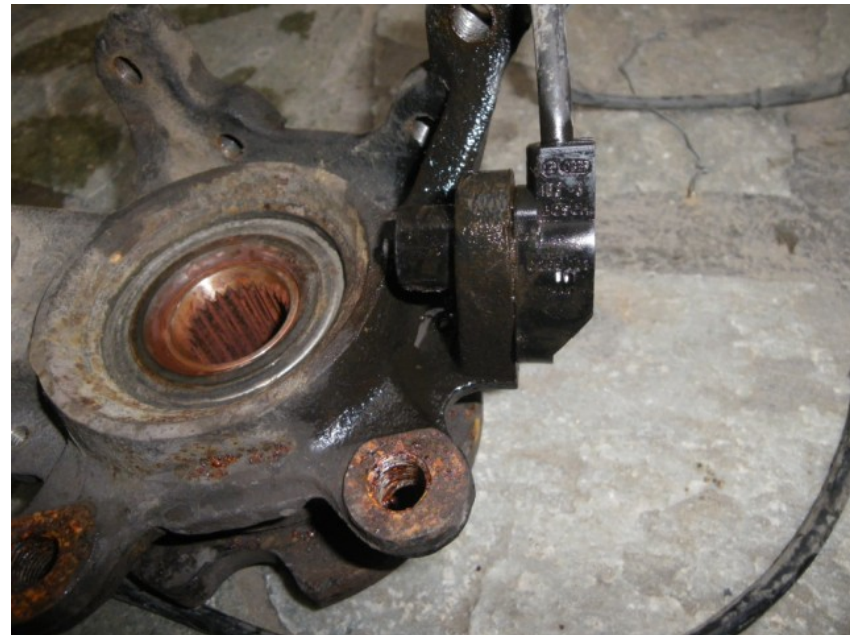
Clearly shown are the ABS CV joint teeth on the bottom of the left photo – on the right you see the extra bracket on the ABS version of the hubs where the induction sensor is fitted.

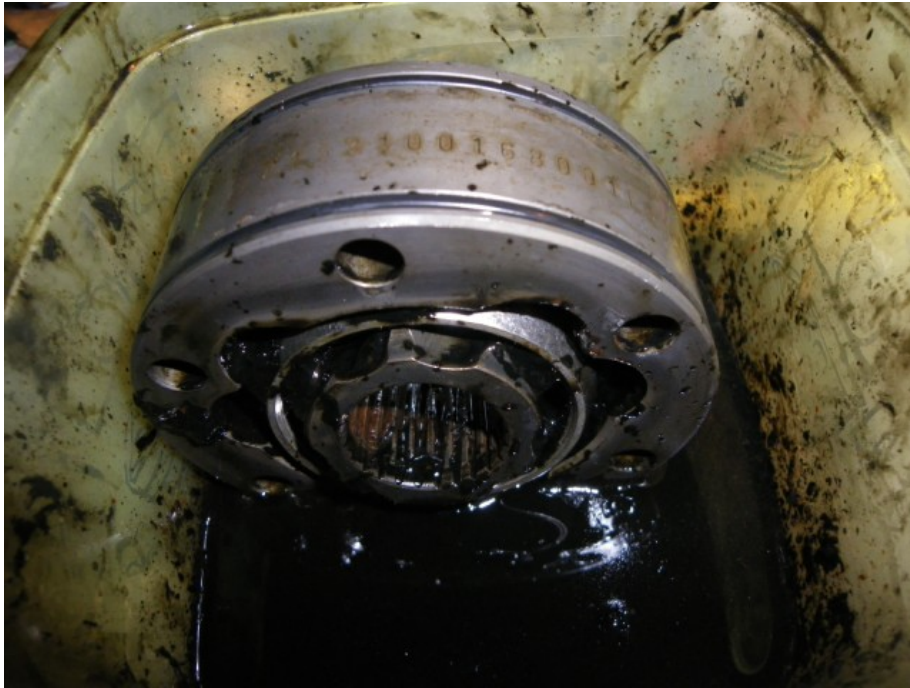
Working on the bench, we will take everything apart. I first chose to take apart the inner CV joint. With a light tap on the CV cases you may expose the CV internals. Wipe off the graphite grease and you will clearly see the lock ring which keeps the shaft attached to the CV joint on the gearbox proximity. Remove the lock ring using expanding pliers and some light tapping, the shaft will pop out of the CV joint.

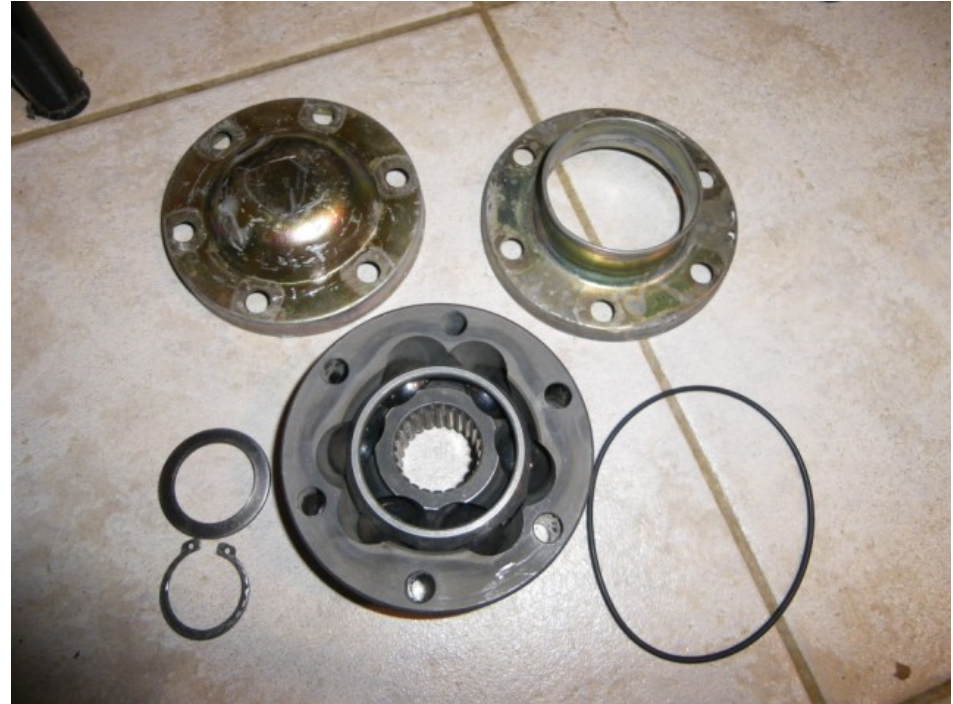
The inner CV joint is now separated from the shaft and it is now soaked in strong degreaser in order to clean it thoroughly.

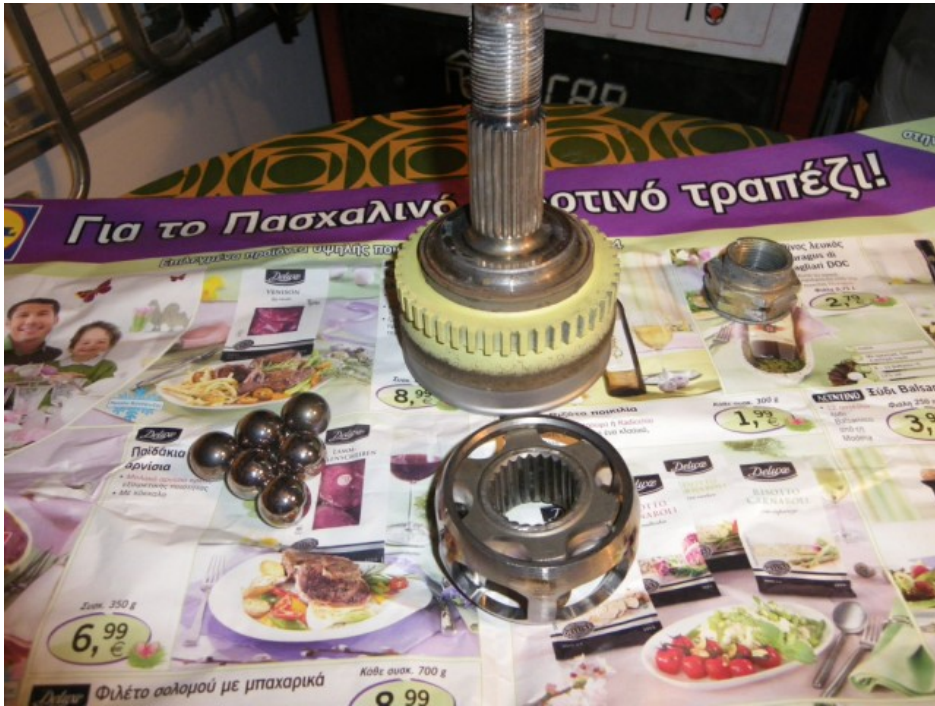
After cleaning the mess, there are the parts of the CV joint. I have chosen to renew the large o-ring which appeared to be worn out by letting grease out.

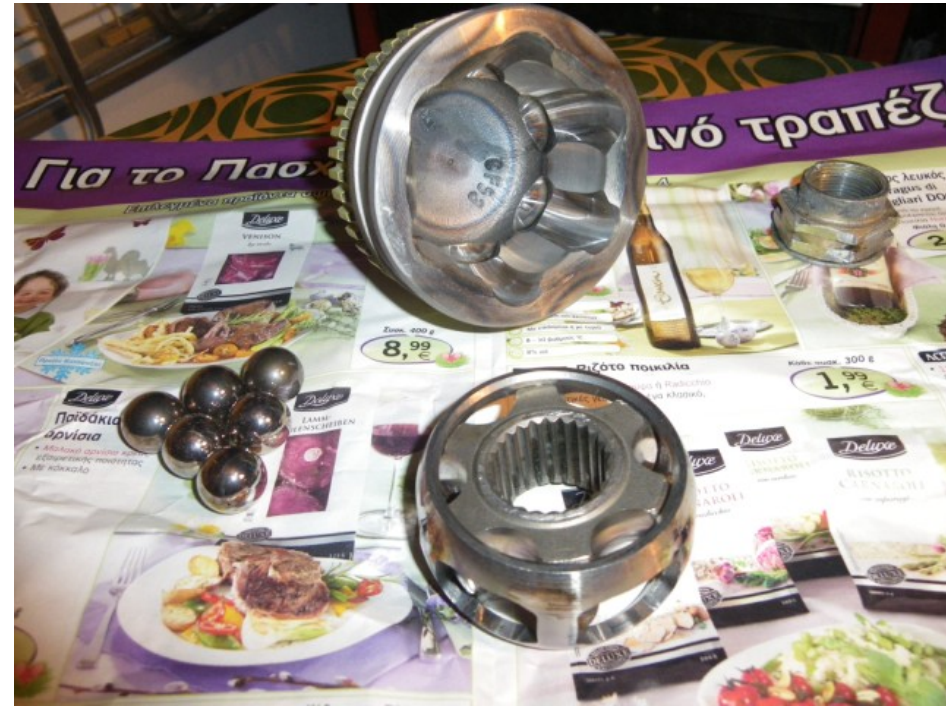
I have done the same for the outer CV joint meaning degreasing and cleaning it thoroughly.

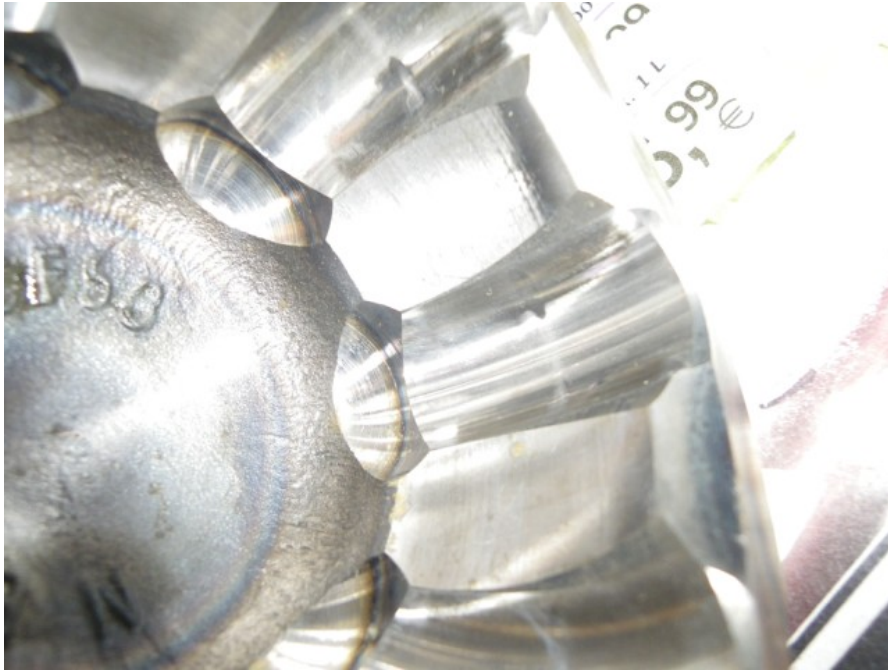
A closer photo of the CV joint.

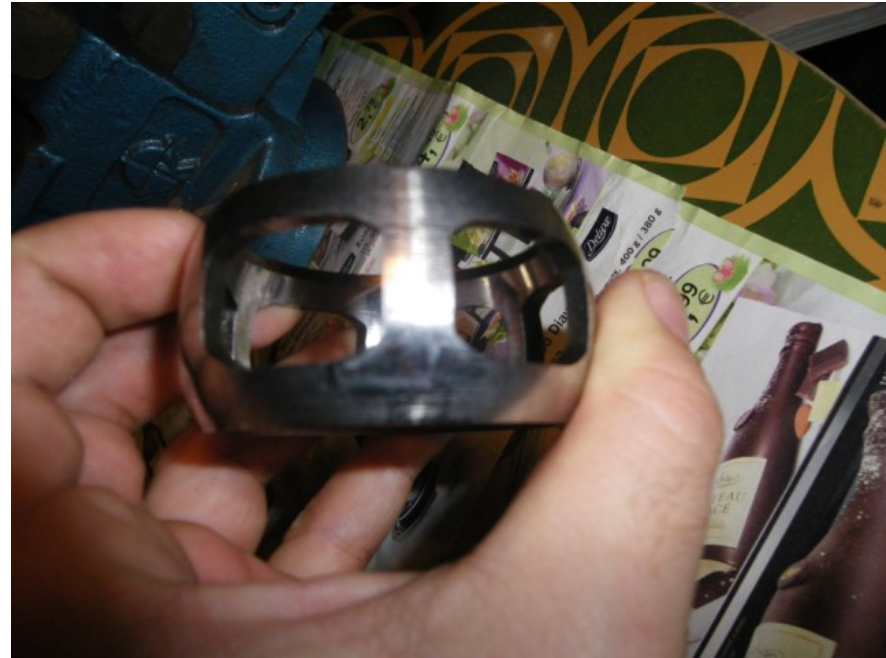
I have demonstrated this close-up of the CV internal cavity in order to show the wear on the recess of the wall.

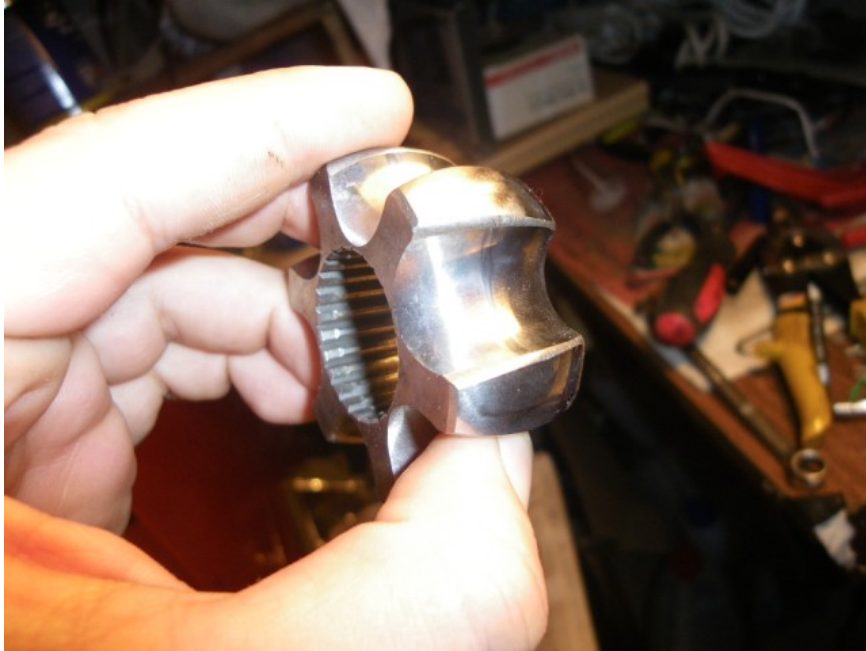
This is the balls carrier ...

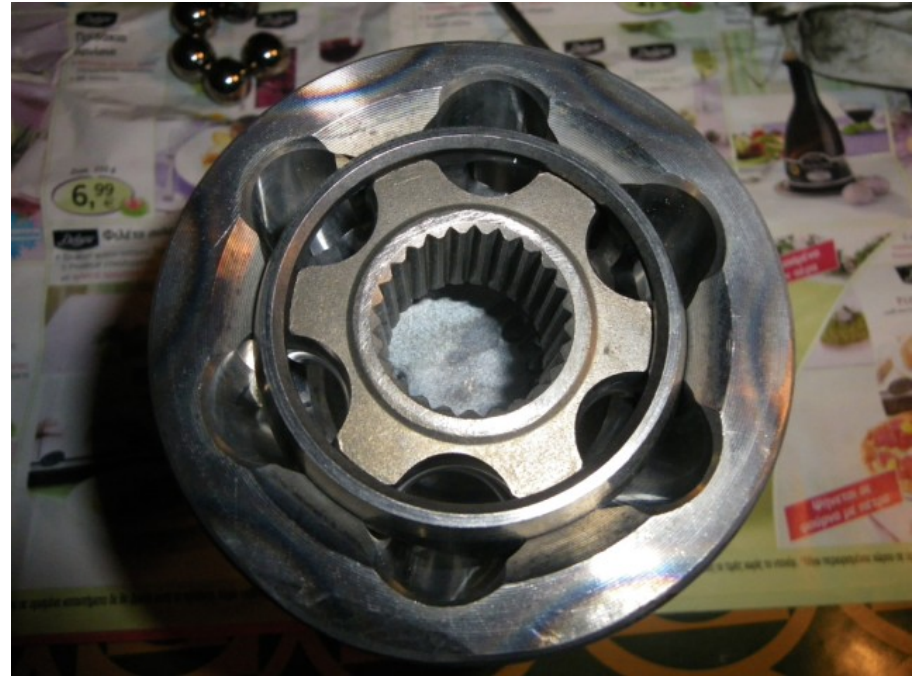
... and here you can see the splined part of the joint where the shaft enters

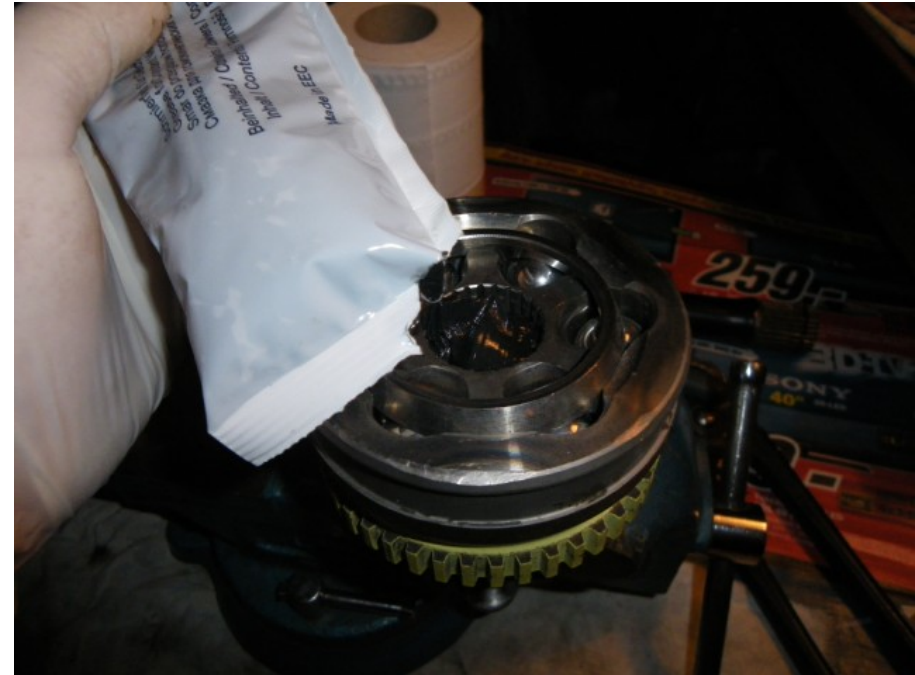
Ready for assembly. New CV boots and freshly powder coated shafts.

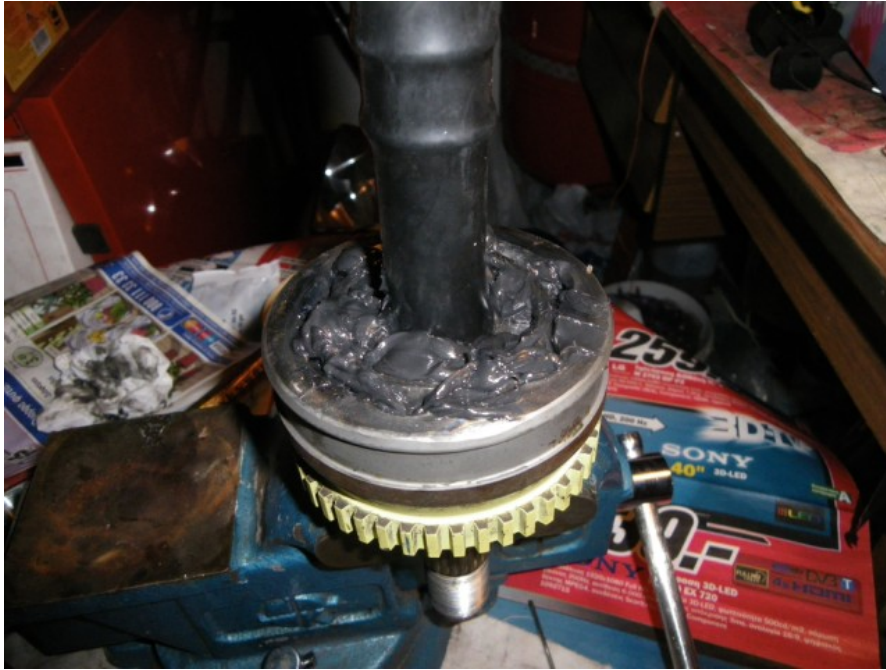
Fill in grease from the splined opening. Be sure to press in grease until you see it coming off the balls. You should now stop ...

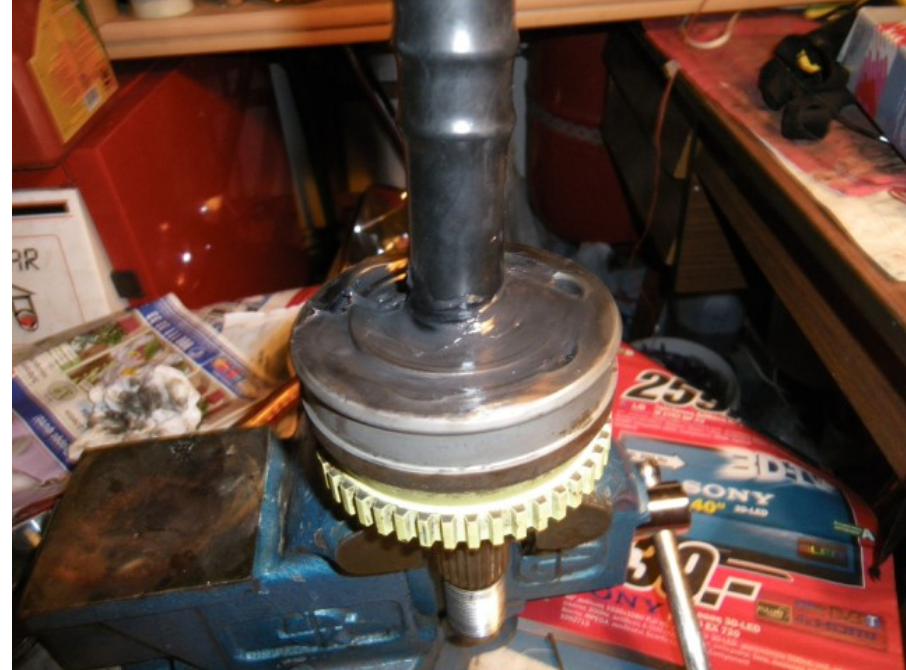
... and press in the shaft. By inserting the shaft you will force out more grease and it should look like above.

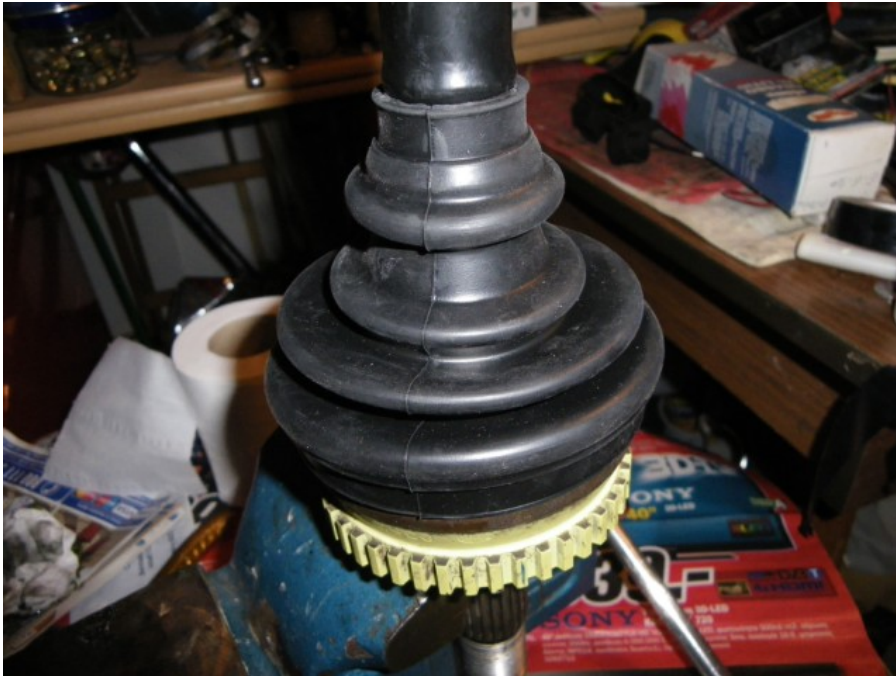
Flatten the excess grease as the photo shows. Although the grease is generally friendly to the CV boots, we don't want direct contact here. So it is better to have grease applied only on the CV joint

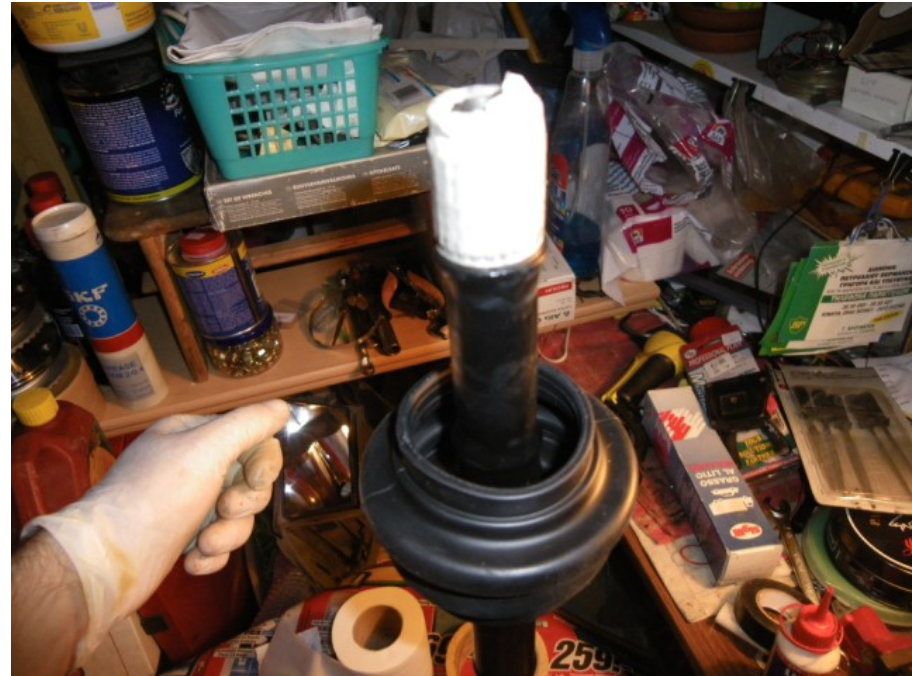
Slide in the outer CV boot and be sure to have it rest on the designated groove on the shaft and CV joint.

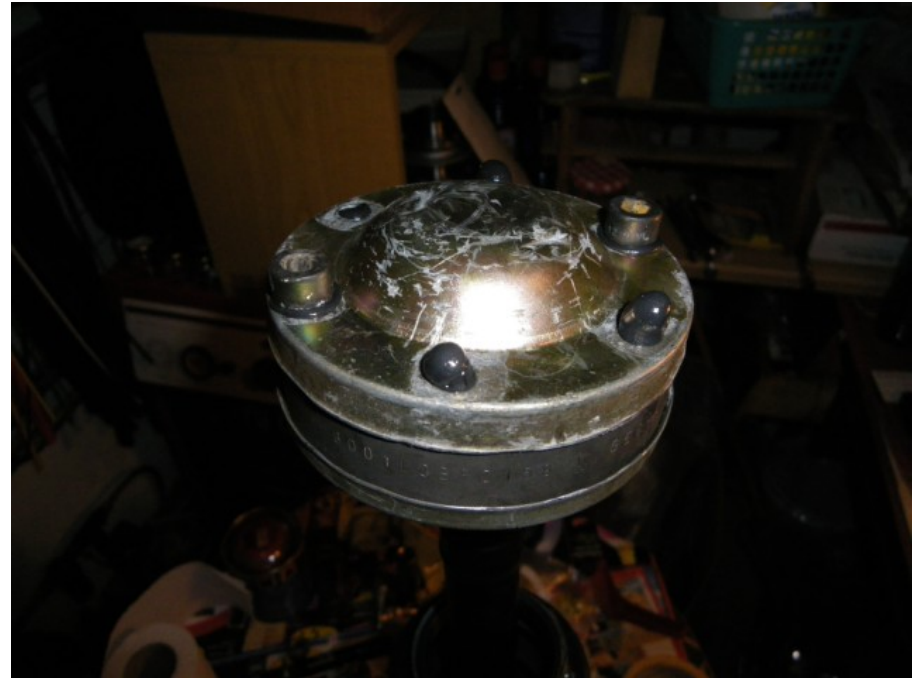
Under the same practice press in the inner CV joint and secure it with the relative lock washer. Then apply grease from the top by pressing it in and keeping an eye from the under until it shows up.

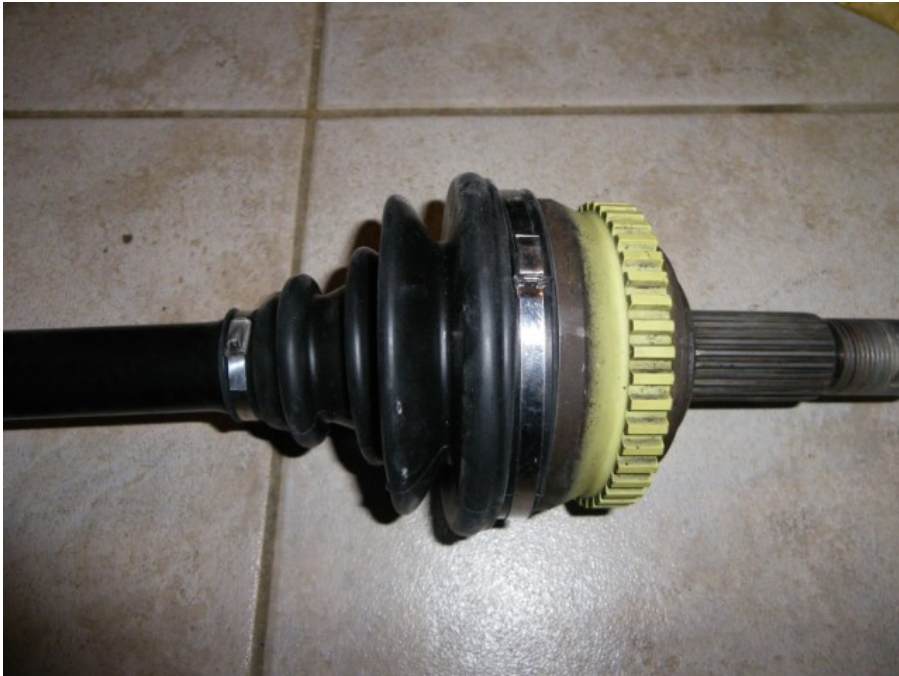
Install the CV cases and keep them aligned to each other relative to the joint by placing two CV bolts. This way the orientation of the two cases and the CV joint body will be straight.

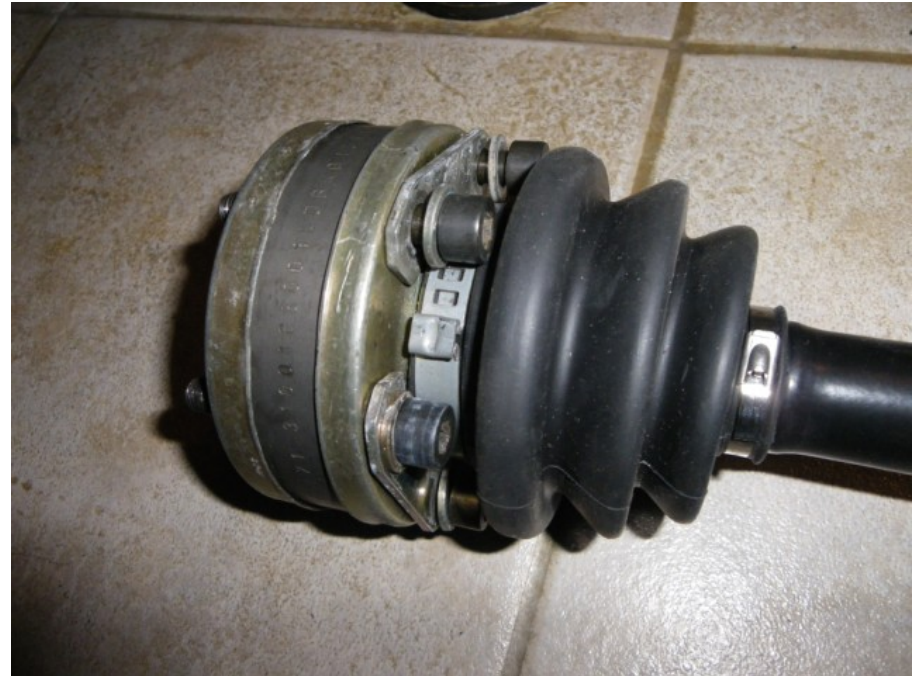
As a last action we will install the CV boots bands for the outer joint ...

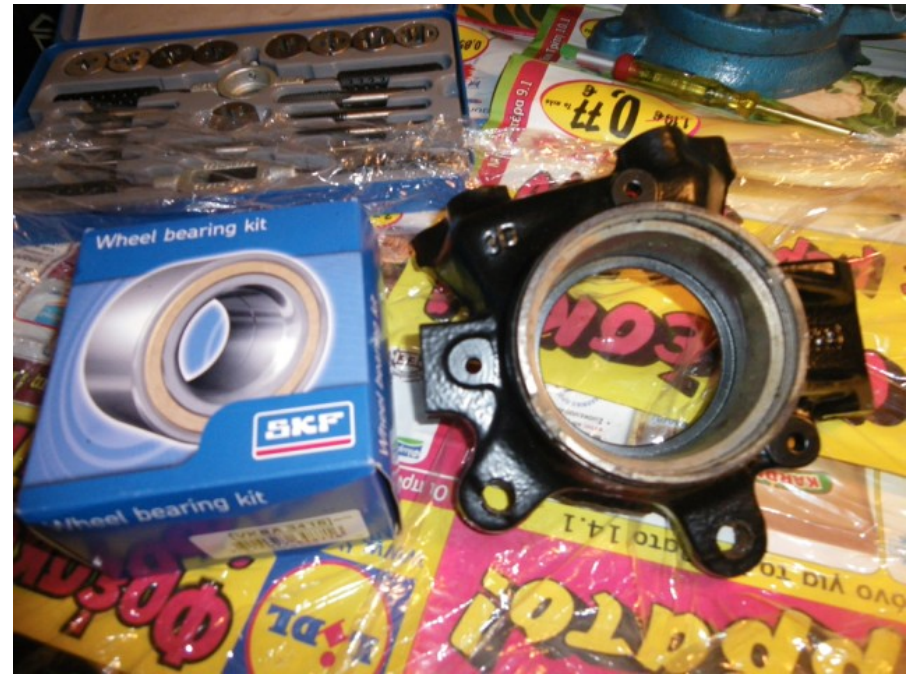
Last but not least are the hubs. Here you can see them as they came off the donor car. They will be taken to the sandblaster – I have masked the places I don't want to be affected like the bearing cavity or the hub carrier.
