## 1975 Alfasud 1.3 ti - The return of the King

### Body preparation

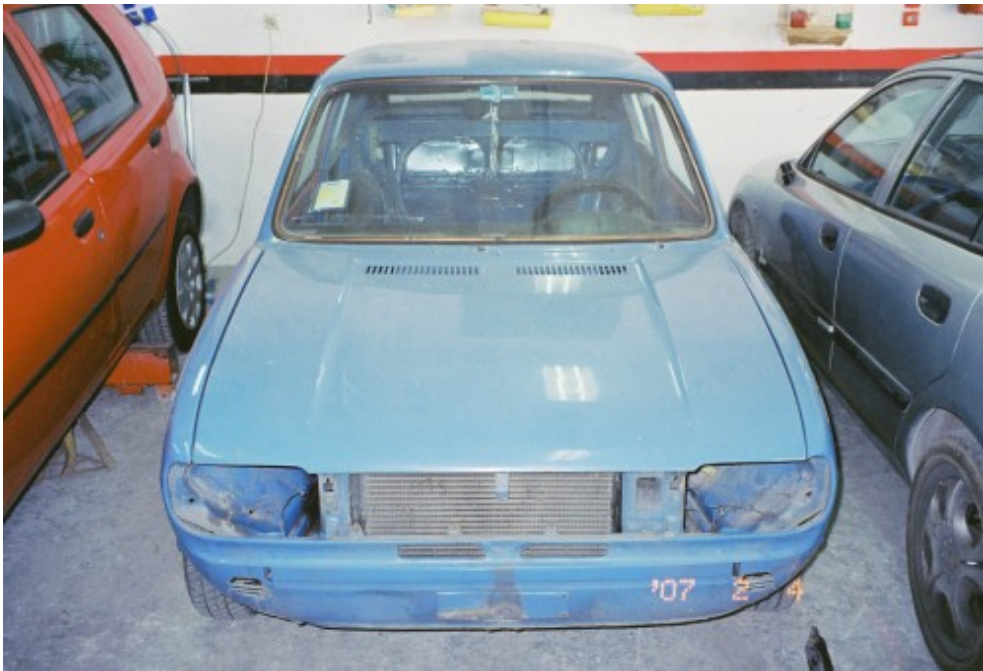
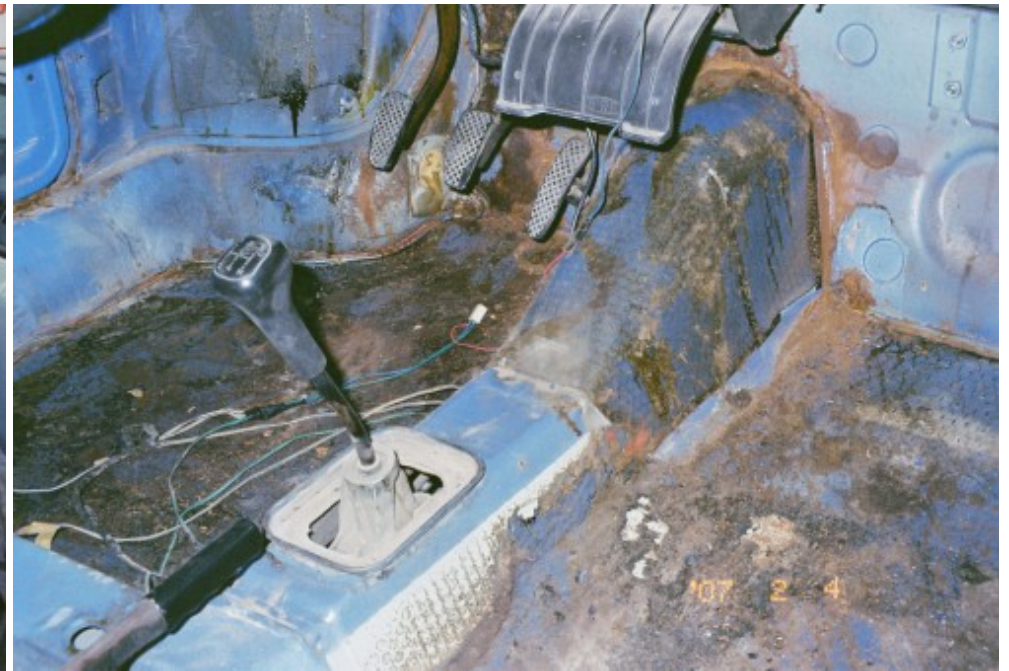
The interior has been completely removed in order to see the extend of rust. There are areas that have not been affected but other areas where structural meaning is essential, rust has eaten sheet metal rendering the car dangerous to drive.

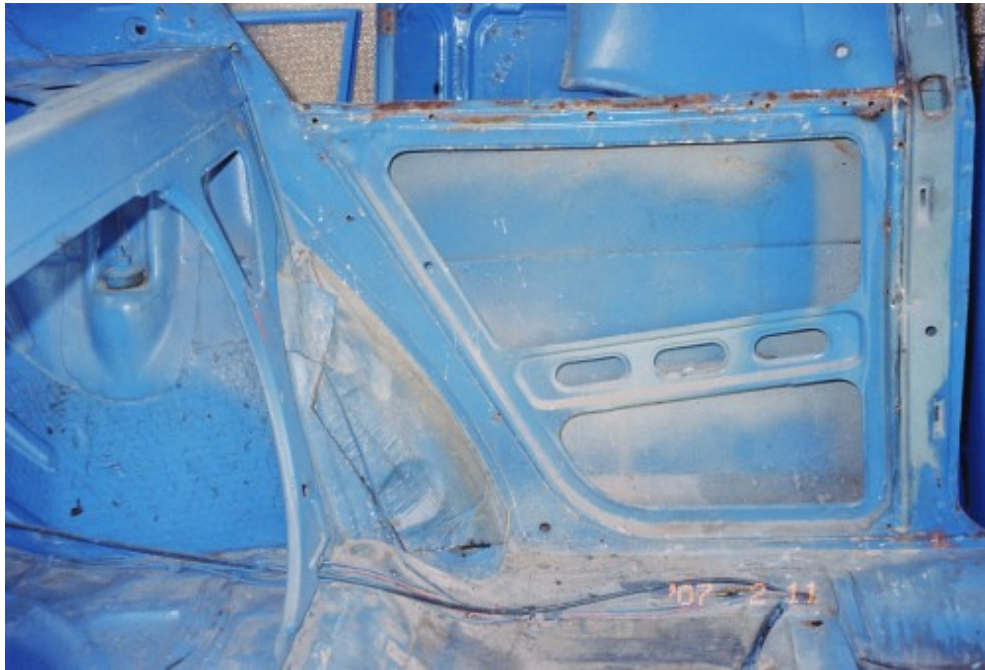
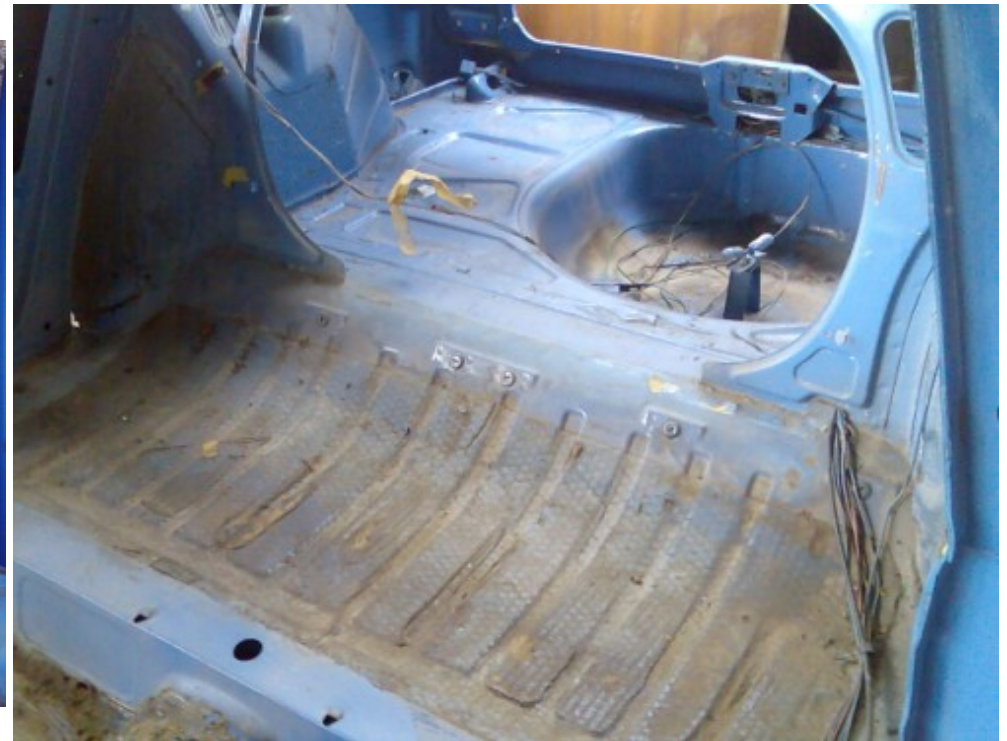
Tar sheets have been removed and the extend of rust is easily seen . Sills have been structurally weakened and for sure new metal will replace the old rusted sections

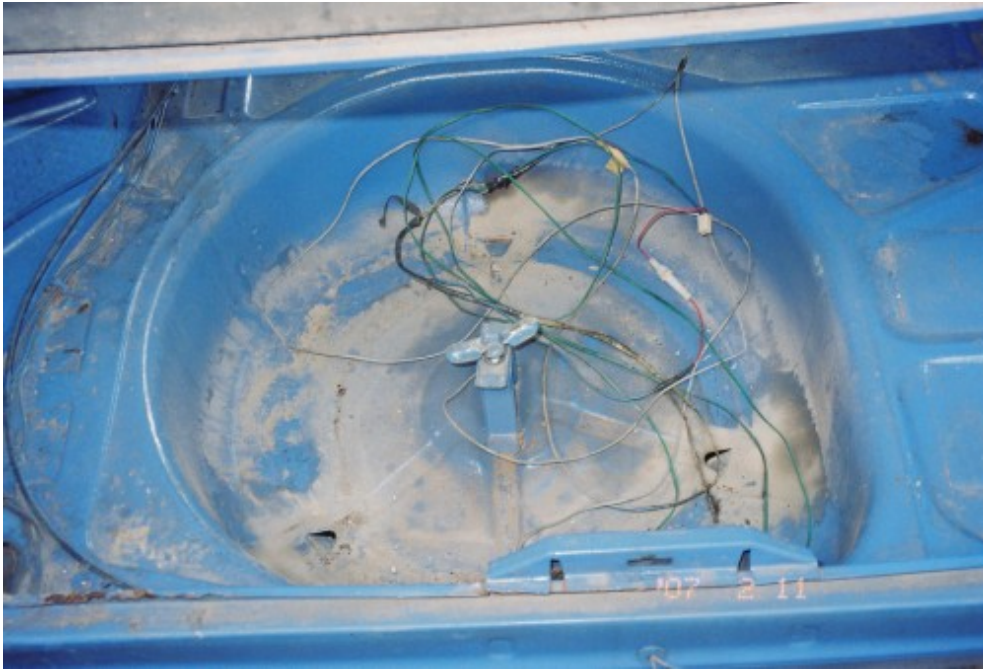
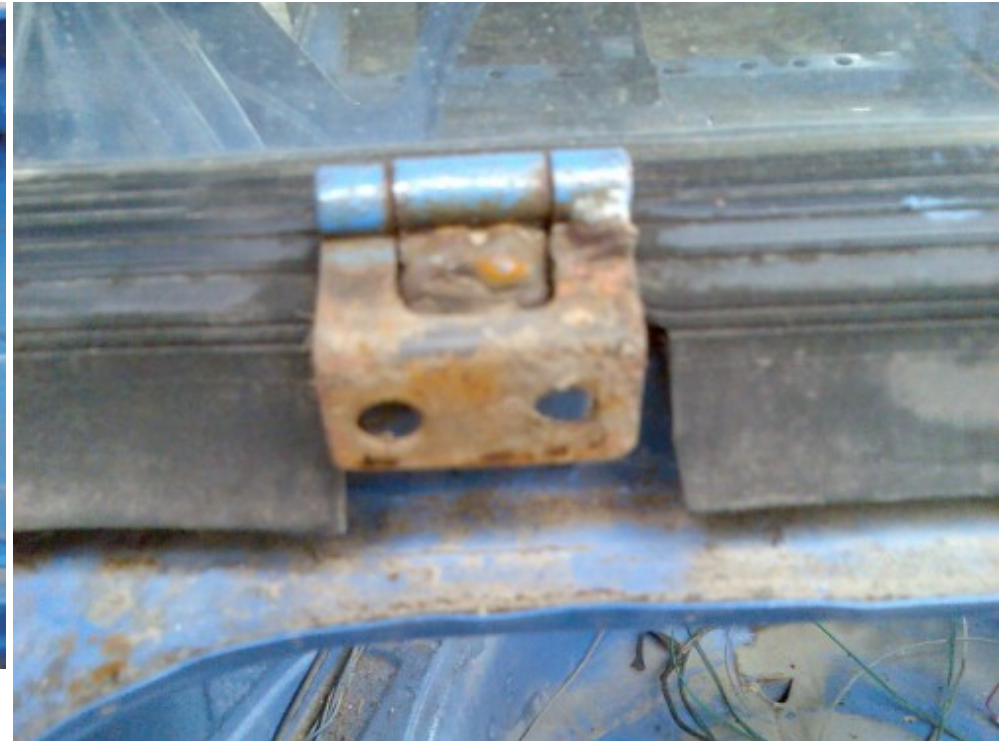
The spare wheel well appears to be in good order. However the wheel arches lips, inner wheel arches, bootlid hinges, lower valances, front chassis rails just to name a few really need attention and new metal welded
