Door Hinge Replacement

The purpose of this guide is to show the process under which the original door hinges were replaced with new ones. I will demonstrate the replacement process for each door by beginning from the front-left door.

1991 Alfa 33 1.4 IE

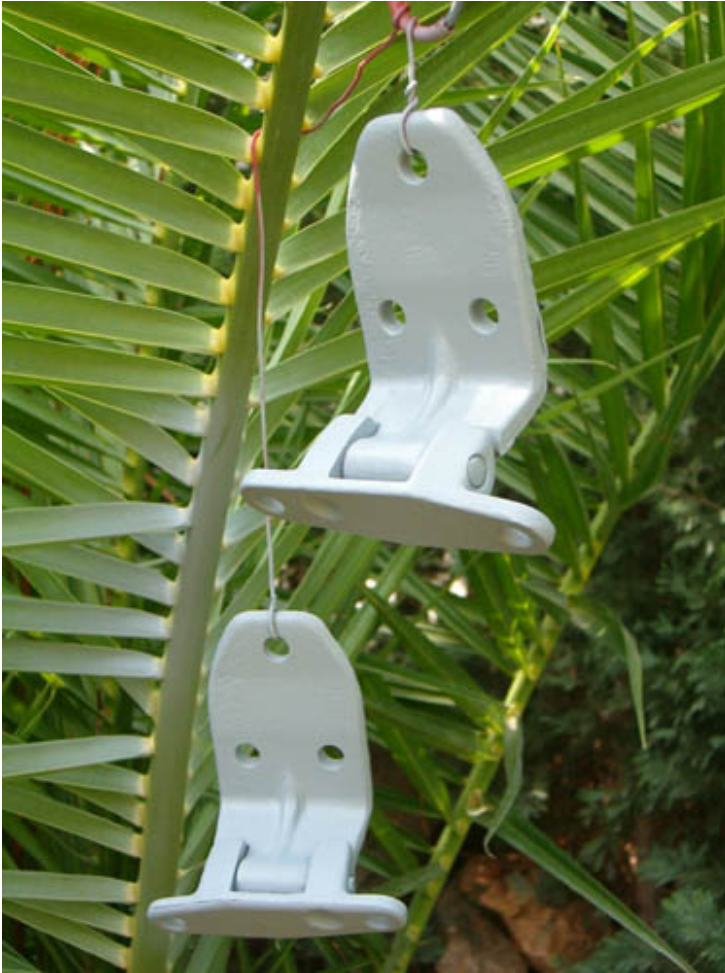
Here are the hinges after the first coat of primer. Another layer will be added after 24 hours...

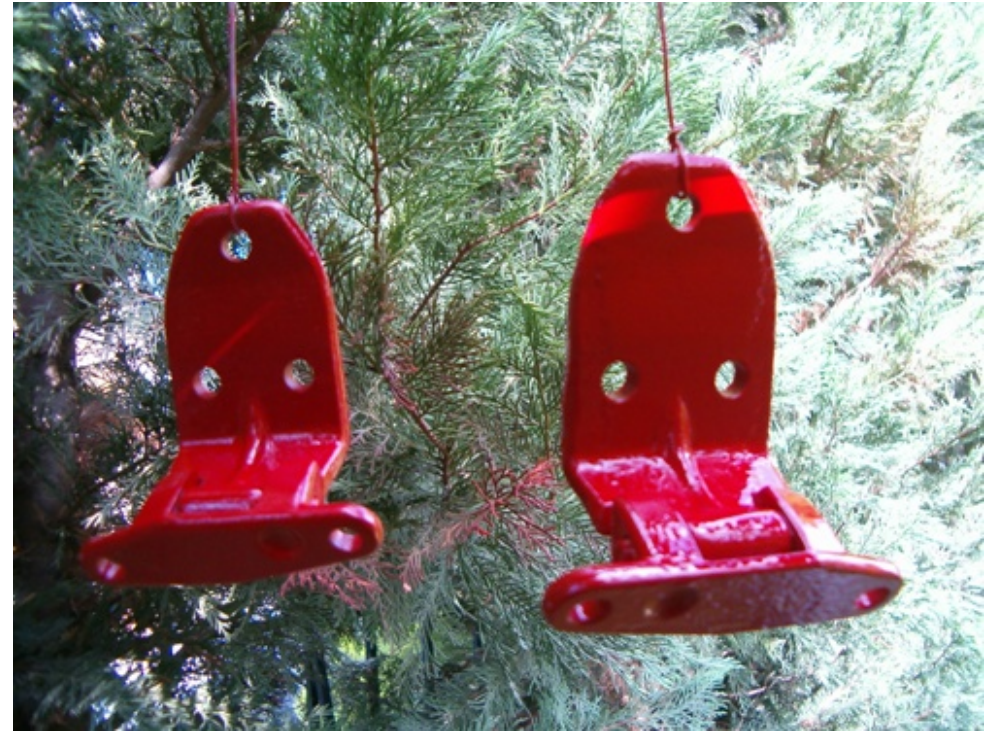
...and two coats of red paint are sprayed with 24 hours difference

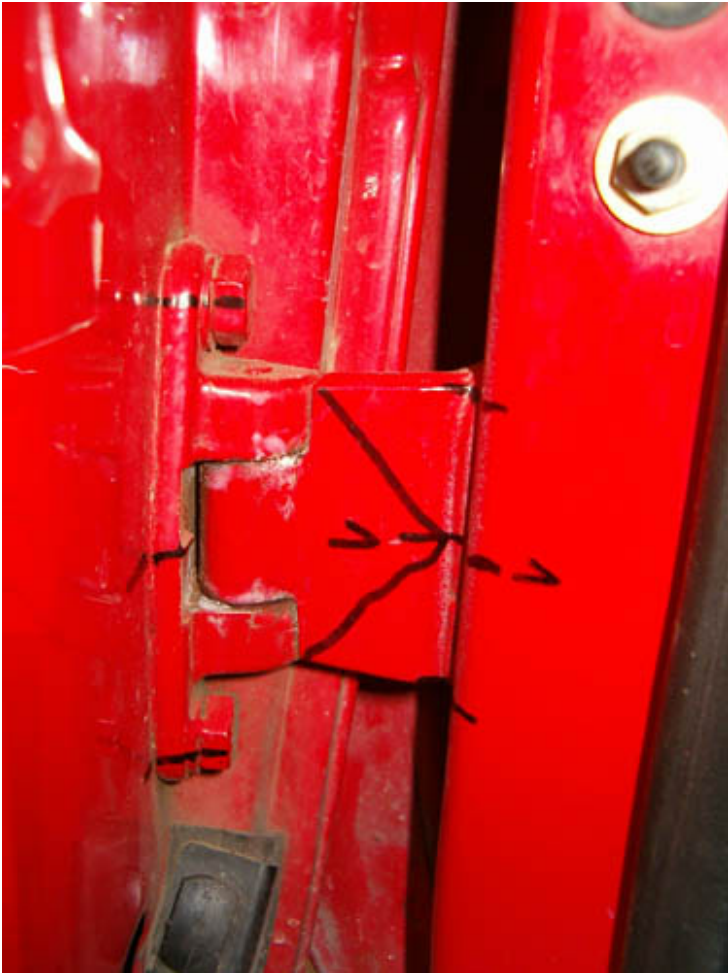
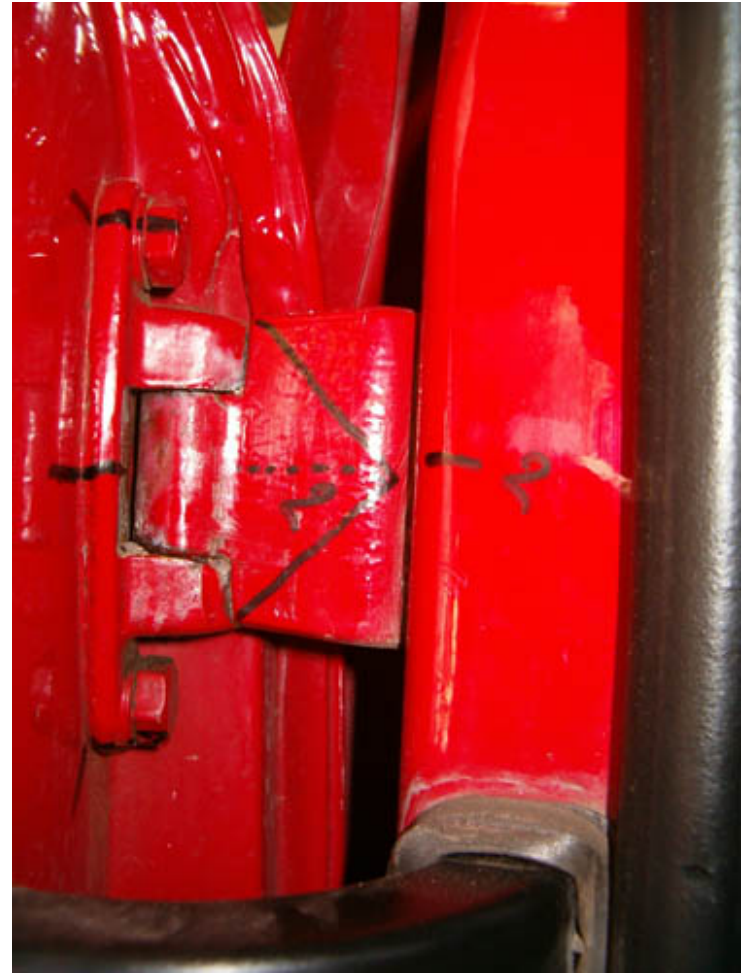
The pictures above show the original hinges (upper and lower). Sign marks have been written on them in order to know the exact position of the old when the new ones are installed.

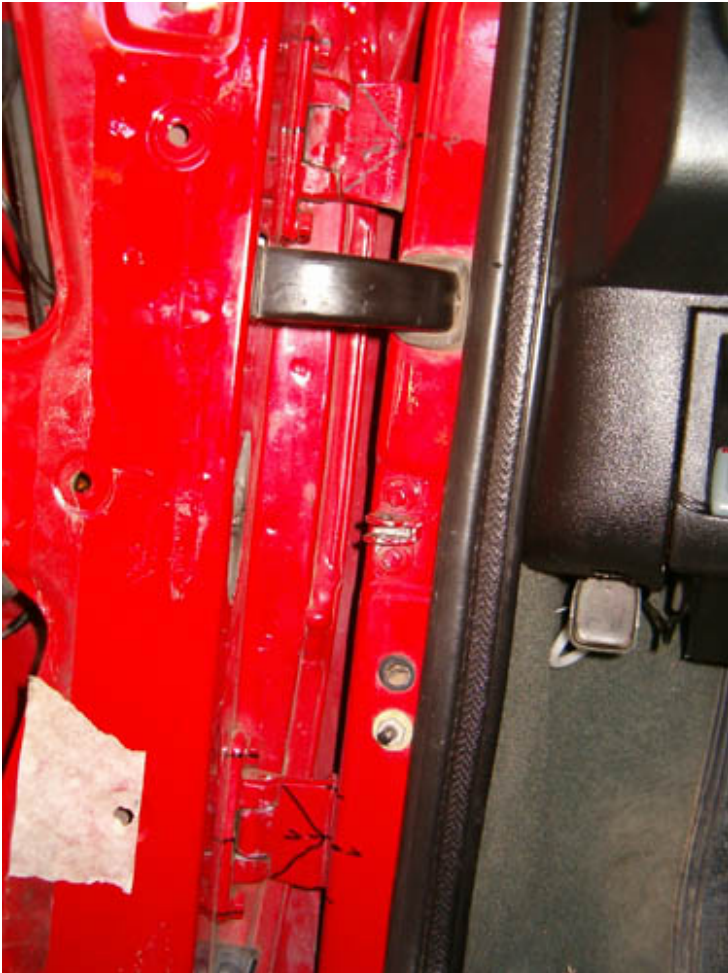
Here is a wider shoot showing the door stripped and left hung by the hinges. The door tie rod has been removed along with the door upholstery cards.

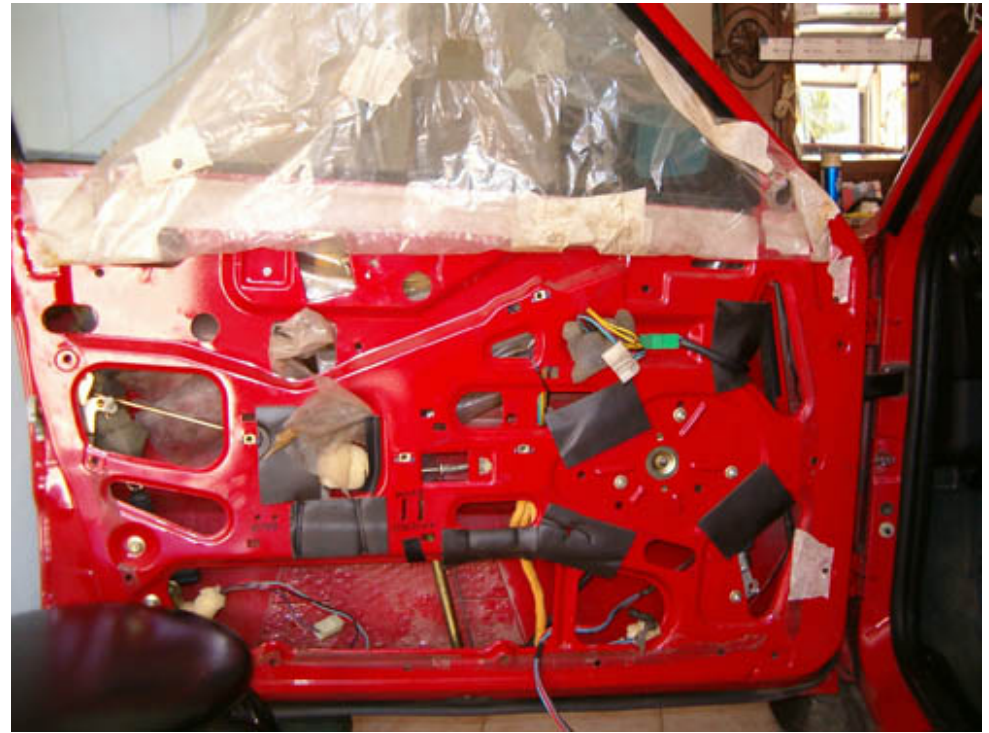
This photo shows an overall view of the door with every cable harness disconnected and getting ready to proceed removing the door.

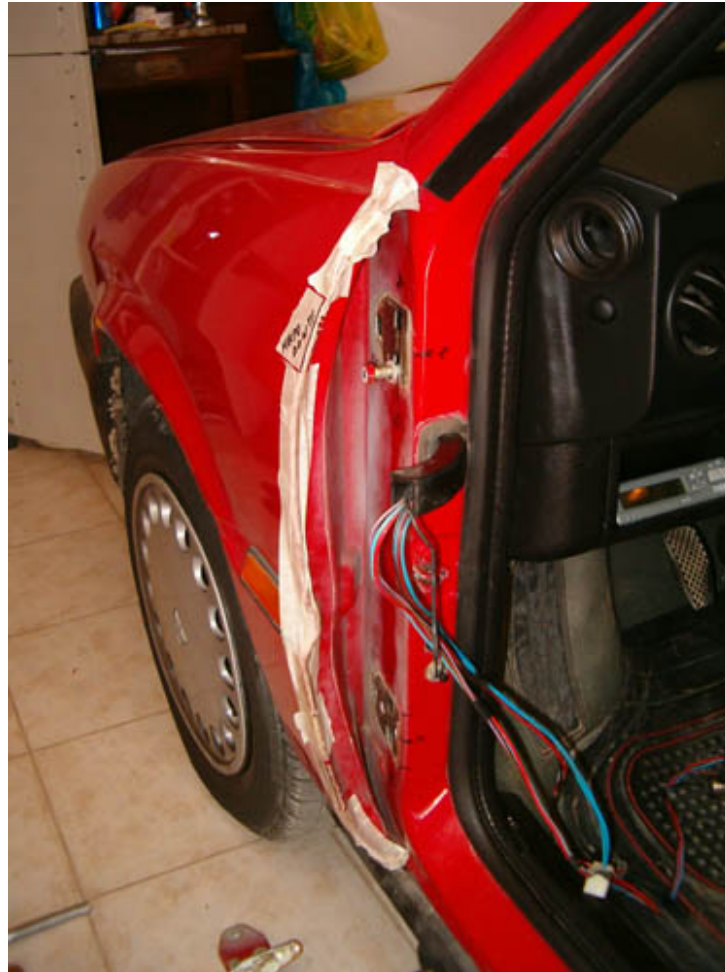
Here is the car without a door. You can see the differences in paint of the A-pillar. Obviously the factory painted only areas seen by the eye ...

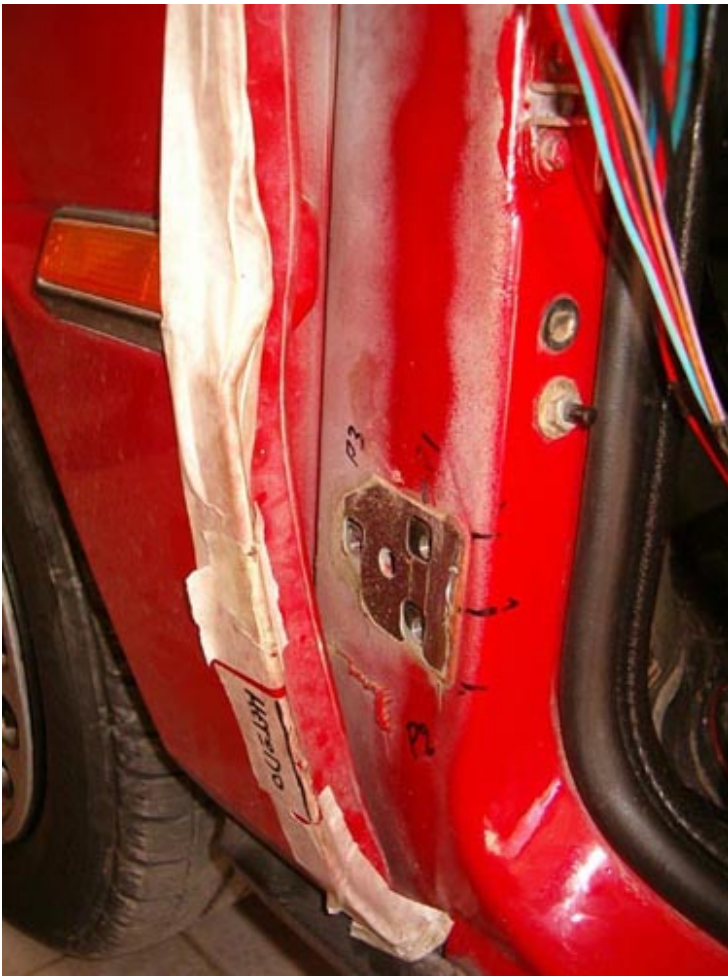
This is the lower hinge been removed and the markings show the screws numbered from P1 to P3

(P stands for Pillar). This would help me identify the screws on installation.

As one may notice there is something written on the tape. If this looks Greek to you it's so !!! This describes the status of the door before disassembly. The upper hinge was creating a small level difference between the wing and the door. The wing was slightly projected outwards compared to the door which was 1 or 2 mm indented.

The marking in the picture showing the lower hinge indicates that the wing-door surface was level.

All these notes would help alignment of the door, in order to see if any differences would be acceptable compared to the factory installations.

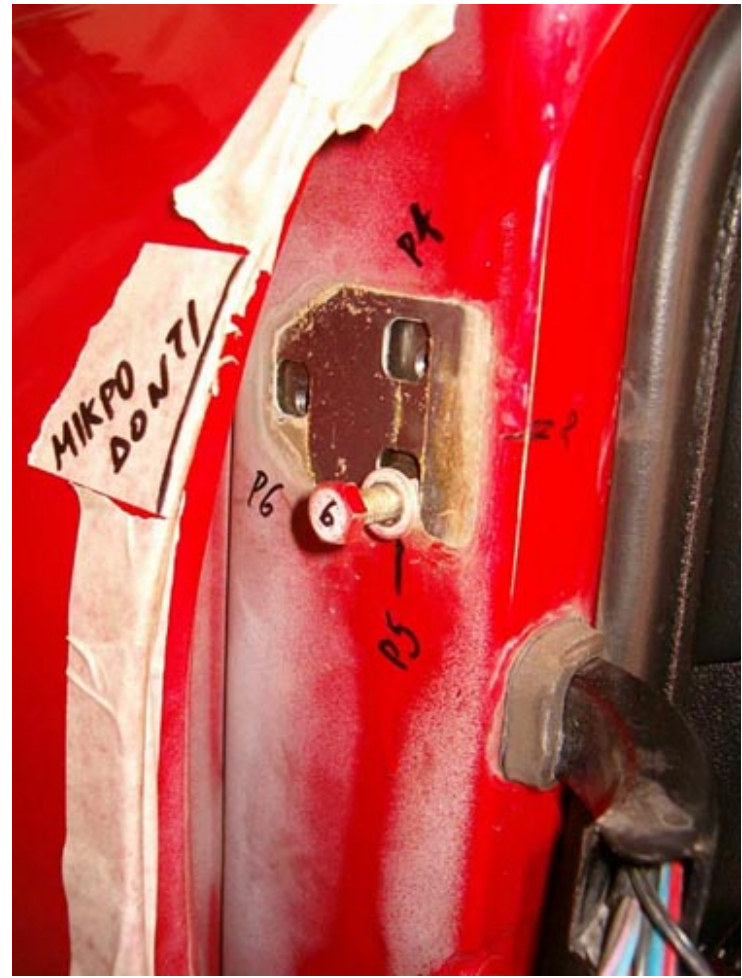
This is the upper hinge been removed and the markings show the screws numbered from P4 to P6. One can see the white adhesive paper tape covering the lips of the wing. This was essential in order to avoid paint damage to the surface upon the use of the tools etc.

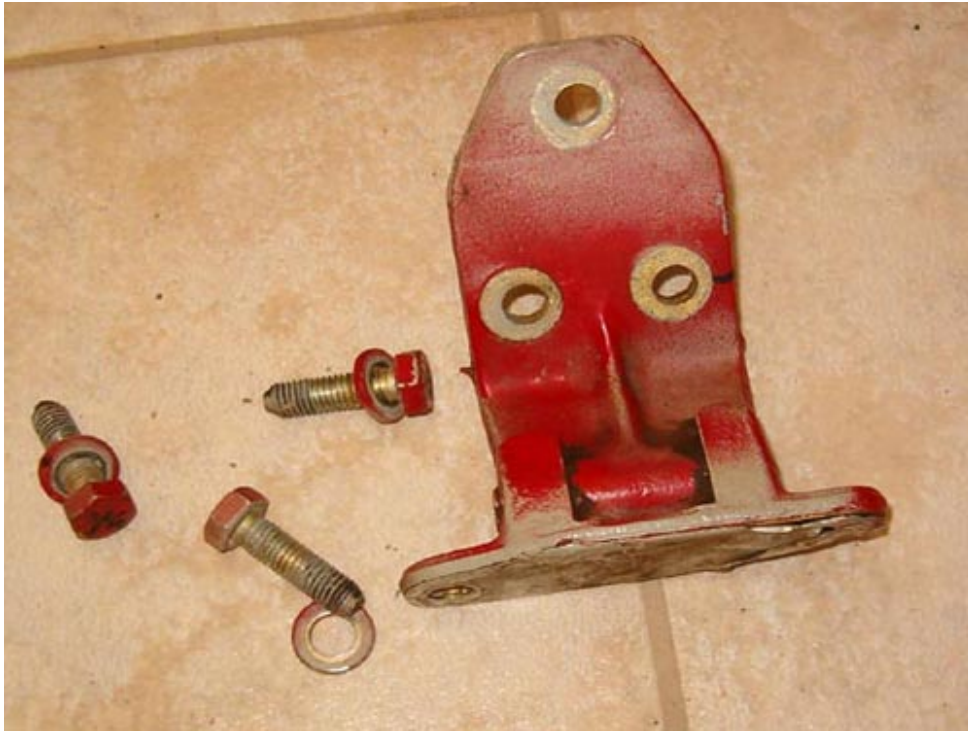
These are the two hinges removed along with their screws and washers. Actually screws are equally shaped in length so there was no reason for me to mark them as I explained before. However it is better to be safe than sorry.

Note the aluminum foil in the door part of the hinge. Actually a spacer from thin tin is wrapped with this aluminum foil which gives the capability to adjust the amount of door indentation between wing and door itself (3 screw area) or how front or back will the door be placed in the pillar (2 screw area). Be sure to clean this spacer and foil out as glue is everywhere; you can use petrol as it dissolves the remains of the glue at the spot.

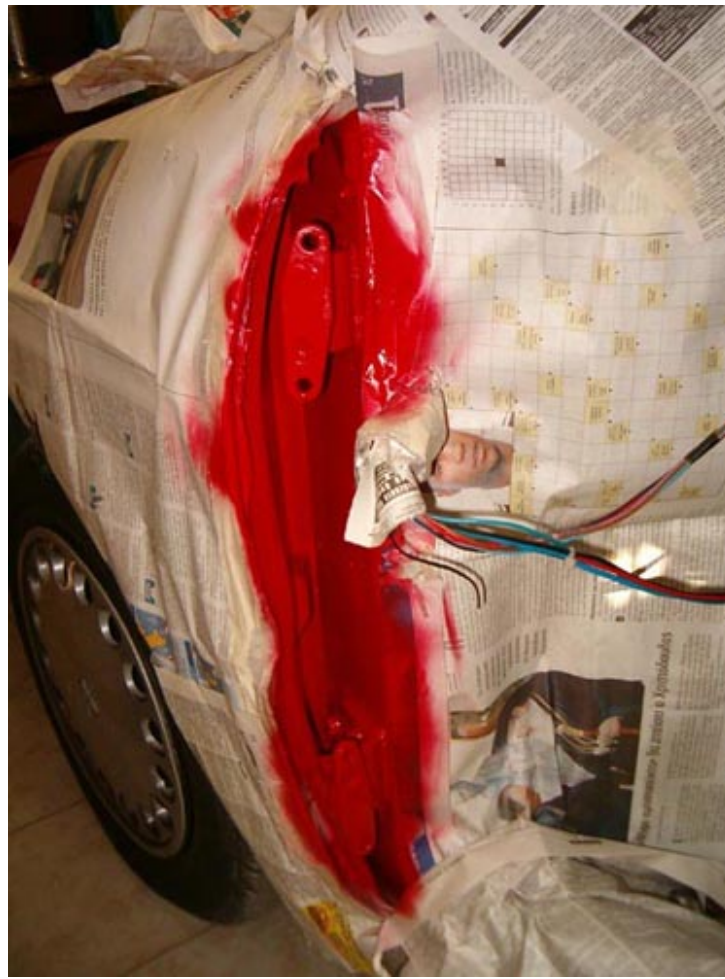
This is how the door looks after installation of the new hinges, alignment and covering the area with newspaper sheets. The primed area was painted using Red 130 color on top.

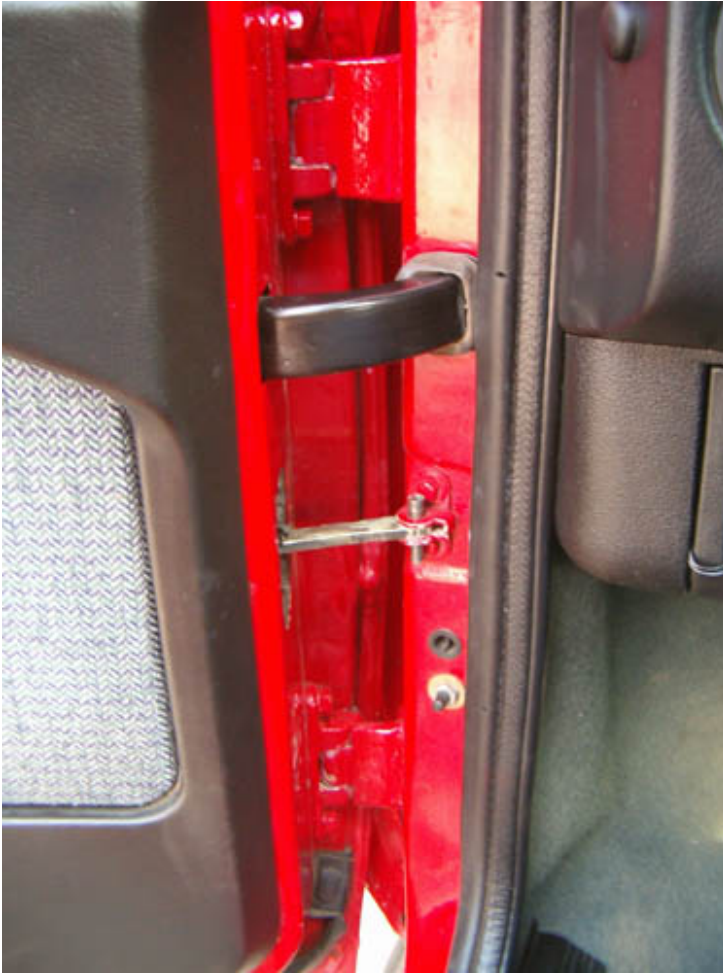
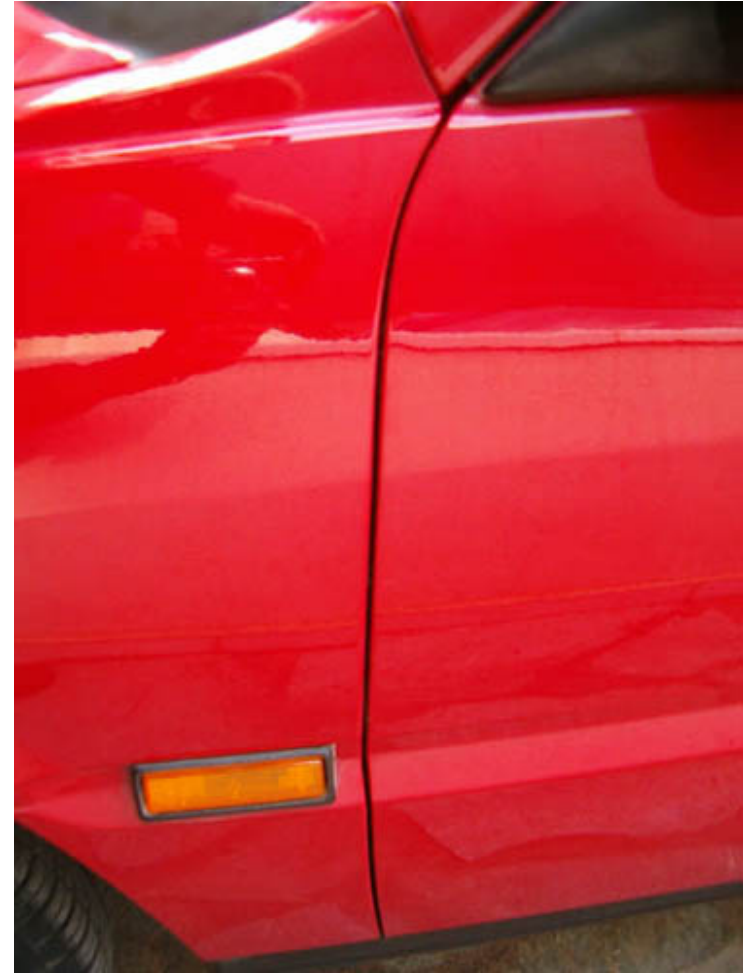
This is the final view after painting and lubricating the hinges with white lithium grease and putting everything together (cable harness, door cards & trims). Note the alignment after installation; door is parallel to the wing, so seems I have done a nice job even if I haven't ever dealt with body panels; it wasn't too bad for the first time.
