## **Door Hinge replacement (Rear Left Door)**

We will continue the previous article by replacing the hinges of the rear left hand side door. I will use again the same procedure and means I employed during the replacement of the front door.

1991 Alfa 33 1.4 IE

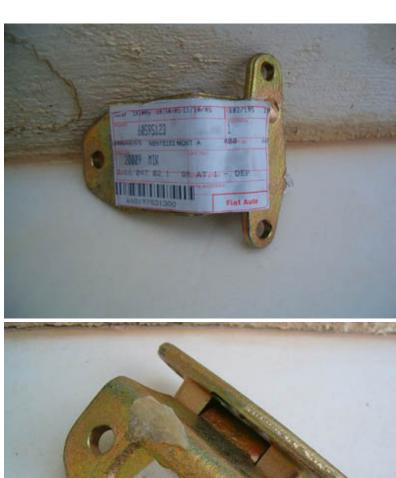
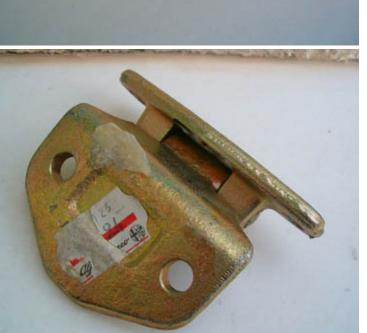
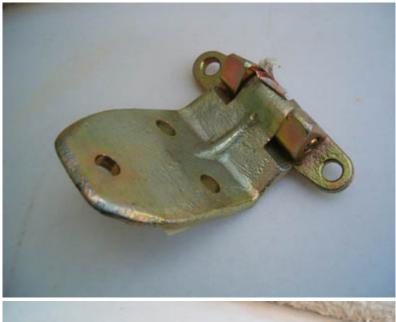
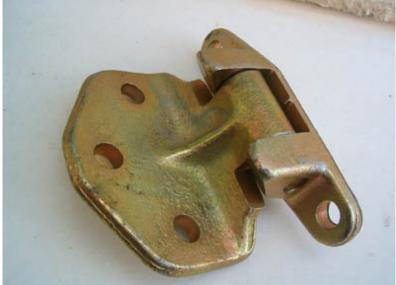
Here you see the hinges as I bought them from the spare parts dealer; unpainted with a lot of dirt. Be sure to remove the labels and thoroughly clean the remains of the adhesive with alcohol. This simple but important detail will make a difference, otherwise primer will not stick to the metal and thus lose its effectiveness.

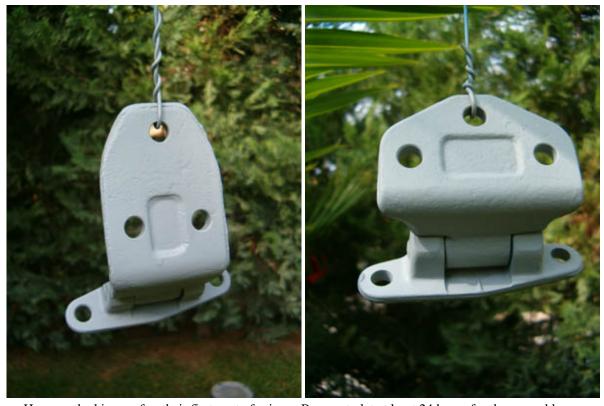
Here are the hinges after their first coat of primer. Be sure to let at least 24 hours for the second layer.

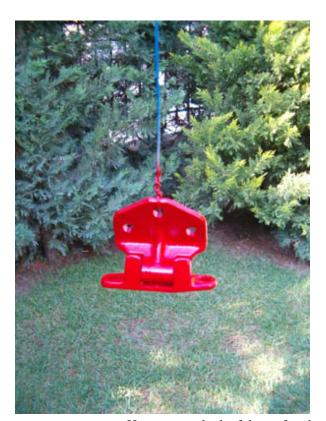
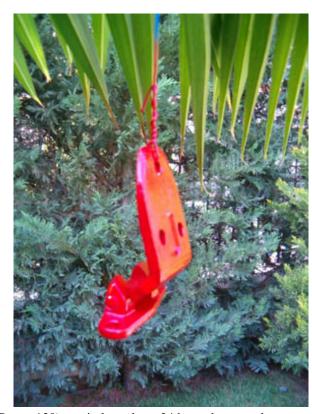
Here you see both of them after the second layer of red paint (Alfa Rosso 130); again let at least 24 hours between layers.

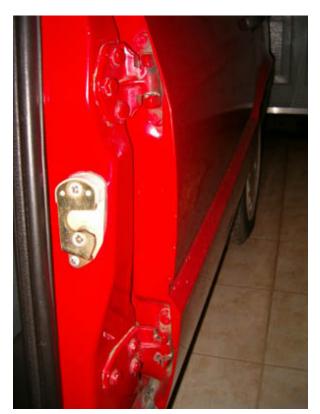
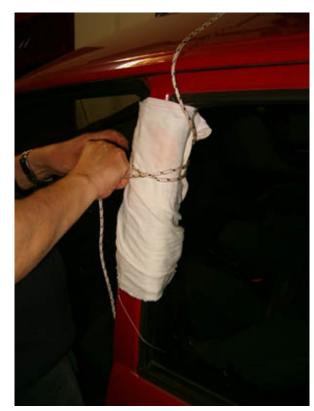
We are now ready to proceed removing the hinges from the door. Since access to them is very easy in rear doors, I chose not to remove the door from the car; I used a large sheet of towel in order to wrap the door frame to the B-pillar and a piece of rope to tight everything together.

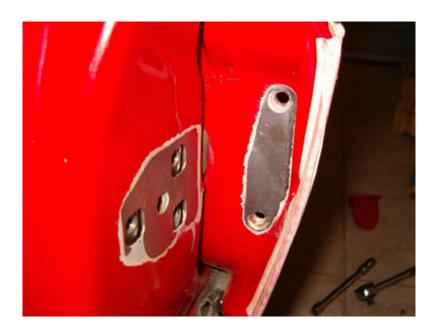
The area of interest is now cleaned from dirt and factory installed sealer and it is ready to accept the new hinge.

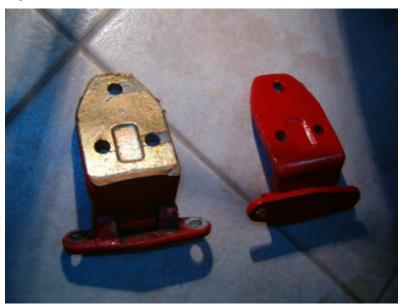
Old and new hinge (left to right)

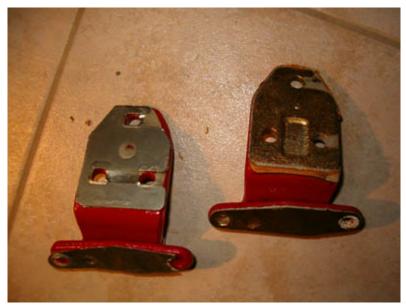
aluminum spacers installed on the new hinge (left)

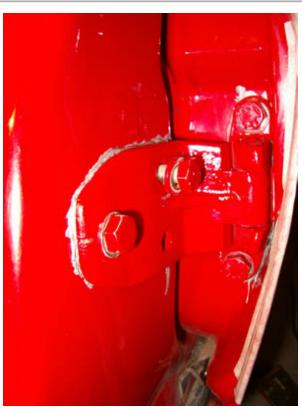
and finally hooked up temporarily

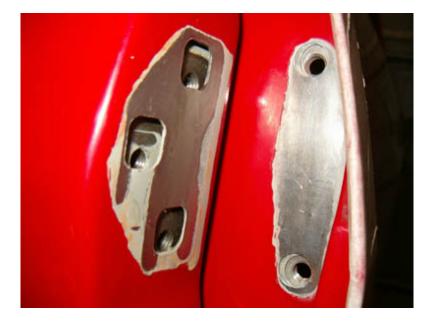
This is the upper hinge area; old one removed, area cleaned out and ready to accept the new one

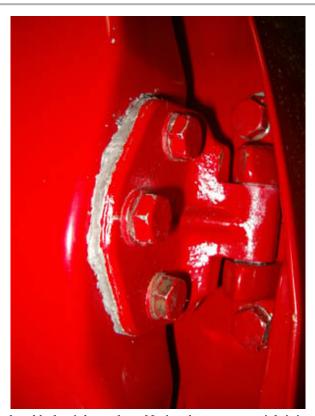
... and upper one installed and bolts tightened up. Notice the gray material; it is seam sealer used to stop water entering the inner body.

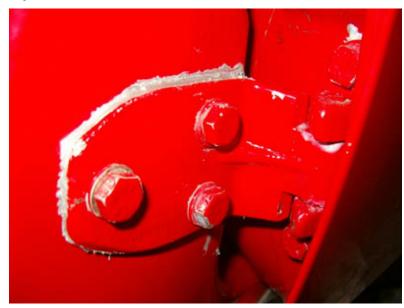
The same done for the lower hinge ...

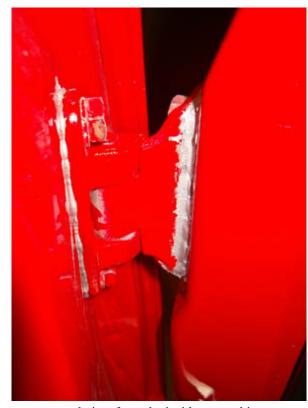
... and view from the inside, upper hinge

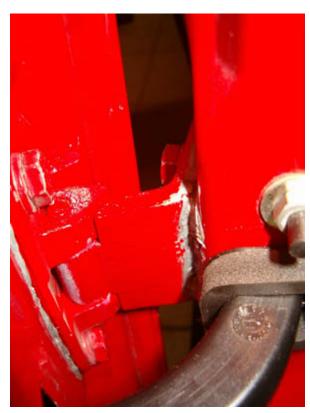
and lower

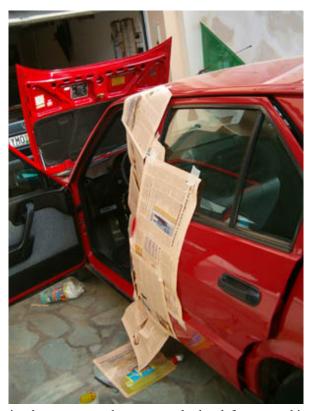
It is now time to paint the gray areas that seam sealer has left not matching to the car's color

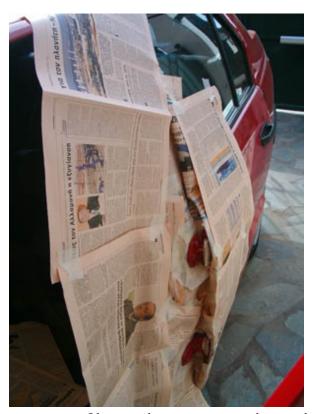
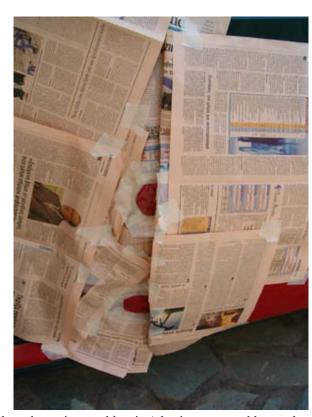
I have used many newspaper sheets and masking tape to cover up every place that paint would stain (plastic covers, rubber seals etc.)

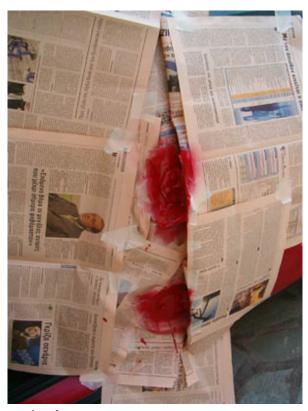
and now everything has been painted

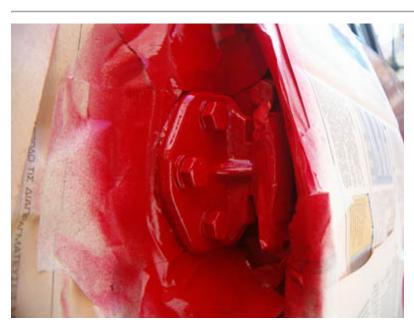
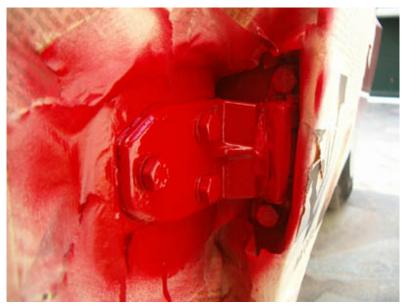
close-ups

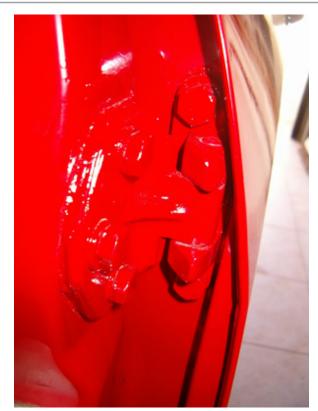
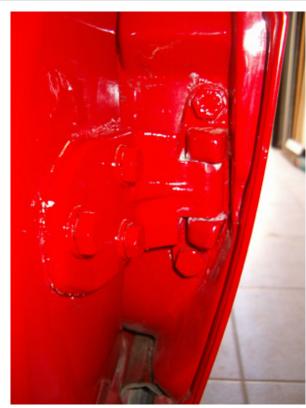
masking removed and final result is shown from outer side ...

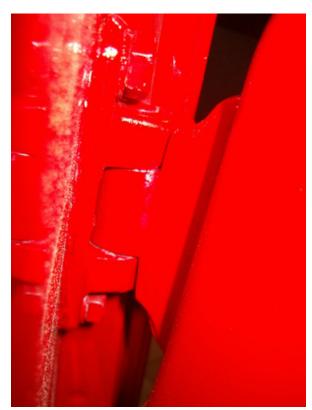
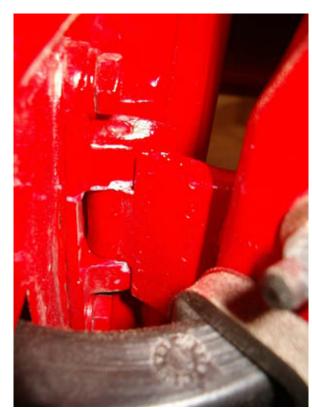
... and from inner side - don't forget to apply white lithium grease to hinges
