## Right Rear Door

Let's now finish the door hinge saga with the right rear door

1991 Alfa 33 1.4 IE

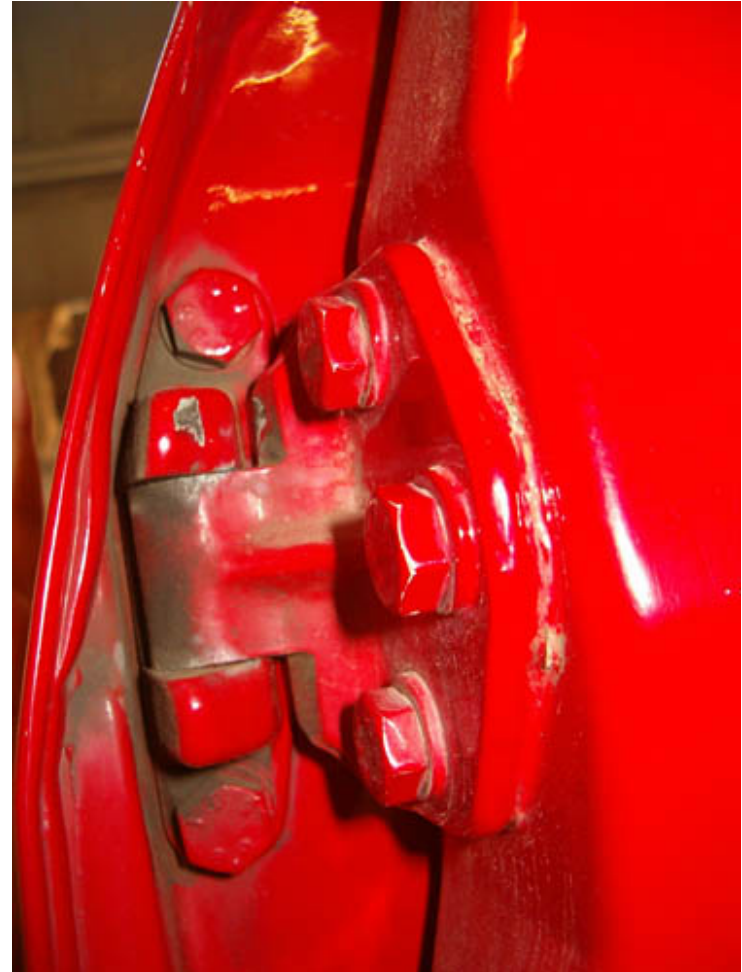
Old upper one

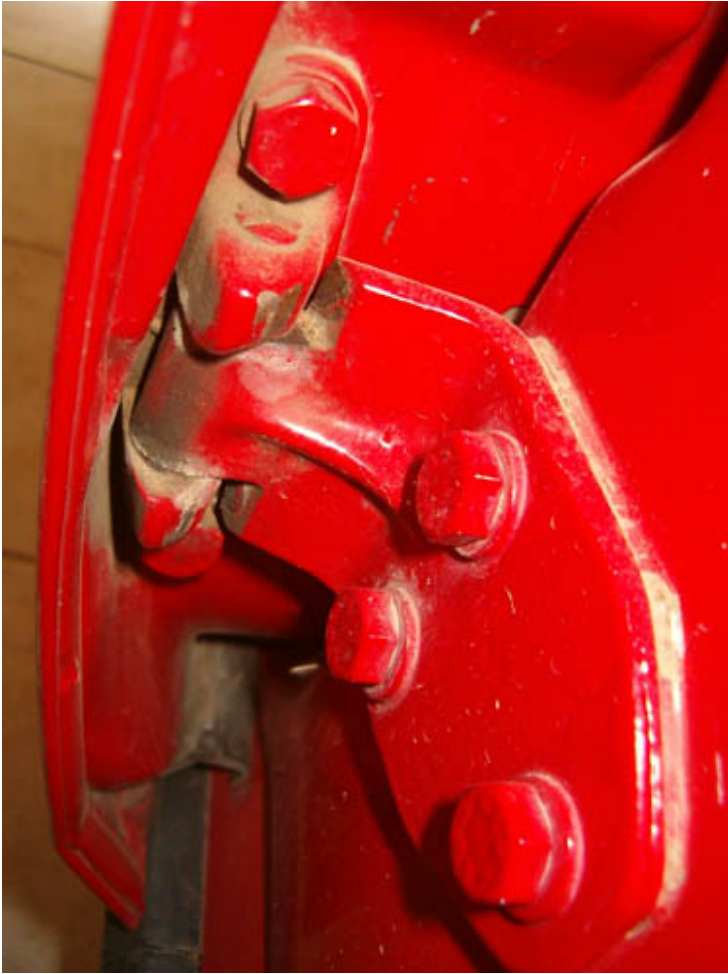
Old lower one

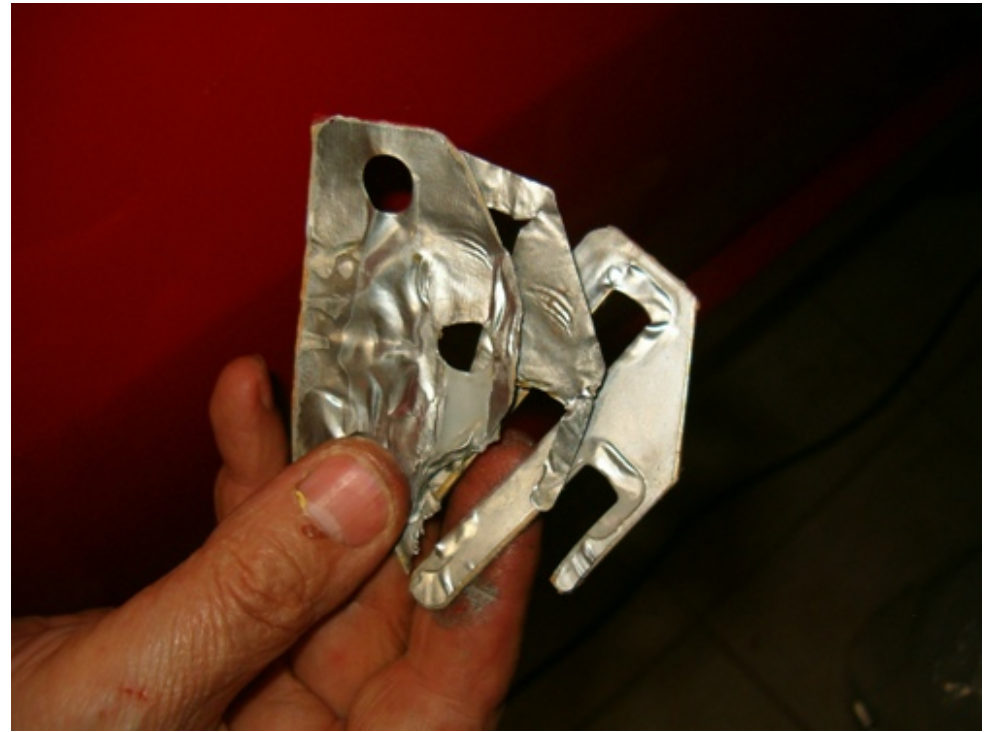
... these are the spacers and their adhesive aluminum foil wrapping them around - this is adhesive foil just for sticking hinge to body part while you are about to torque down the bolts.

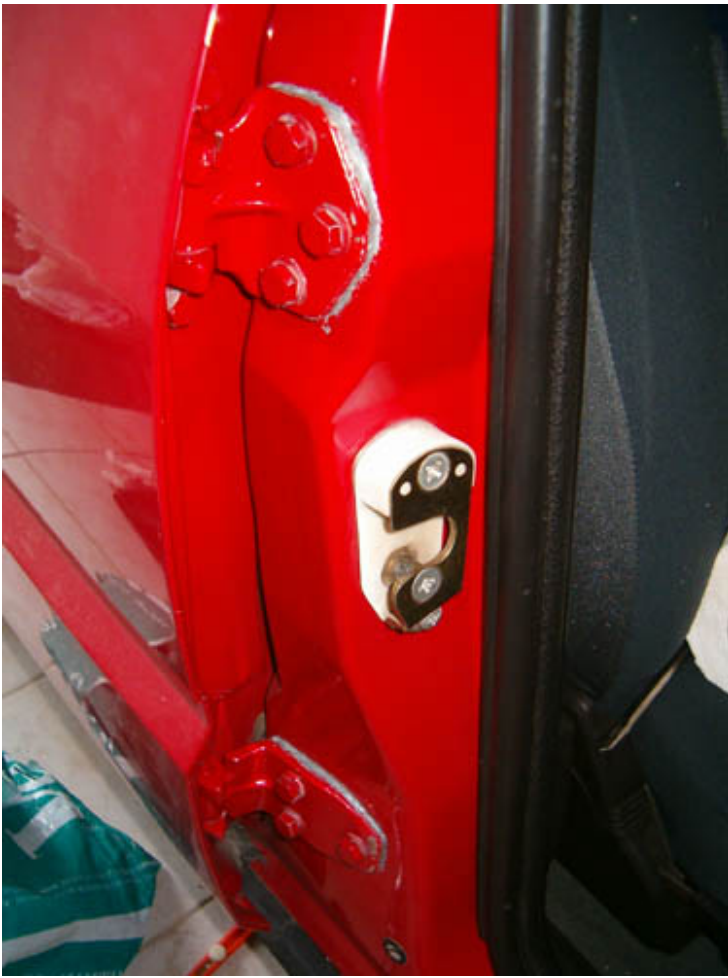
End result before painting the sealed area

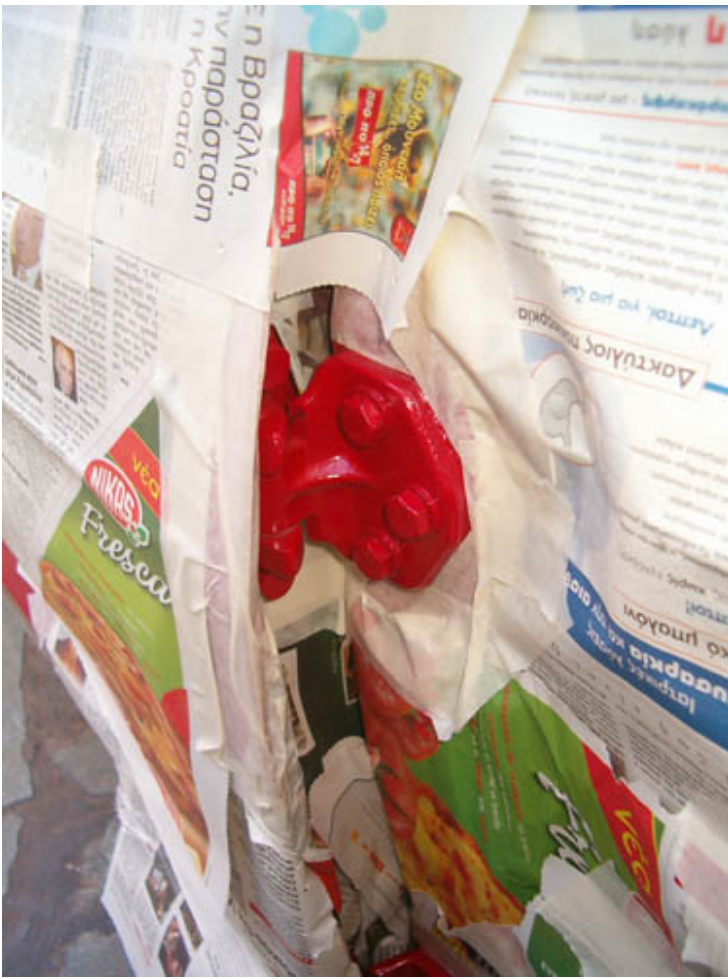
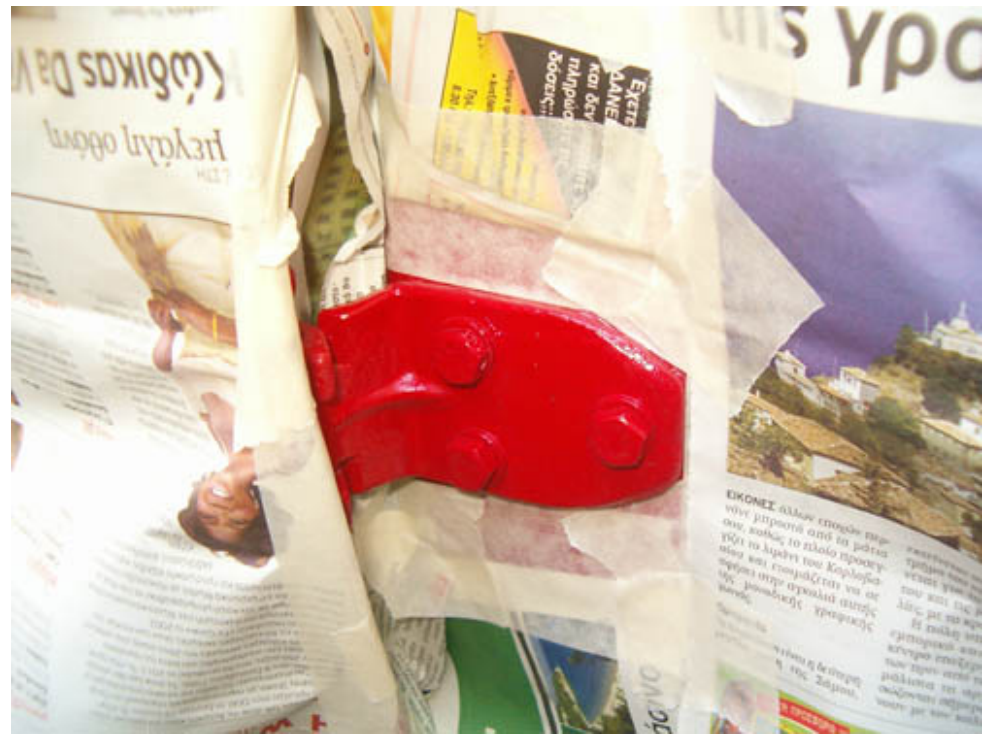
Detailed view of the masked area around upper and lower hinge

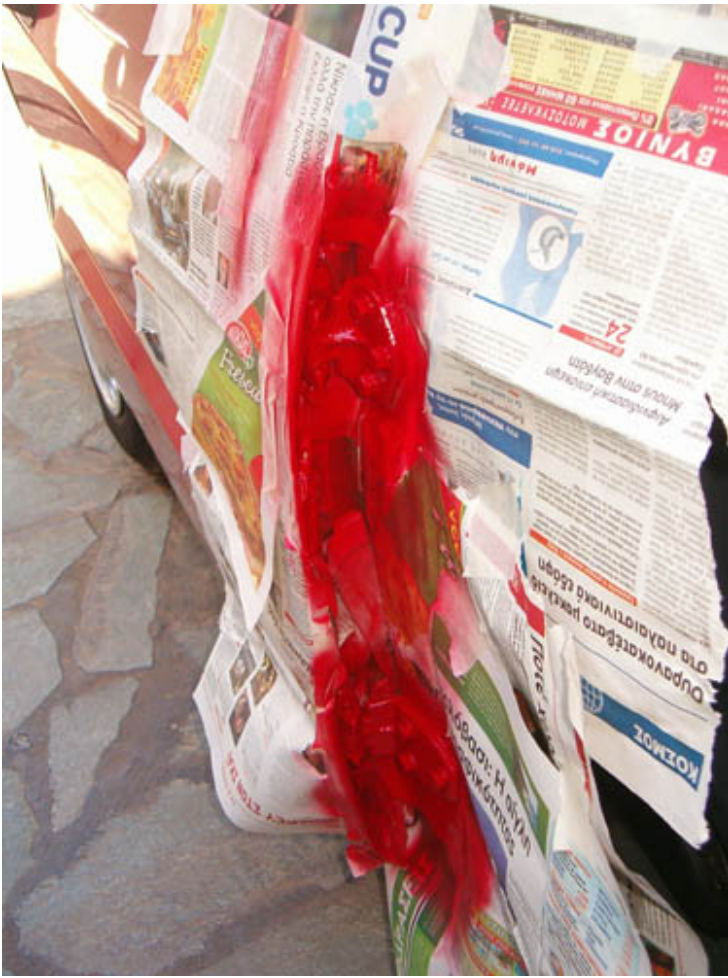
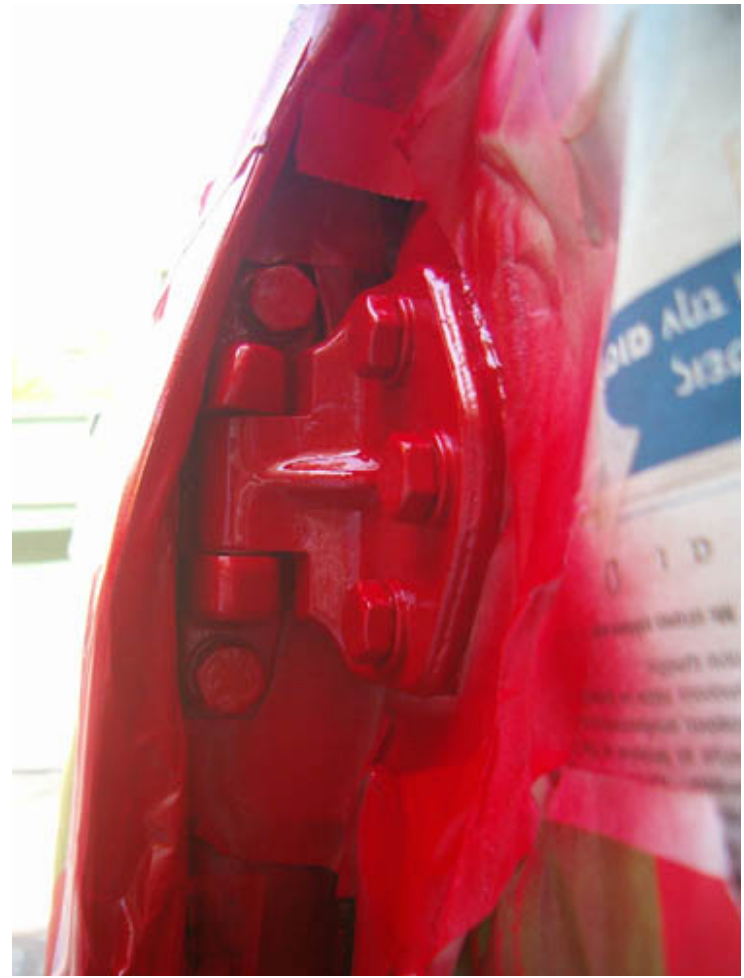
fresh paint has just been applied in the upper ...

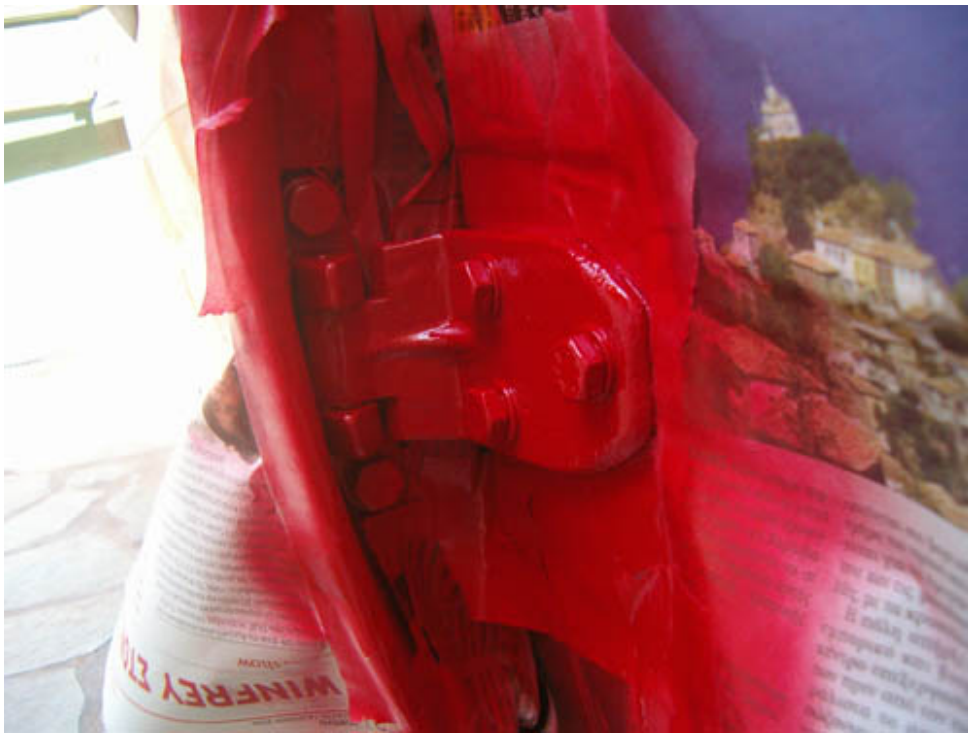
... and lower hinge

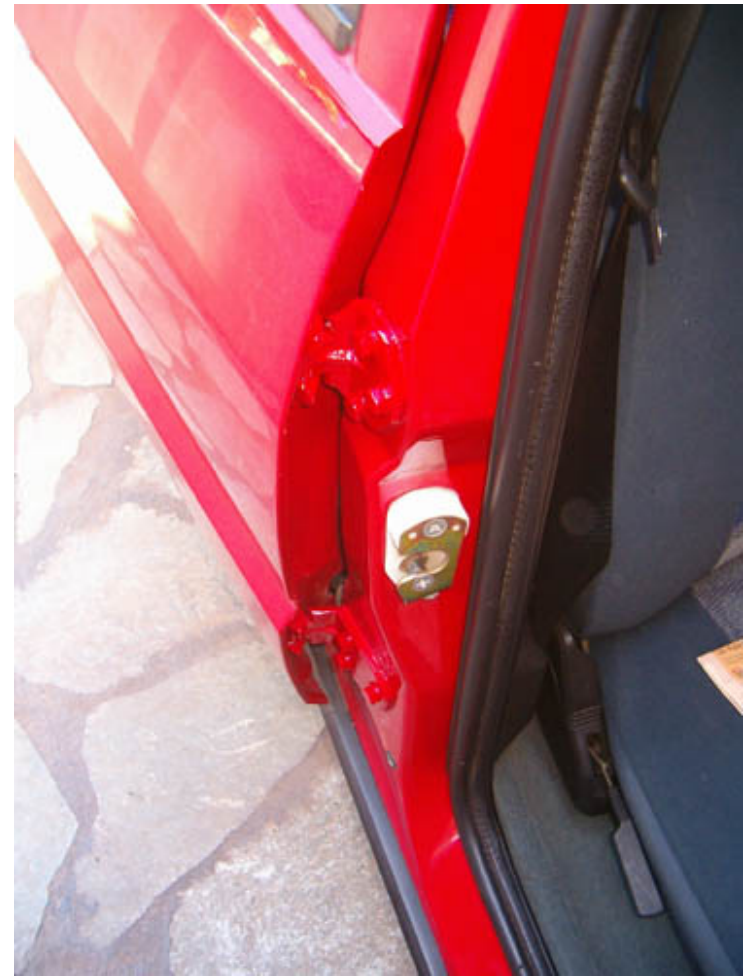
end everything's appears nice and neat!

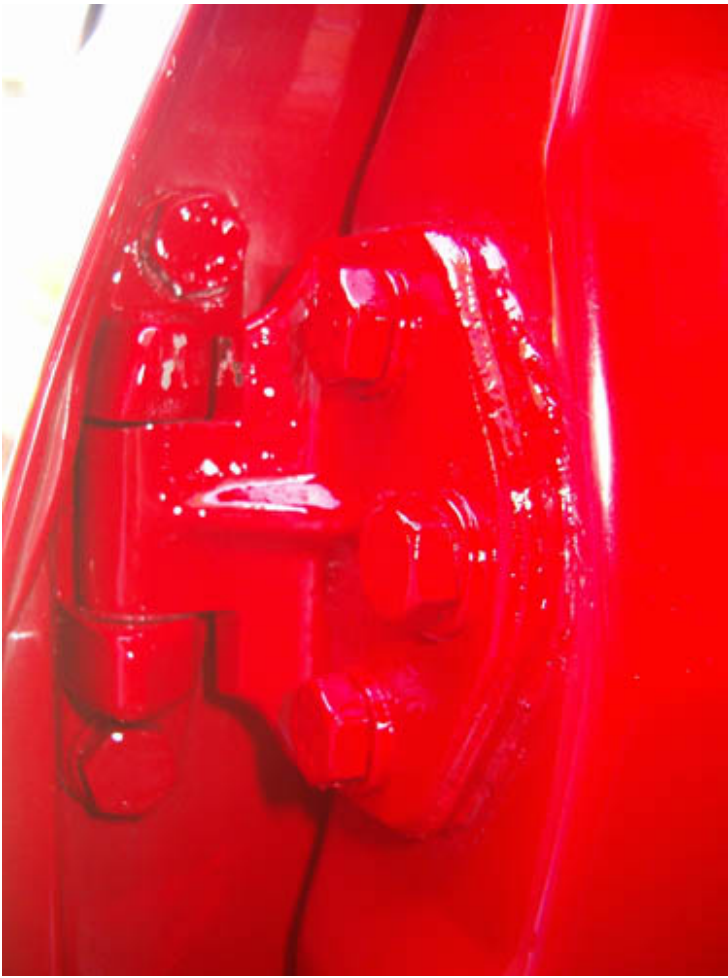
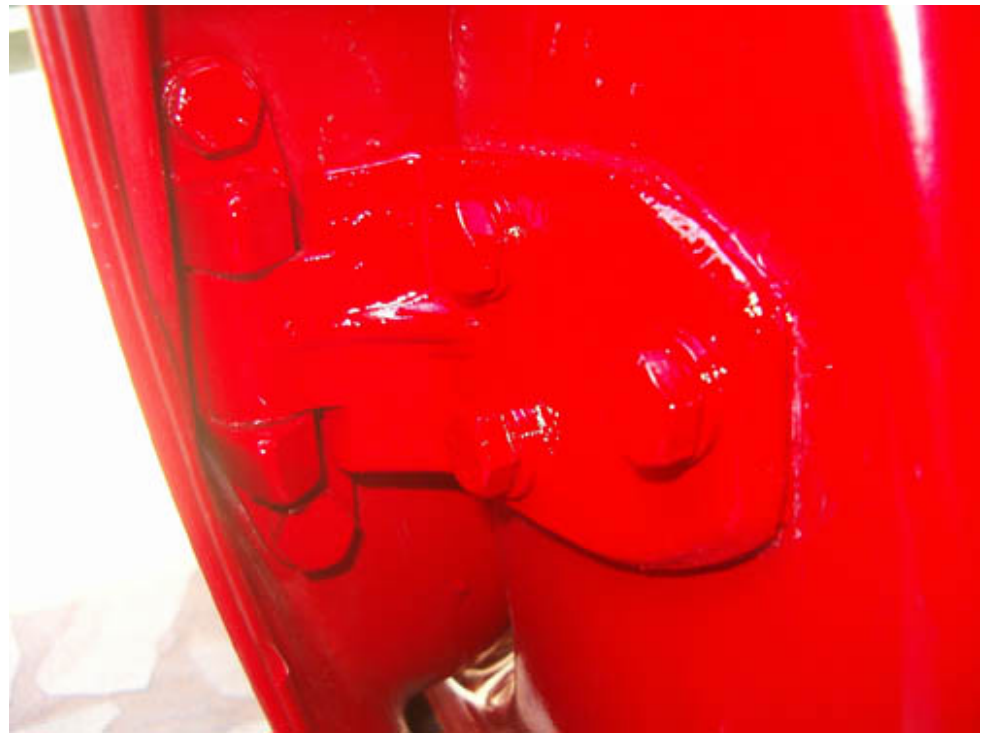
also very nice even at a closer look!

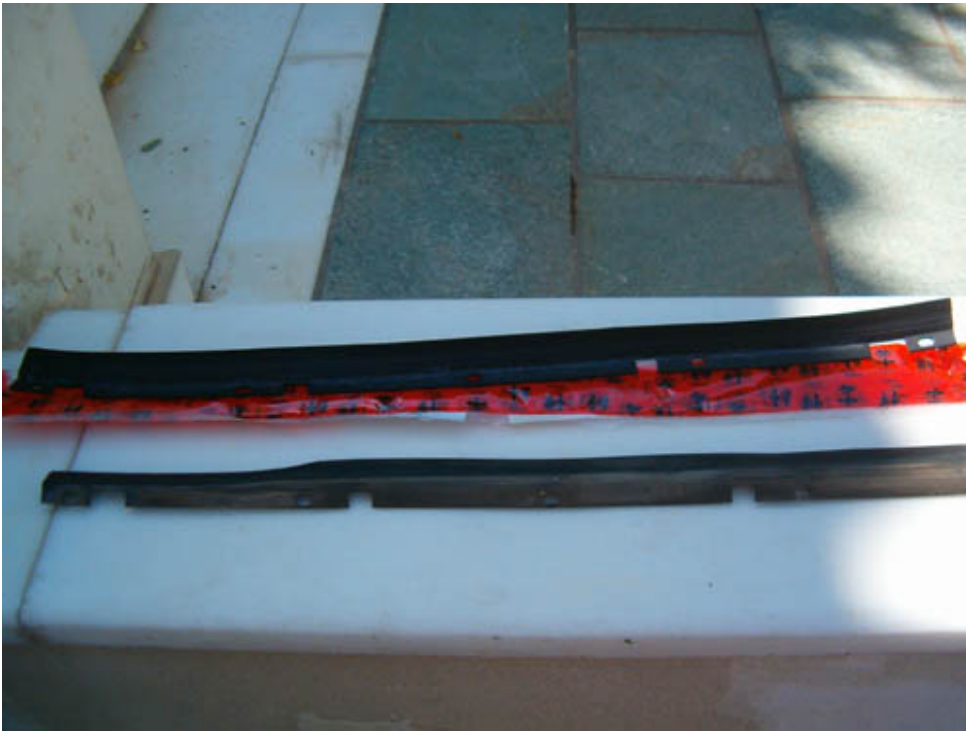
This is rubber protection for the lower part of the door. I have replaced all four weather strips but only here you can see documented the process since the process is standard.

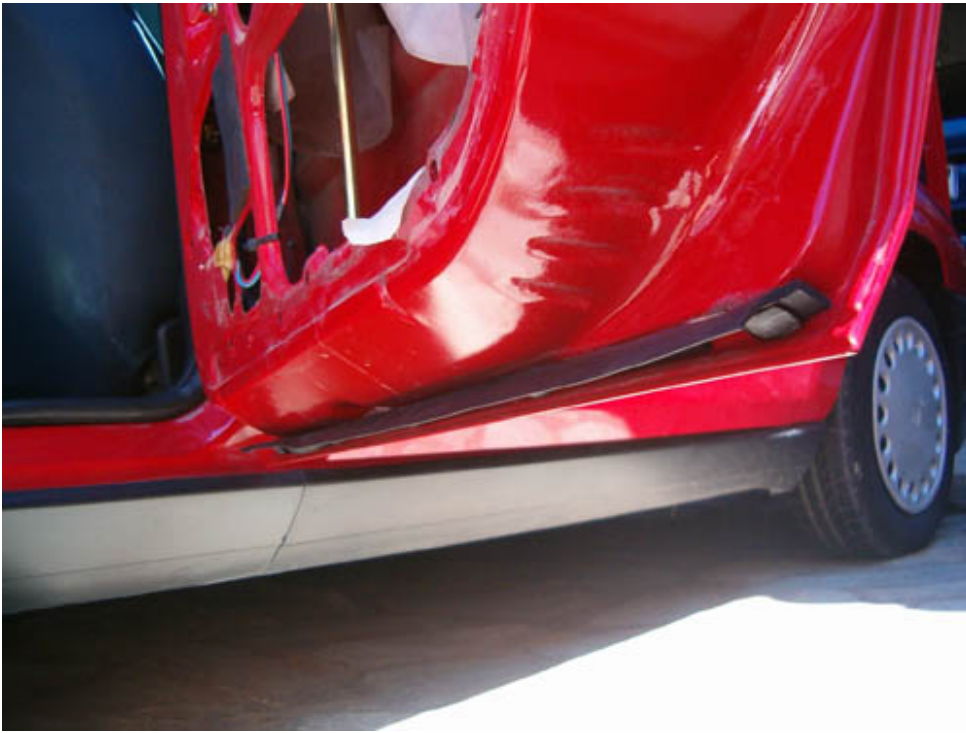
I also found it practical to clean the inside of the door. It may sound weird to you pouring water inside the door but there is no need to worry. The door is designed to expel water from a couple of oval openings at the bottom, as you can see in detail in the photos above. That's why older cars would rust at the door bottoms as there was no drain provision.
