## Braking System Restoration

## Calipers rebuilt

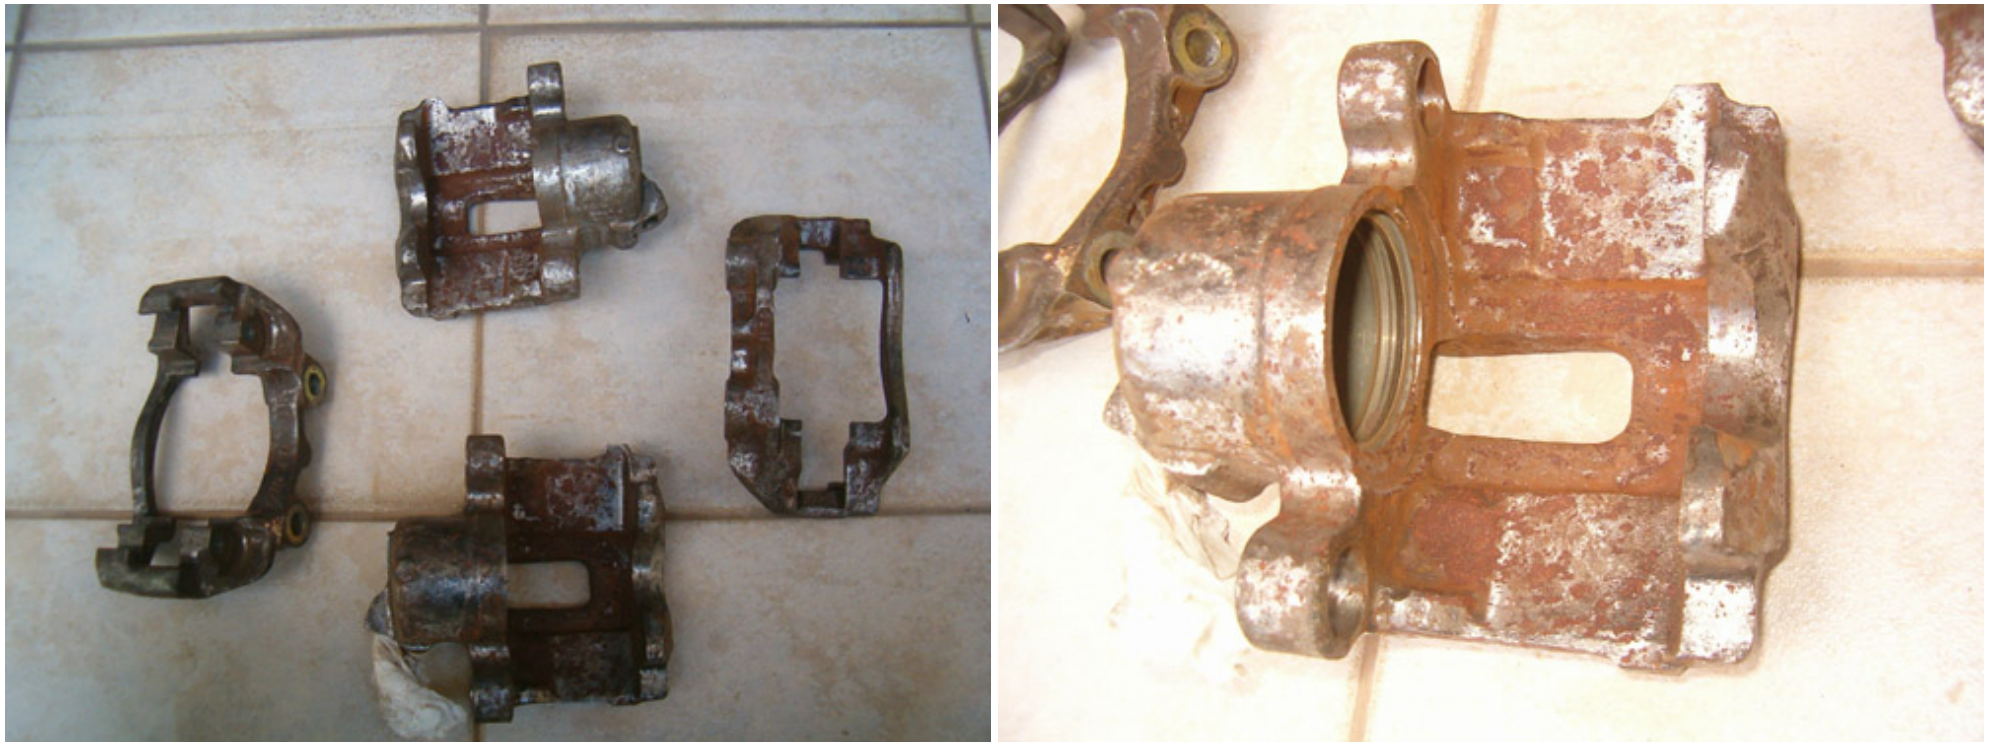
These are the calipers for the vented disks. I have already used the stone bits to remove rust and dirt. The amount of rust was quite a lot but with careful and systematic work I have removed most of it. As you can see the brake piston is already out of the caliper; I used a foot pump to pop it out attached in the brake hose fitting. Be careful during this procedure as the piston has enough force to create injuries, so be sure to keep your hands away from the caliper.

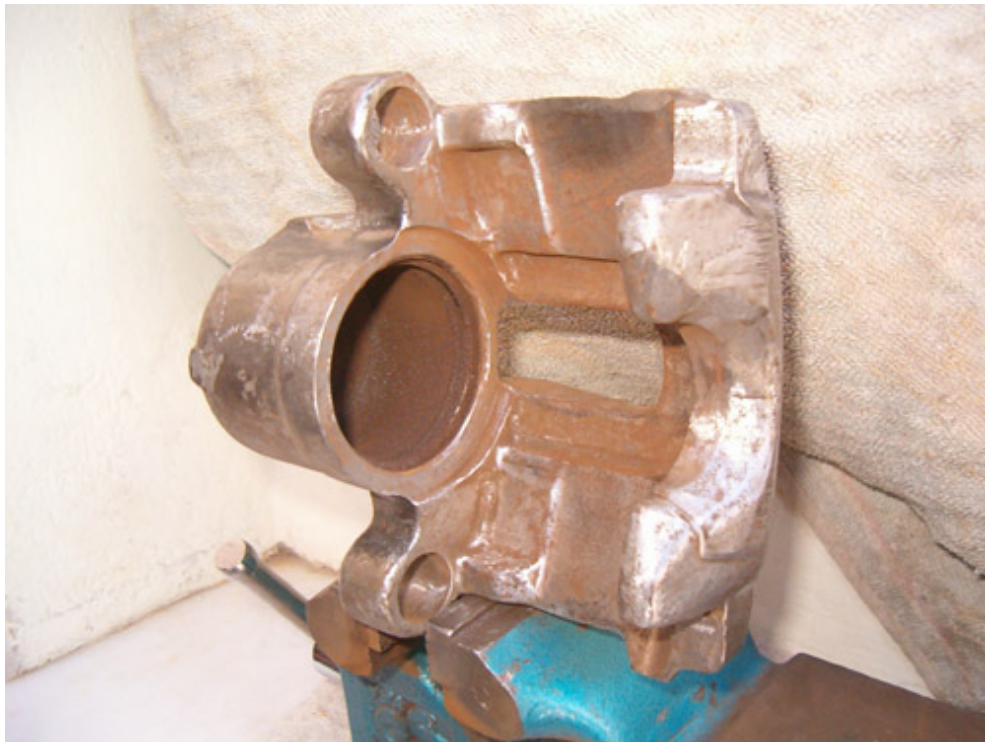
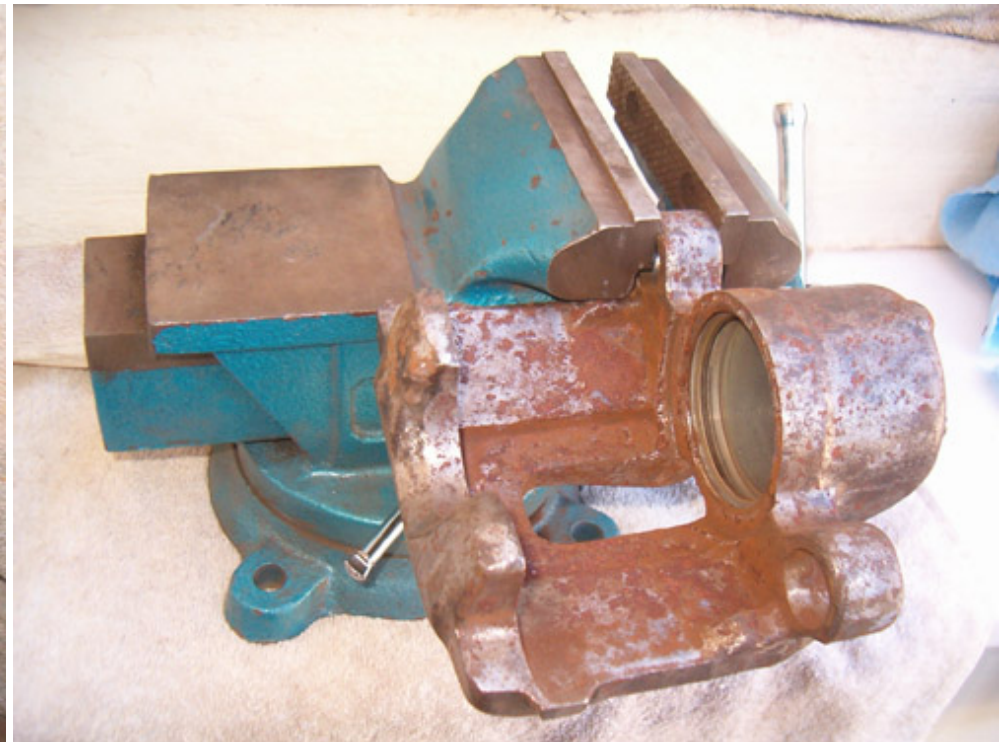
The parts of the calipers that stone bits cannot enter will be treated with rust inhibitor so that rust is buried once for all.

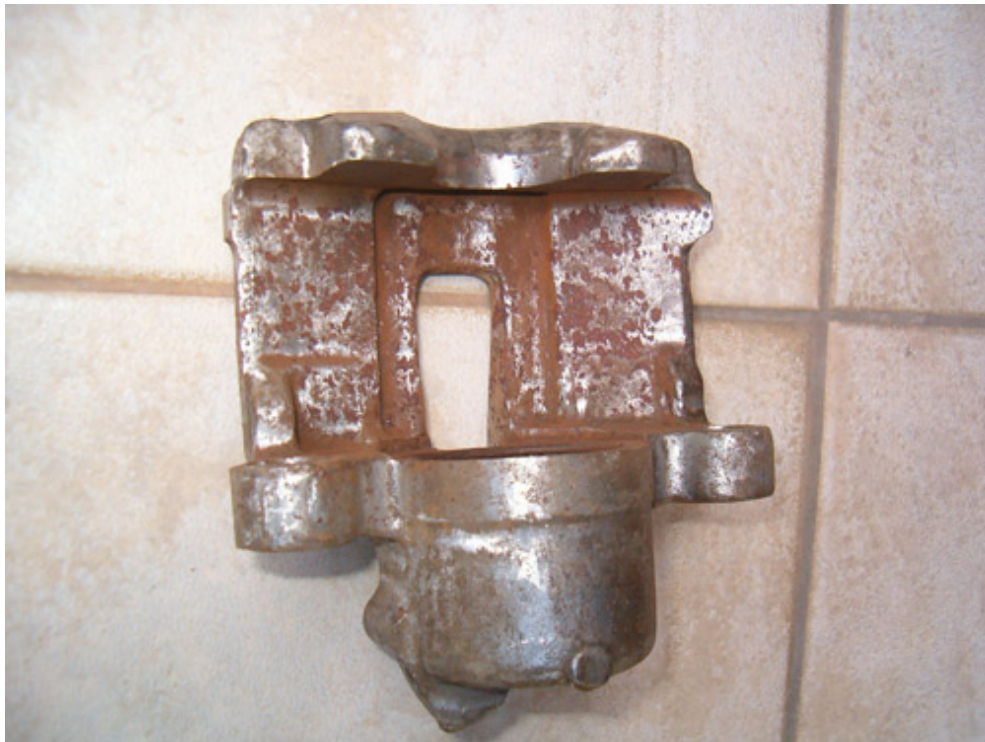
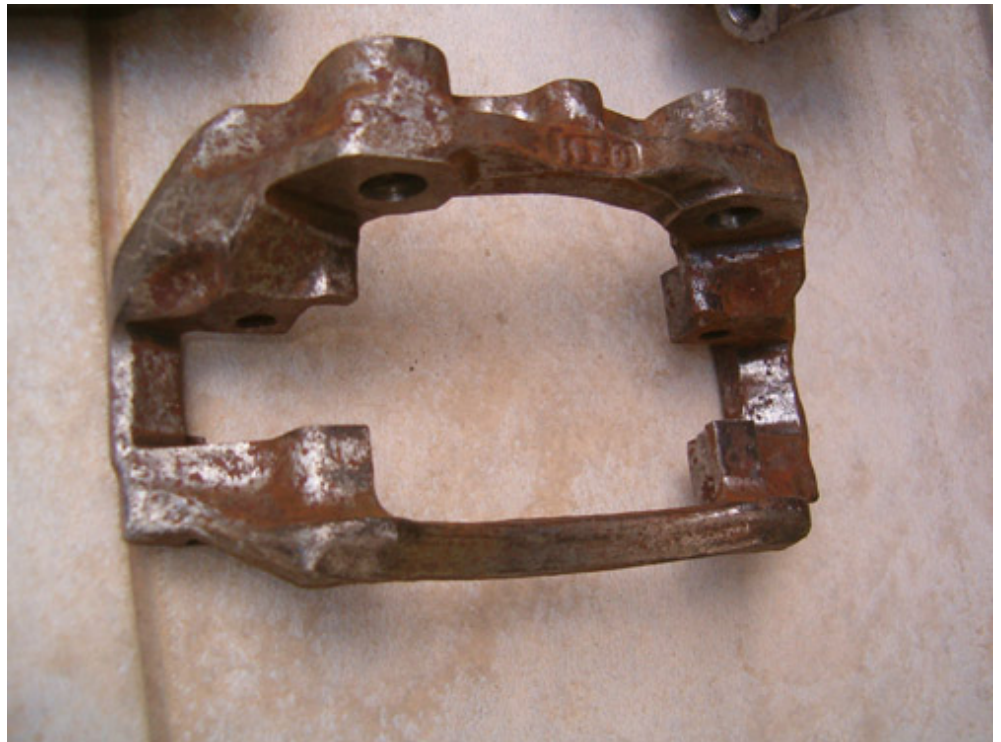
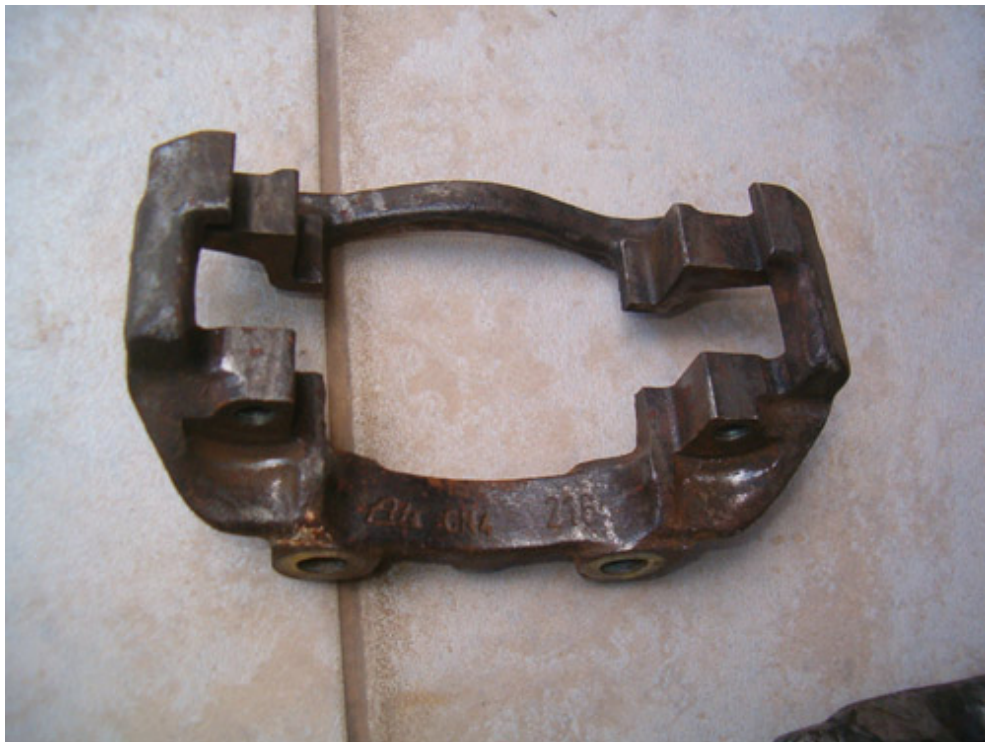
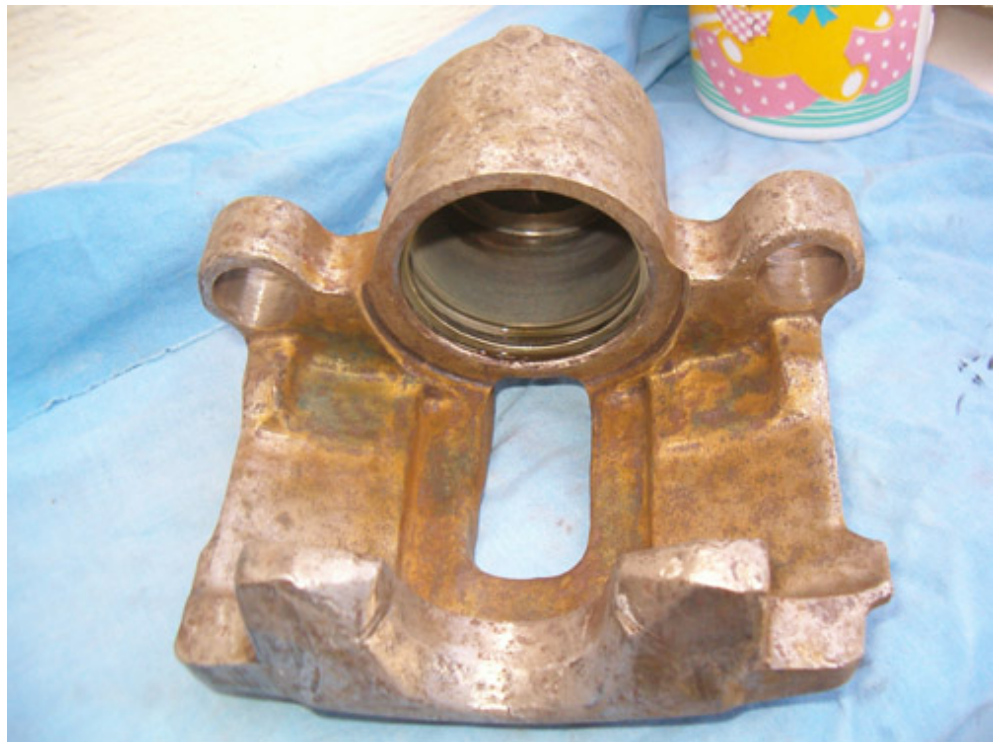
Here you can see the final stage just before rust inhibitor is applies. I have used plenty of alcohol to clean the surface; this way no foreign material interferes with rust inhibitor and thus reducing its effect.

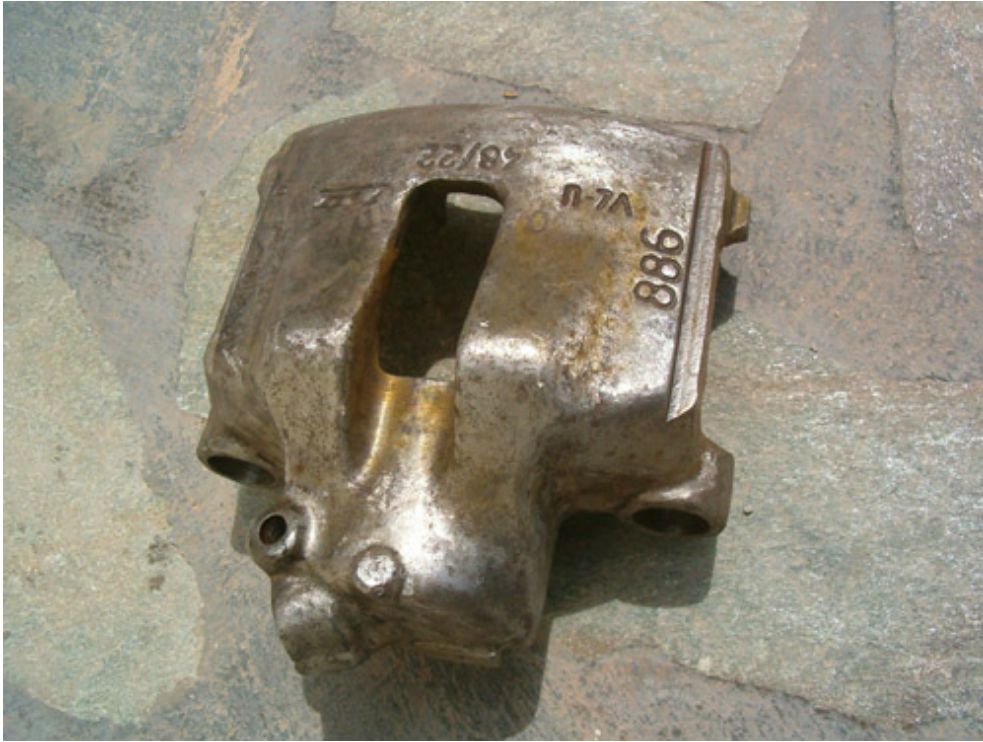
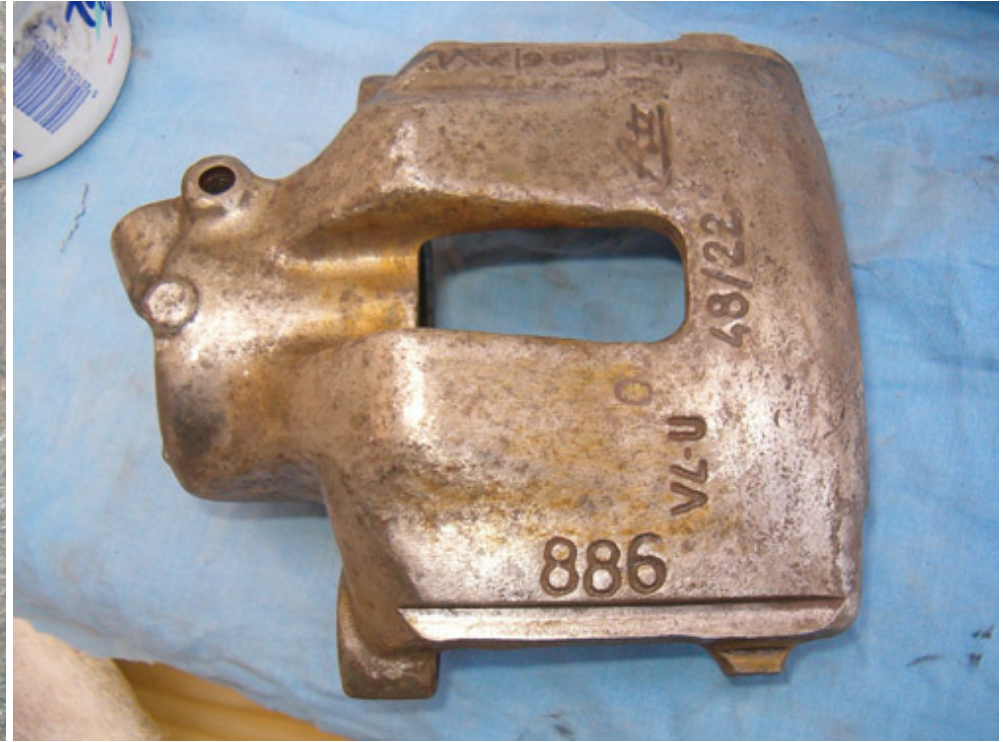
See the clean surface!

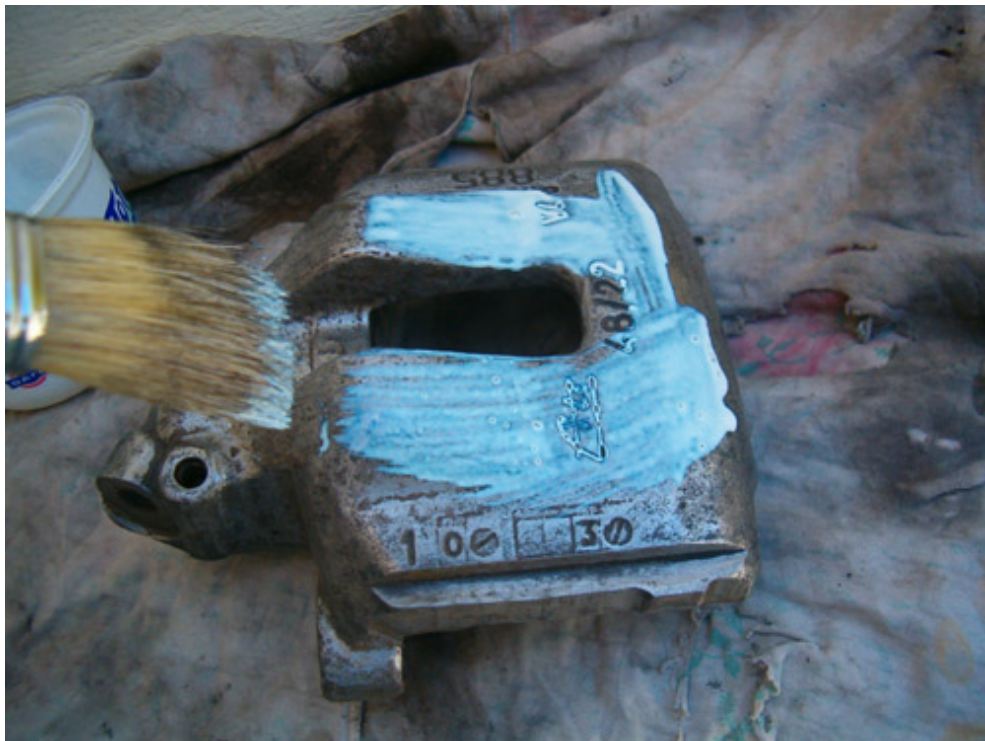
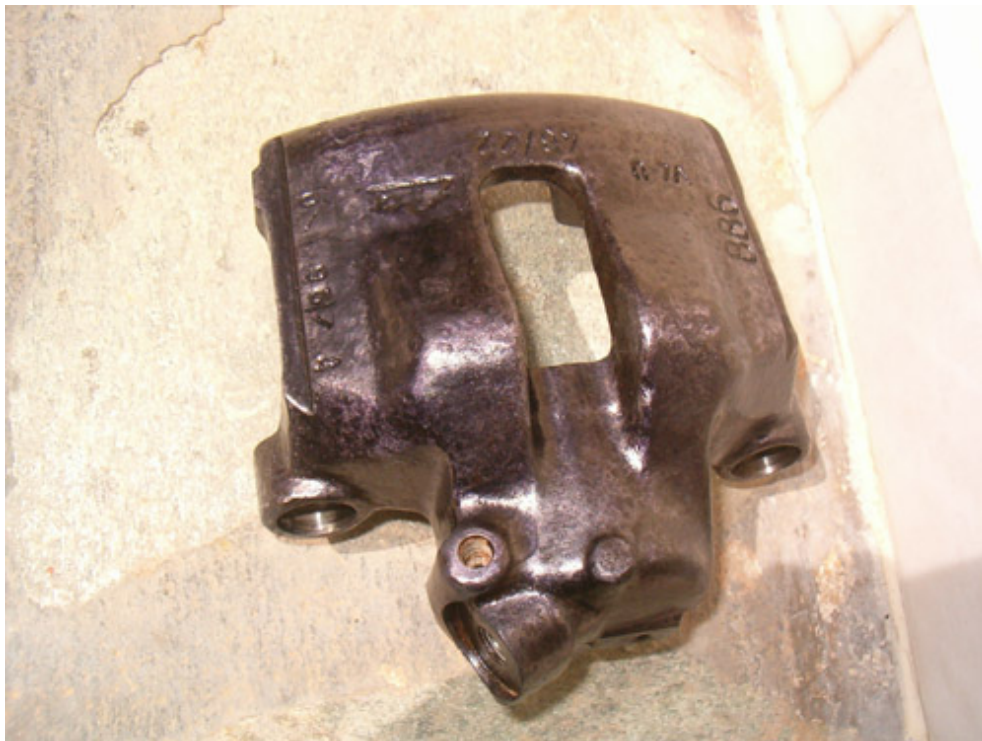
Rust inhibitor is applied and the final result. This material needs around 2-3 hours to cure and stick to the rusty surface. Once the material is applied to rust then it instantly changes color to a deep blue one whereas clear indicates healthy metal.

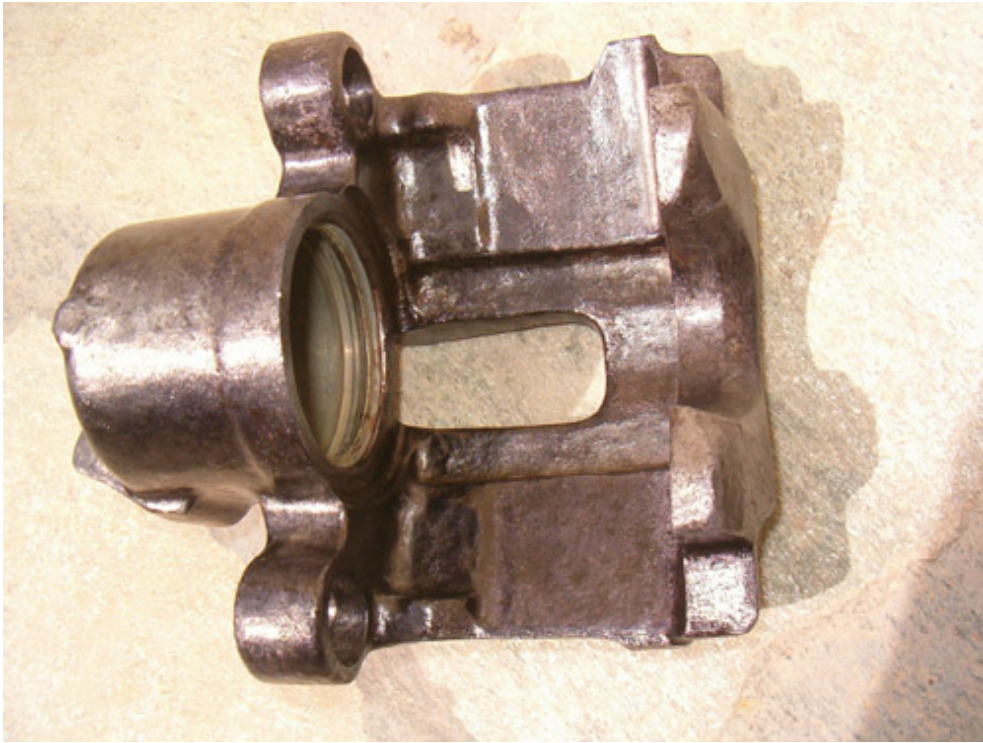
Inside of the caliper is treated

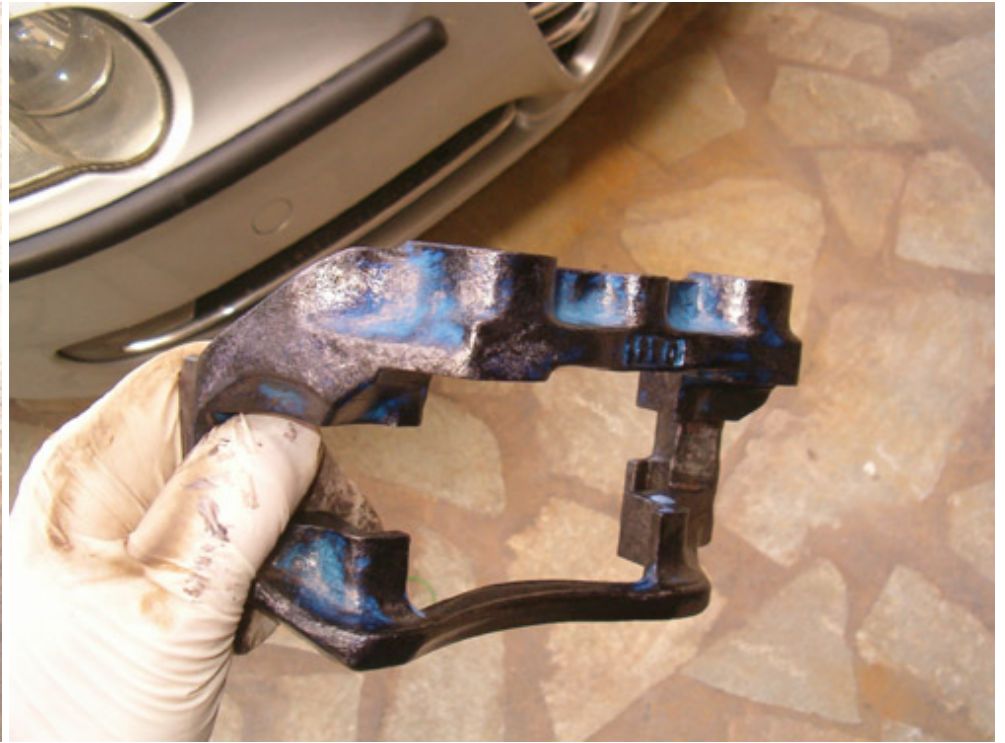
and the caliper bracket also

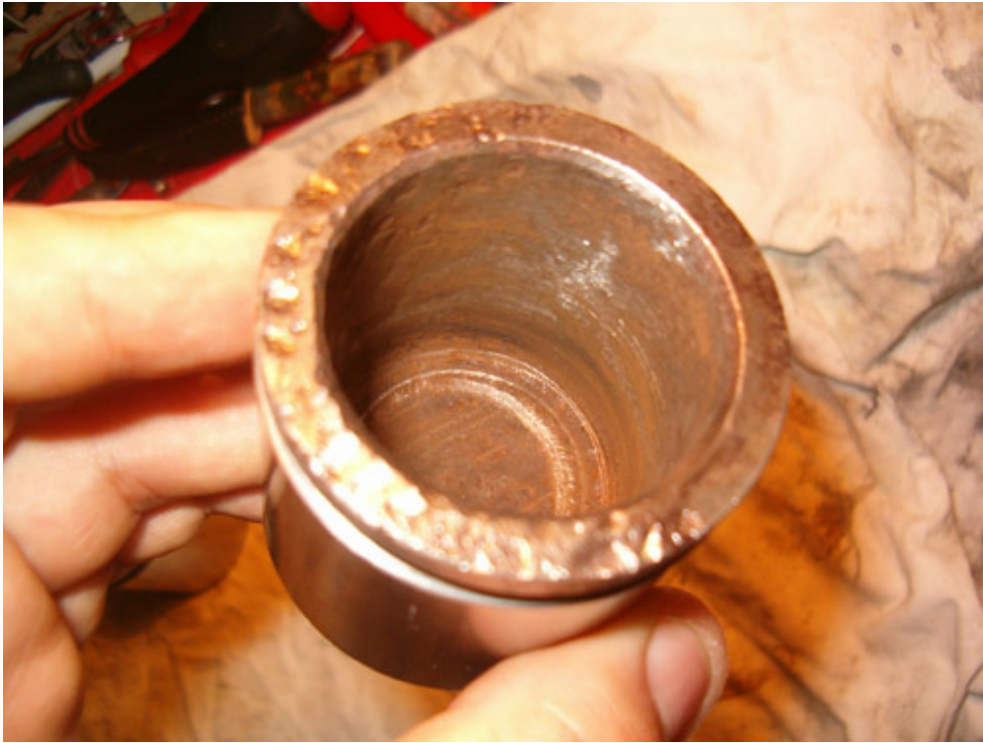
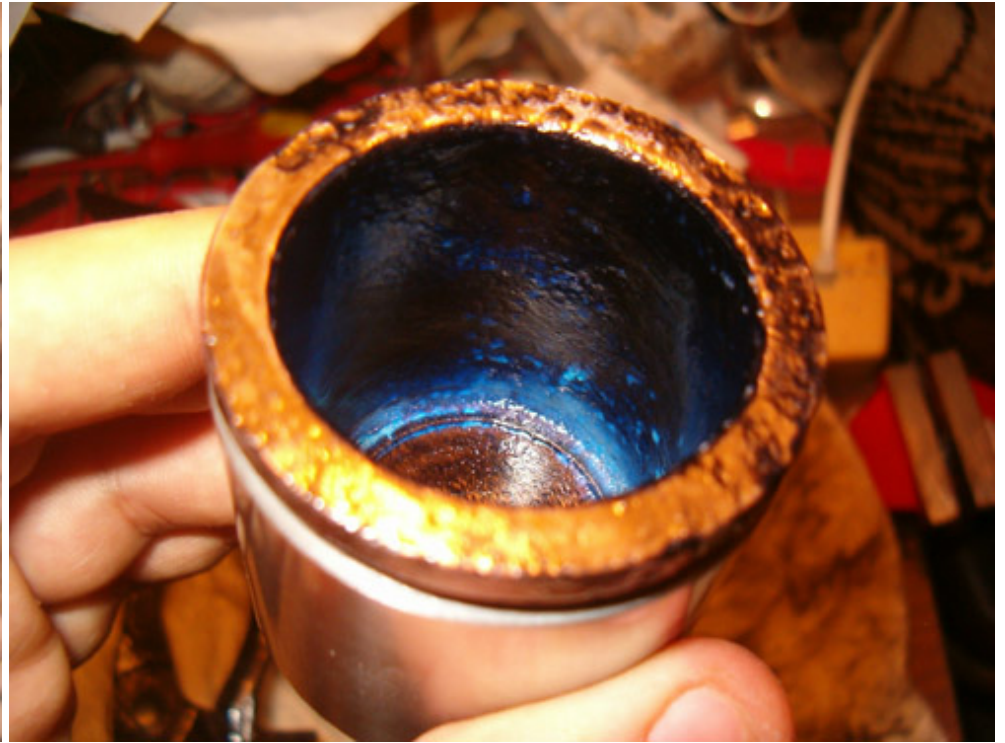
Here you can see in detail the piston internal right after cleaning it from rust. Major rust has been removed and it will be stopped by the inhibitor. As you can notice on the right photo, this material turns to dark when it attacks rust.

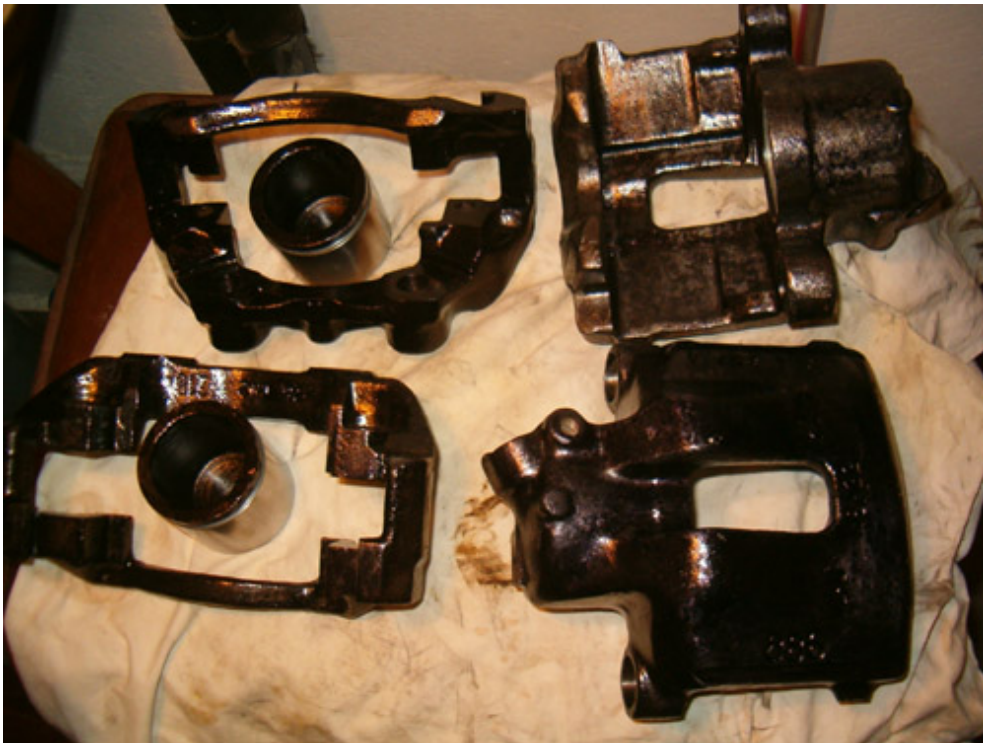
All parts are now treated with rust inhibitor

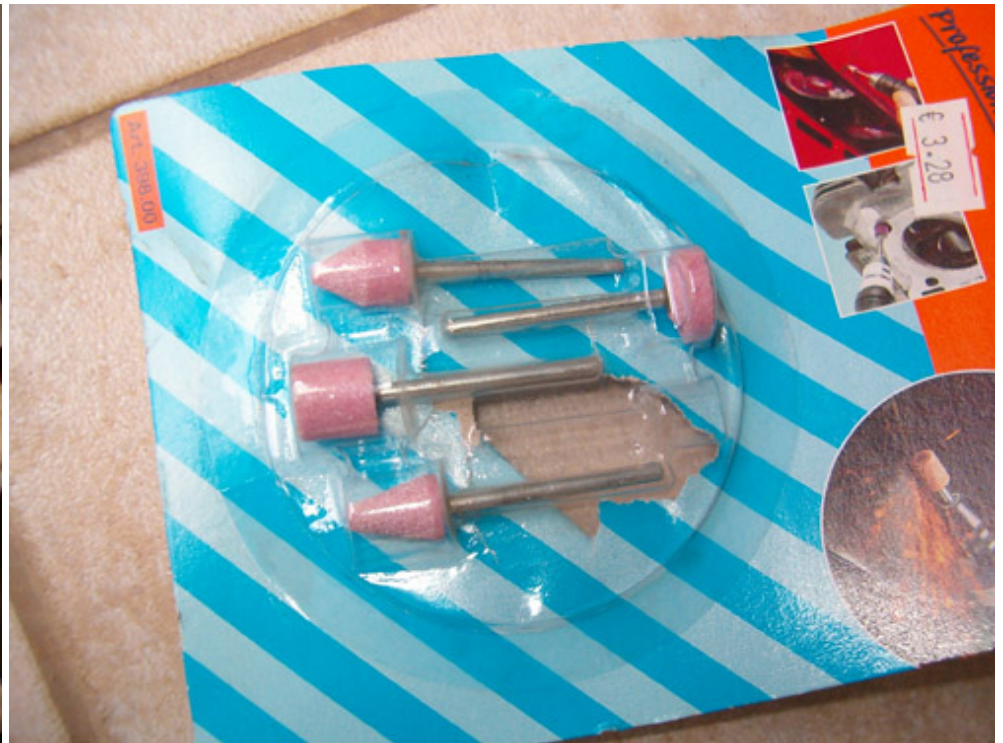
These were the stone bits I used to remove rust. Various sizes and shapes will give you the best result

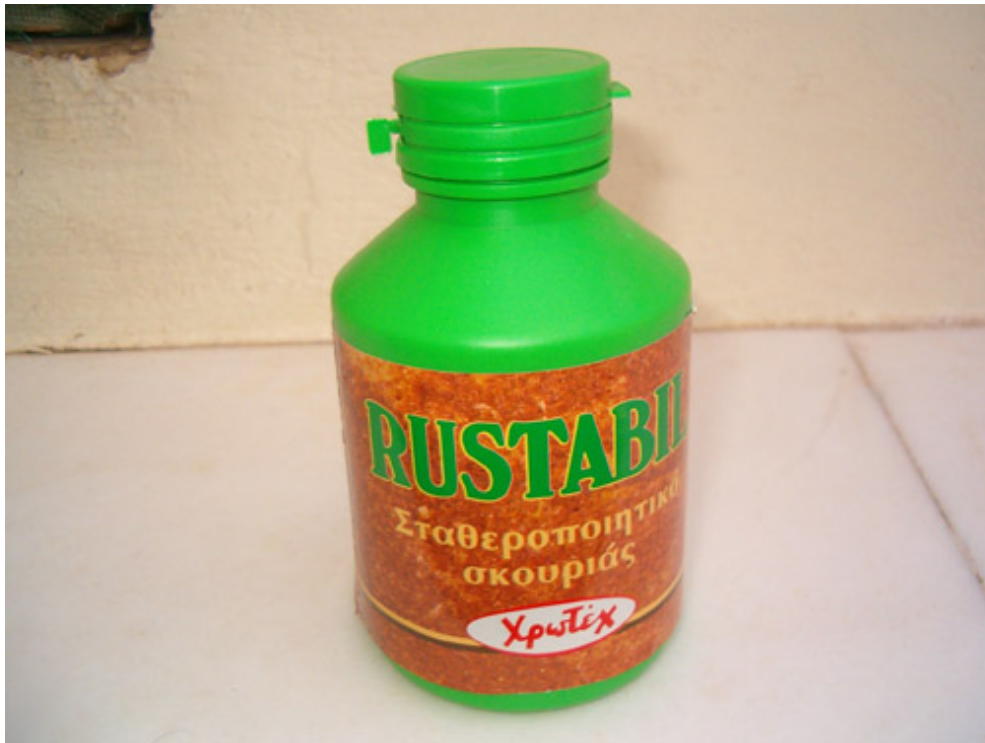
Rust inhibitor ...

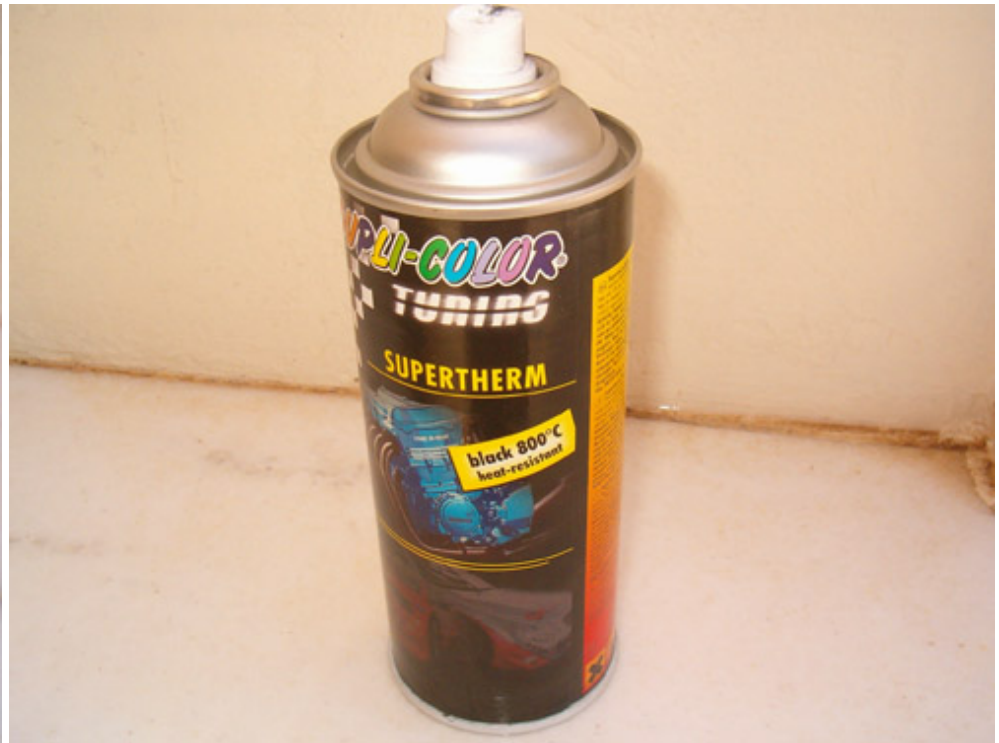
... and high temp black paint in aerosol can which will be the top coat

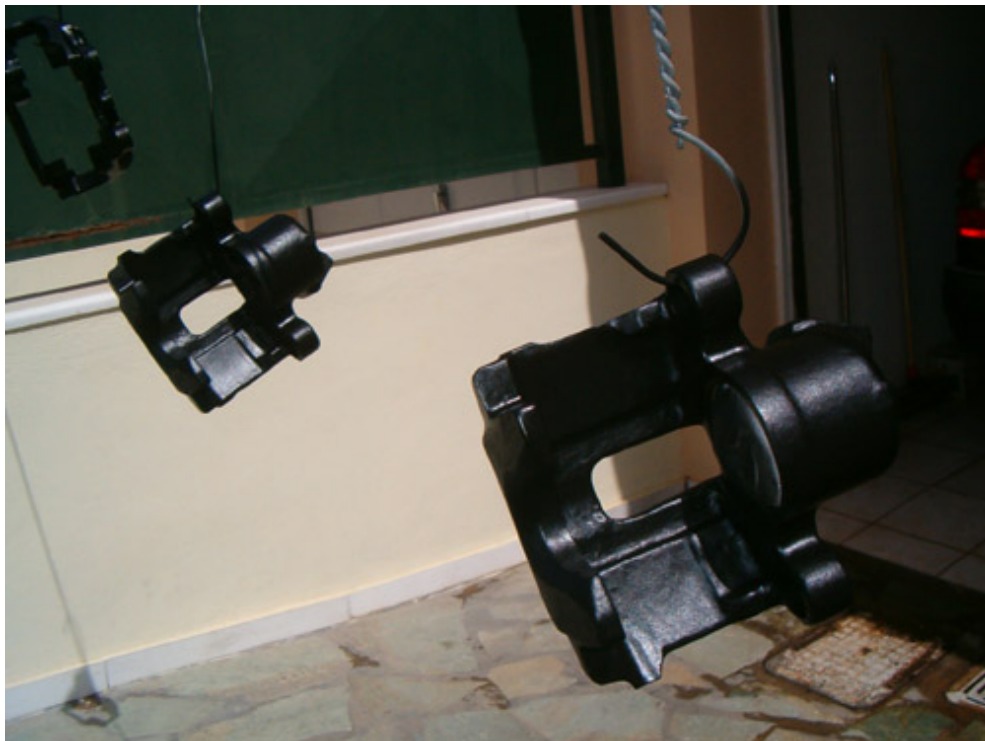
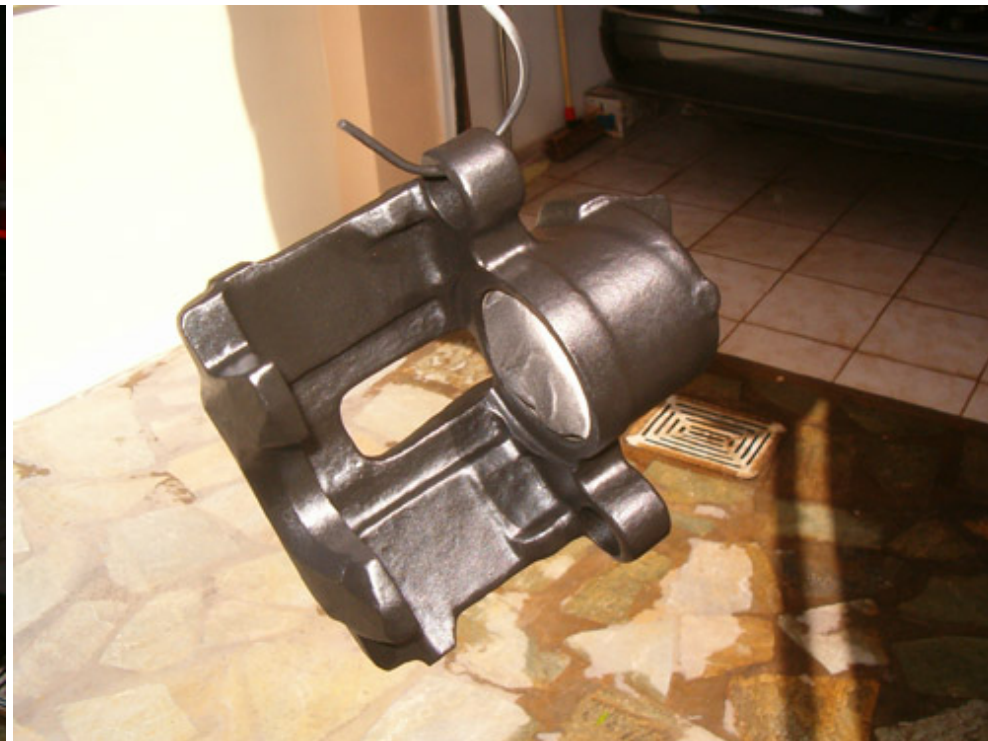
Here you can see the calipers painted at last. I choose the hanging method as there are no surfaces left unpainted. Be sure to mask the cylinder internal surface!

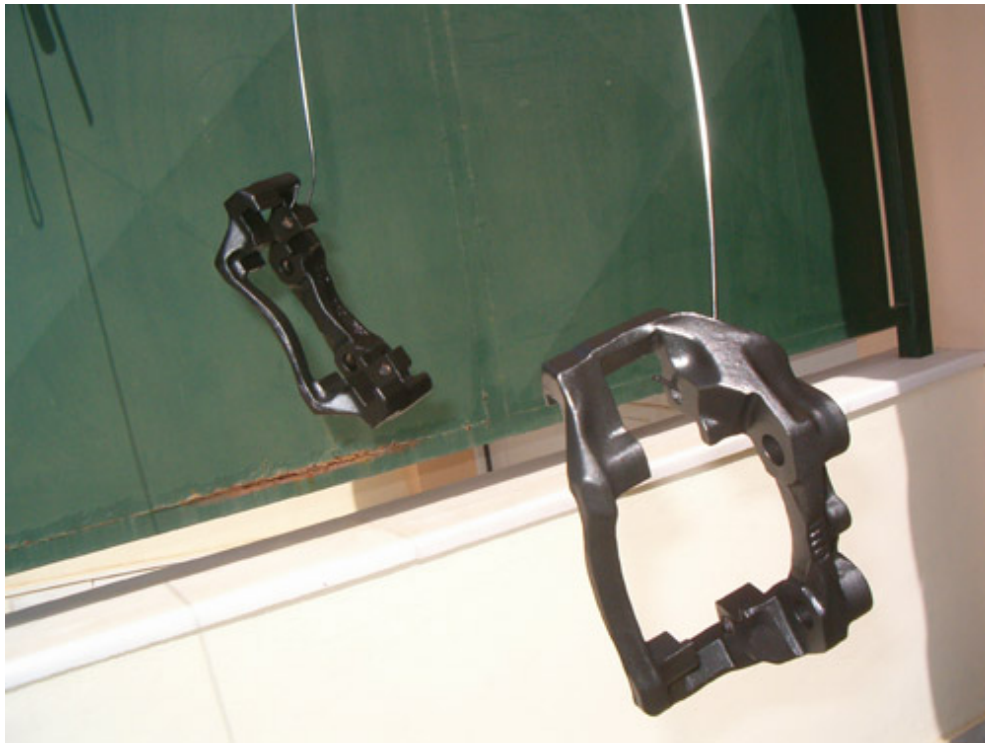
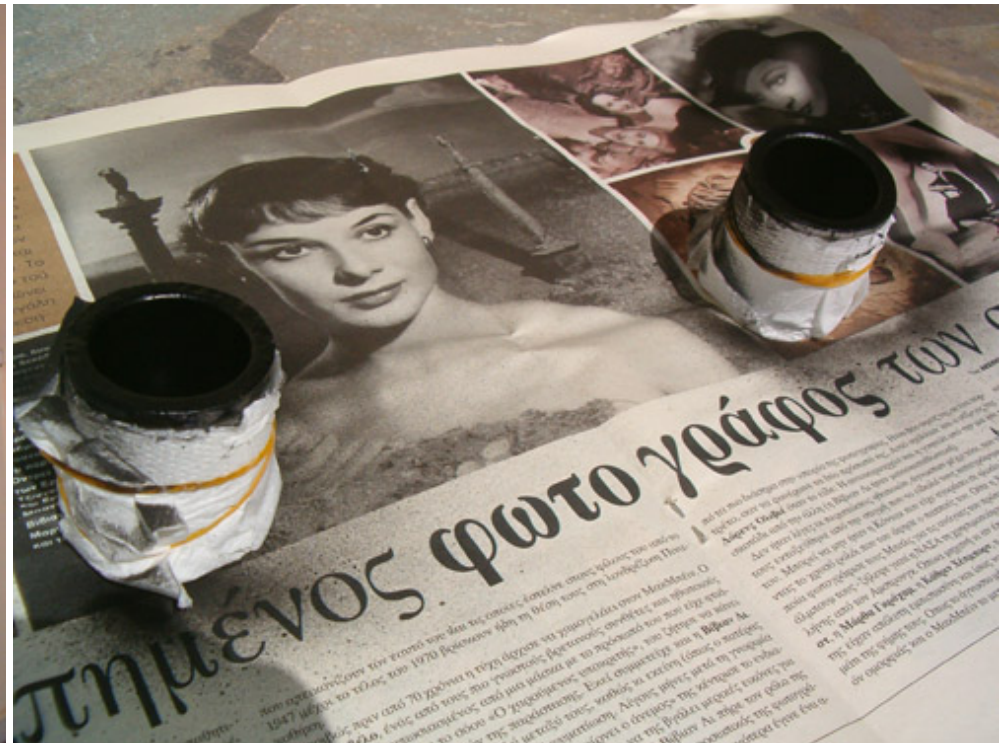
Caliper brackets painted along with the piston internals

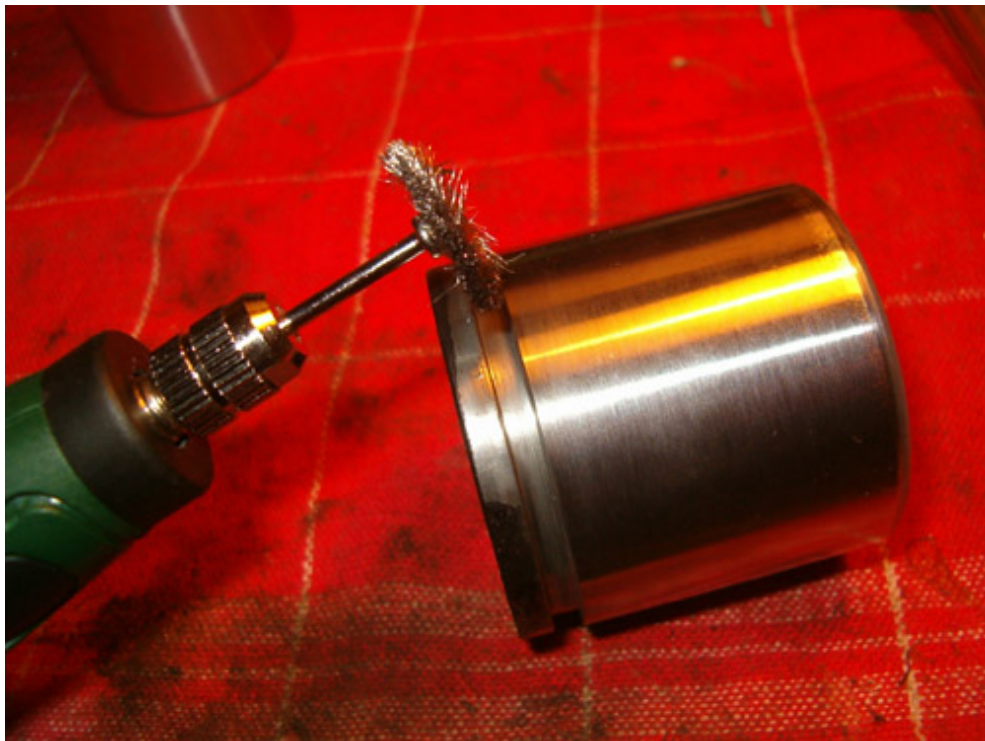
Using the small wire brush on the Dremel tool, I have removed any leftover traces of foreign material

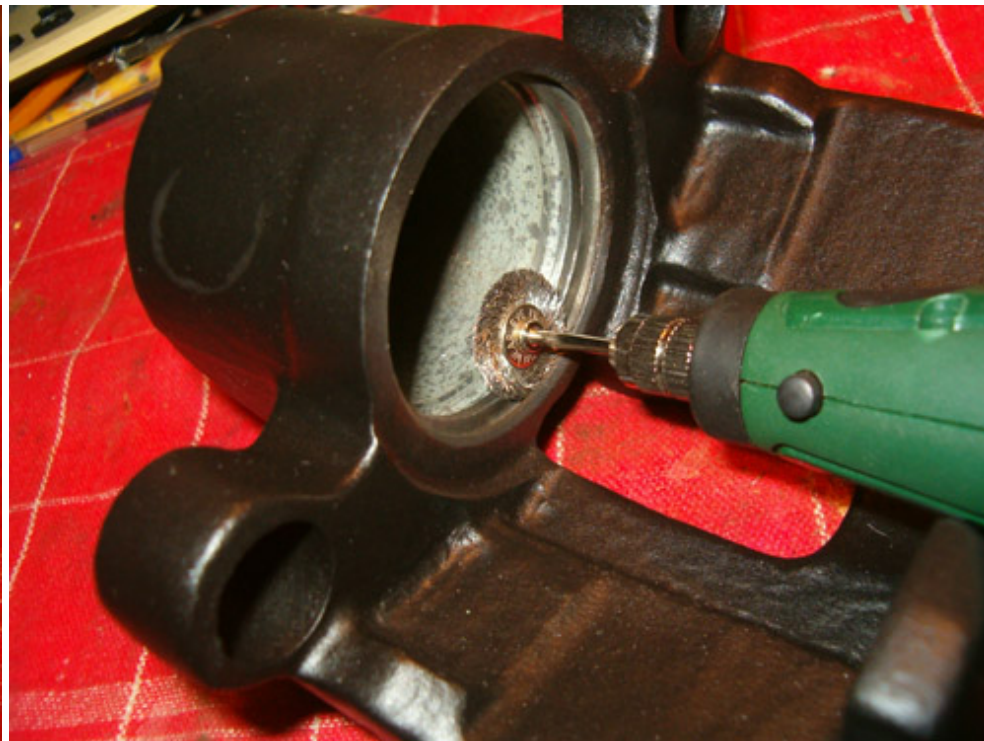
The same done on the caliper; remove dirt from the seal and dust cover groove

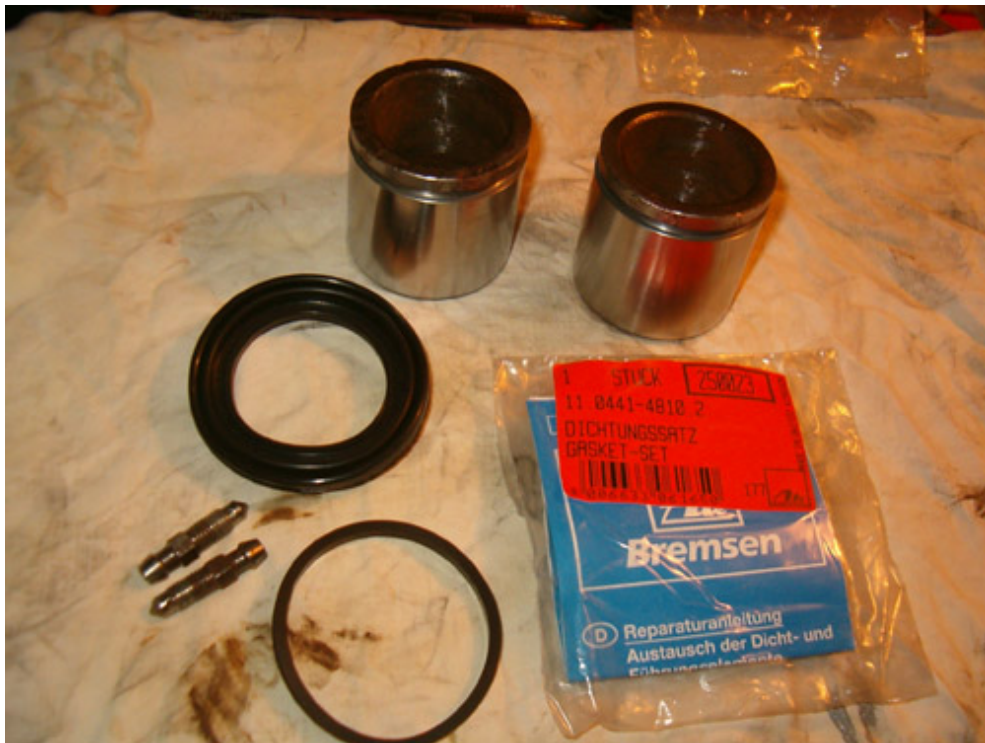
Here is the repair kit; ATE 0441-4810 is the part number for the Alfa 33 16V calipers

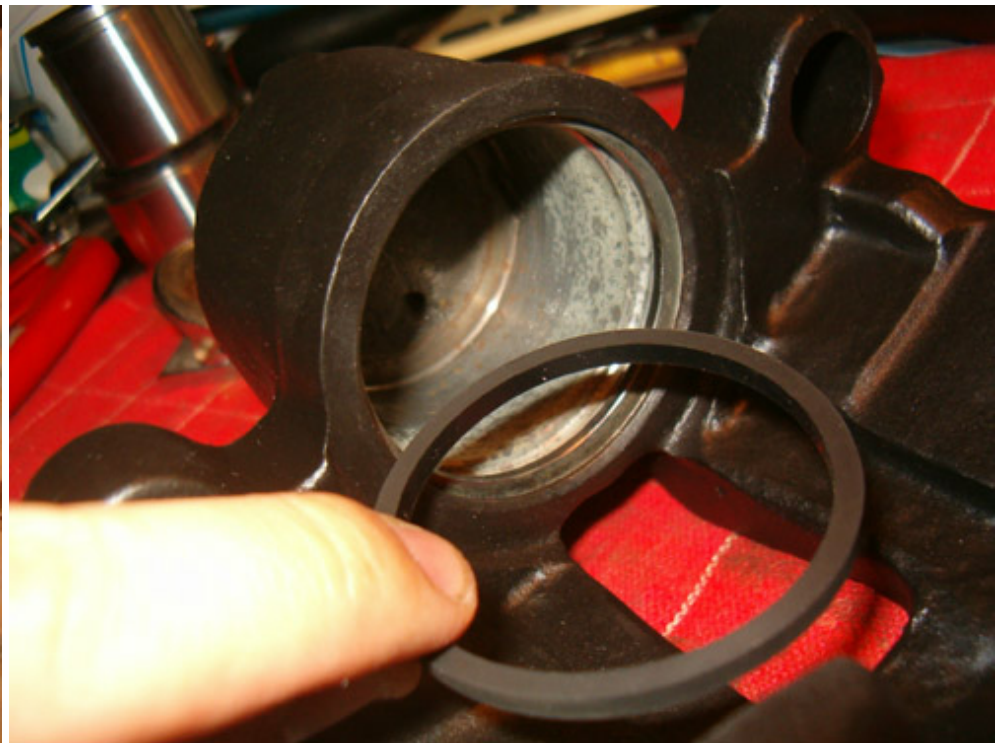
Install the piston seal on the cylinder

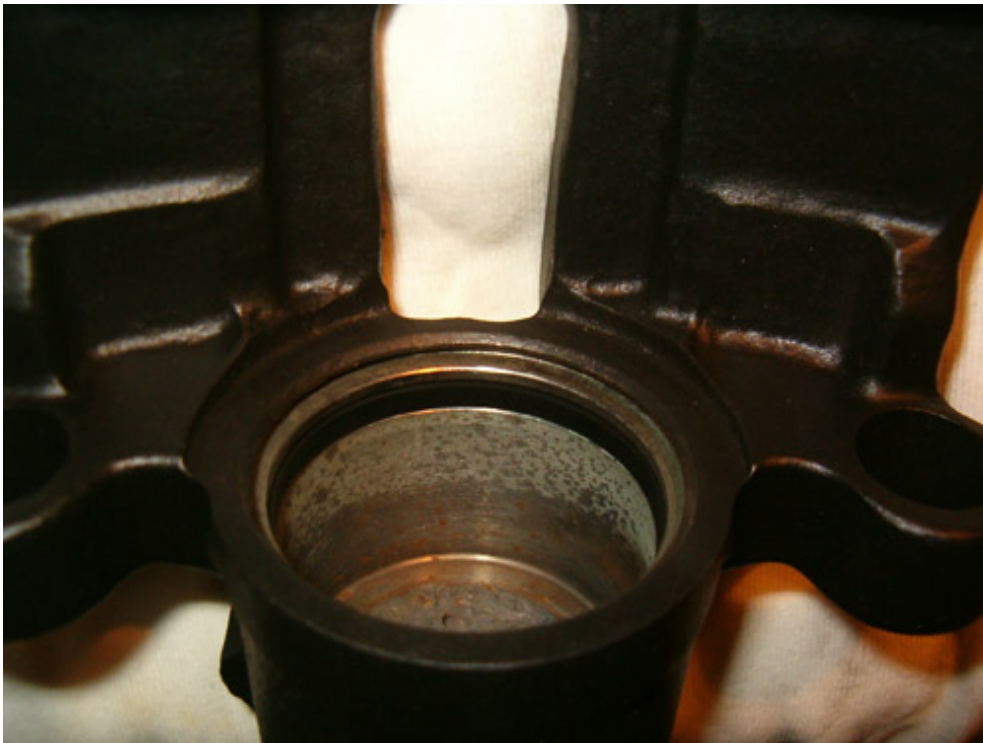
Be sure to seat it properly

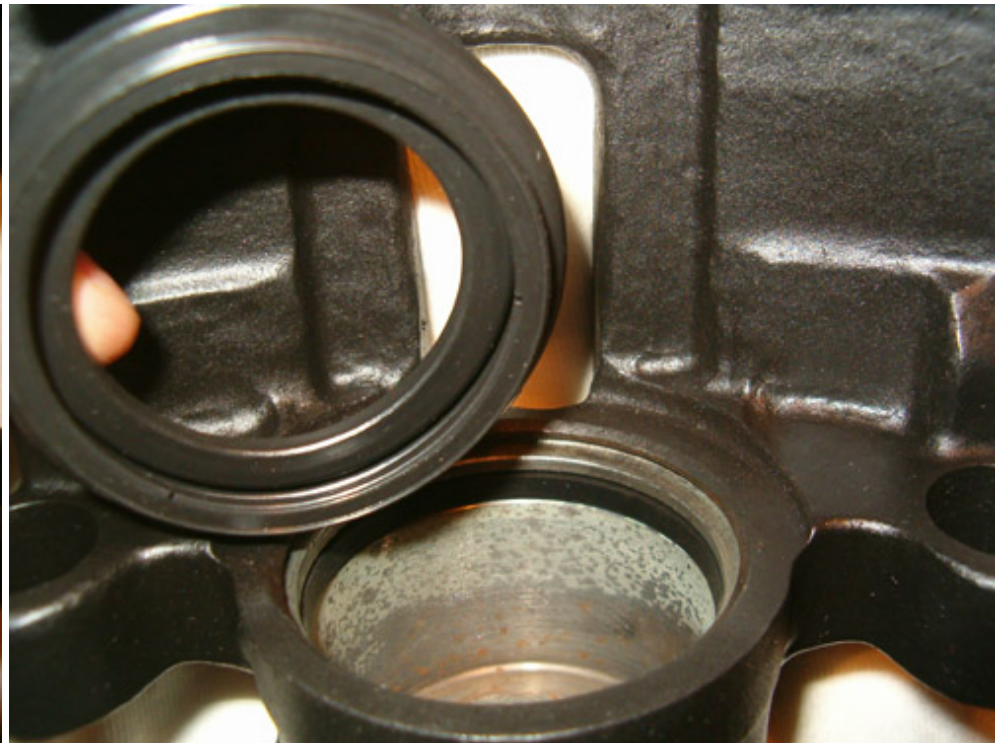
Proceed installing the dust cover
