## Braking System Restoration

## Calipers rebuilt

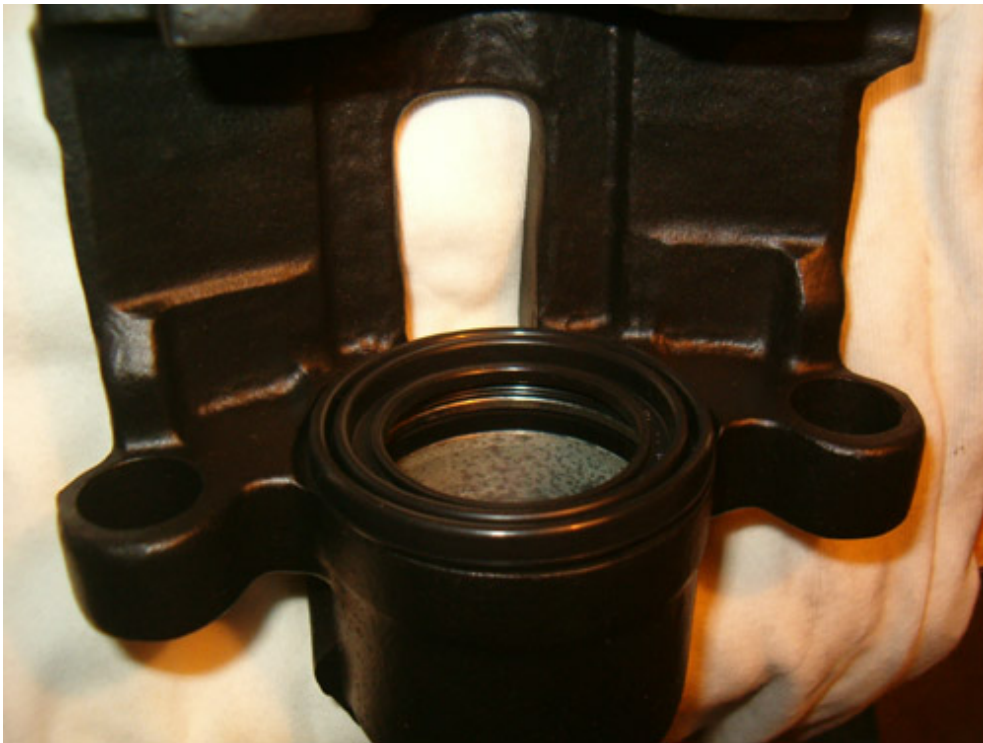
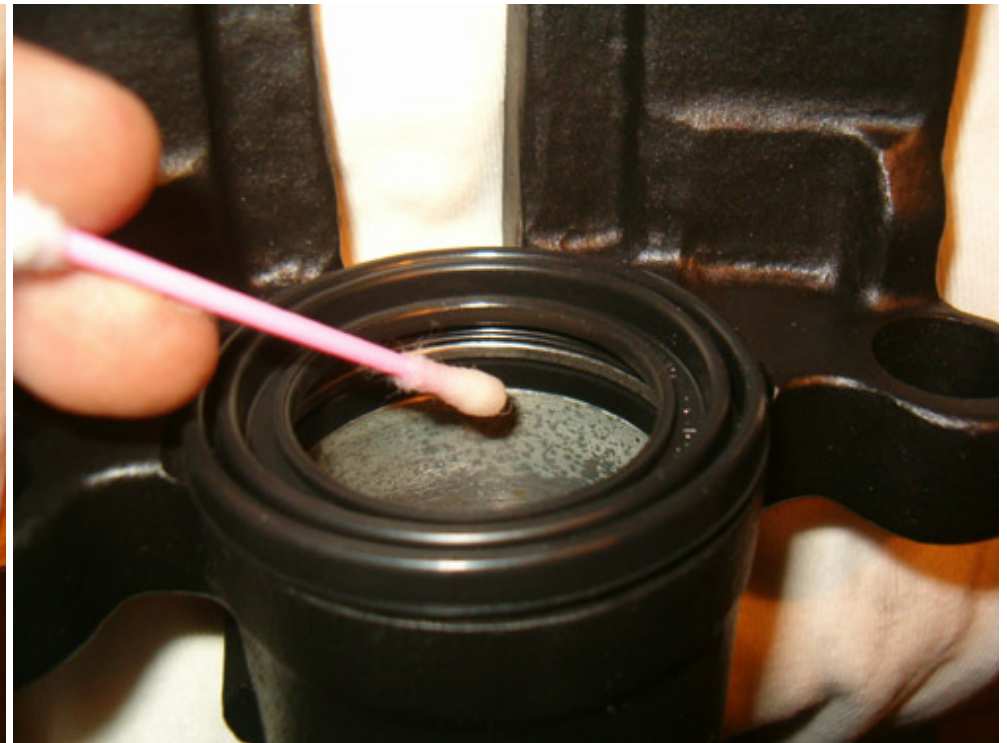
It should look like above. With a cotton pad soaked in brake fluid lubricate the dust cover lips; lubrication here is essential as we need to have the piston slide easily. The option to use brake pad paste is also acceptable.

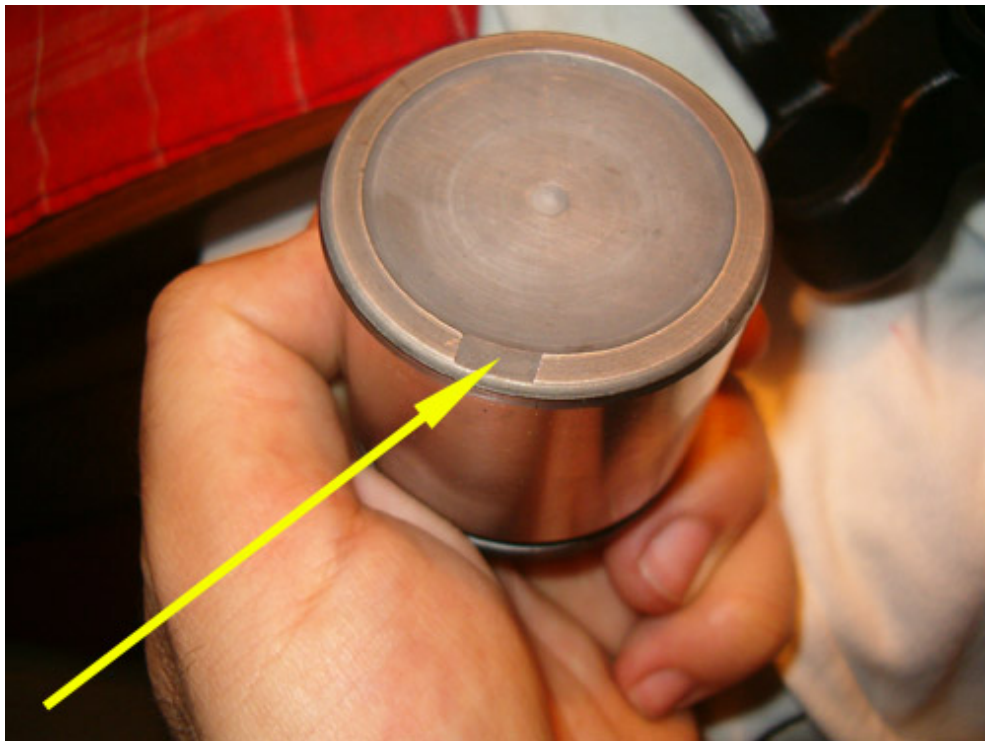
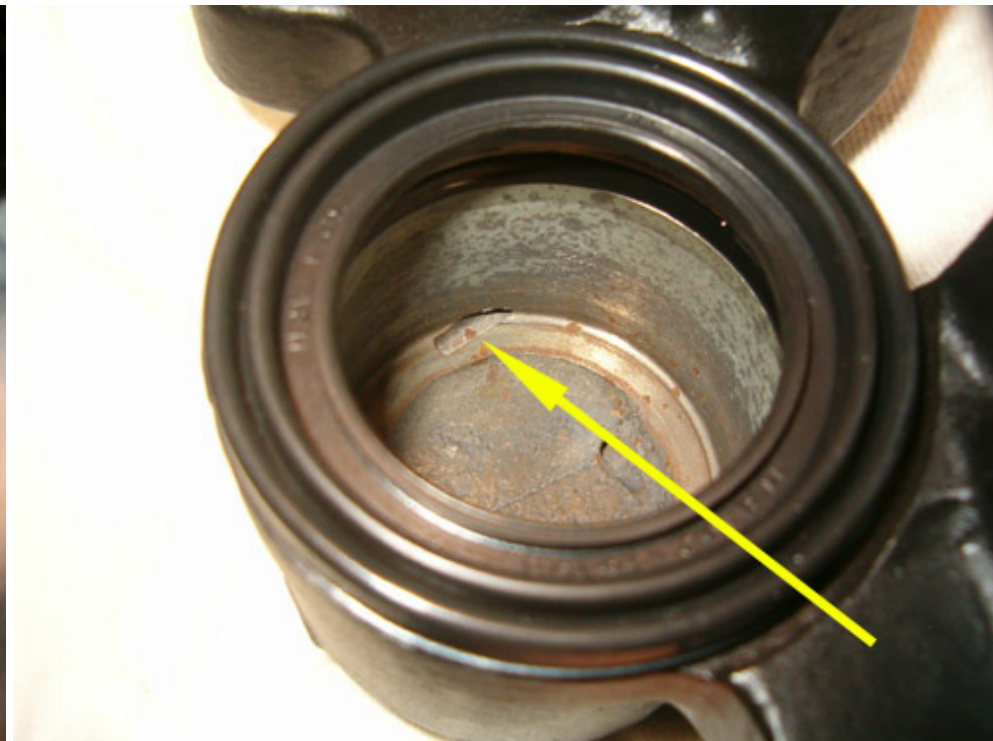
Make sure that the notch of the piston lines up with the opening in the caliper. This opening is the bleeding nipple galley, so we need to "help" air/brake fluid out!

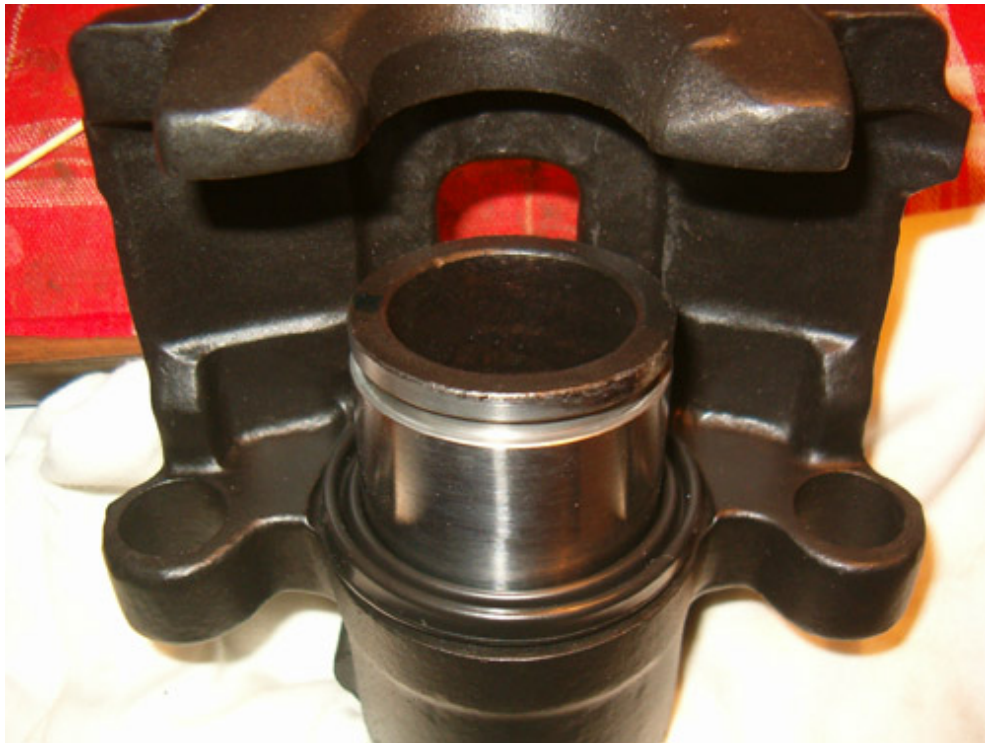
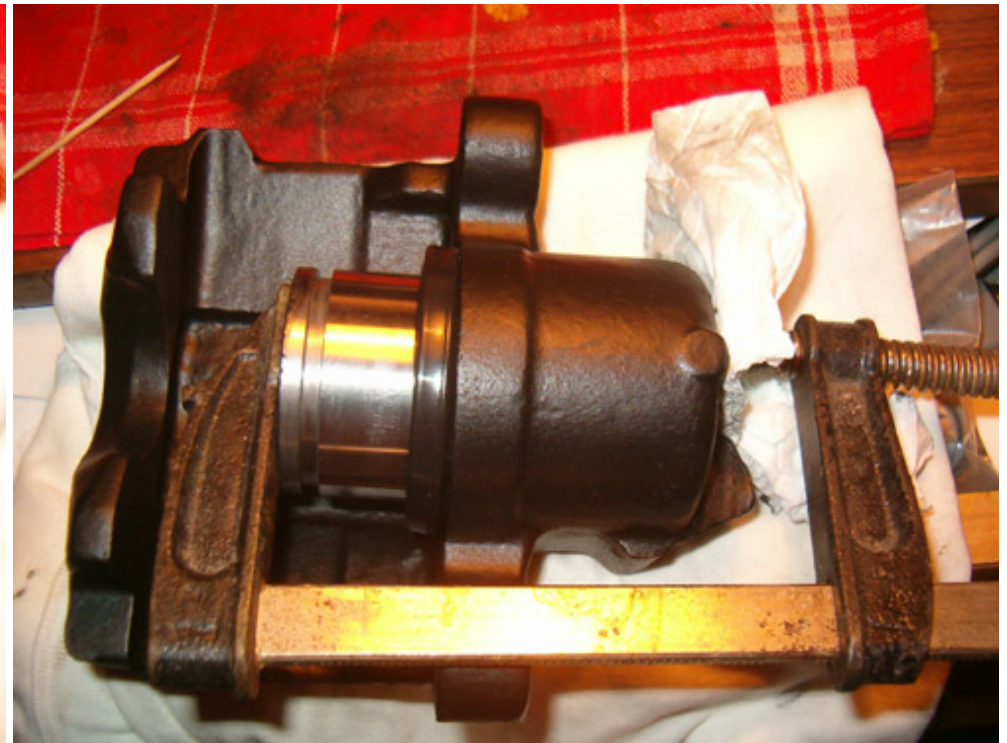
Place the piston on its seat and very carefully use the bracket to help the piston slide in the cylinder. Once it has seated correctly in the seal, it will slide very easily; otherwise if you feel difficulty sliding it in, stop and try over again until it goes in correctly.

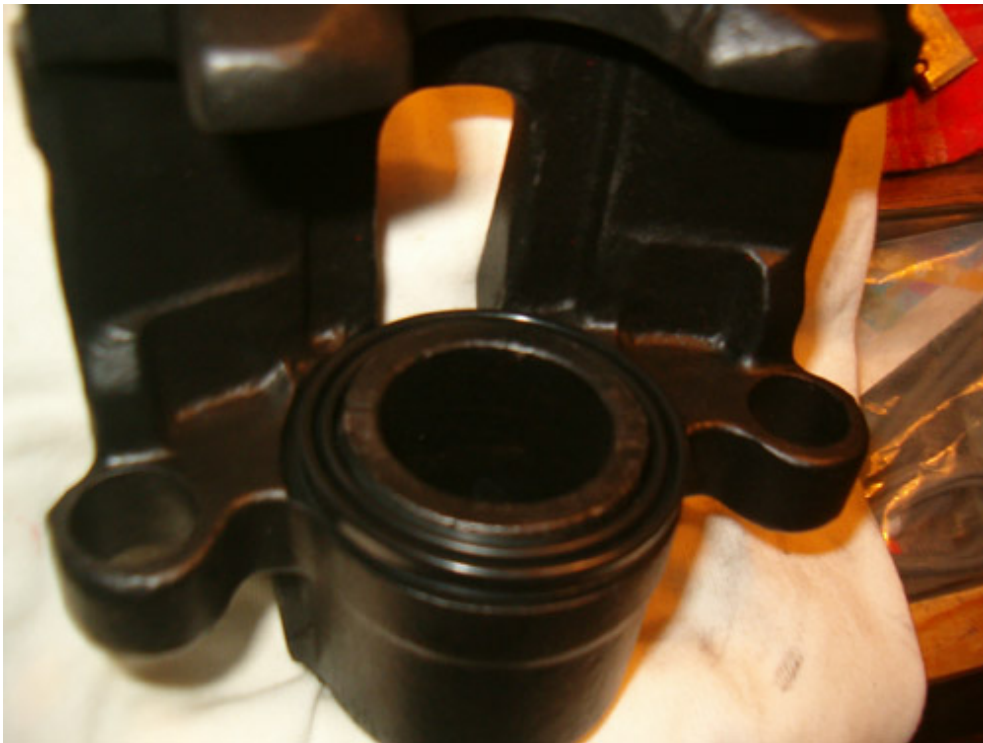
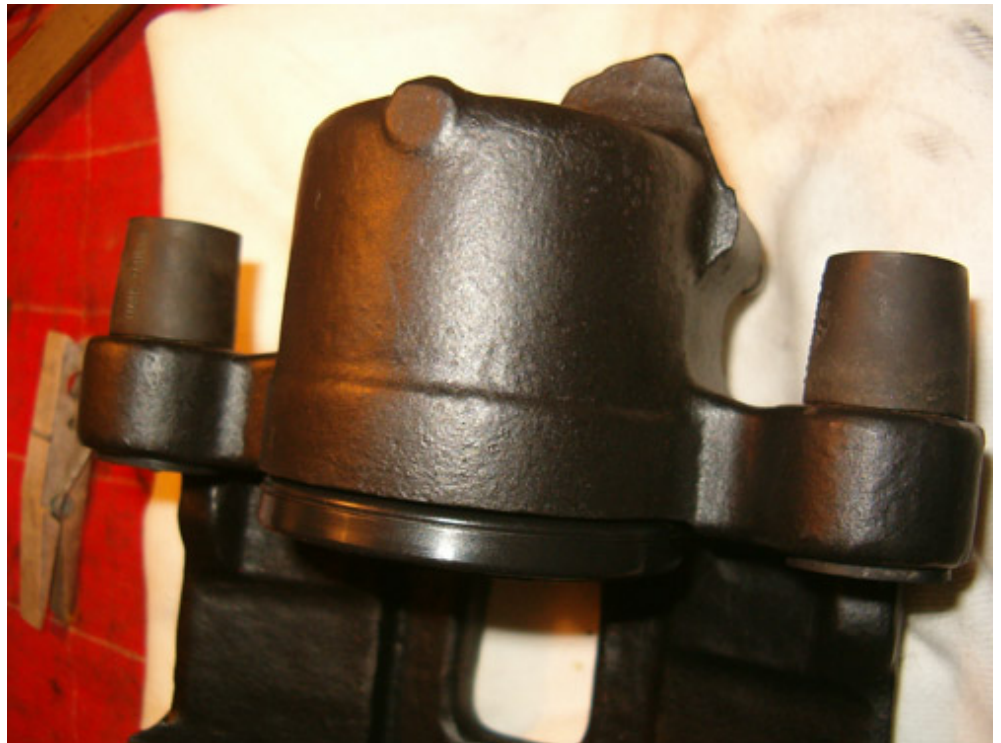
Brake piston is now correctly placed on its seat. Be sure that the dust cover internal lip is correctly seated in the piston groove.

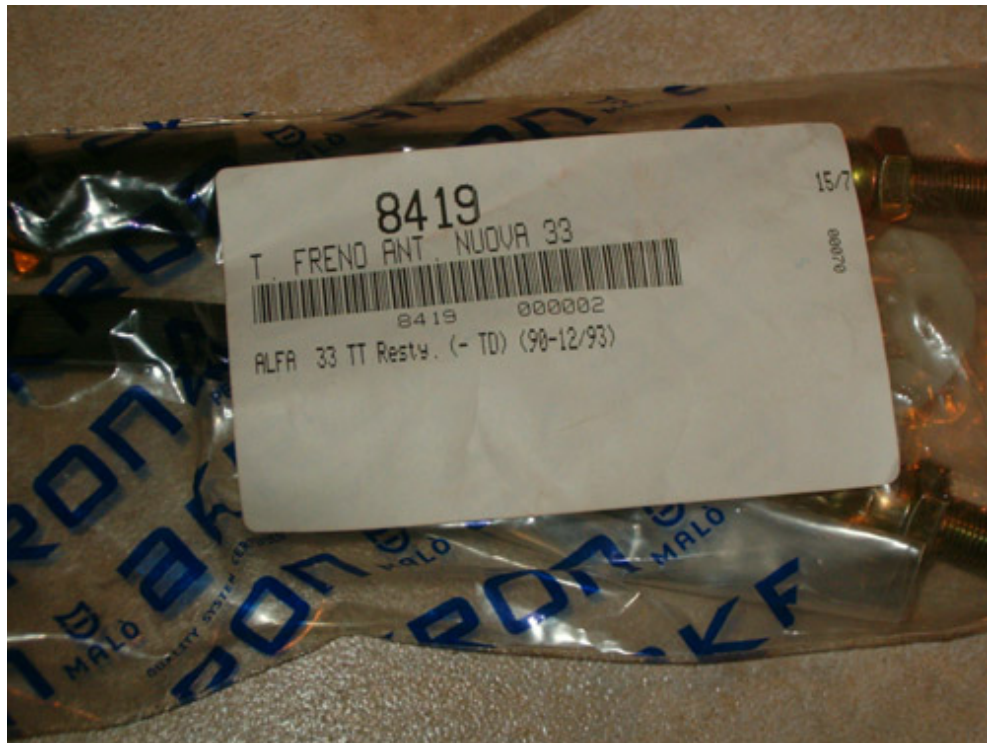
Finally install new brake hoses and fully tighten them

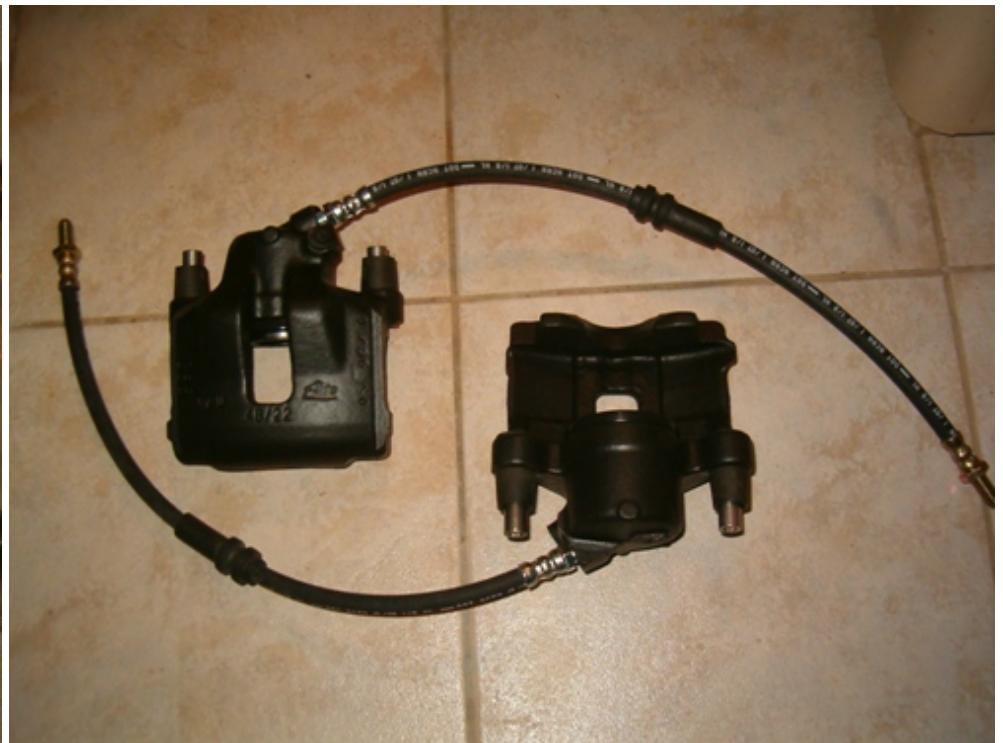
Brackets are now ready to be installed on the car.
