Rear axle bias valve

Next thing I had replaced were the master cylinder and the rear axle bias valve. I didn't photo document the MC replacement procedure however I did for the bias valve. The bias valve replacement is however quite tricky as it needs proper adjustment by applying a certain amount of weight in the adjustment hook.

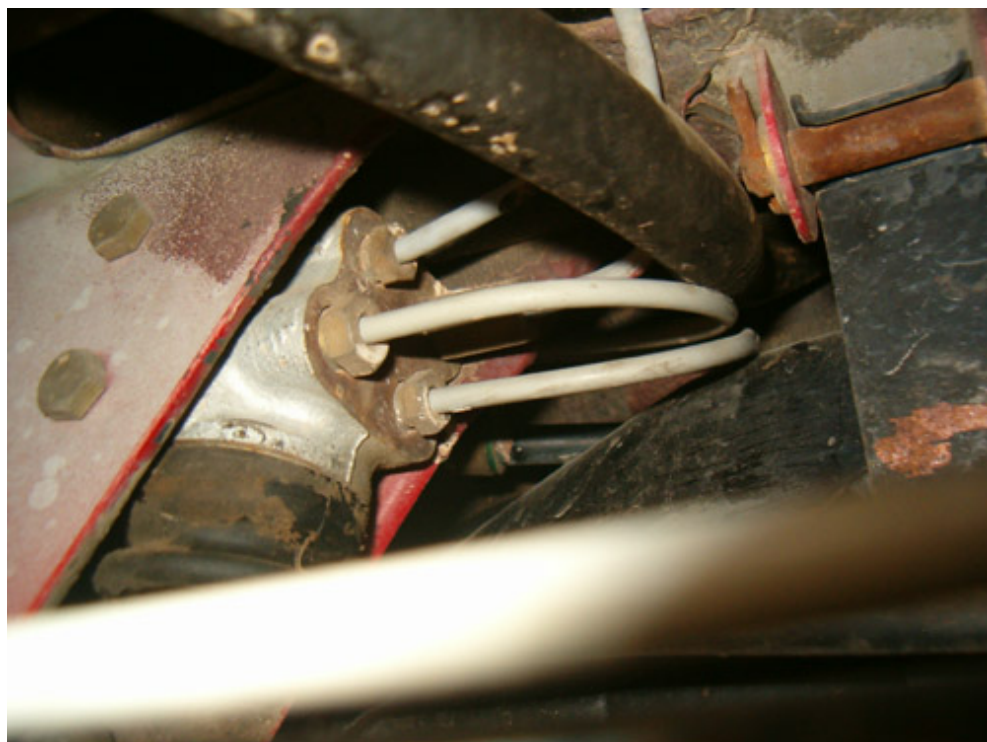
Here you can see the bias valve. It is still the original valve fitted during production of the car back in 1991. Sorry for the angle of the photo but working and shooting in such tight area is very awkward !

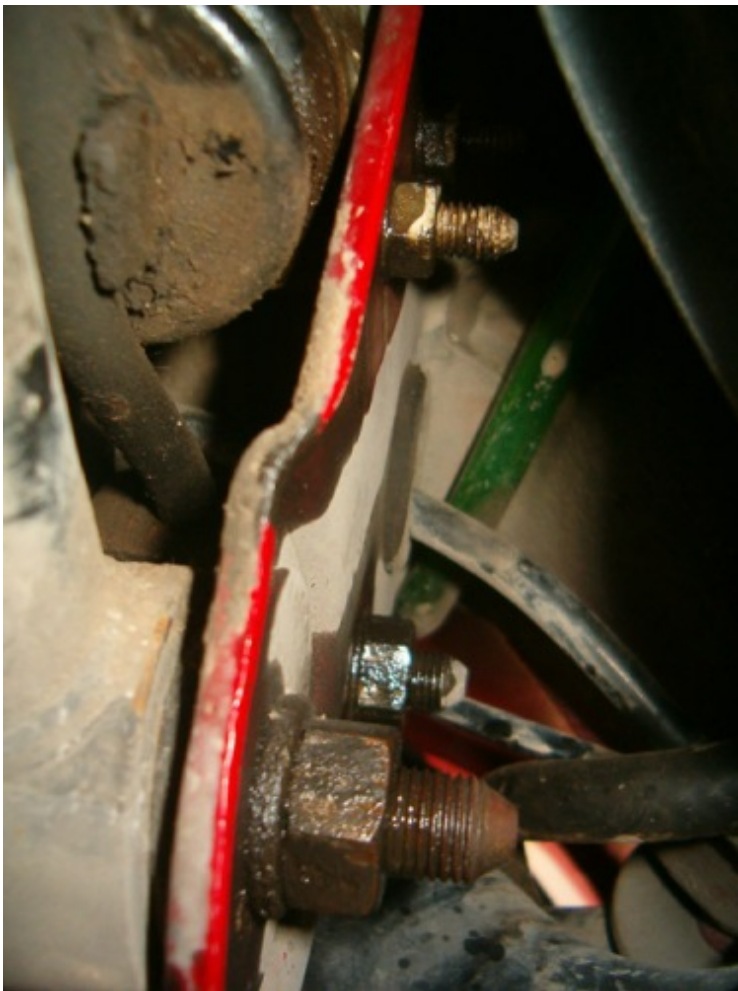
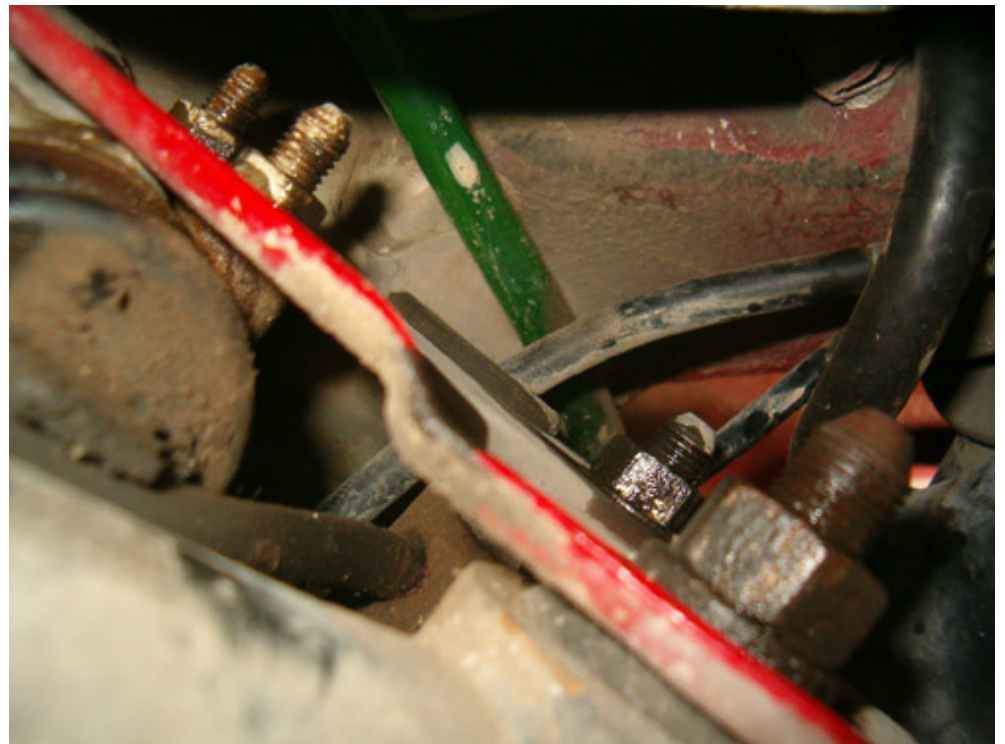
Here you can see all the designated bolts and nuts from different angles

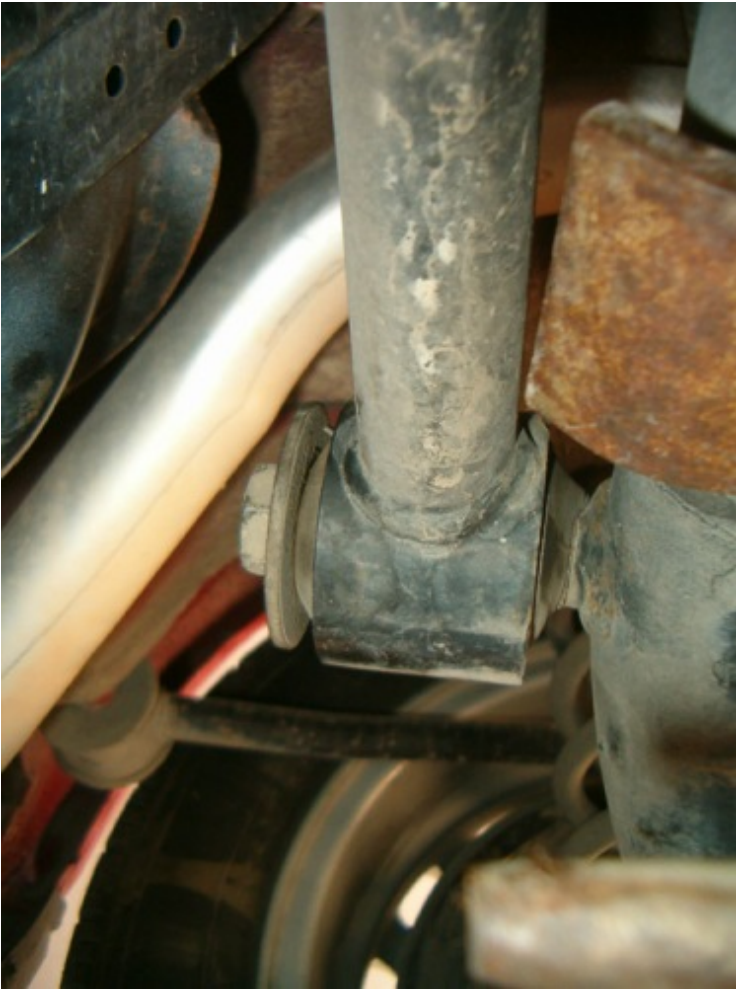
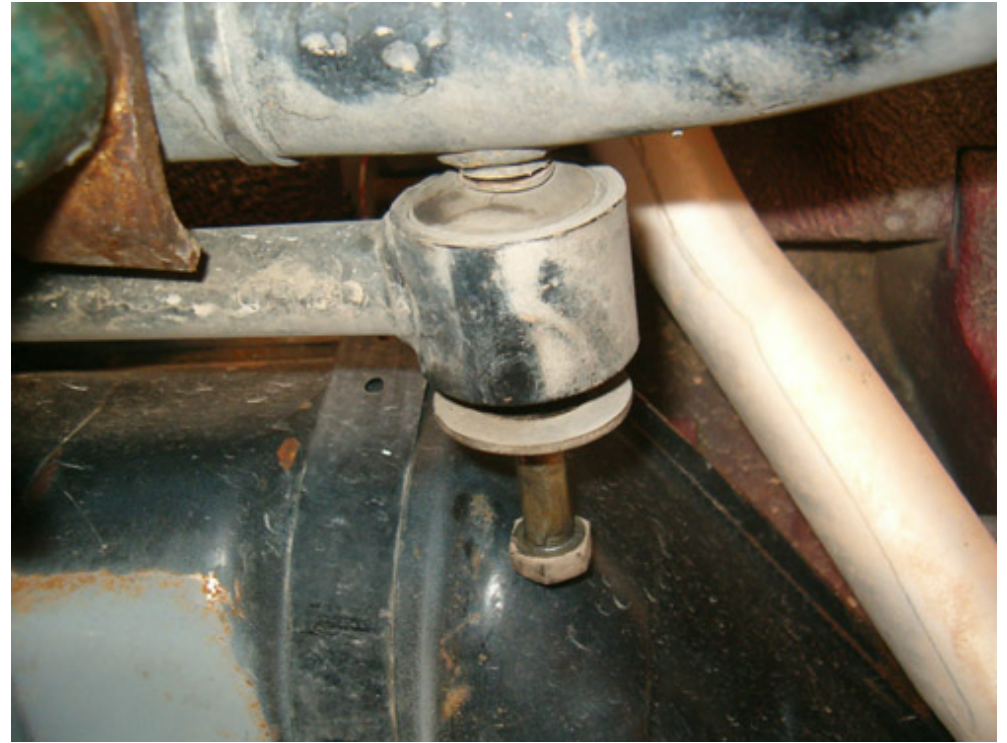
This is the other end of the Panhard bar. In case you need to remove it off the car, then you must have an assistant lift a little bit the rear of the vehicle as the bolt is quite long and hits the fuel tank

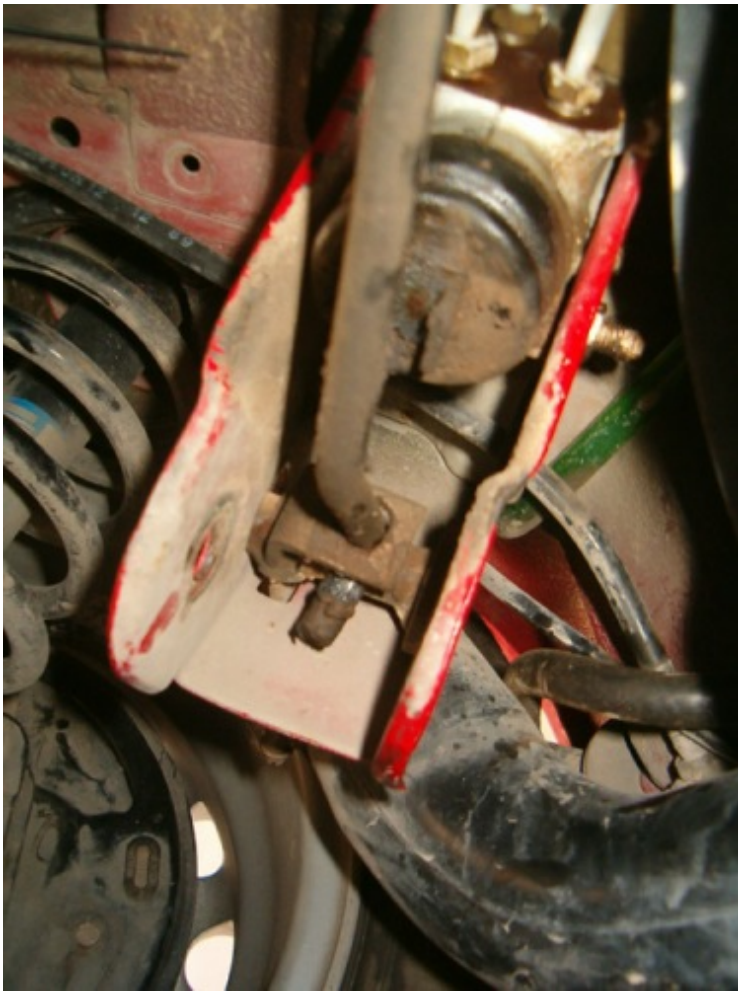
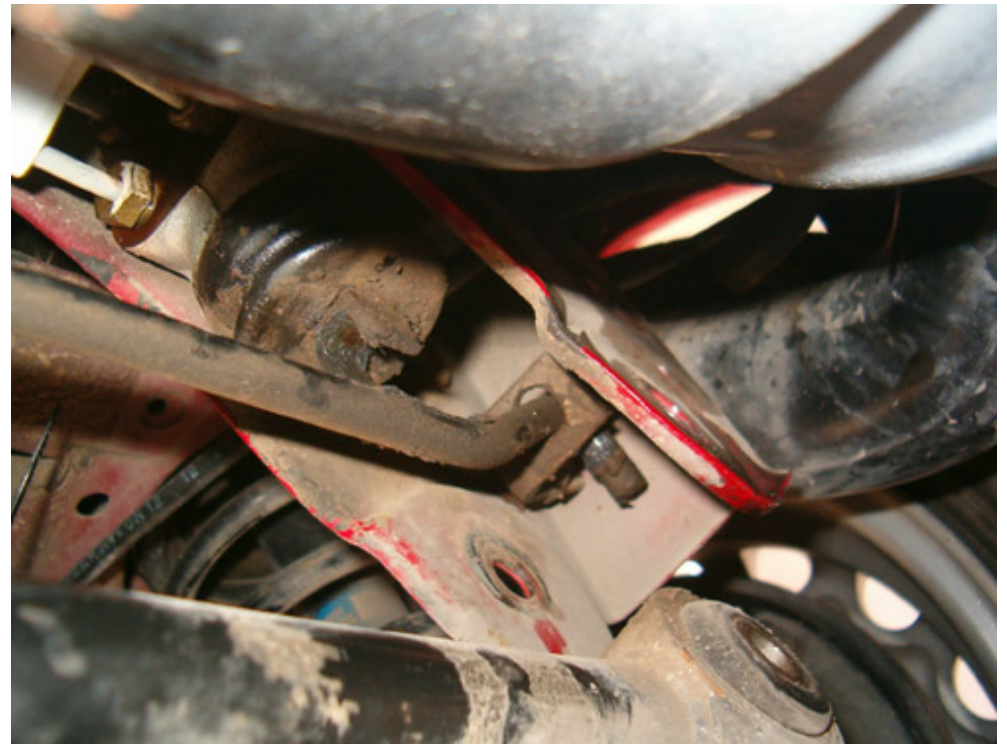
Once the Panhard bar is out of the way the adjustment hook is seen on the end of the spring.

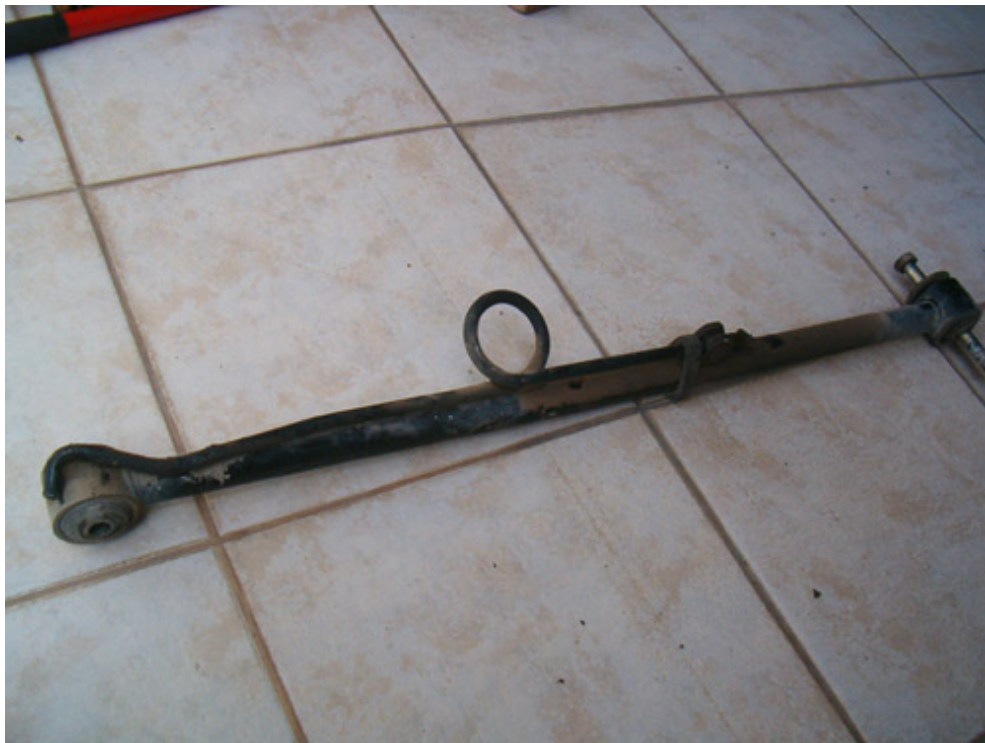
Here is the Panhard bar, along with the spring.

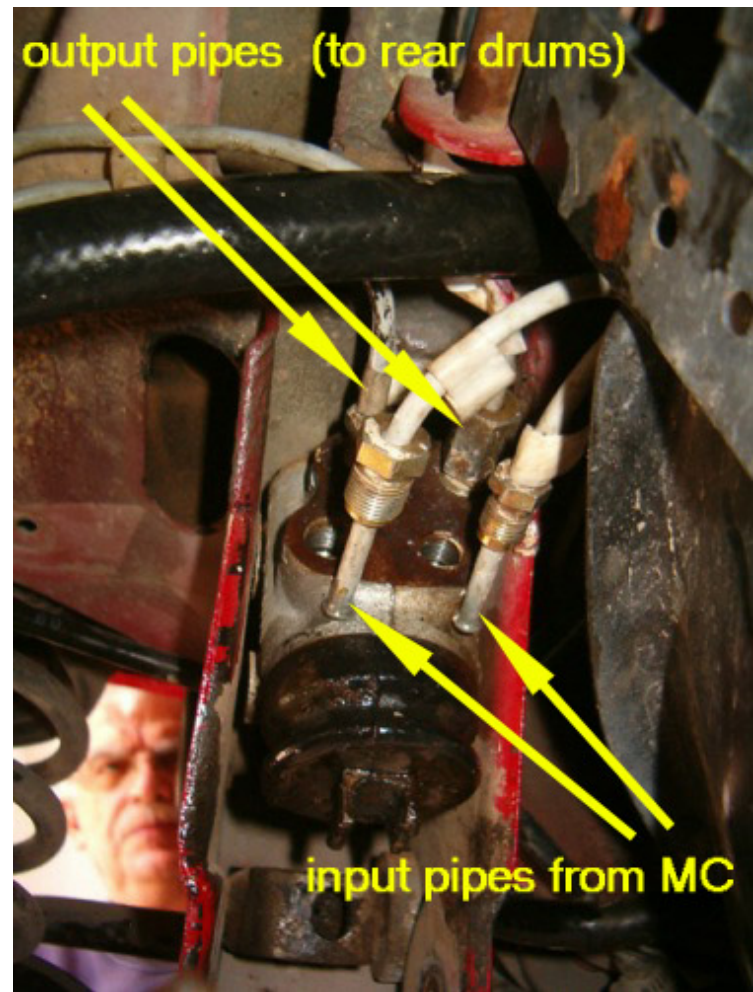
Time to remove the bias valve. It is advisable to marke the brake lines so that you don't mix them up while refitting

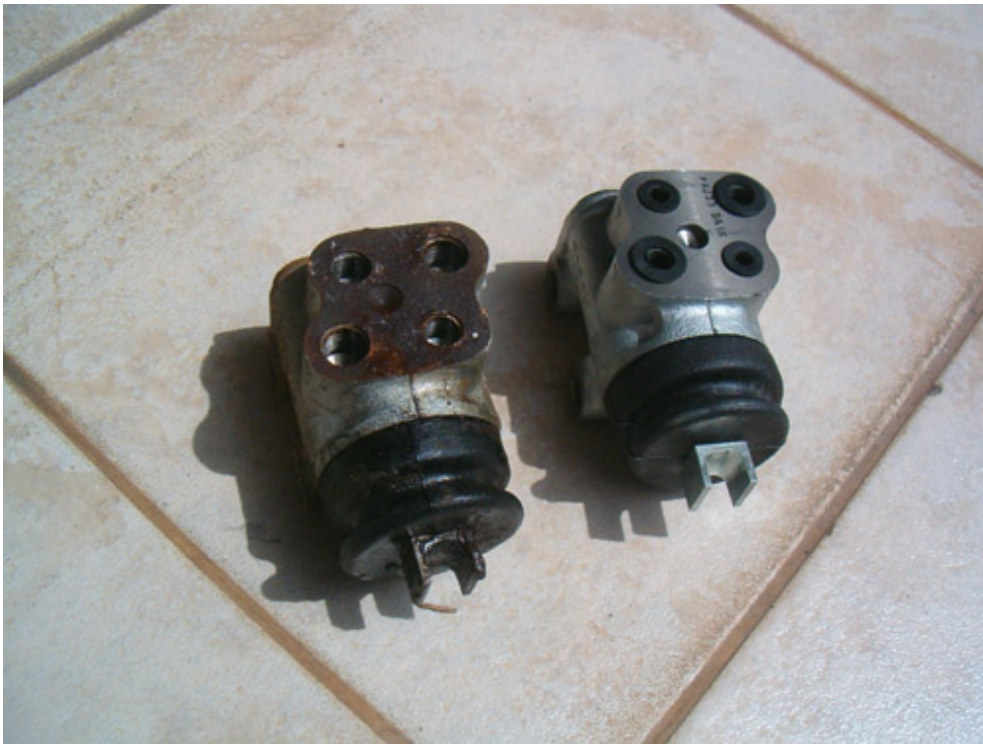
New and old one

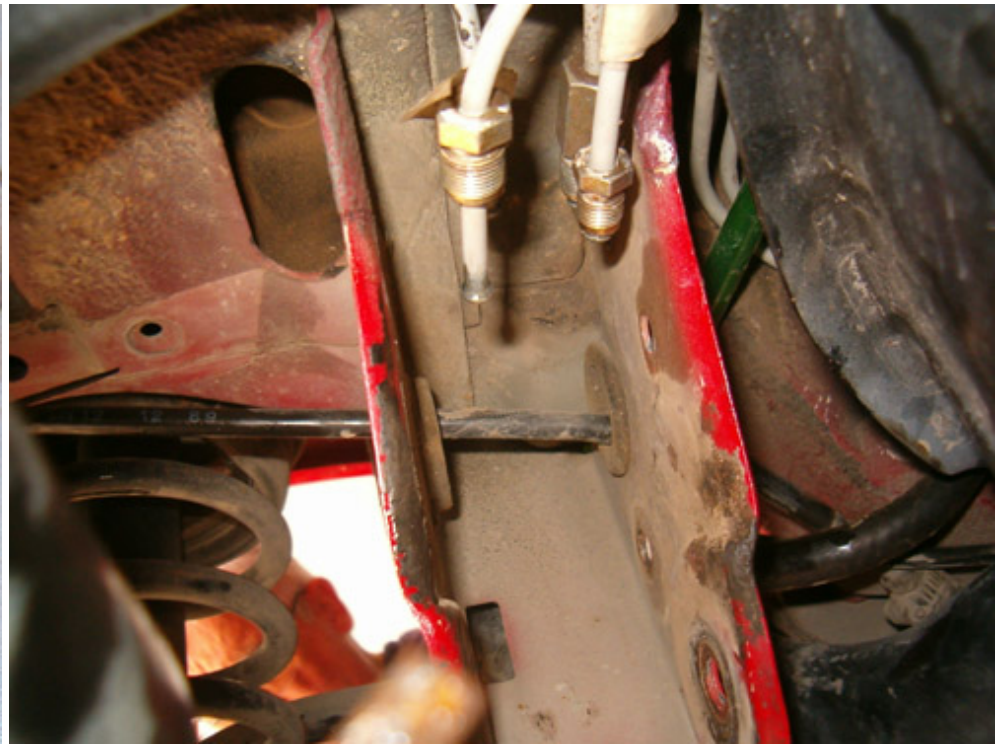
Bias valve cavity

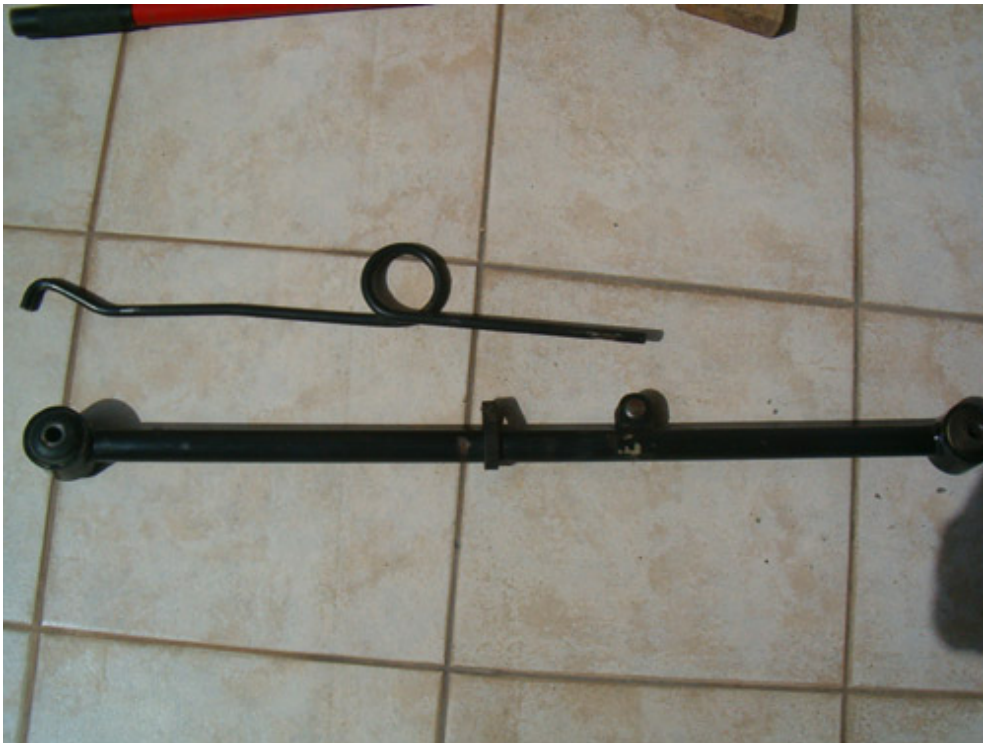
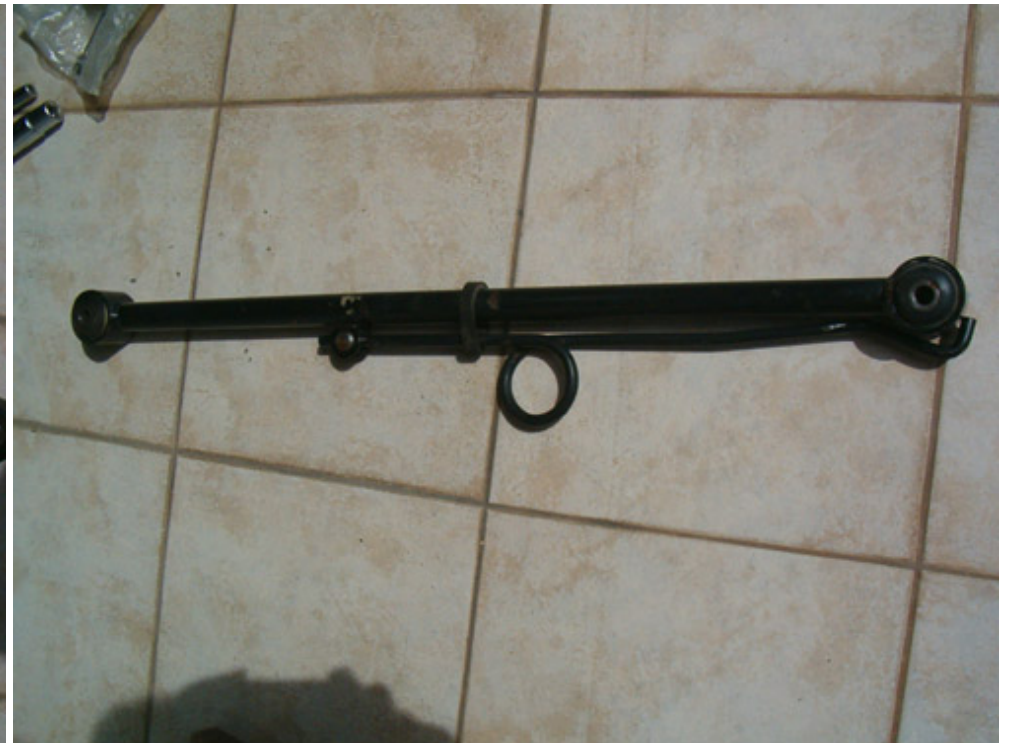
It is time to clean up the Panhard bar. The funky rubbing you may be hearing while driving the car in bumpy roads is originating from this specific bar.

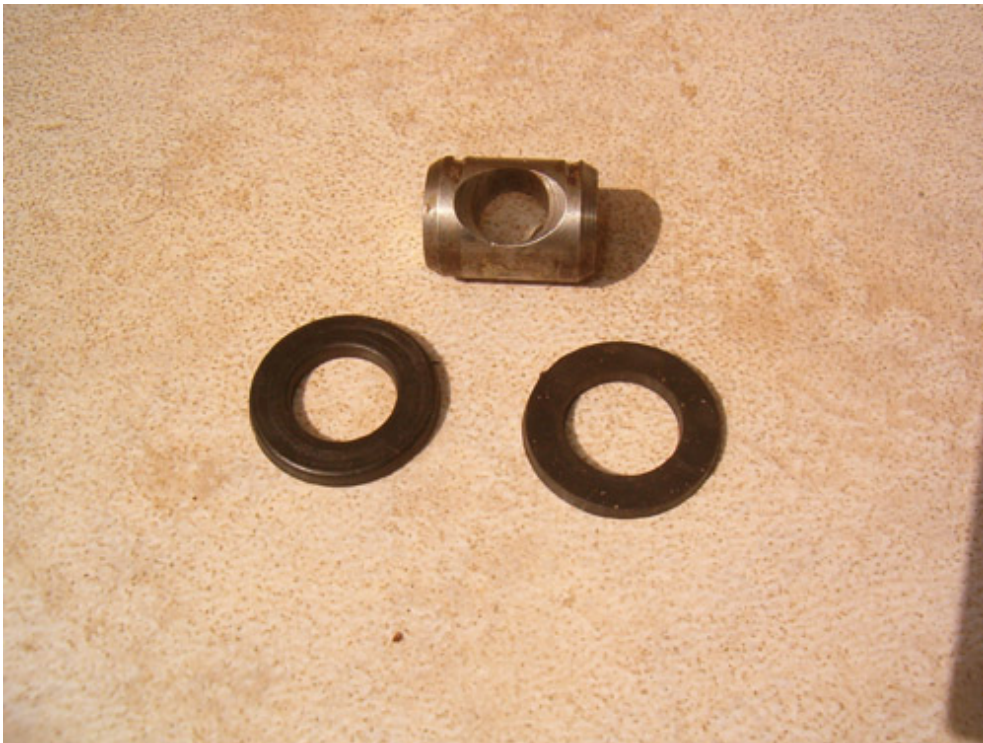
The metal rod you see above is actually the proximity of the spring. Road dirt gets inside the rod and results in metal to metal rubbing hence the funky sound.

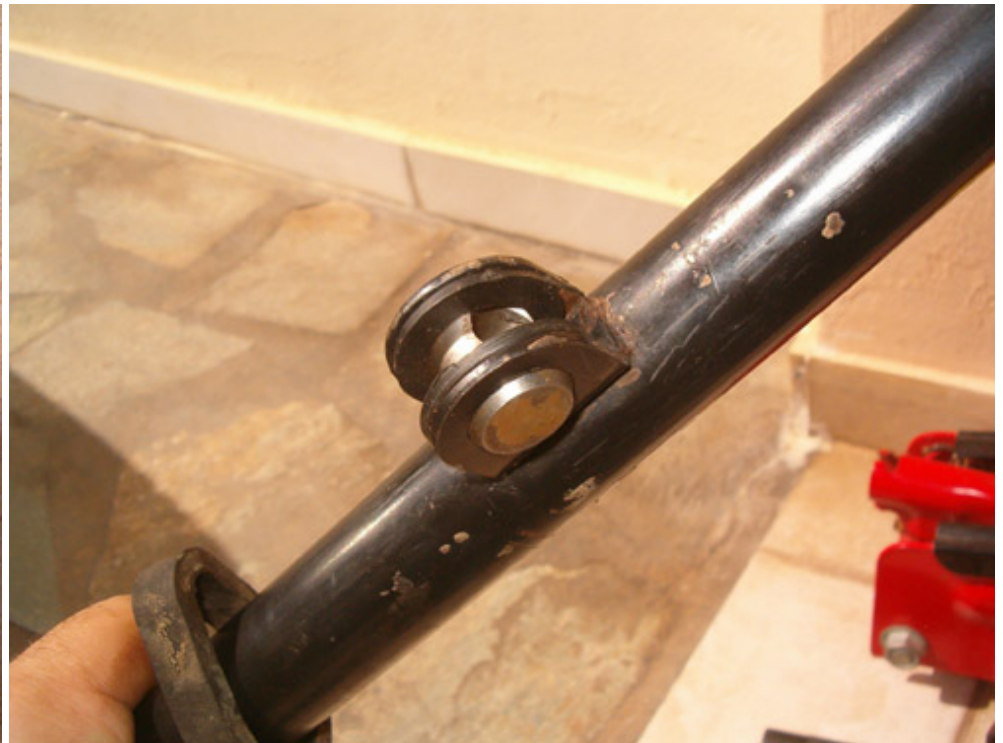
I have used new rubber pads which will keep the spring seated correctly.

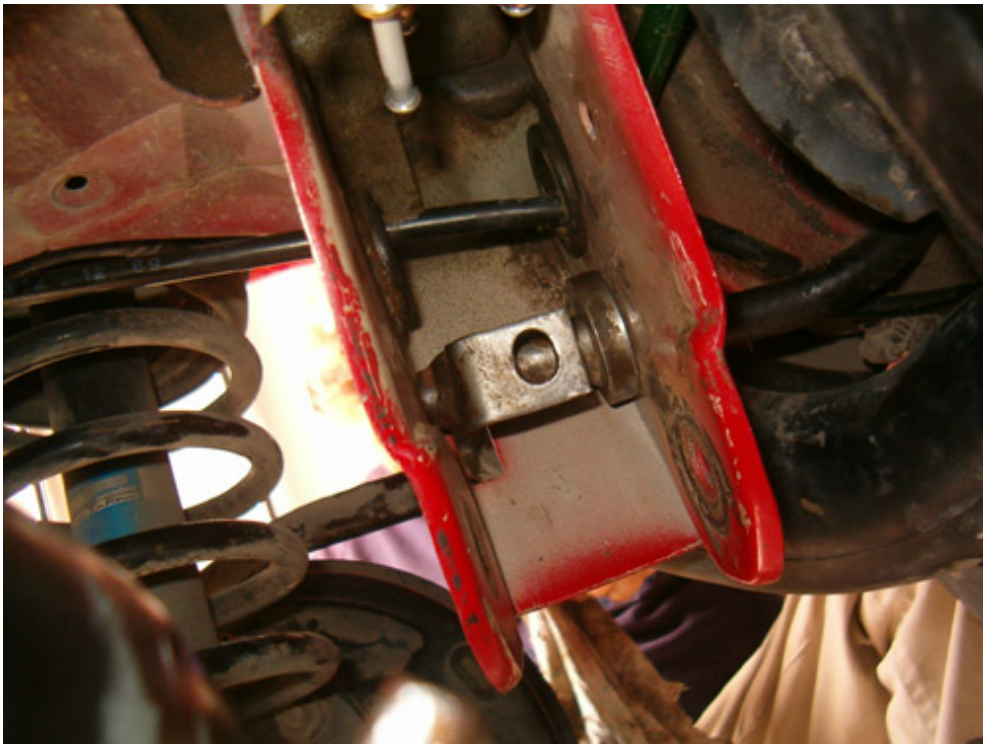
I have cleaned up the cavity and installed the adjustment hook

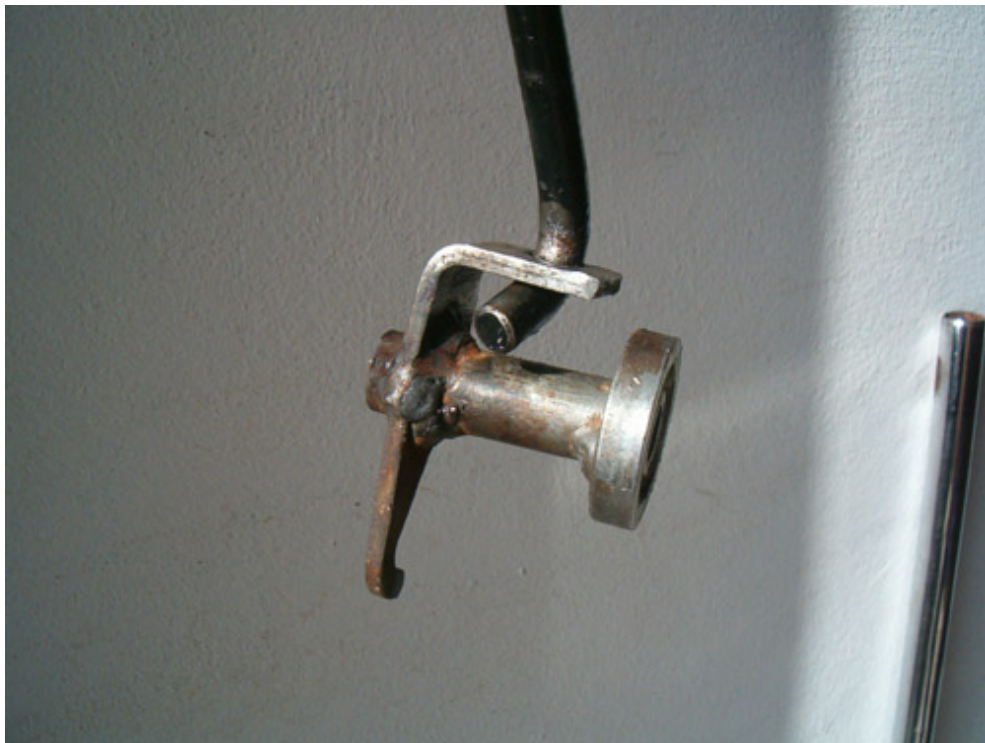
making sure that the curved end sits as the photo indicates. A piece of advice here: These hooks have are prone to cracking from ageing, thats why you see the welds on the bottom. Mine was cracked so I had it welded to the correct position.

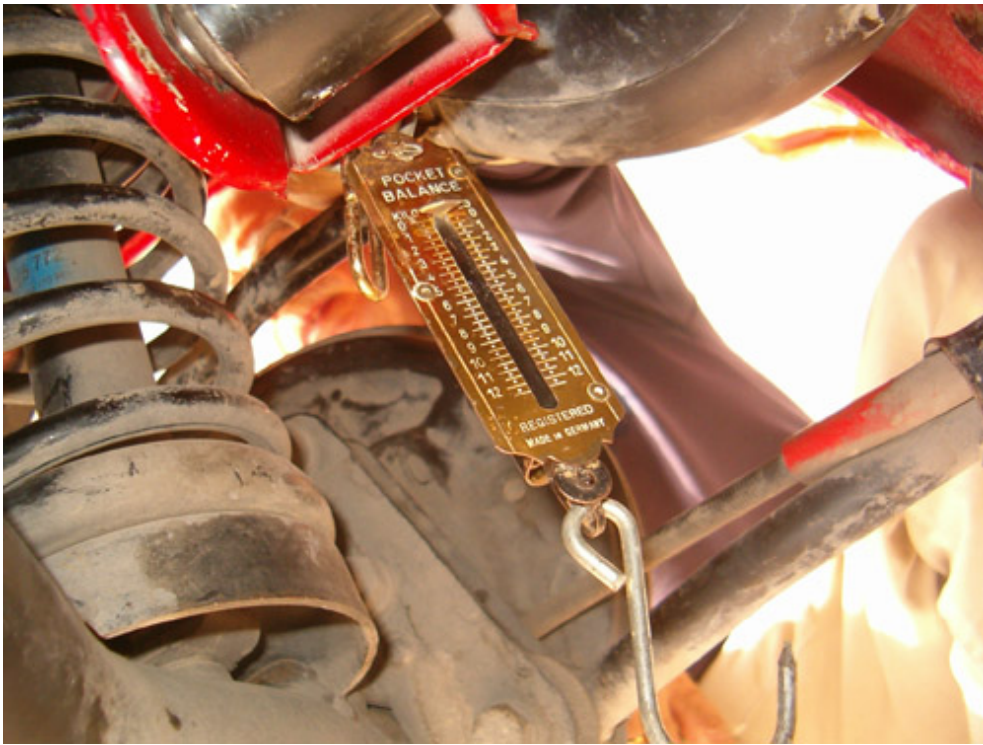
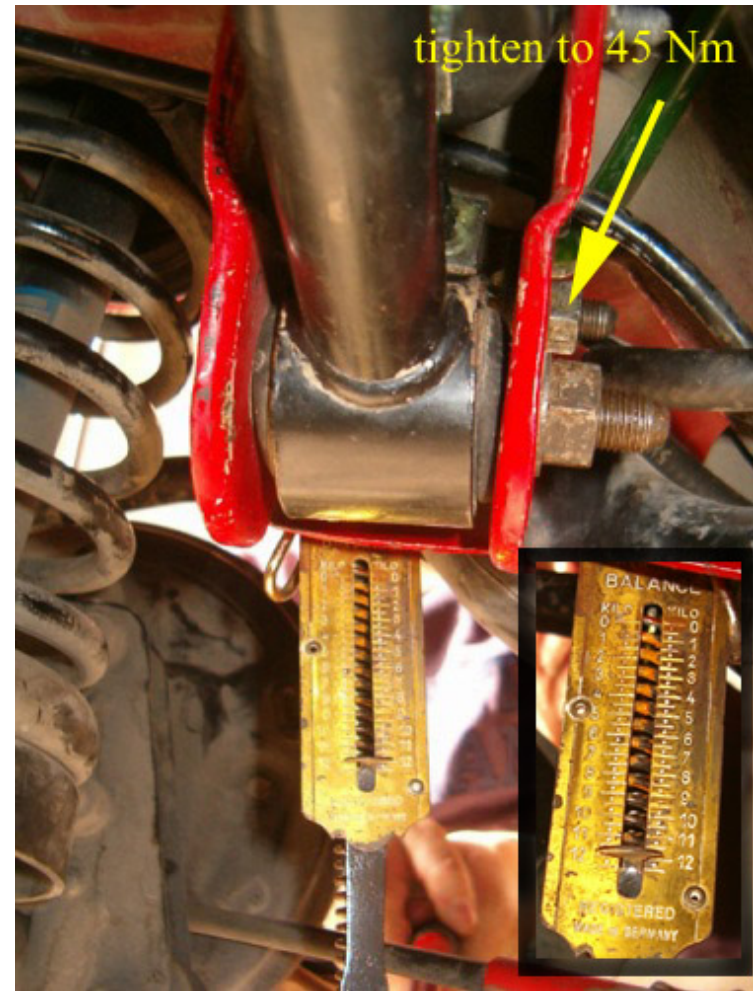
I have used a weight scale in order to preload the bias valve adjustment hook; the predefined weight is defined at 12.2 Kg. Once you have loaded the adjustment hook with 12.2 Kg, push the bias valve spring upwards until the end of the valve stroke. While pushing the spring up, tighten up the bias valve adjustment hook bolt at 45 Nm.
