Clutch Master Cylinder Replacement

Seems that the clutch master cylinder decided to give up the ghost chronically close with the slave cylinder. The result was weak clutch pedal feel and the worst of all brake fluid has been leaking and corroded the surrounding area of the pedals.

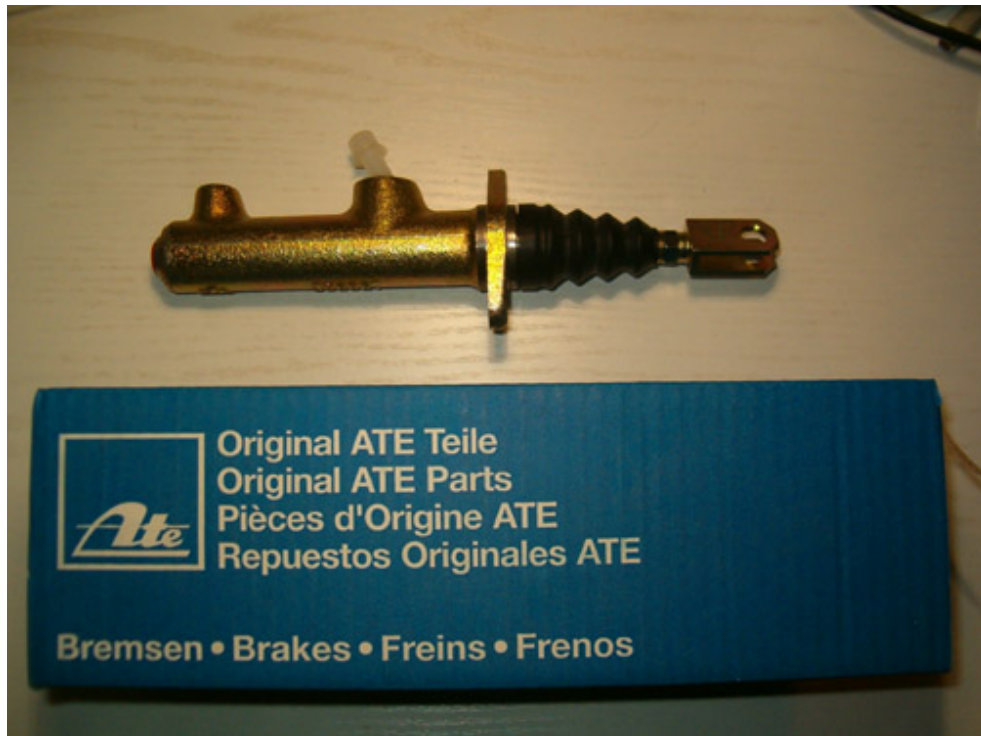
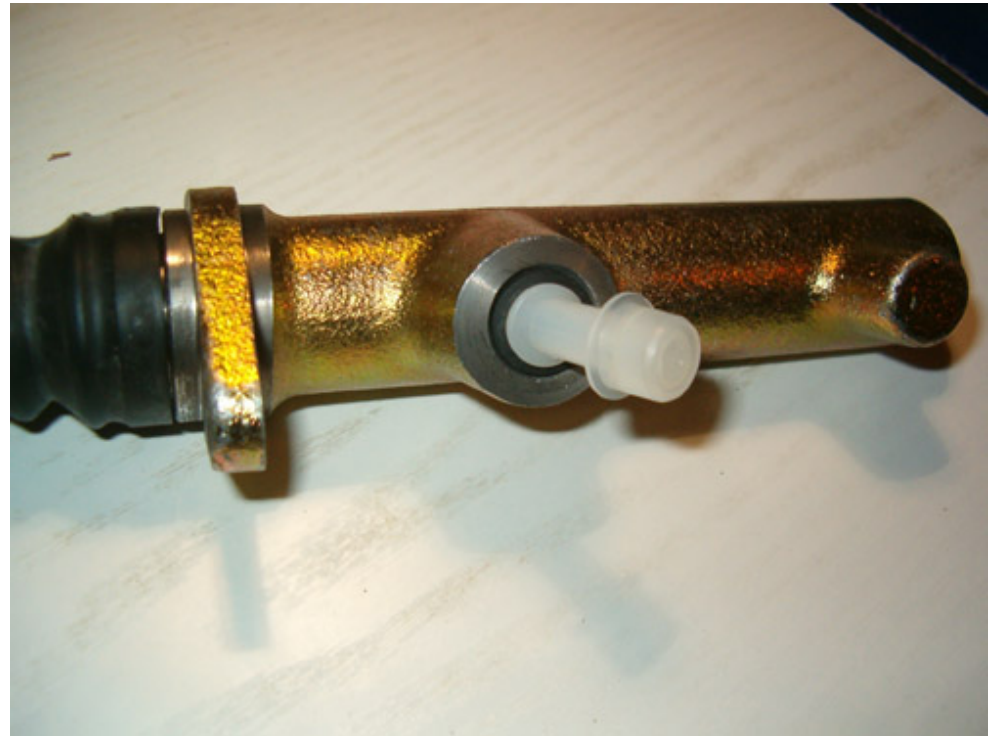
Here you see the new master cylinder. I chose to buy an ATE cylinder for the sake of excellent engineering these products have. So far I have been very satisfied with these, so I stick to them.

A close up. This nozzle is actually for supplying the cylinder with brake fluid; it is sealed from factory so that no foreign material enters the interior.

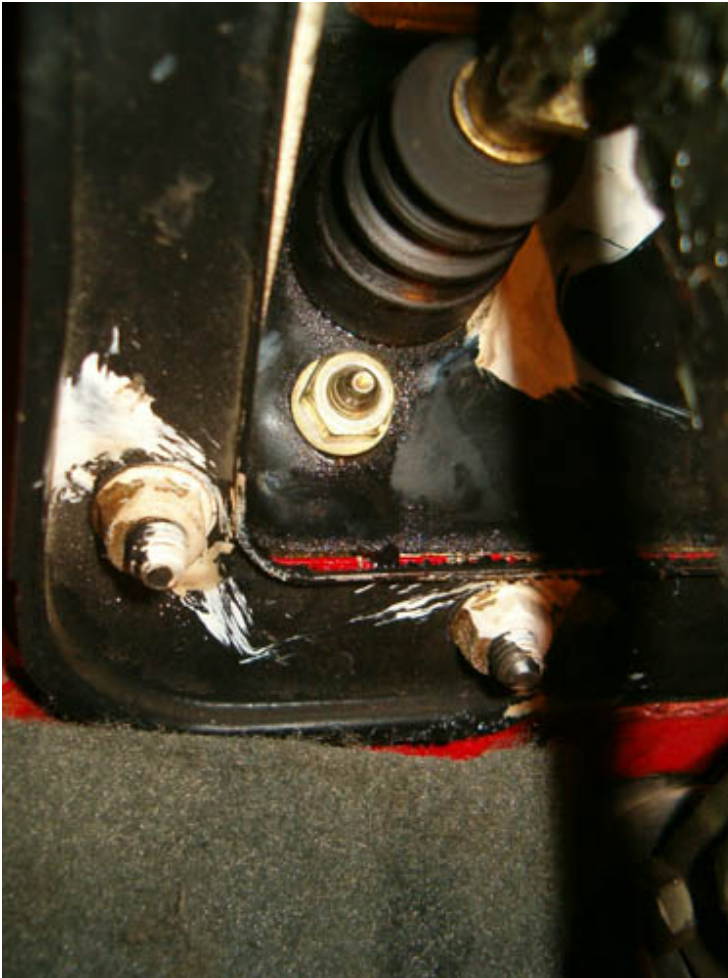
This view is from the interior showing the corrosion done to the area by leaking brake fluid. I will need to remove the pedal assembly so that everything corrosion has ruined is repaired.

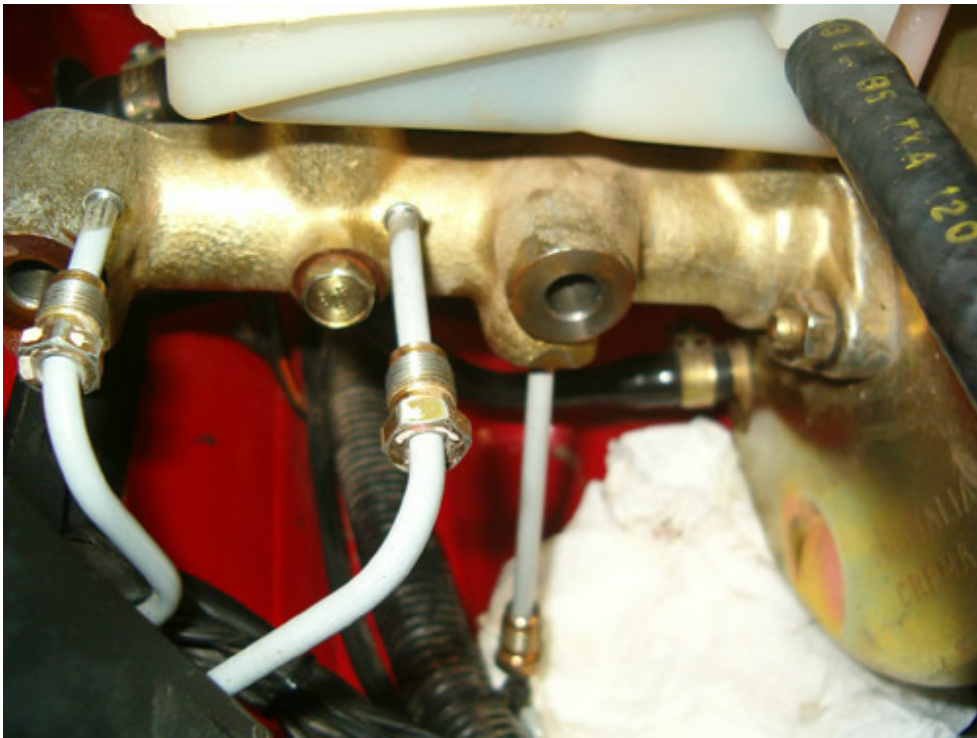
Got them out!

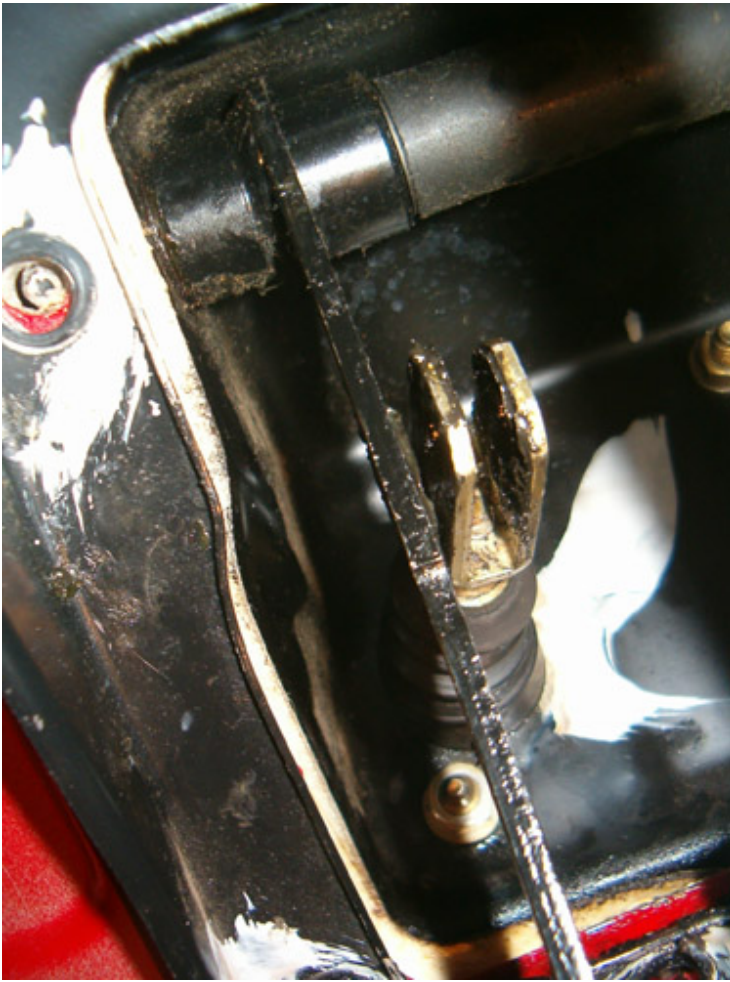
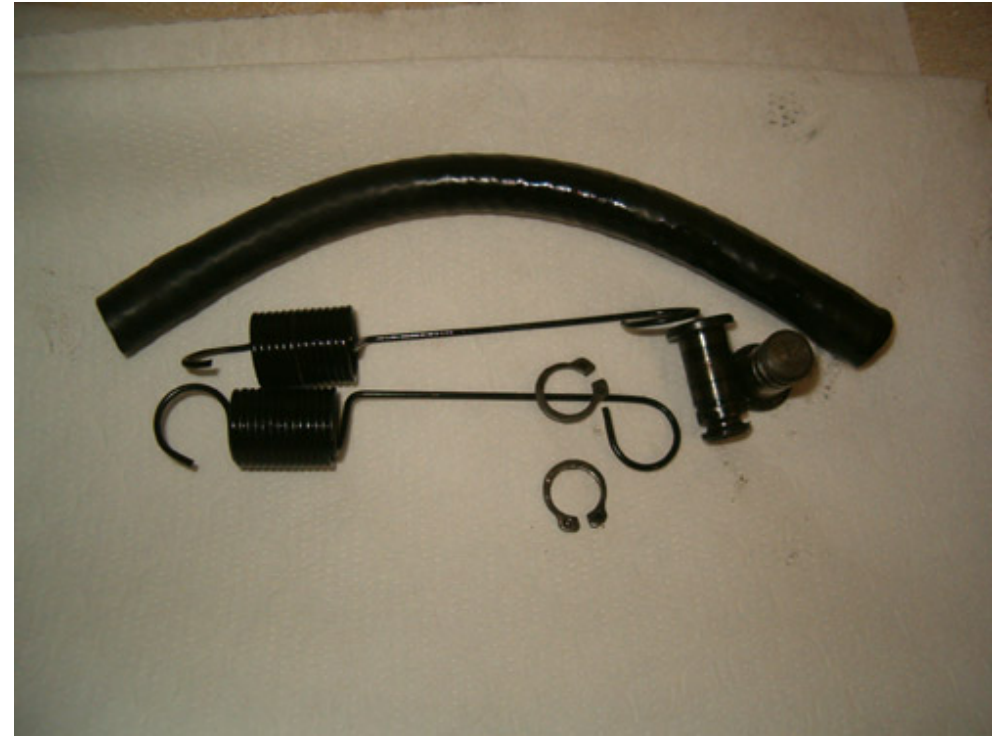
Here are the pins along with the relative lock rings keeping the cylinders attached to pedals; Also the springs are used so that the pedals are always kept in the beginning of the travel.

Undo the 6 nuts securing pedal case to chassis and proceed removing the pedal assembly

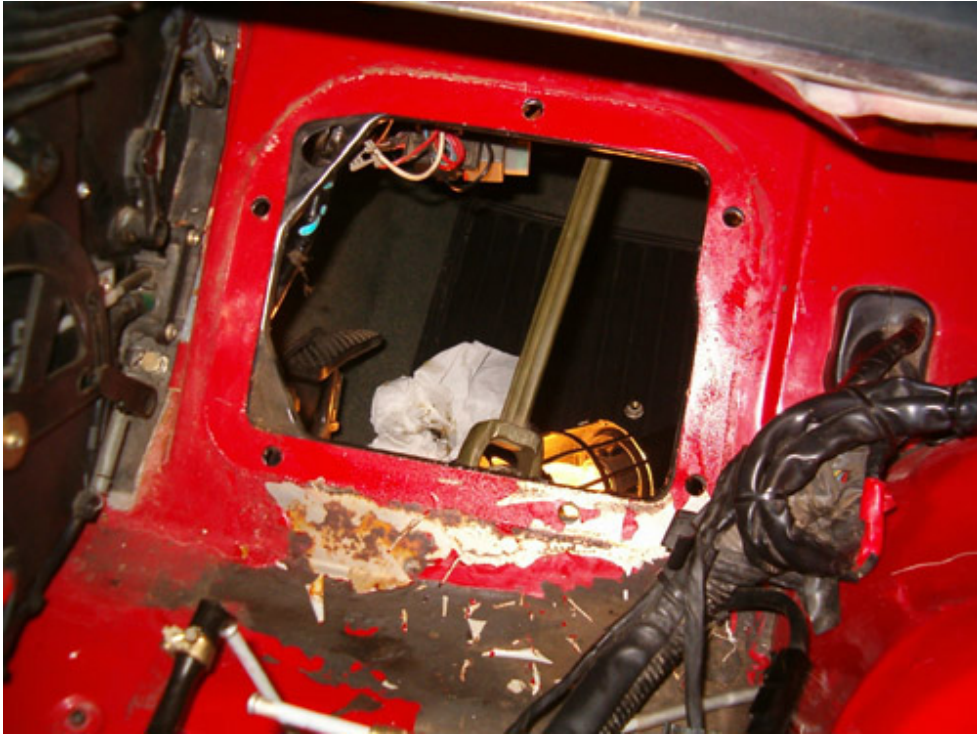
The complete assembly is out

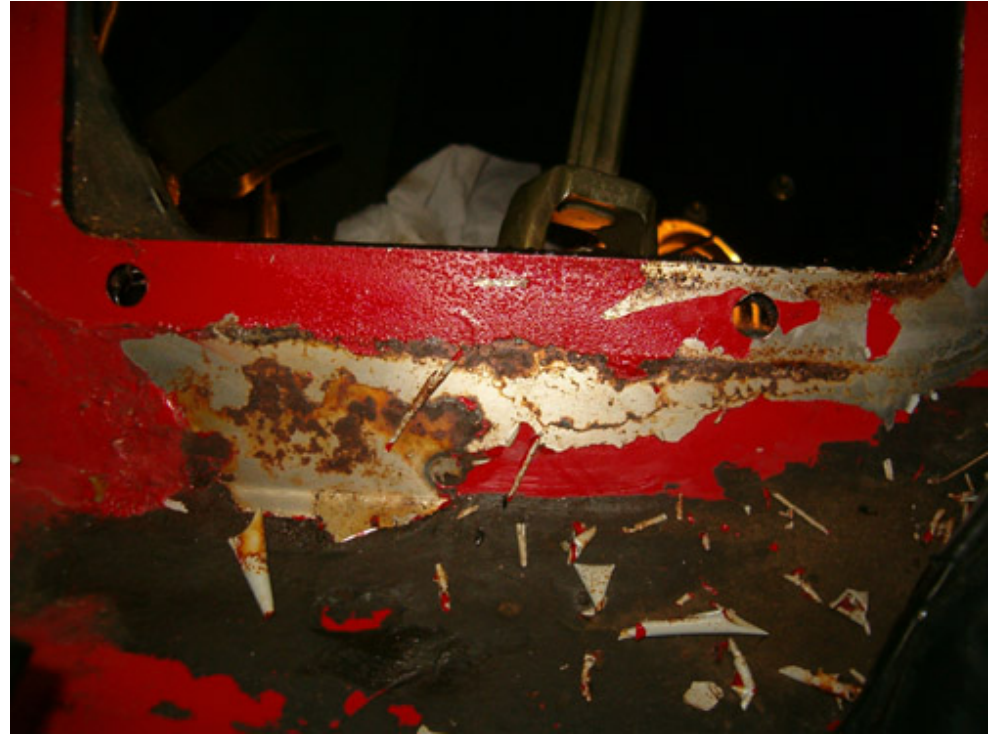
Notice the extend of corrosion... Don't worry this will look like new in a short time!

Using a wire brush, I removed corrosion and bare metal is now shown. It would be wise to clean the bare metal surface from dirt or oil traces by using a clean fabric soaked in alcohol; this way primer will stick to the metal as no foreign material will intervene between primer and metal.

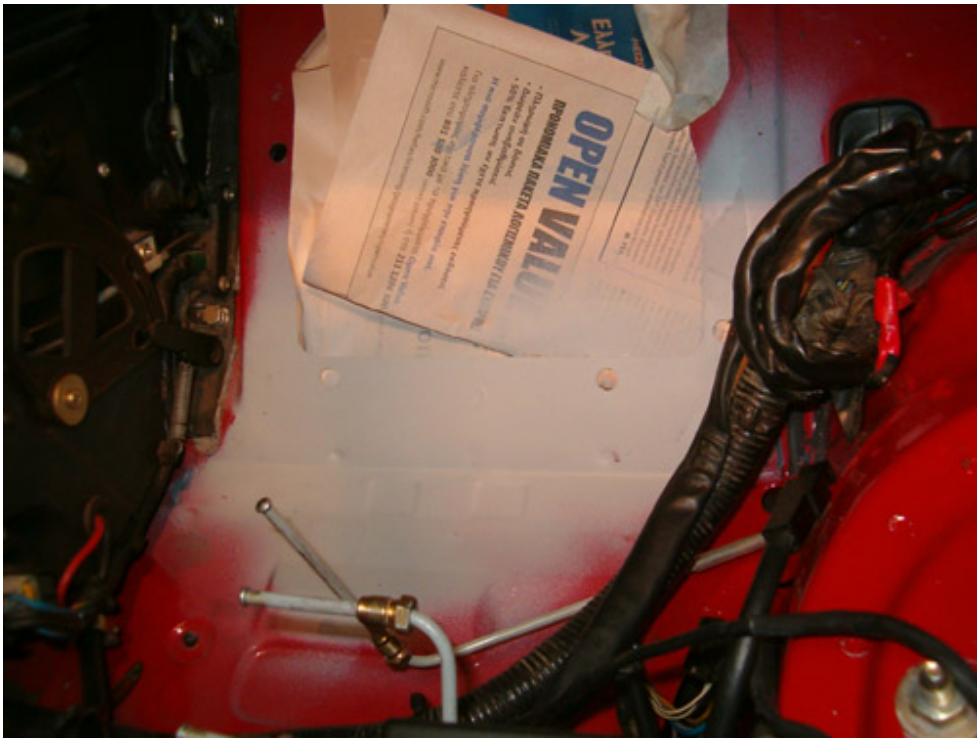
First layer of primer is applied. I will apply another layer of primer and 1 final layer of paint. All these should be done with 24 hours difference between them.

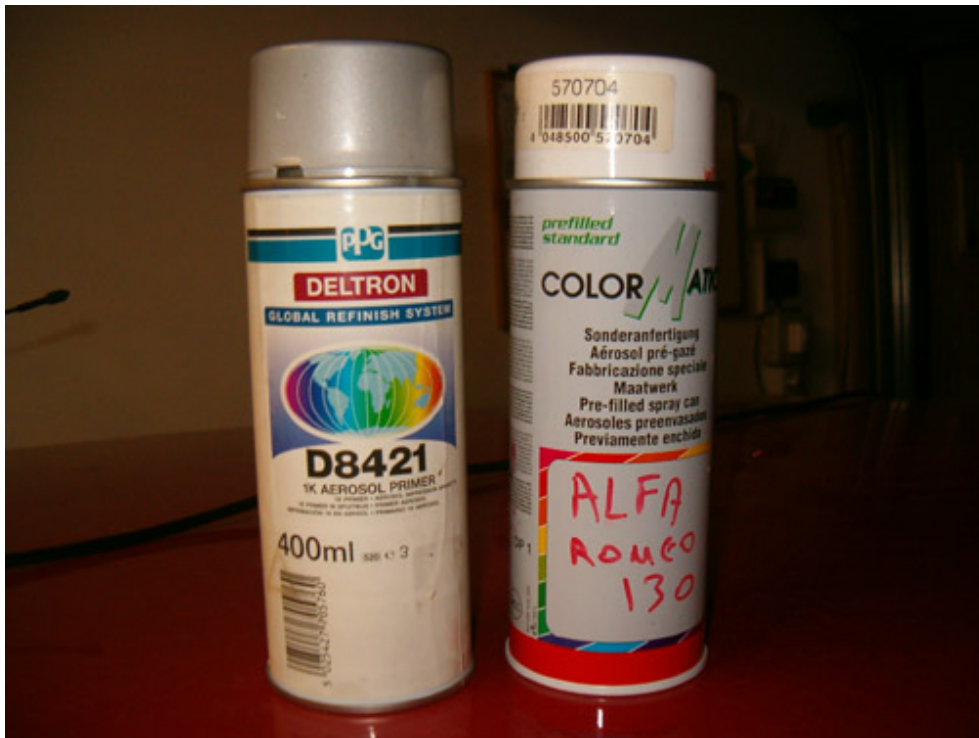
... final layer is applied; this section is ready

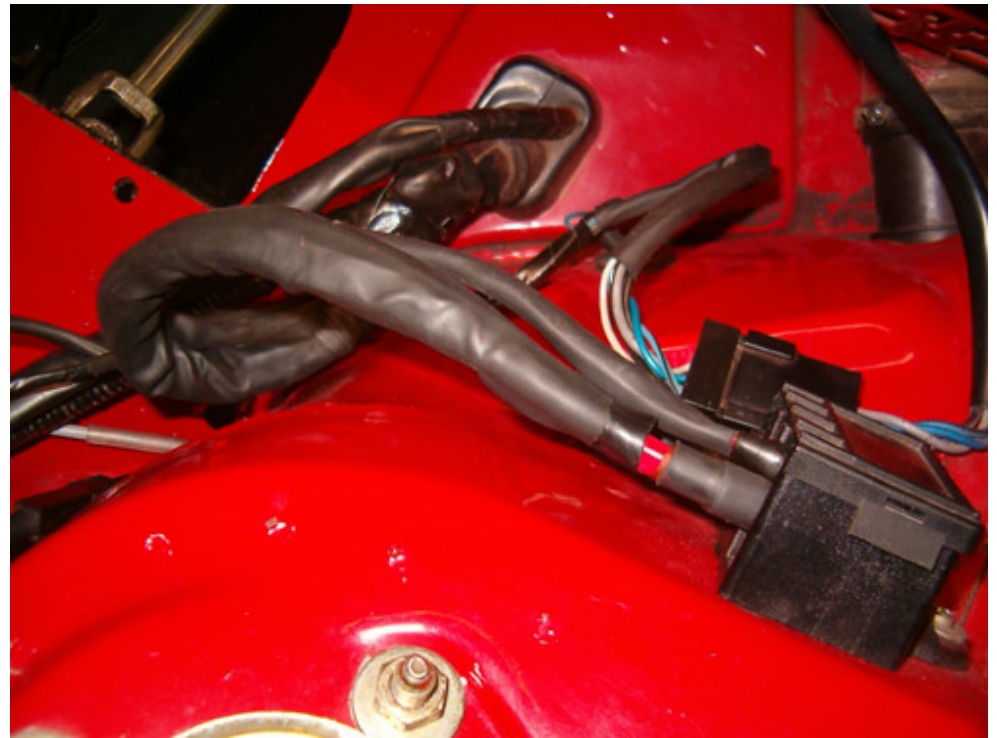
Heat shrinking tubes were used to keep the harness together...

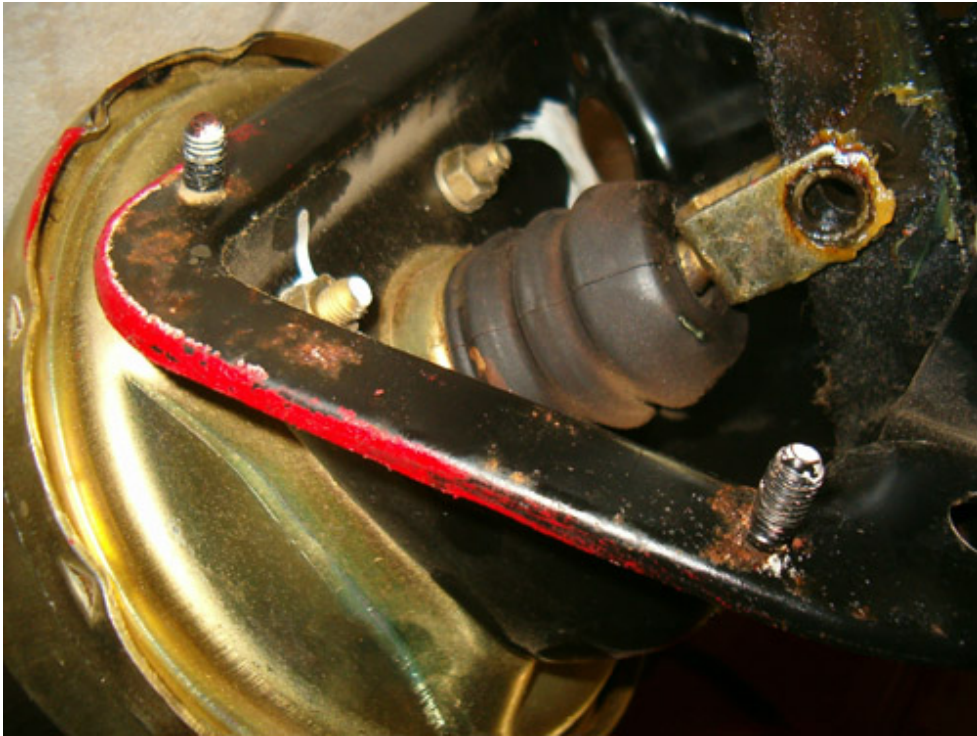
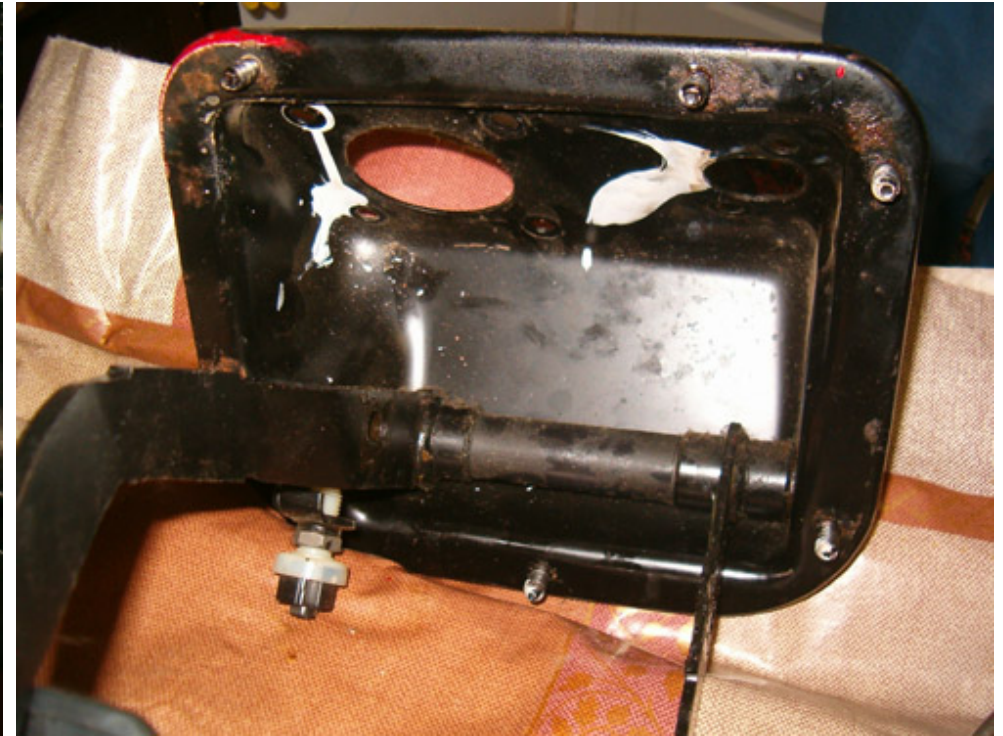
... and then the brake servo unit by undoing the 4 10mm nuts. Notice rust formed around the threads of the pedal case; corrosion will be remove and then re-sprayed

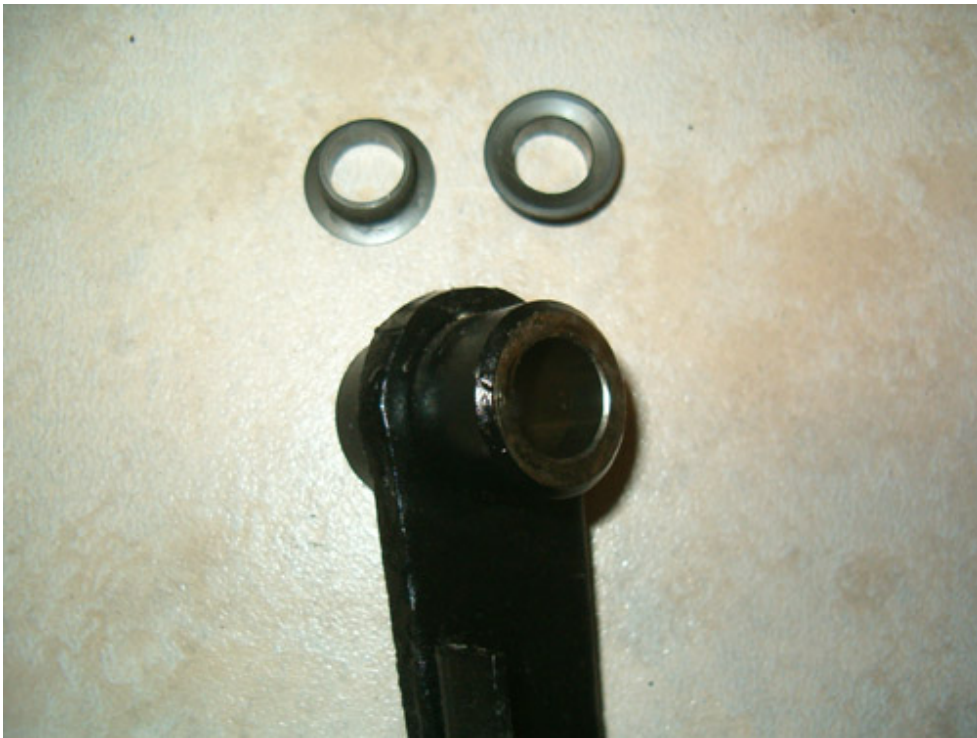
A close up of the pedal shaft and its bushings. Be careful with these bushings as they are plastic and an NLA (No Longer Available) item.

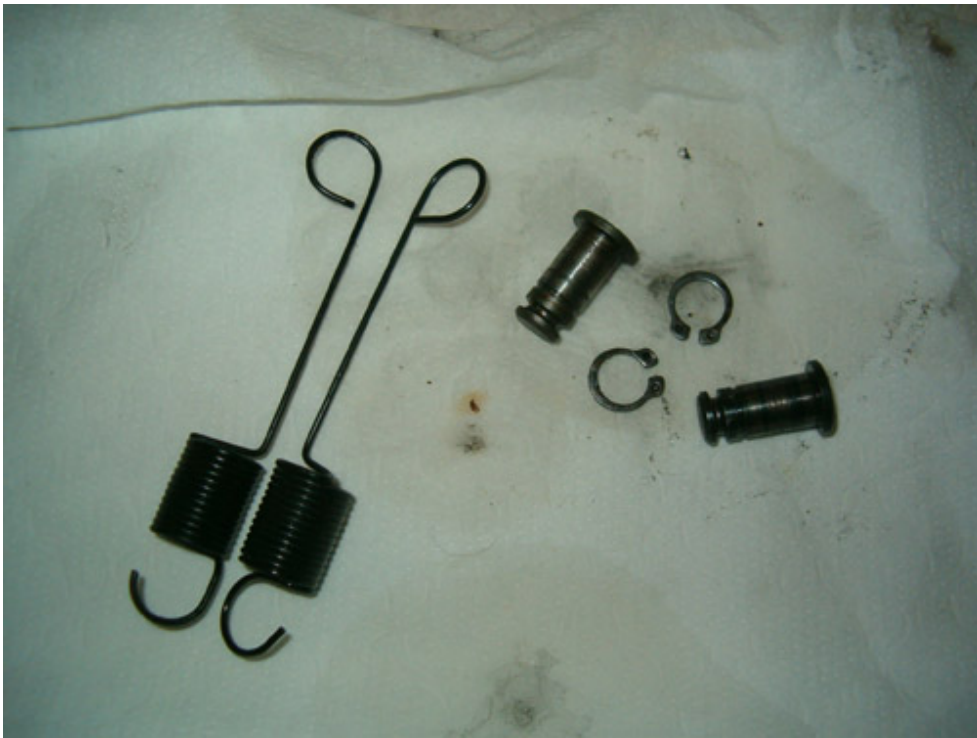
Pins, lock washers and support springs

Move on to the interior and hook up the pins, lock washers and support springs of the pedals shown in the picture below. Don't forget to connect and adjust the brake lights switch.
