# Alternator rebuilt

1991 Alfa 33 1.4 IE

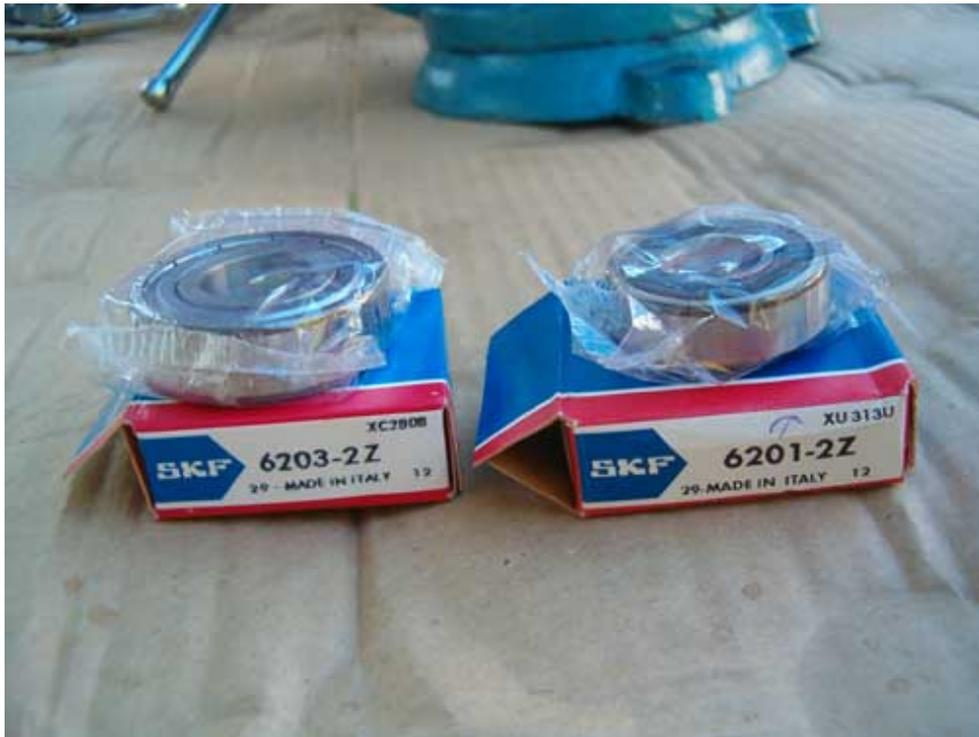
These are the new bearings out of their package ...

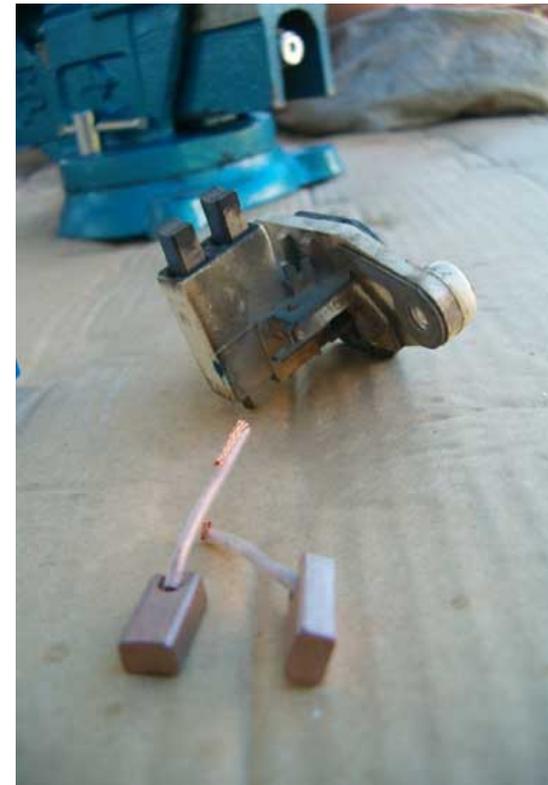
... and these are the new brushes that will replace the old ones

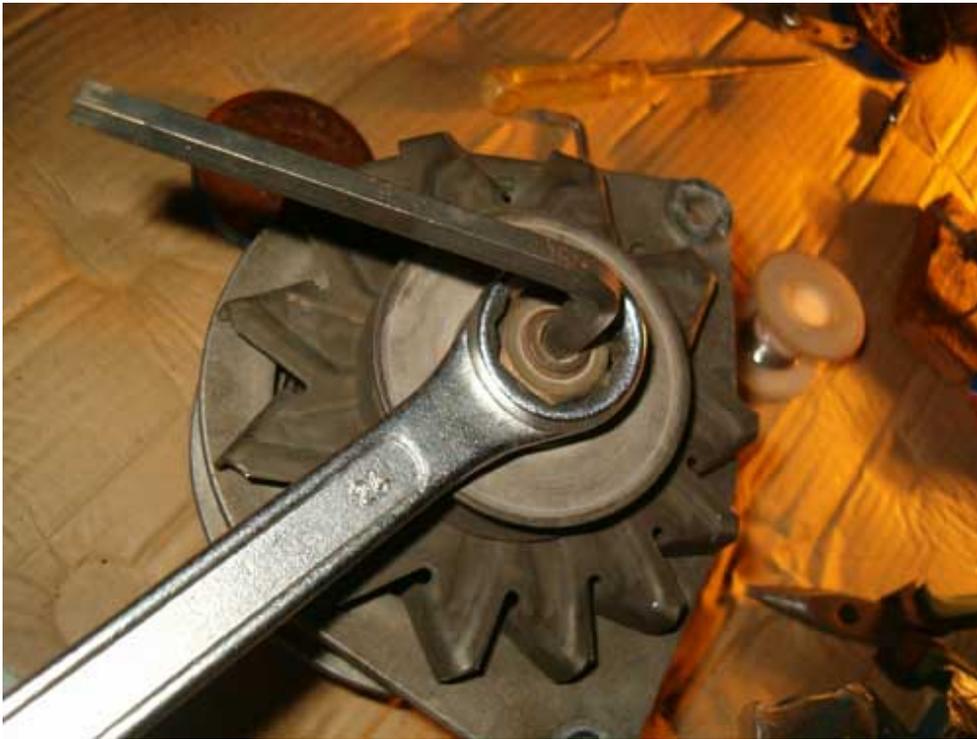
Using the 24 mm wrench and the 10 mm allen key, remove pulley and fan of the alternator. Do not mix the order of the washers under the nut and fan.

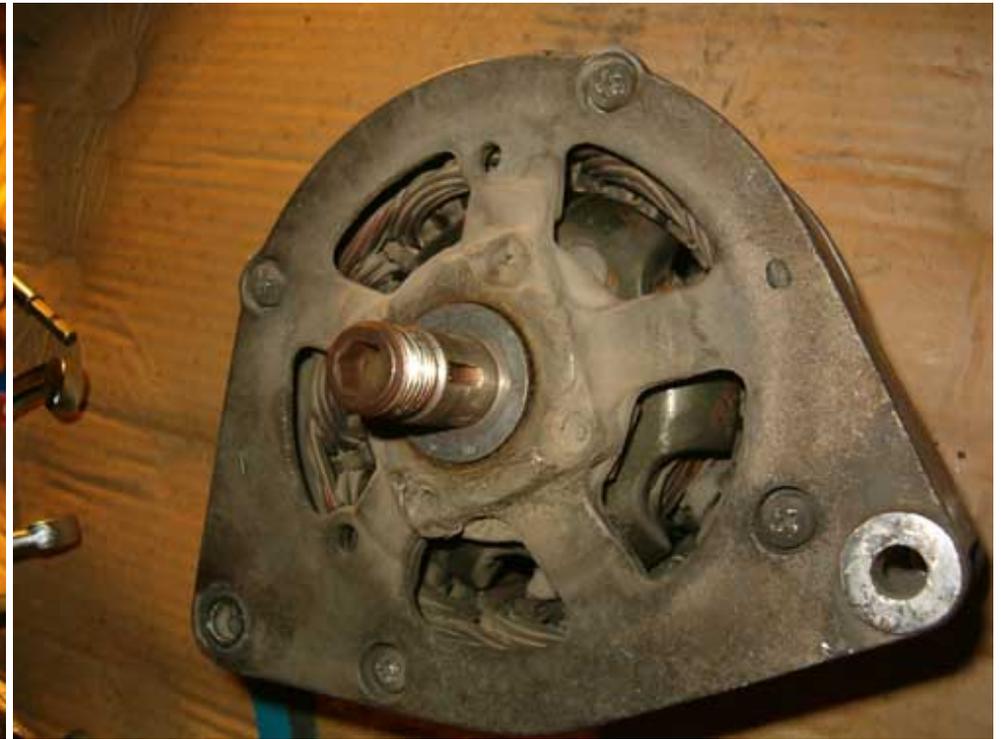
Here is the alternator without pulley and fan. We now need to undo the four bolts on the circumference of the casing. Since these bolts may have never been out, it is pretty likely to ruin their head as they are stuck to the alternator body; do the following trick and you won't miss a single bolt!

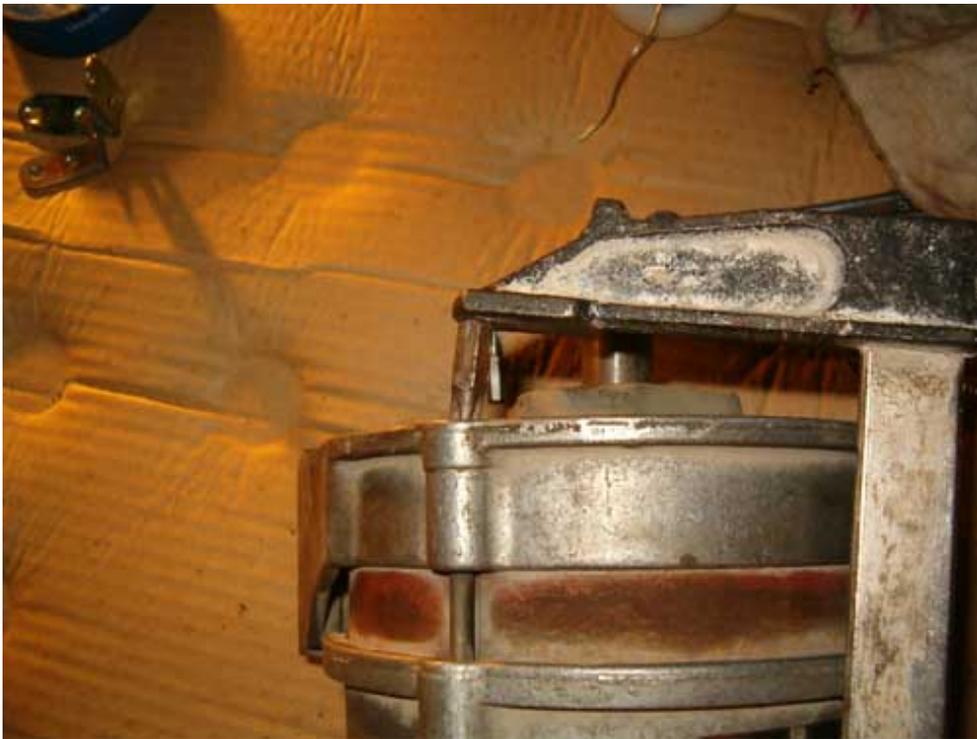
Get hold of a carpenter's brace and a cross screwdriver tip. Make sure that the tip perfectly fits to the screw head.

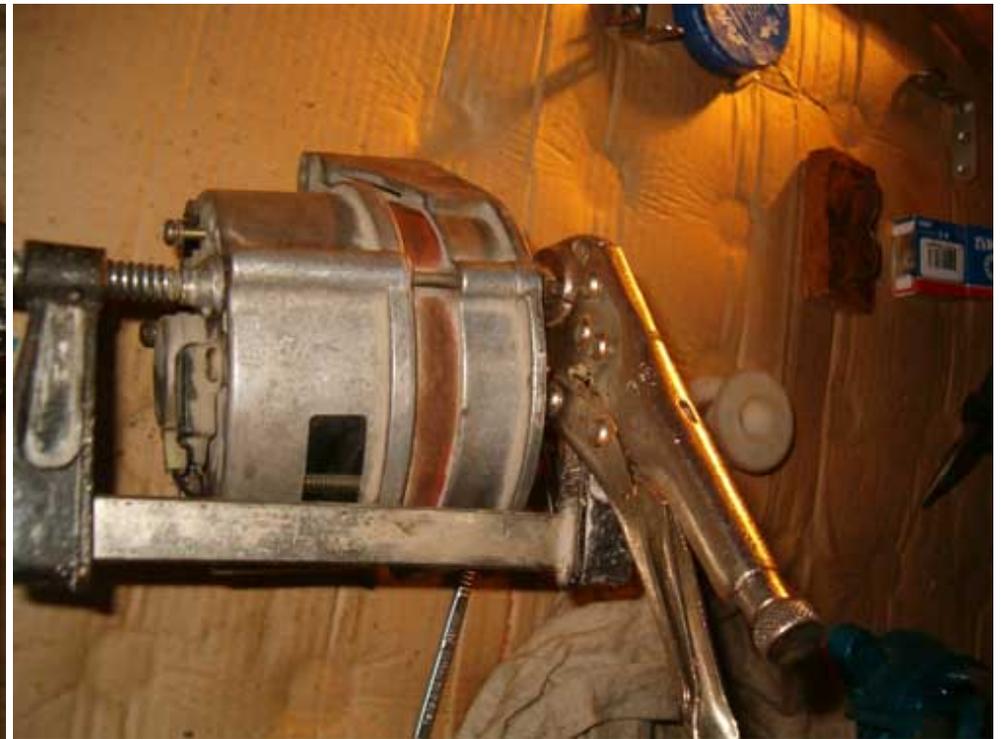
Tighten the brace and using the pliers just unscrew the bolt. It will loosen right away.

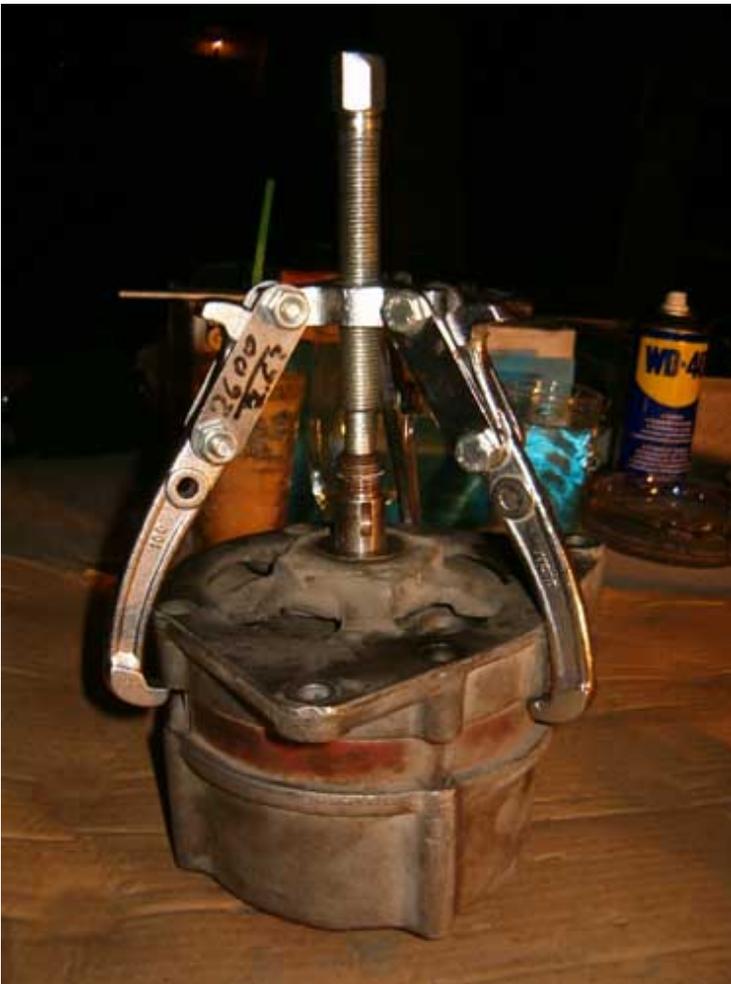
Now using the bearing extractor, pull out the front case of the alternator. Just screw in the vertical bolt and the case will slide out of the rotor

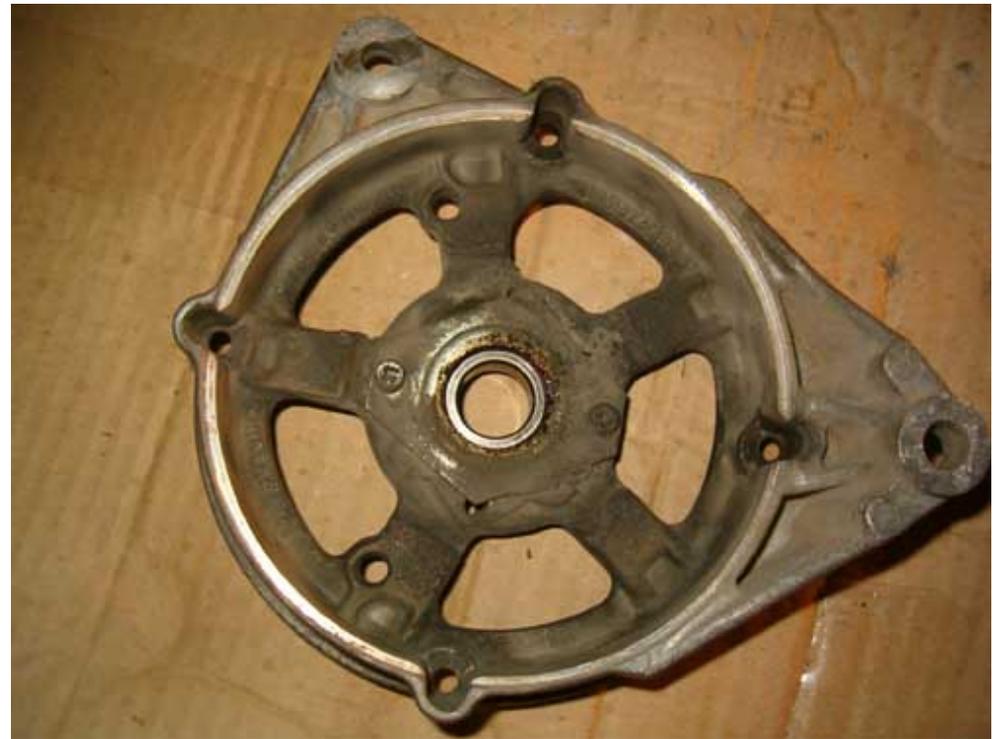
Here is the front case extracted. You can see the front bearing (SKF 6203) in the centre and the two bolts keeping the plate attached to the body.

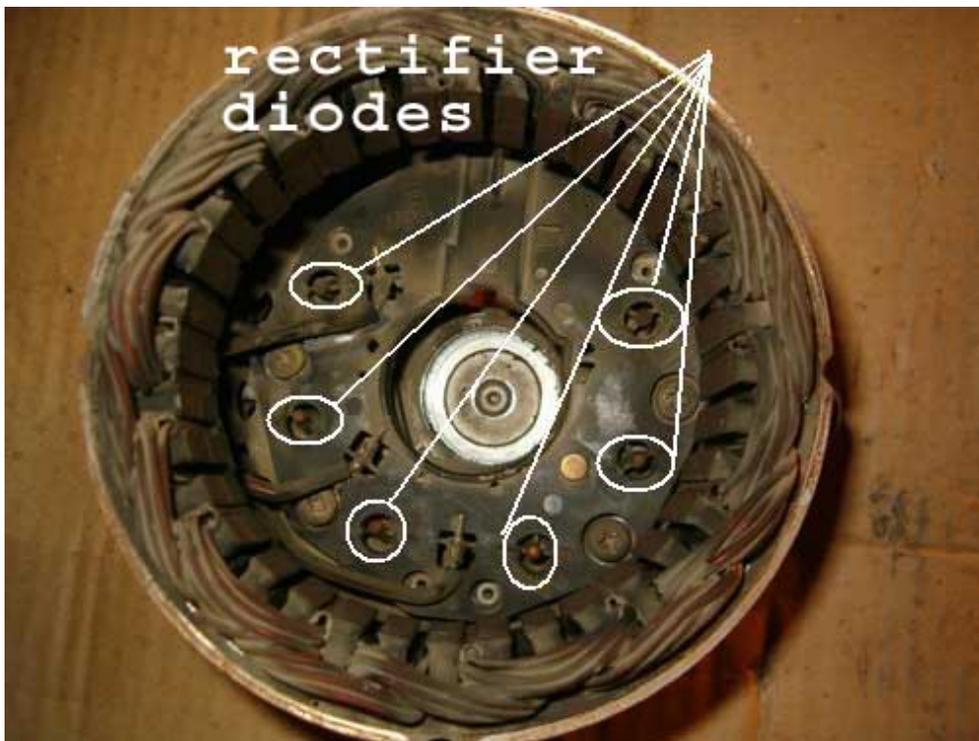
This is the heart of the alternator. You can see the stator in the circumference and the rectifier bridge in the centre. Notice the six diodes (brown color) of the bridge; these actually convert AC to DC for the electrical system.

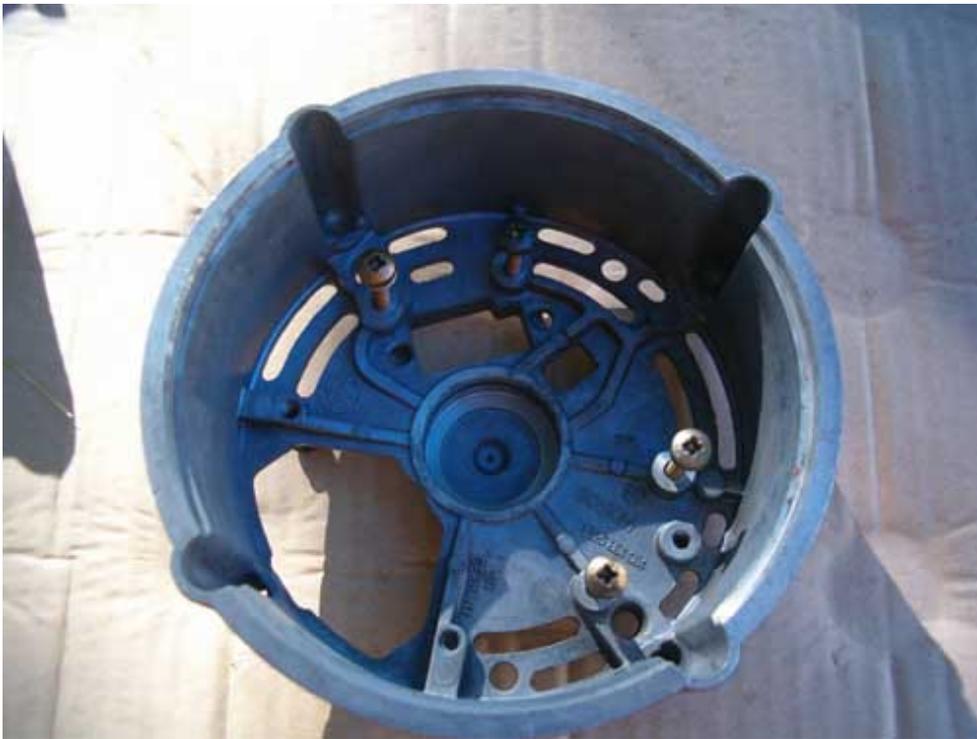
These are the cases of the alternator. Here you can see then cleaned with diesel fuel which eats away dirt.

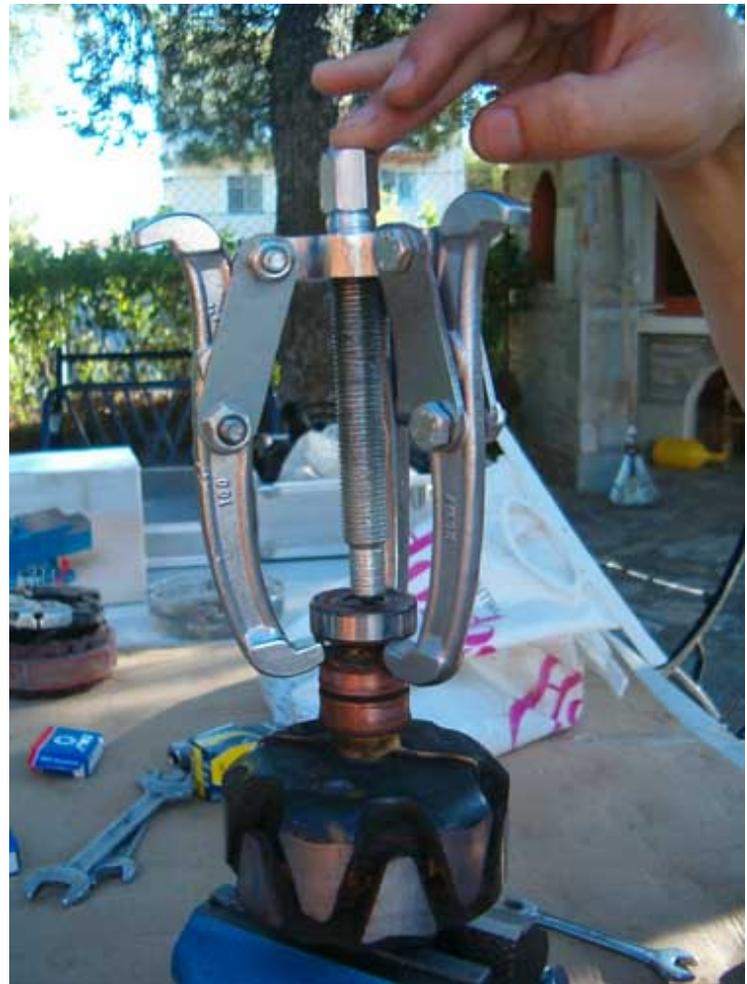
Now we will remove the bearing from the rotor using the extractor. Do not attempt to remove it by using other means !!! You can easily damage the slips rings and you may need to replace the rotor!

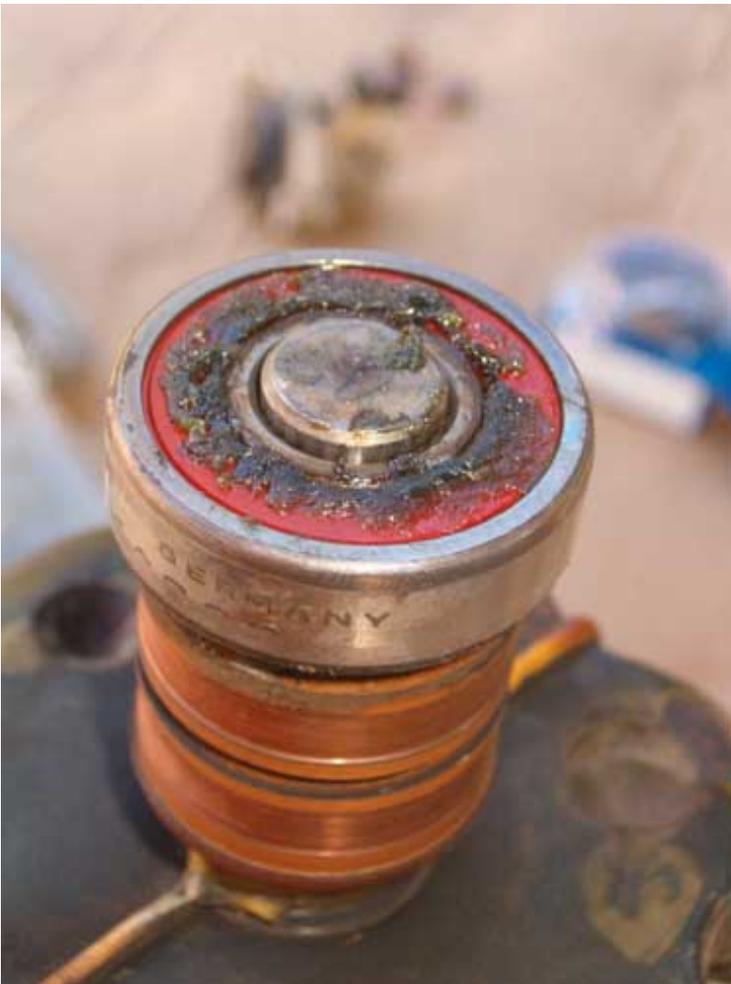
A close -up of the bearing which has lost its grease ... Needless to say that the play of the outer diameter is big enough!

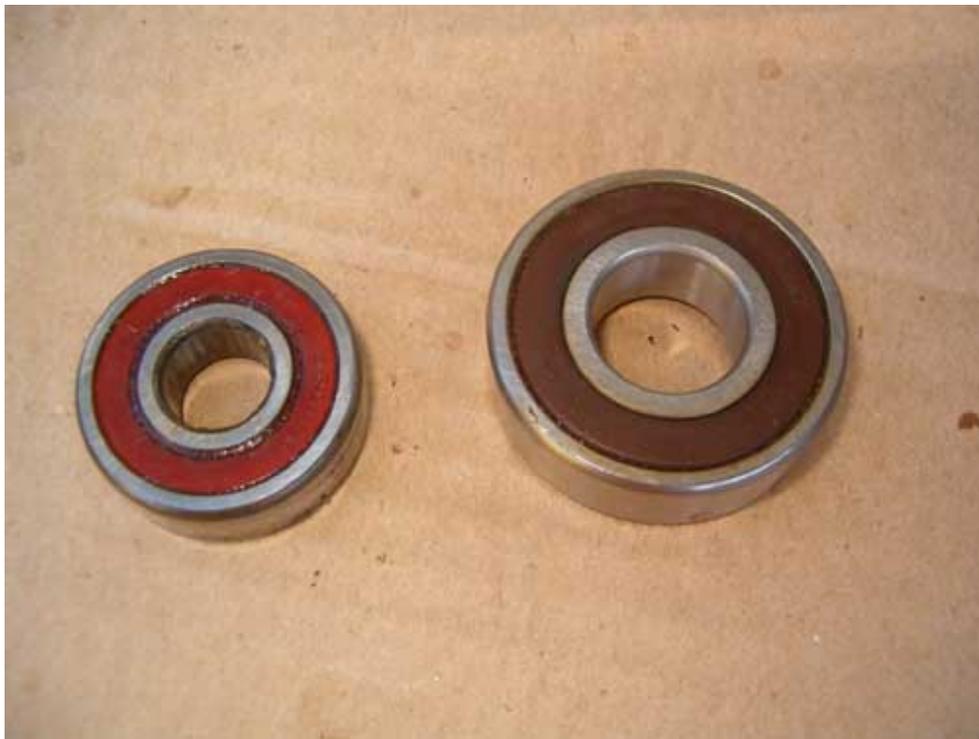
... and finally got it out! Both bearings are shot.

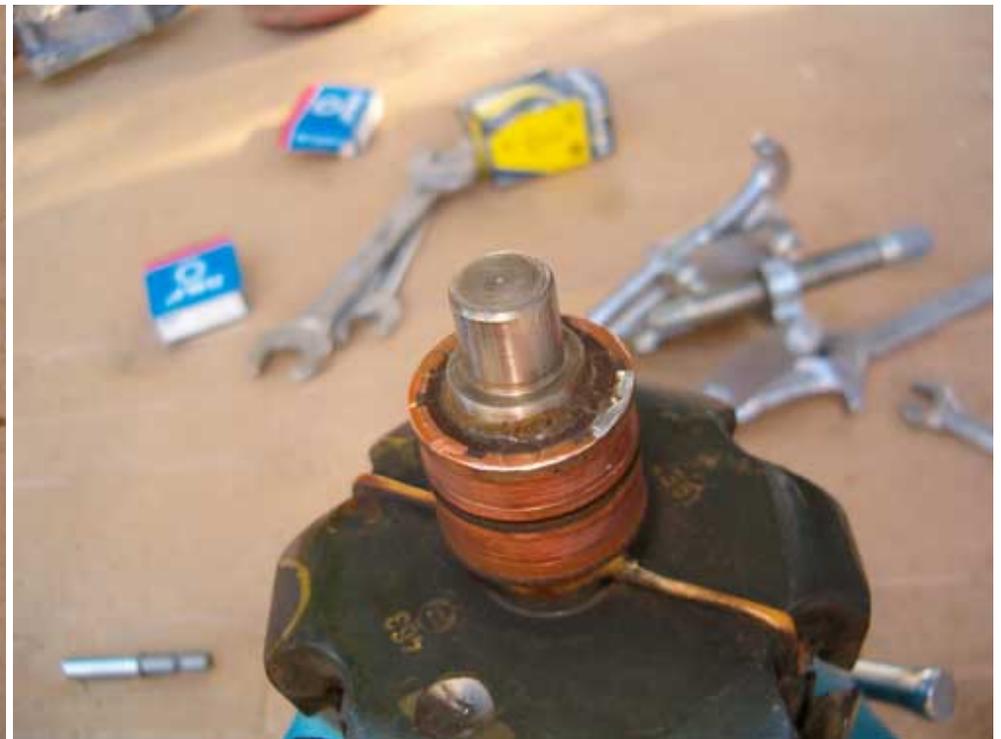
Now it is time to flatten and polish the slip rings.

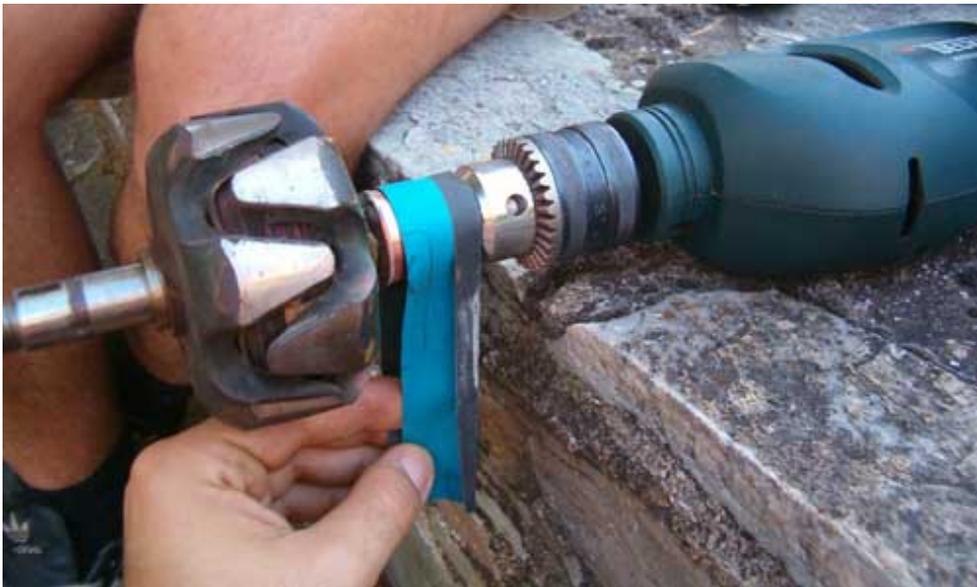
Rotate the drill at low speed and place the sandpaper so that it covers the surface of the slip ring.

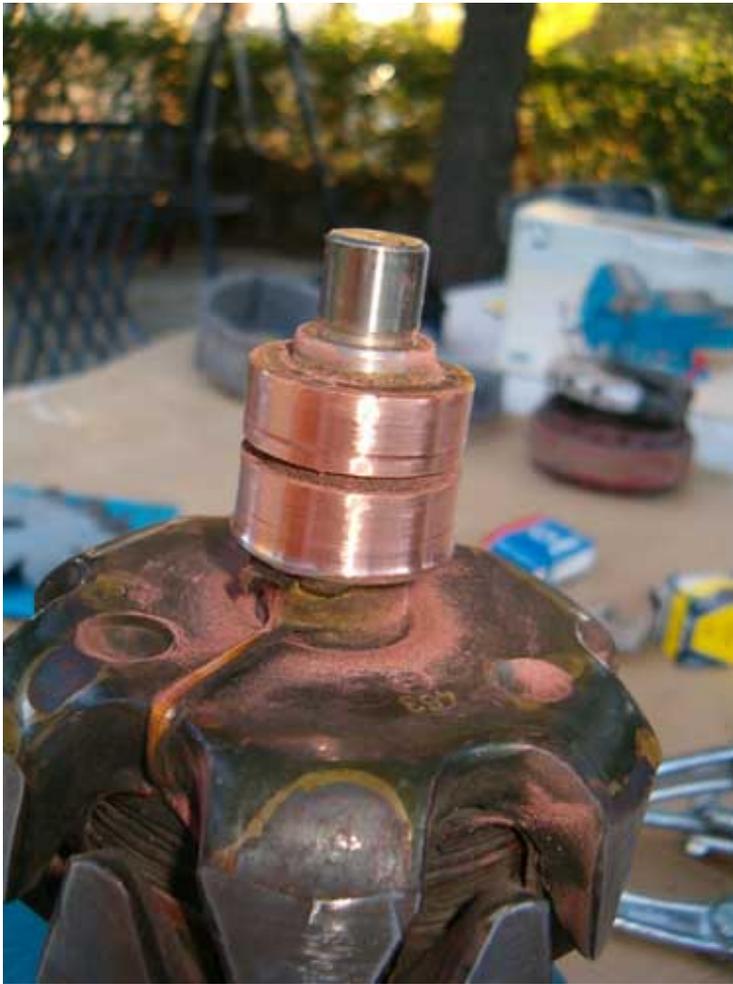
When you have reached the above state you can actually polish the rings using very fine sandpaper in order to give a shiny view and smooth any roughness created by the 240 grit sandpaper.

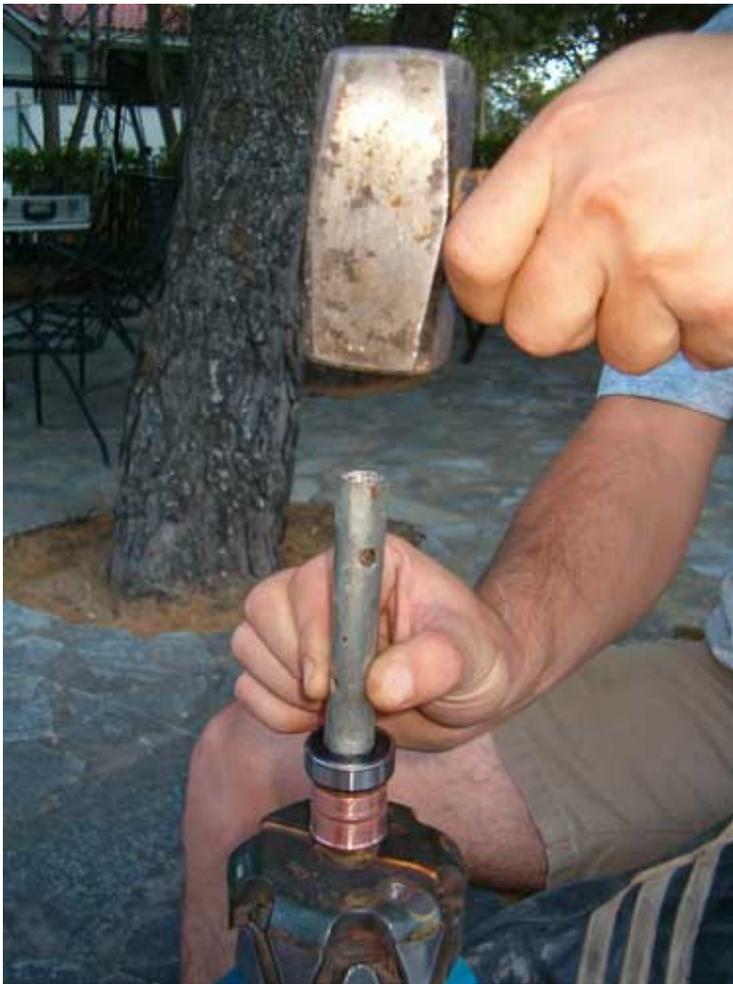
Here is a critical part. Find a socket exactly the size of the bearing inner ring. Place the socket on top and with a hammer punch it steadily making sure to have the bearing sitting vertical to the axis of the rotor. Do not use another way for this installation as hitting the bearing anywhere except its inner ring, it will definitely destroy the inner balls and both rings (inner and outer).

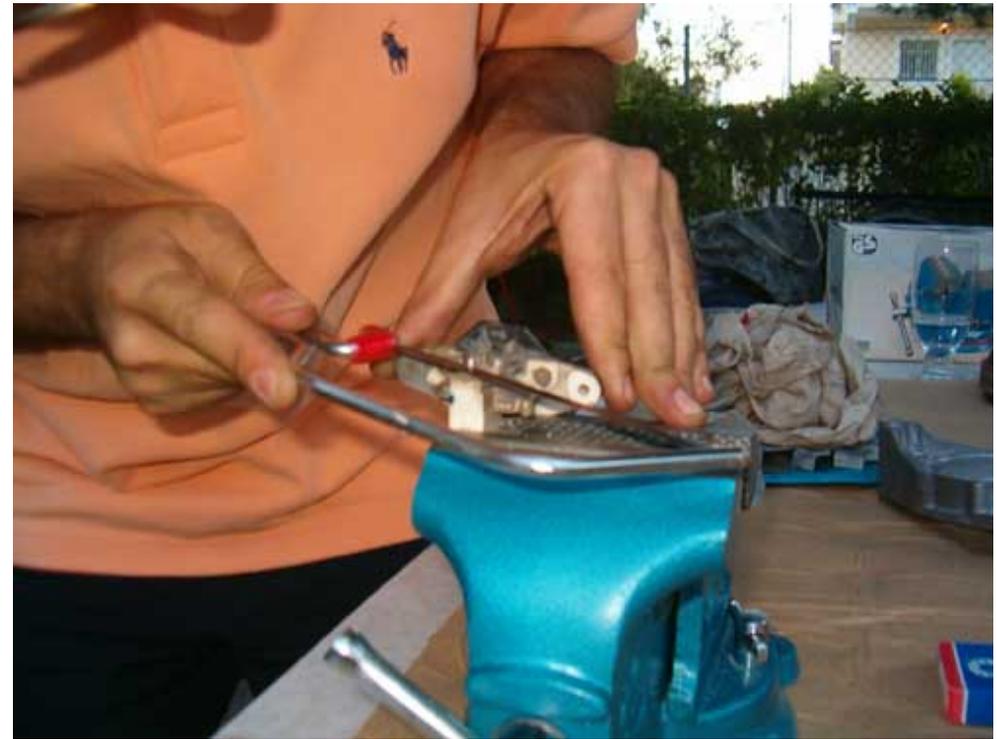
It is now time to replace the regulator brushes. Place the regulator in the vice and with a metal saw, cut the ends of the brushes extruding. It is then much easier to unsolder the brushes.

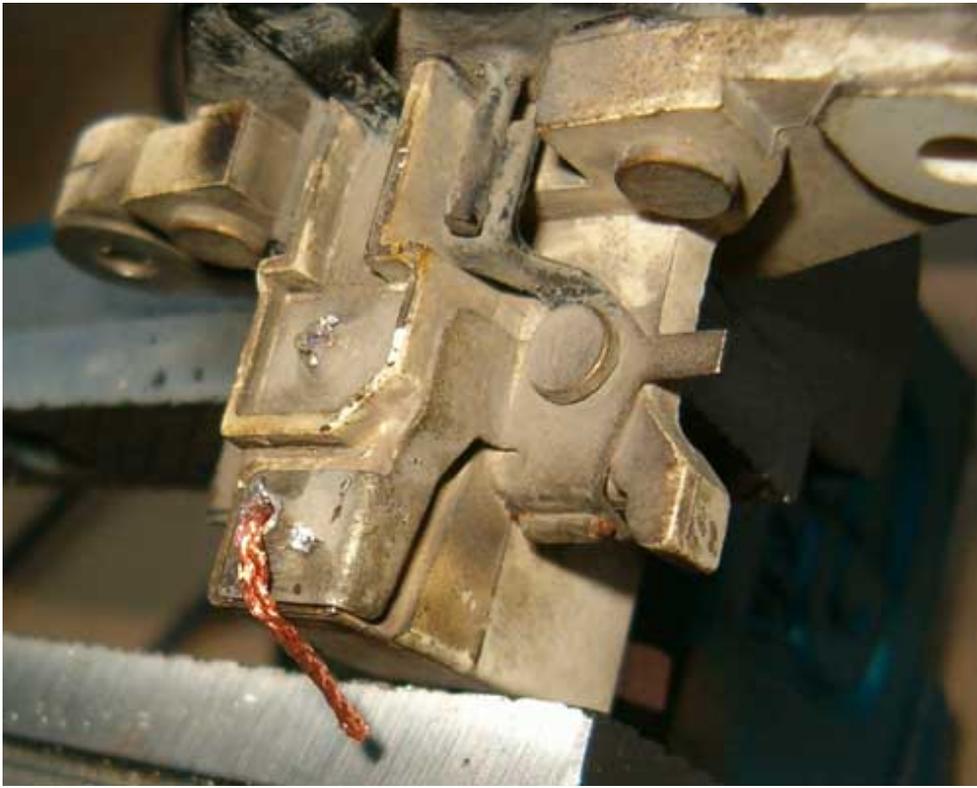
Install the new brush along with the retaining spring and solder the brush wire to the body of the regulator

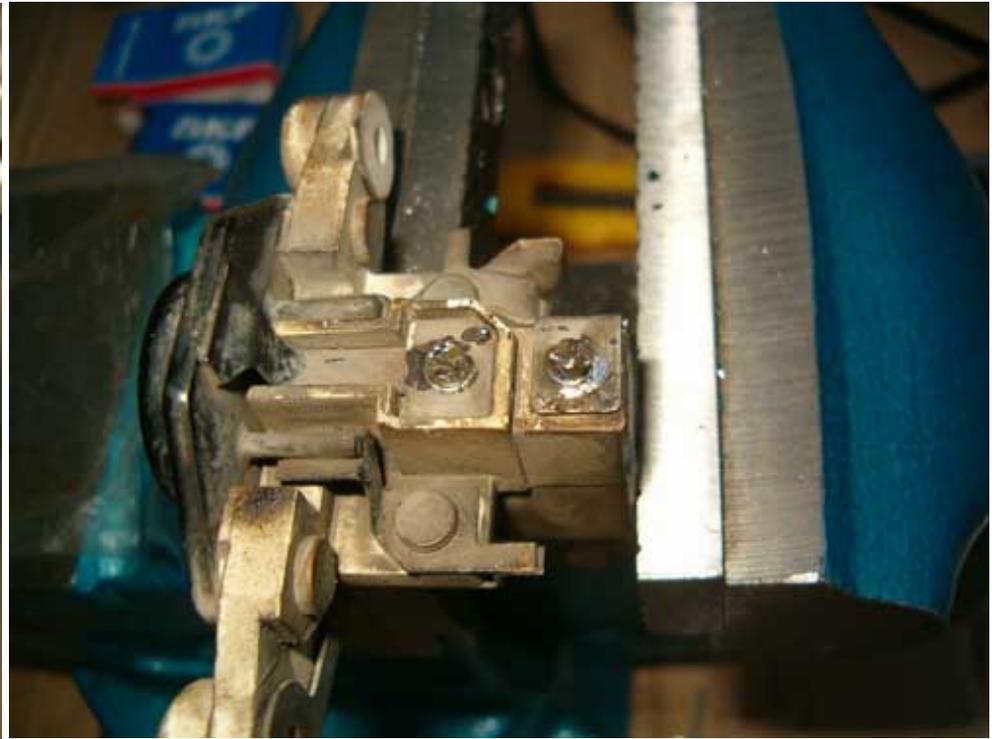
Here you see both brushes replaced and the remaining wire ends cut out. We are now ready to proceed assembling the alternator.

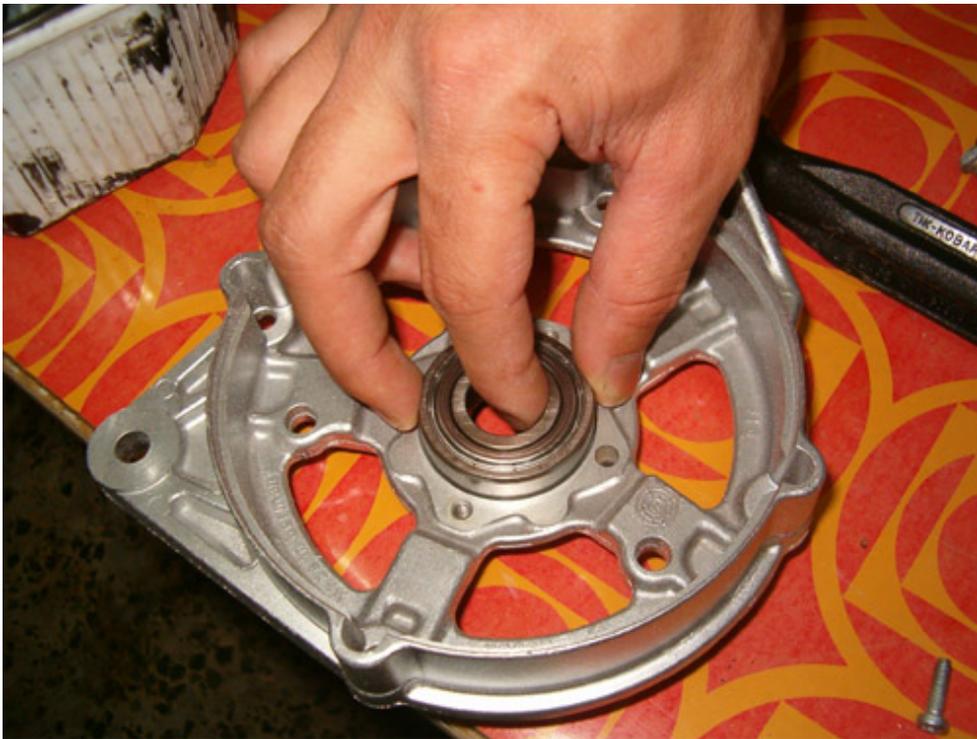
Let's now install the front bearing (SKF 6203). Just install it on its place; no need to hit or press it in.

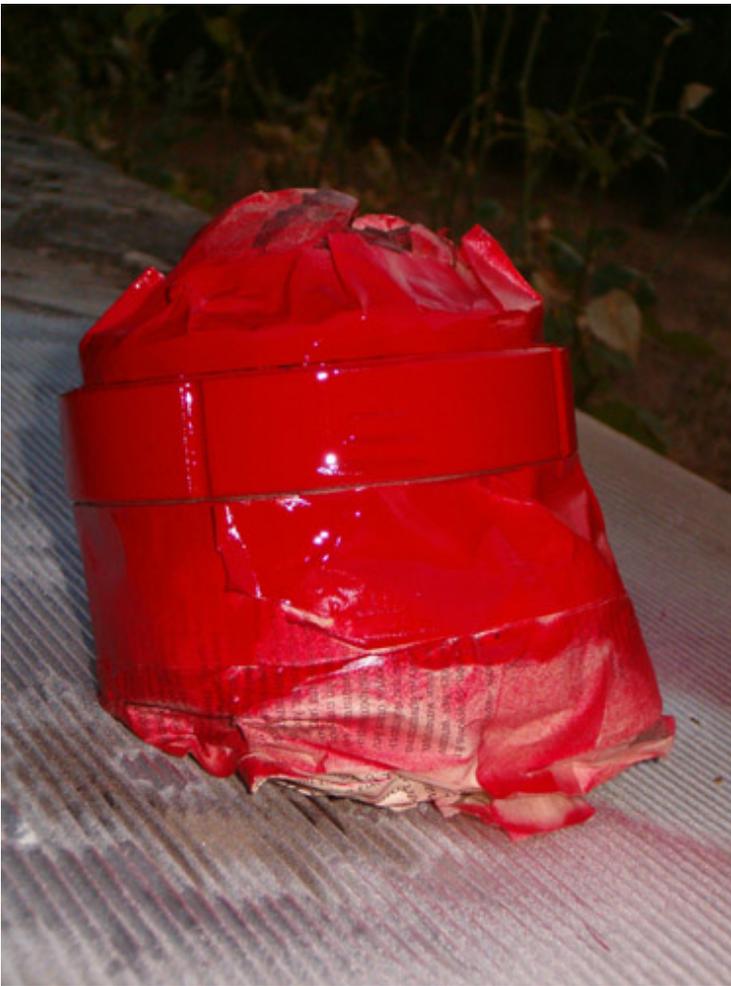
This is the rectifier bridge and the visible portion of it painted in red. We have masked everything out with newspaper sheets and paper tape.

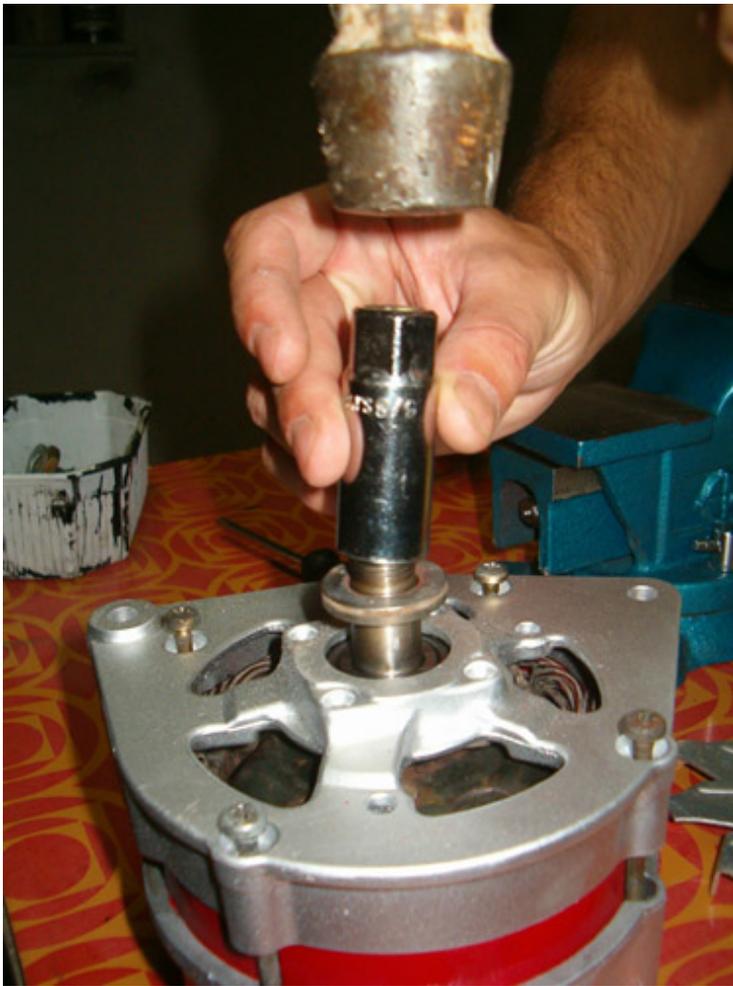
install front cover and with a socket punch in the washer as seen in the photo. Also install and bolt in the four long screws that actually keep the cases and rectifier bridge together.

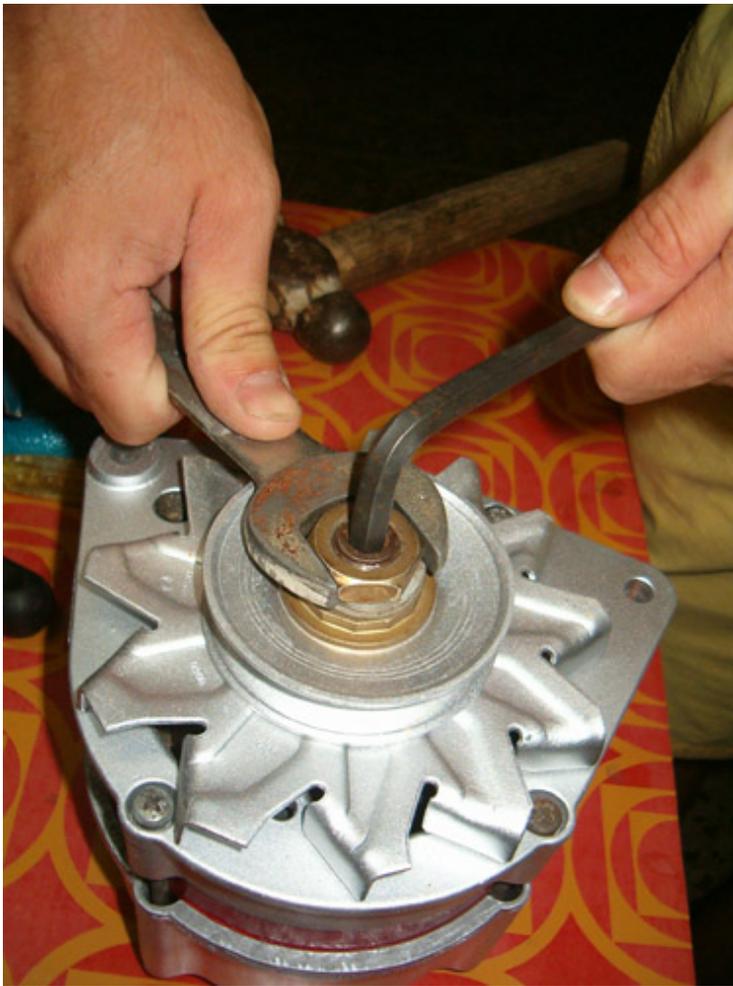
Now fully tighten the nut (24 mm key) with the help of a 10mm allen key

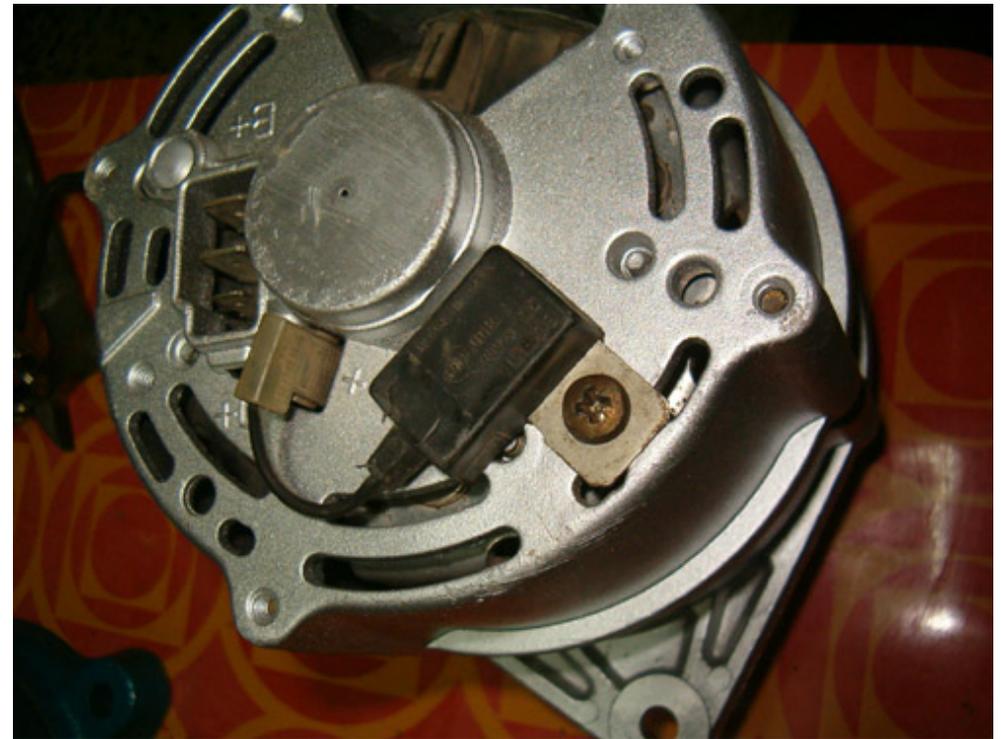
Proceed installing the capacitor which has as purpose to absorb high frequency electrical waves created by current generation. Without this device you could hear in your radio player high pitched sounds which would otherwise escape from the electrical system.

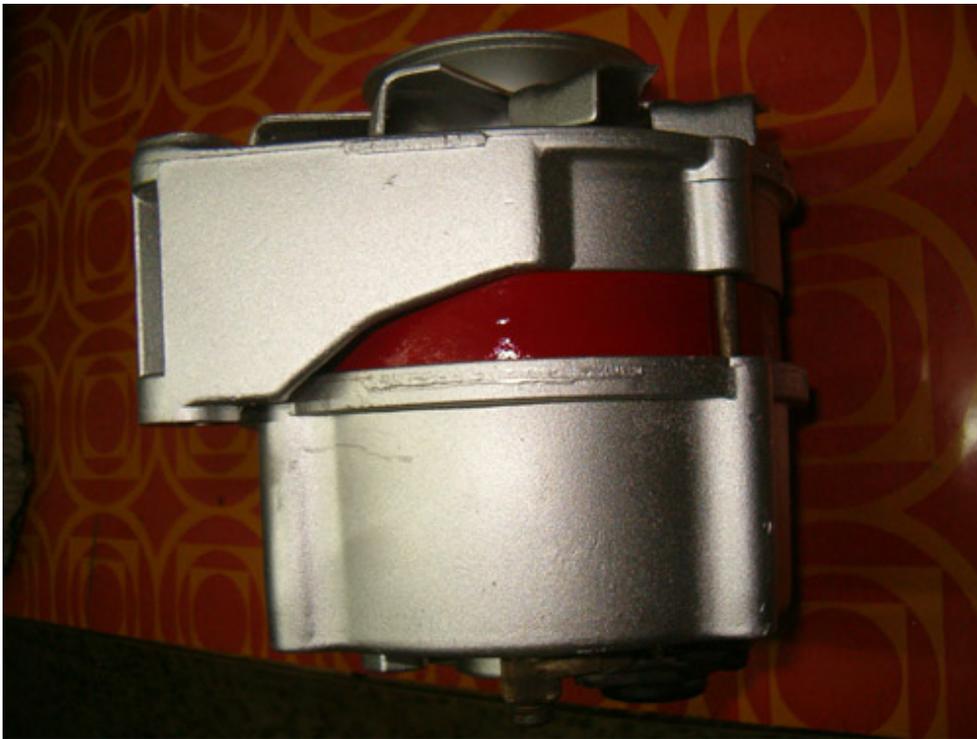
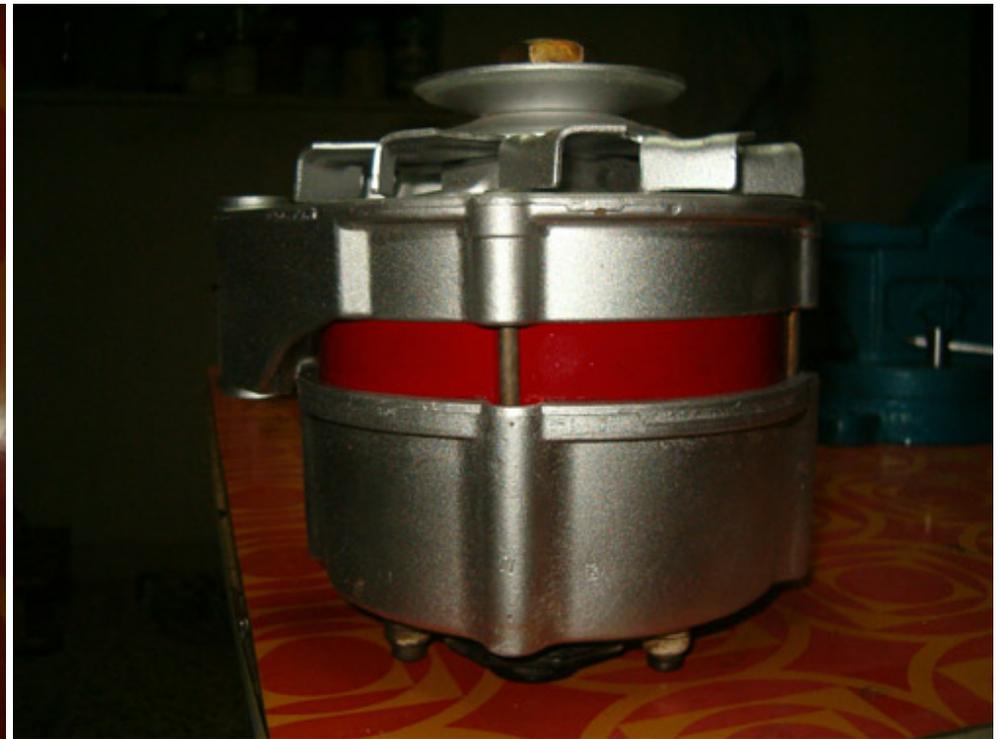
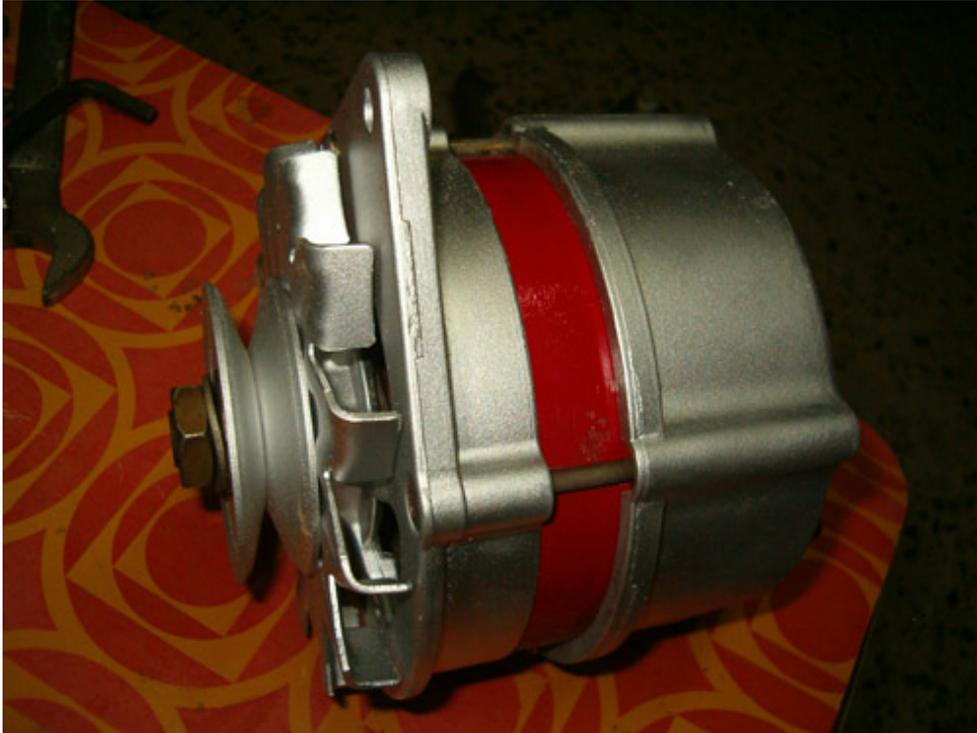
Alternator is now ready for installation to the car. We measured the output of it on idle and it was almost 14 V; on 2,500 rpms it reached 14.3 V. For sure the alternator will last double years as this was a ground - up restoration. Well done!
