Gas Tank Restoration

Tank Removal

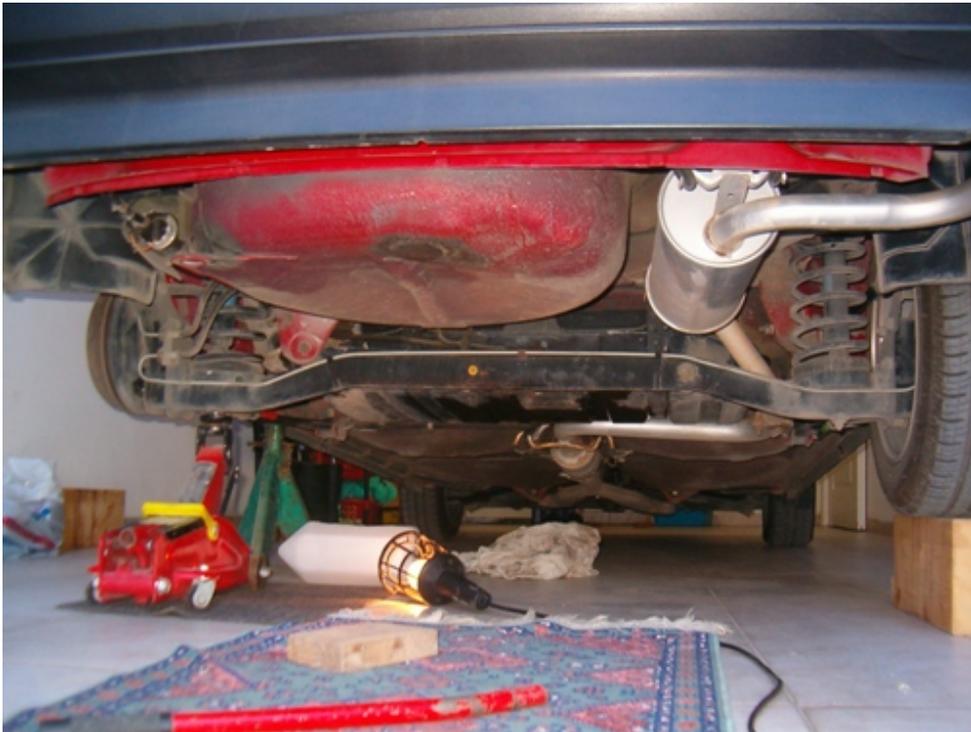
Raise the rear of the car in order to get as much clearance as possible. I used a stand at the left jacking point and a piece of wood under the right side wheel; this way I feel safe under the car.

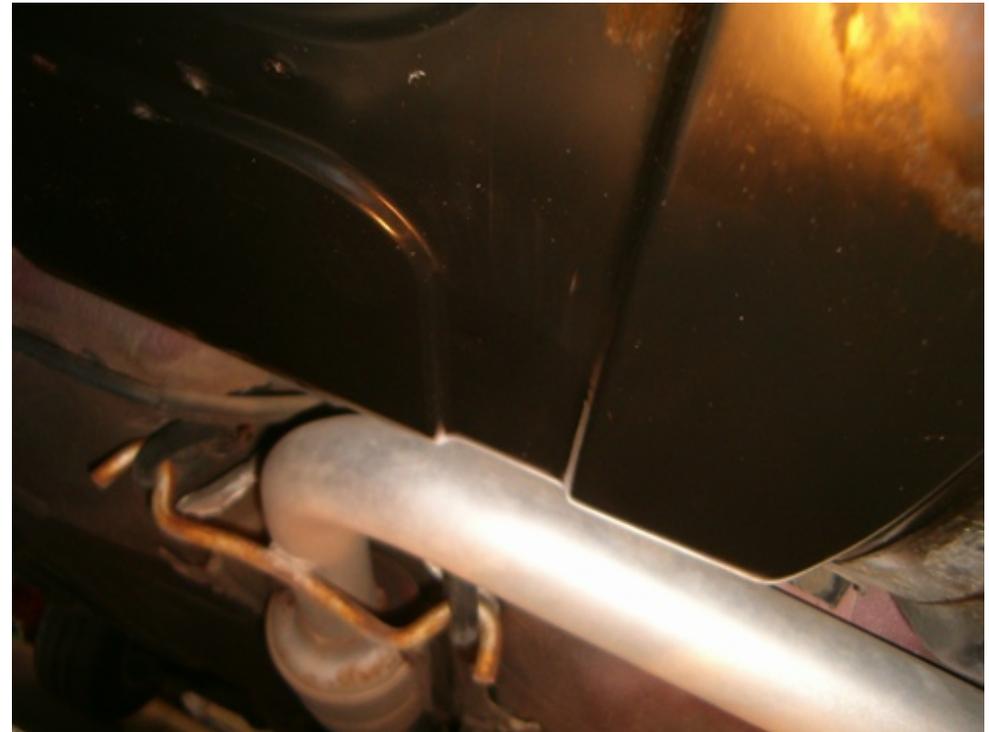
Not clearly seen but this is the part of the tank where the leak is located; it comes off a spot weld.

This time I decided to solve the tank issue once forever (hopefully!). I had noticed a very good product advertised on the web and used by many car enthusiasts which claimed to seal the tank internals and fight corrosion on metal tanks. This is POR15 Fuel Tank Sealer (<http://www.por15.com>)

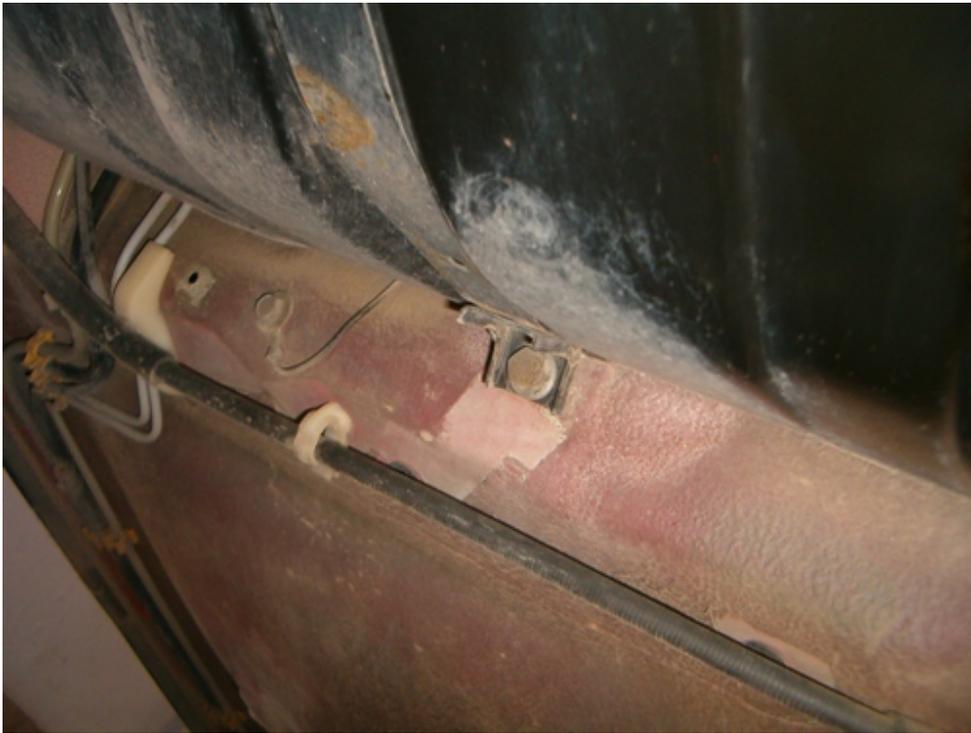
We must remove the two strap bolts which actually hold the tank in place...

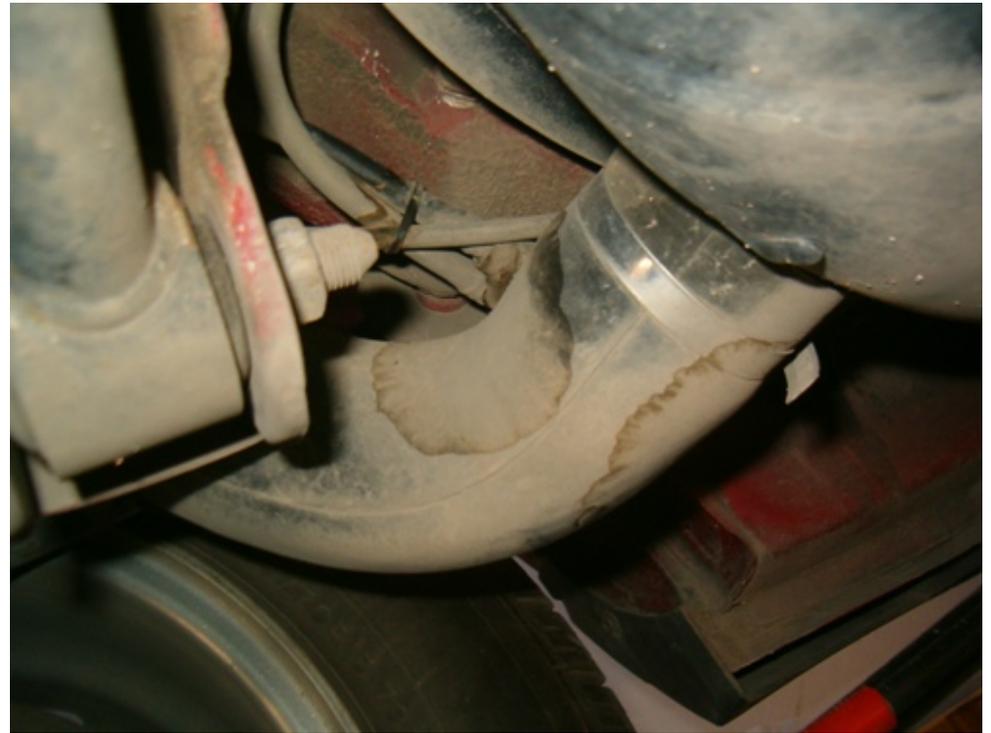
... and the fuel filler neck.

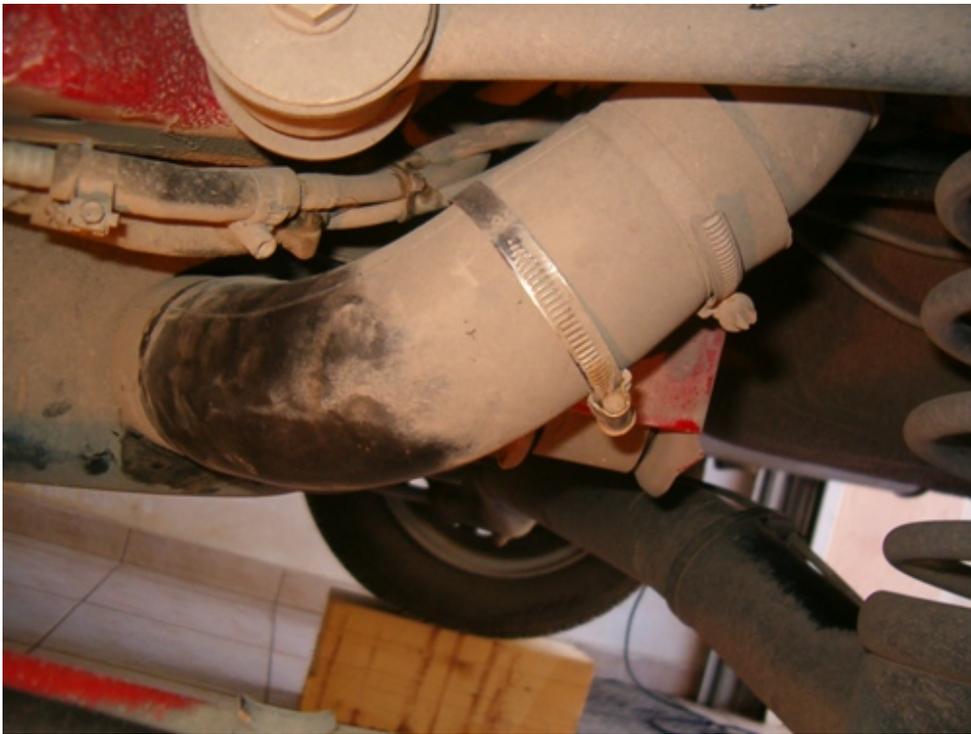
There are two large hose clips that hold the curved hose in place

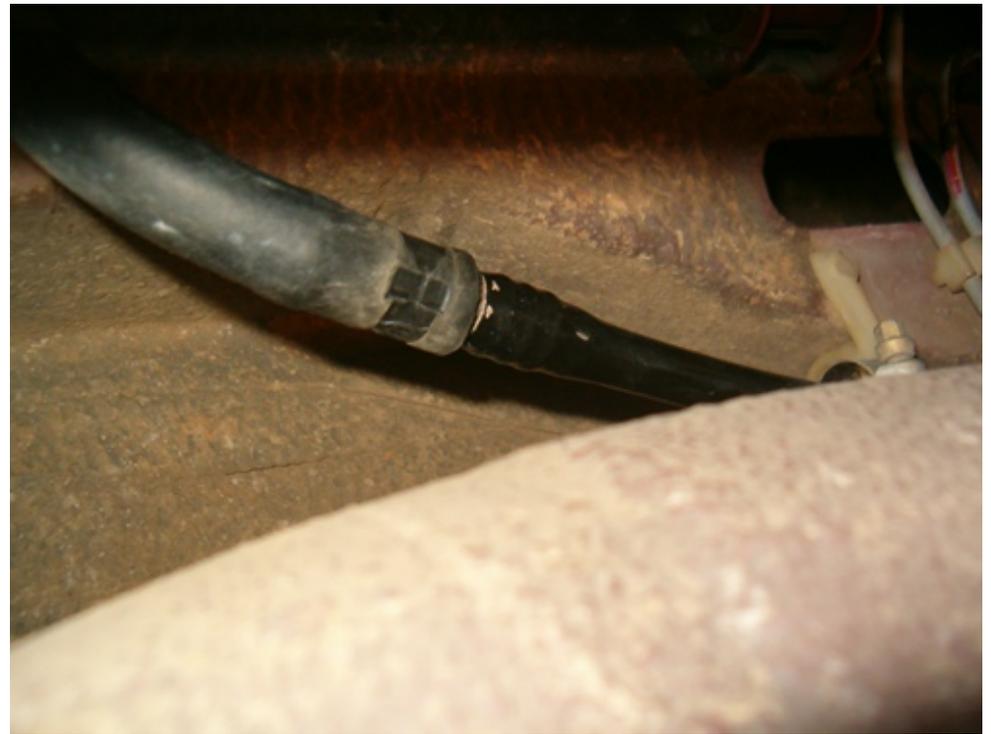
Then undo the clip on the fuel hose that sits just behind the spare wheel well.

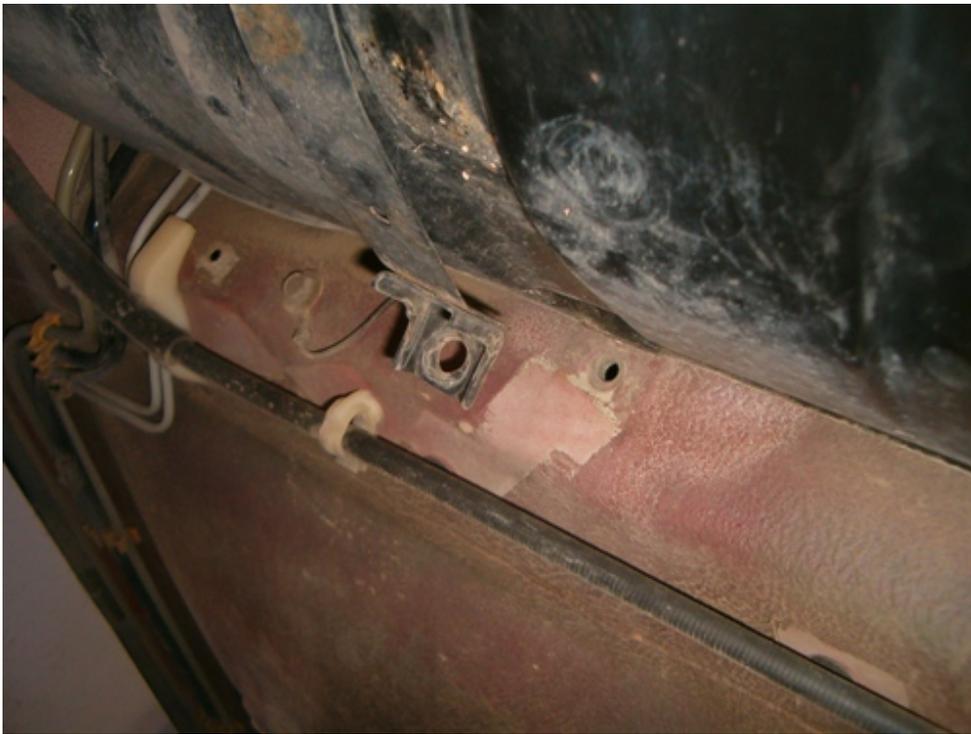
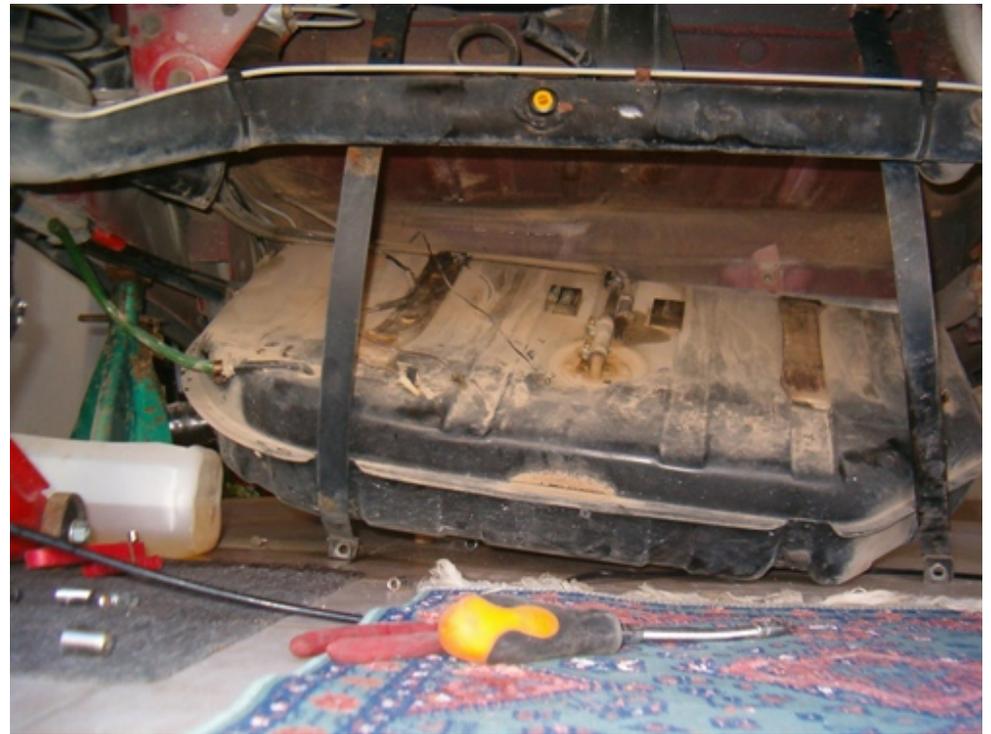
Once the strap bolts are removed the tank easily drops as shown on the photos

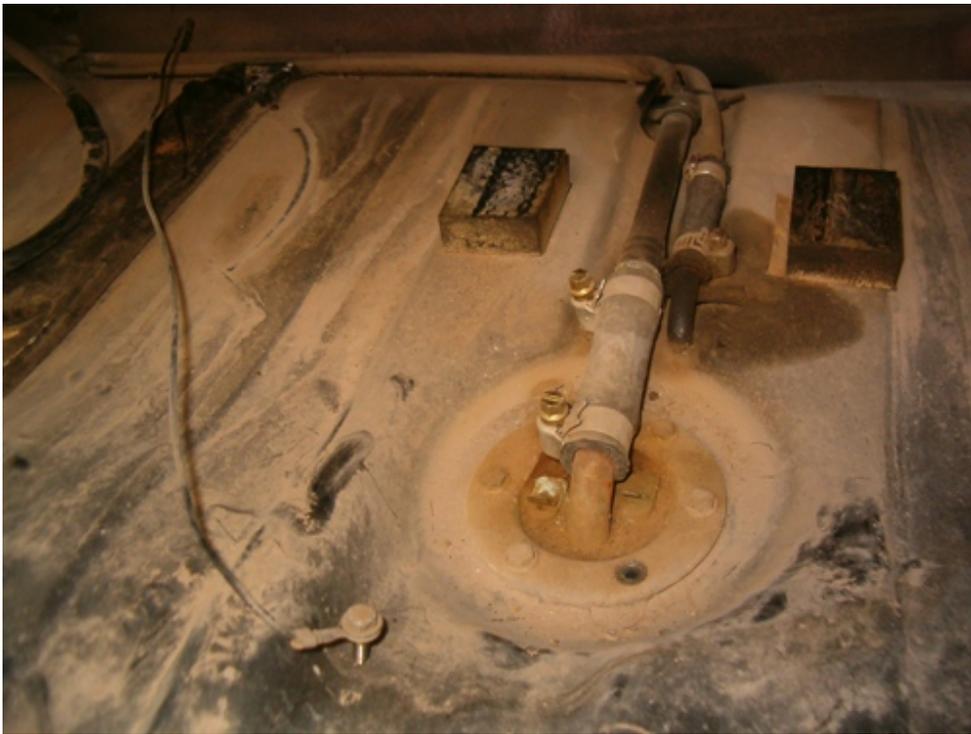
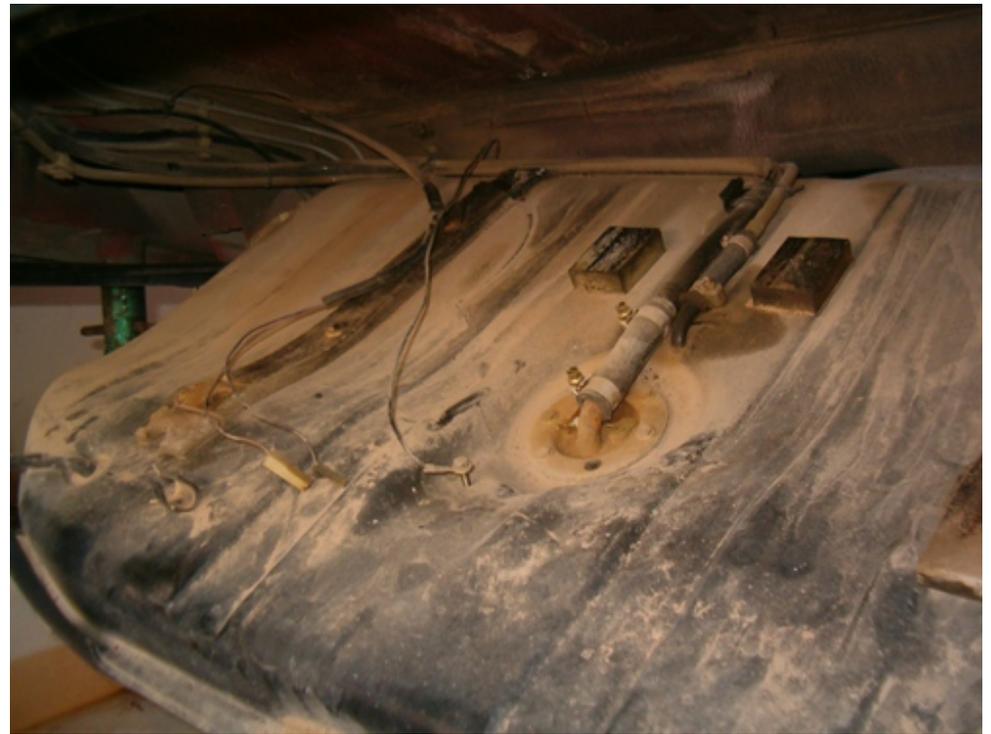
A couple of close ups show the fuel sender unit along with the fuel supply/return lines. Quite nasty is the earth lead that must be removed along with a fuel sender unit bolt. For sure I will find a better solution of attaching the earth lead to the chassis once I restore the tank

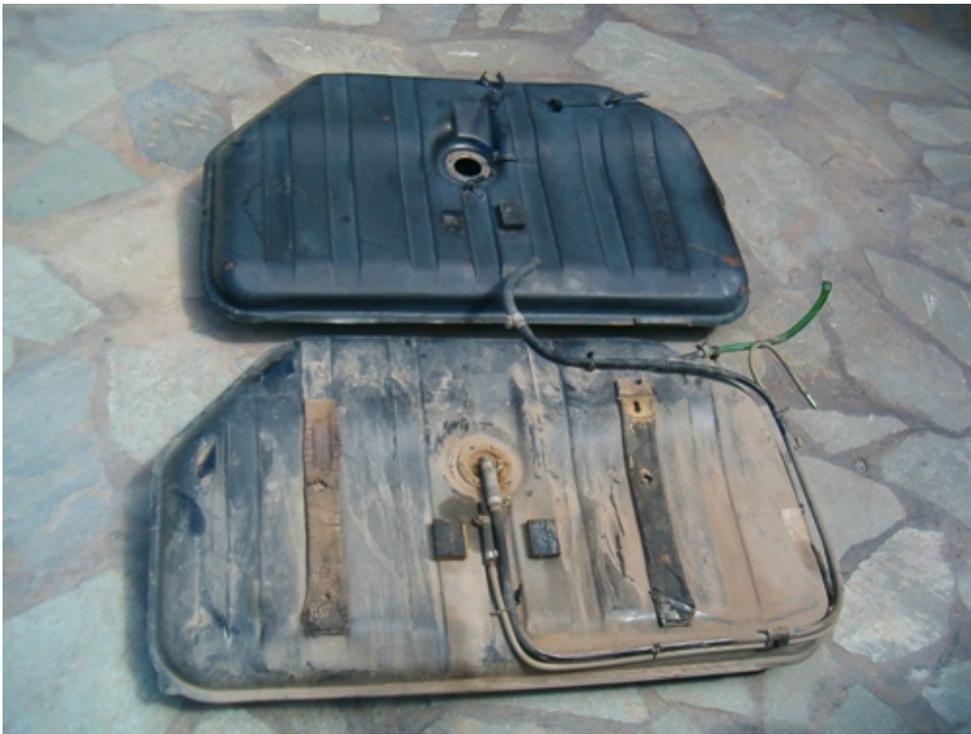
Here are the two tanks demonstrated. The upper one is the temporary replacement that my friend Dennis kindly lended in order to keep the 33 running while I am rebuilding the original one.

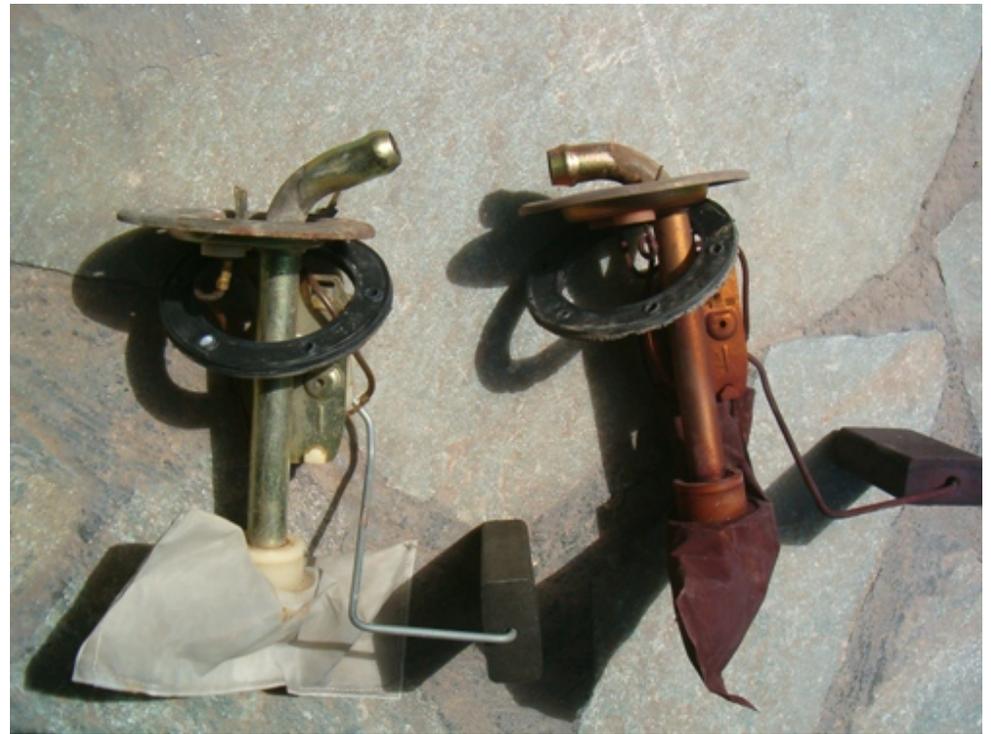
There are a couple of differences between the two tanks as far as the fuel sender unit is concerned. The original tank has the sender unit facing forward (front of car) whereas the replacement tank has the sender unit facing backwards.

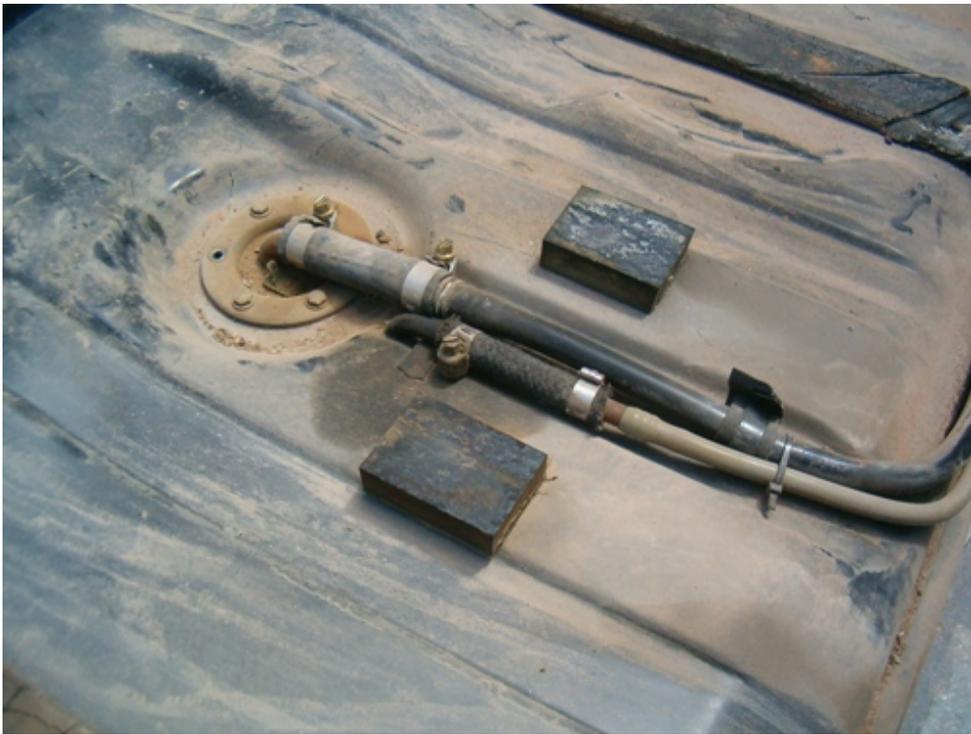
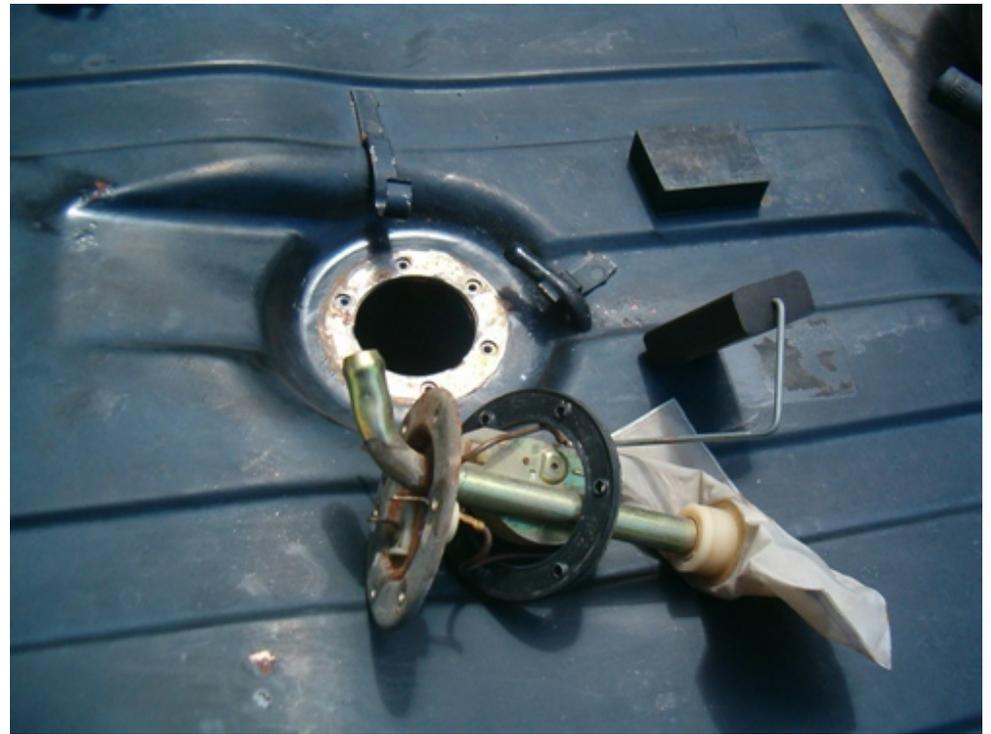
The same principle is applied to the pipe routing. As you can see in the photos above, the original tank (left photo) has the fuel return pipe facing forward (front of car) whereas the replacement tank (right photo) has the return pipe facing backward (rear of car). This is of no major concern as the return pipe will be routed using a flexible 8mm fuel line.

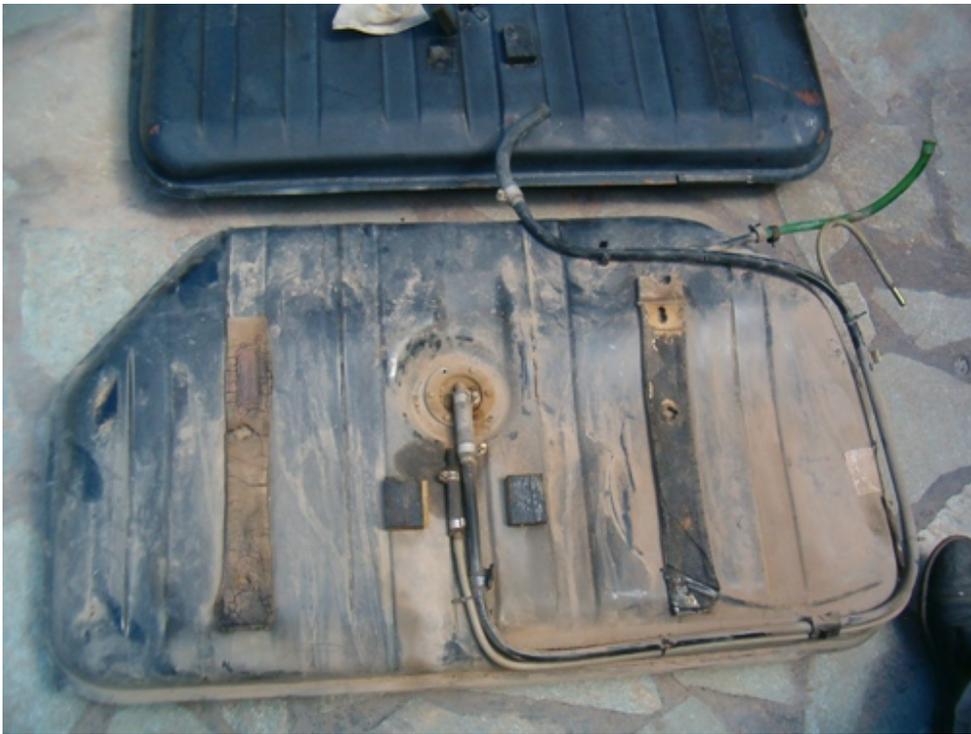
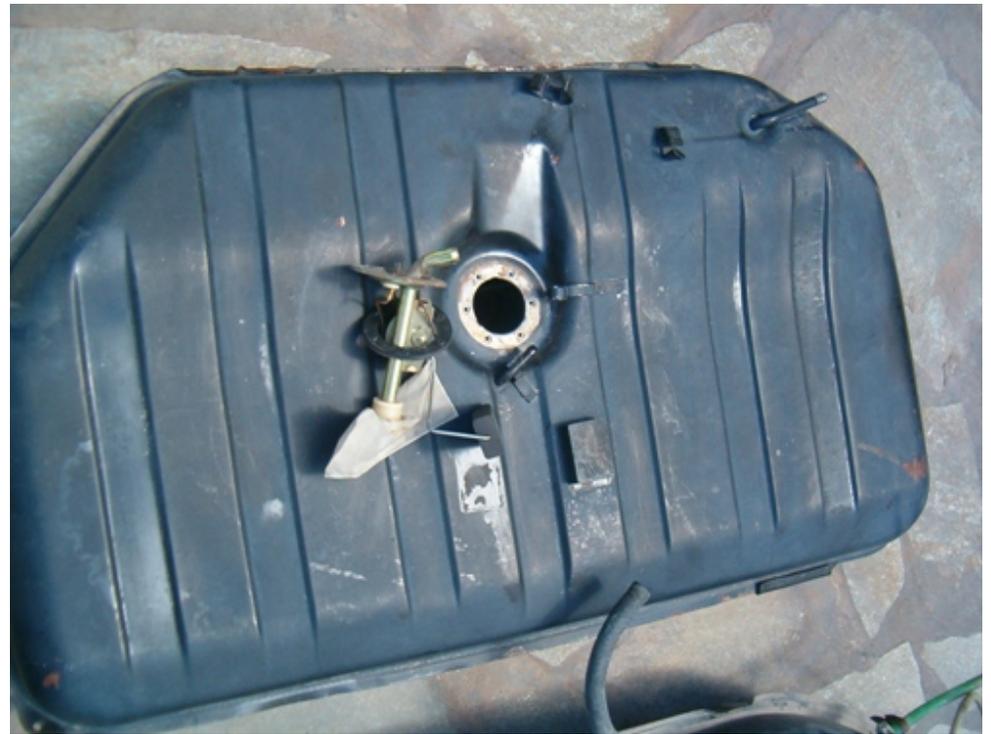
General view of the two tanks showing their differences
