Donor Car

Here you can find some pictures from the donor car. It was a hassle to work on a wrecked car full of dirt over the years, broken glass everywhere, sharp edges all over the place... I was lucky enough to deal directly with the A/C elements since the car had a front end collision and many parts like hood, bumper were already missing. However, condensers were totally ruined if not present. Freon hoses showed sings of tears which required replacement with new ones should the time come to fit everything to my car. Such things were of minor importance since the most crucial parts were intact; compressor and evaporator unit.

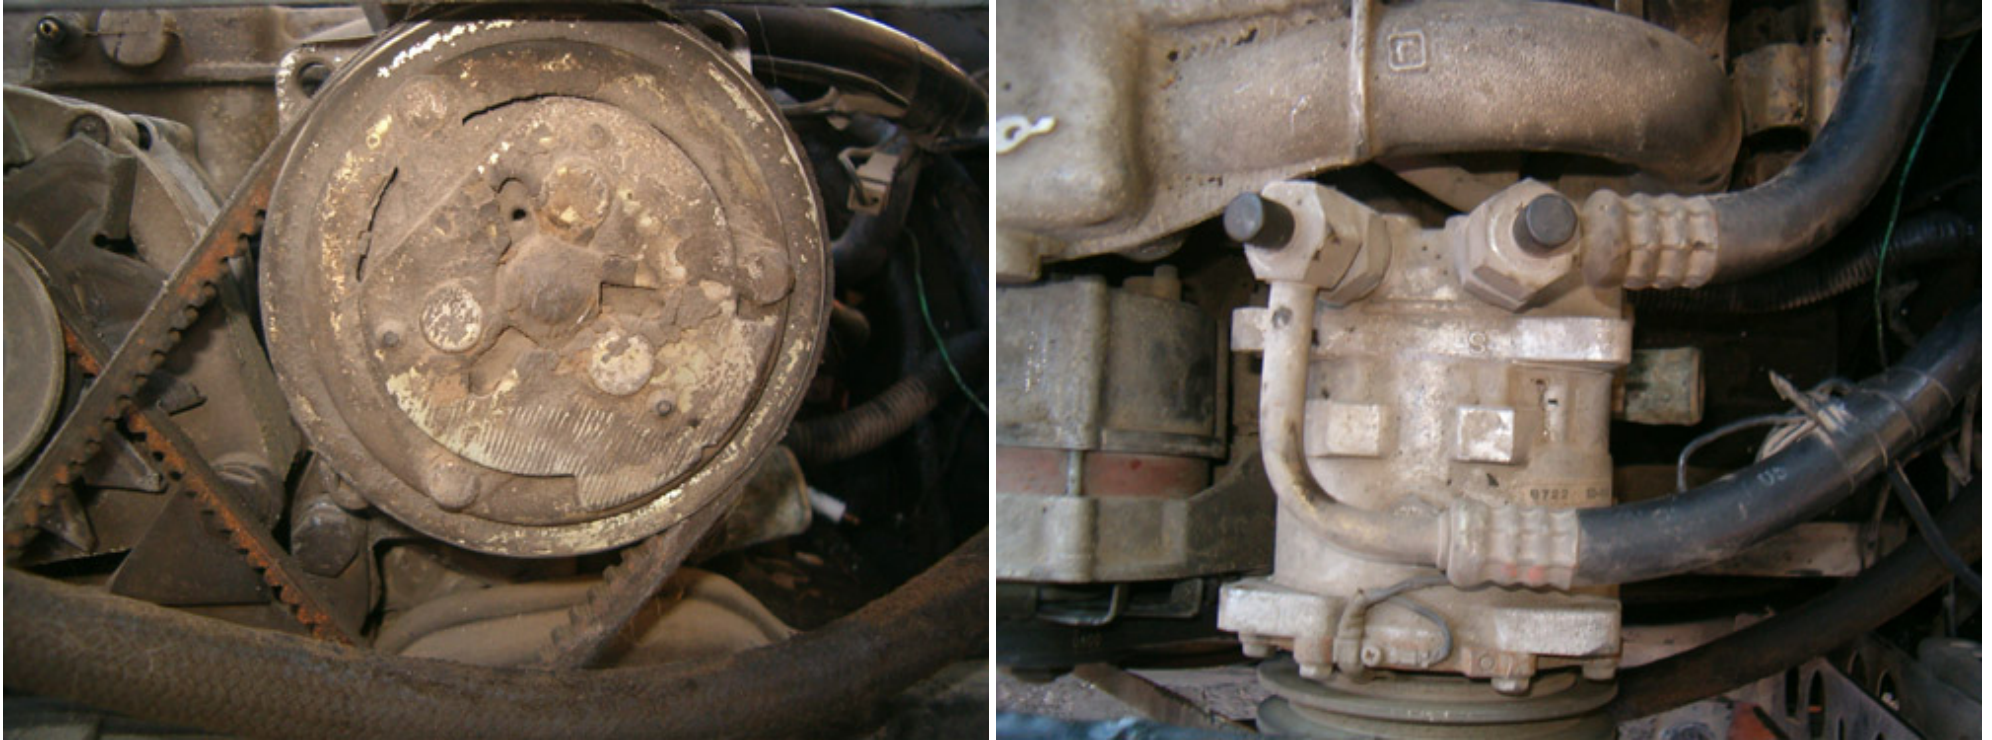
Here you can see the compressor and its bracket. Quite dirty as most of the engine bay...

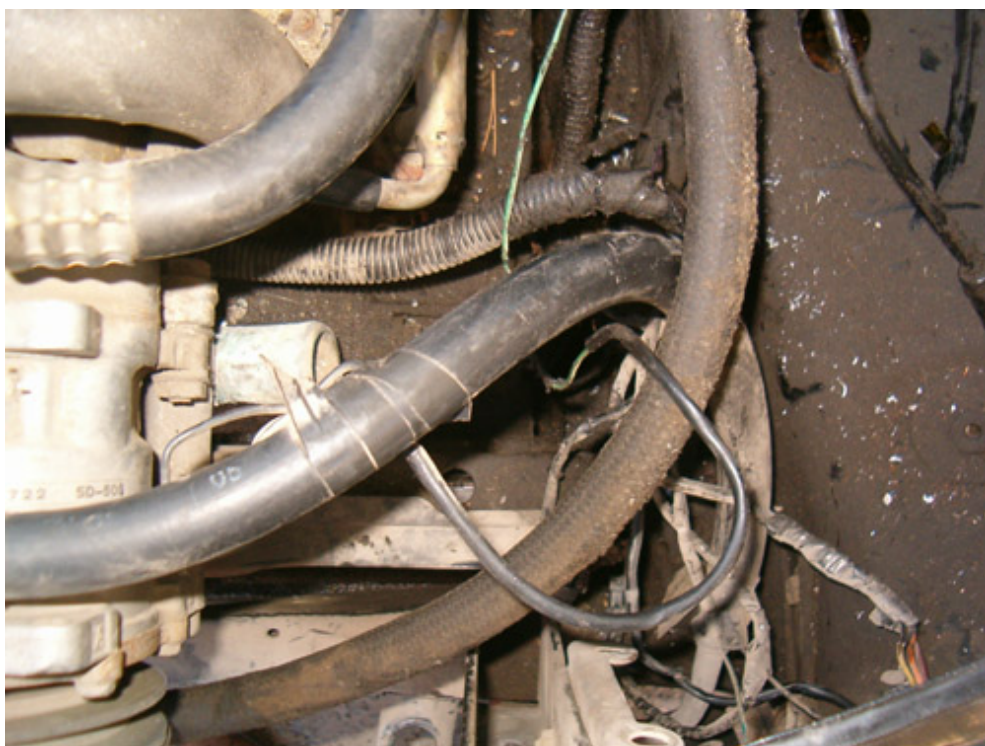
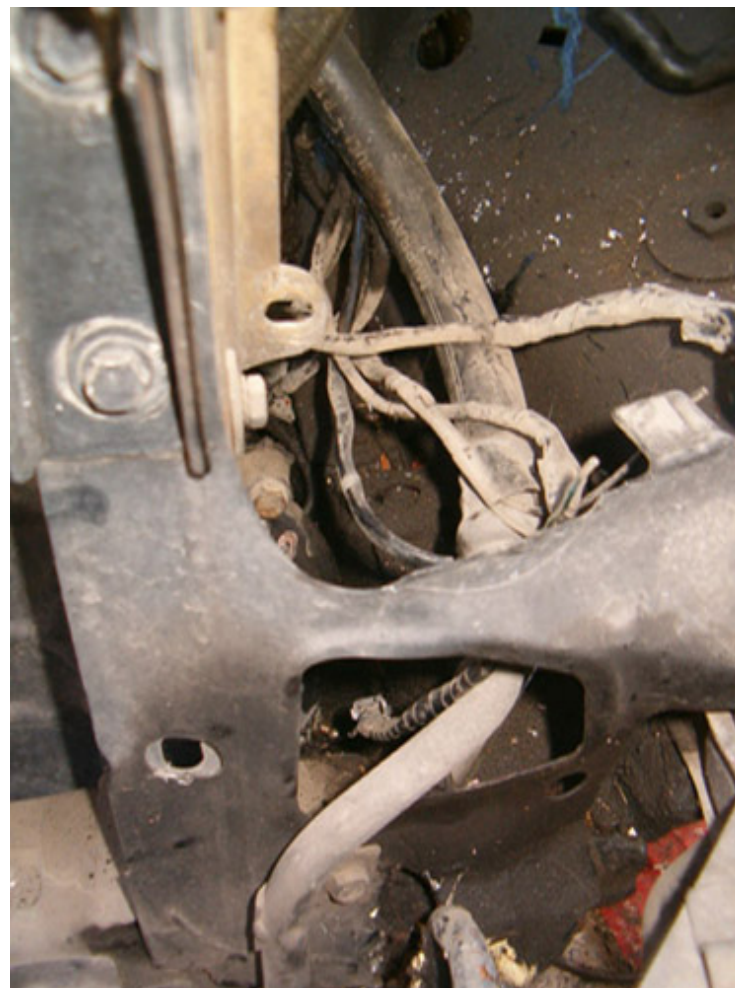
Pipes towards the left side condenser

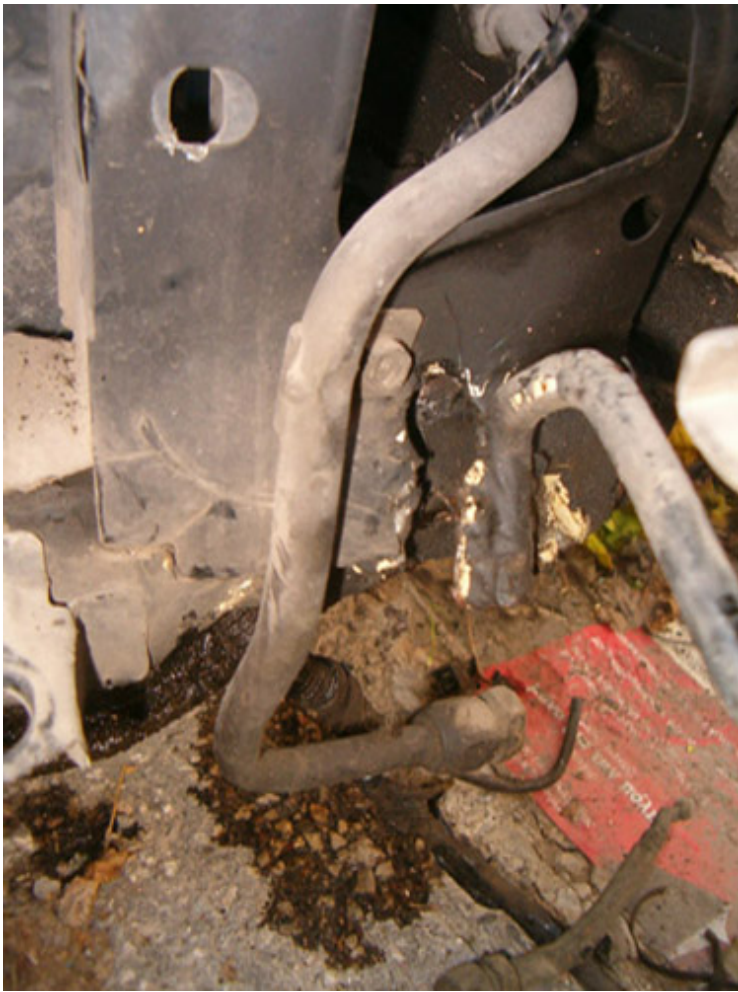
(or what was left out of it)

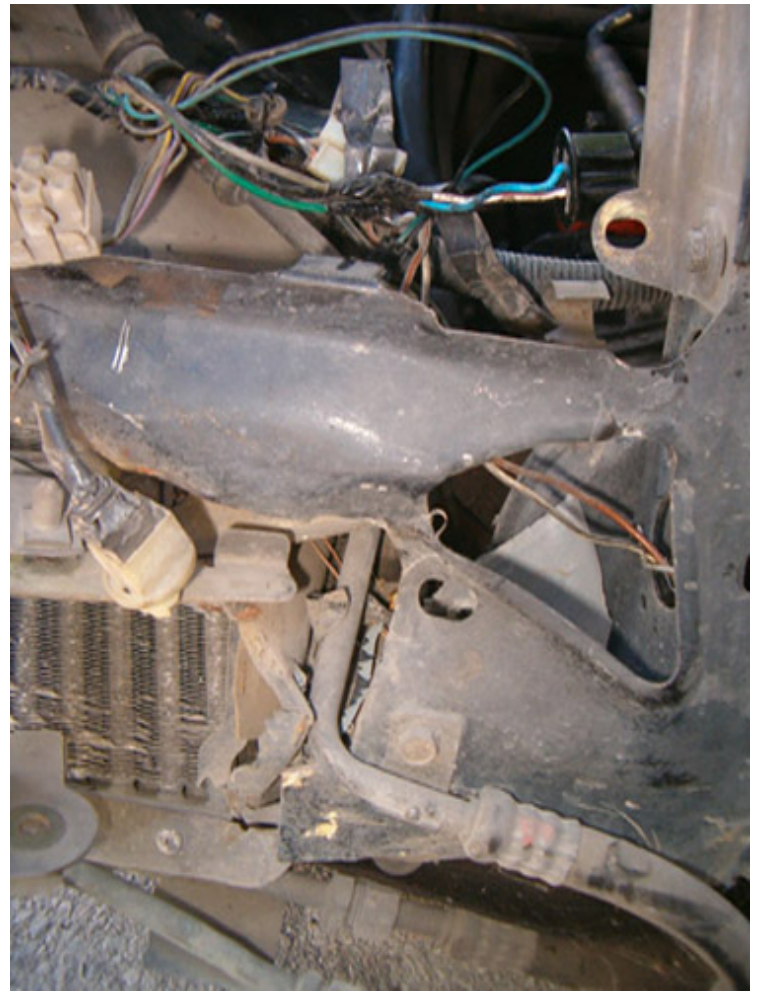
right side condenser

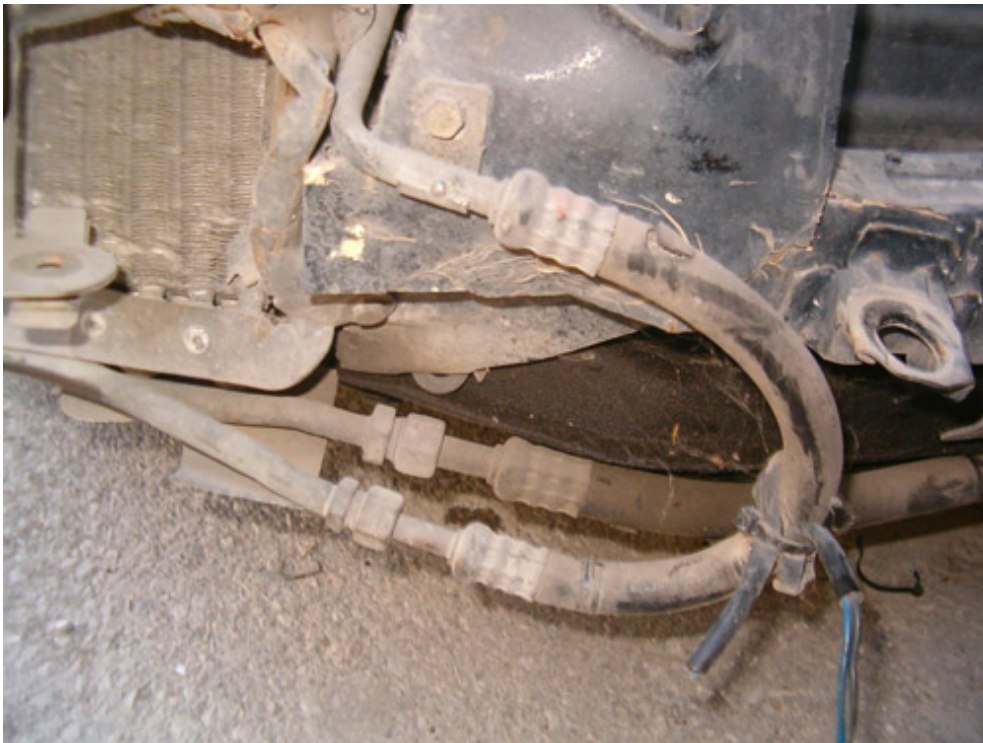
Right side condenser somehow survived from the accident but the hoses didn't so...

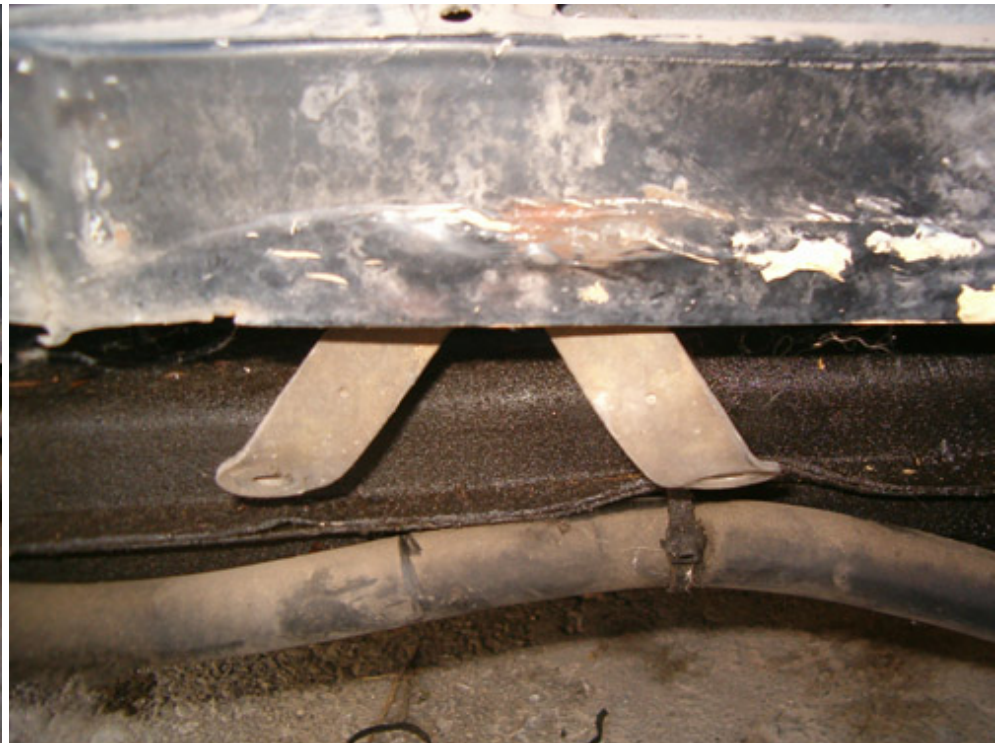
Horns bracket. A very important element since the horns will be moved to the front cross rail.

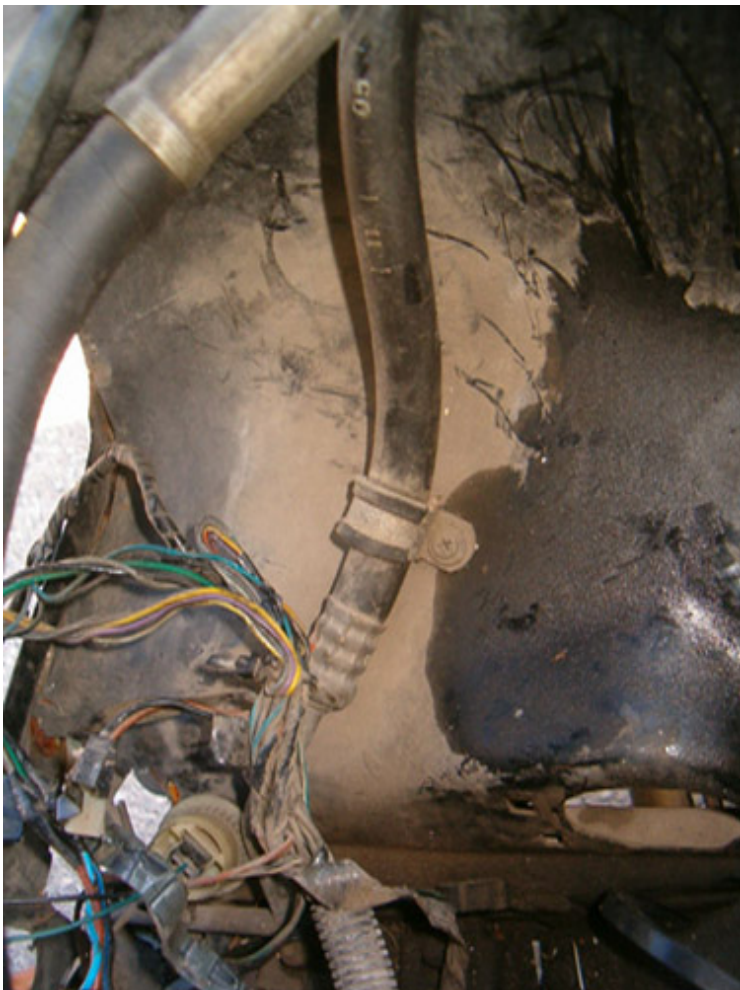
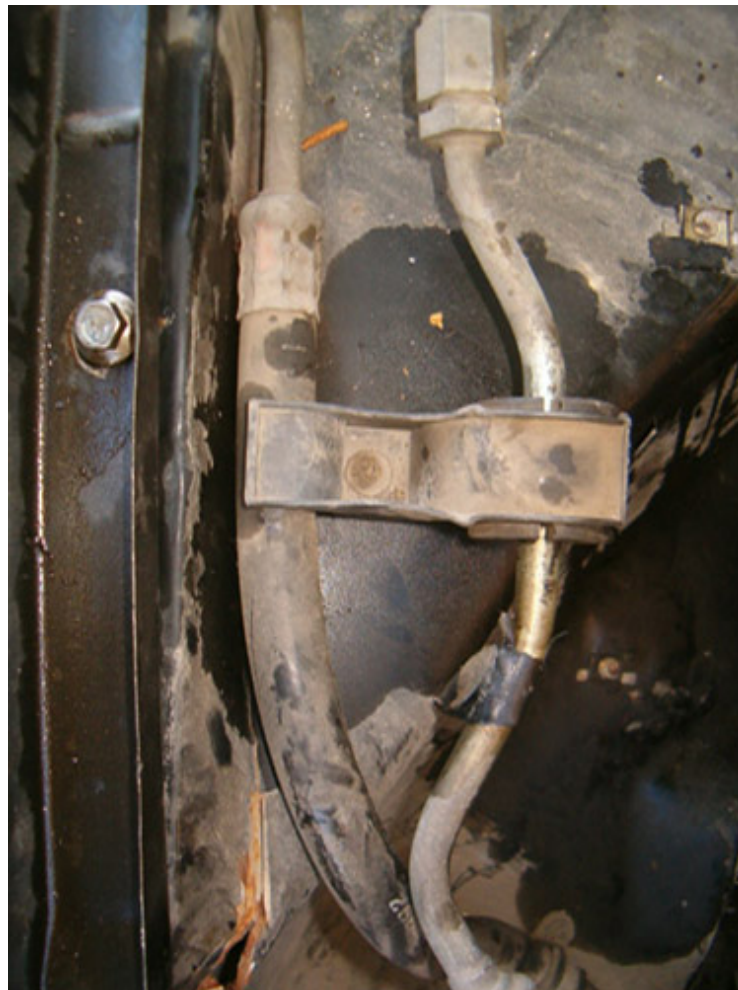
Pipes towards drier filter/evaporator

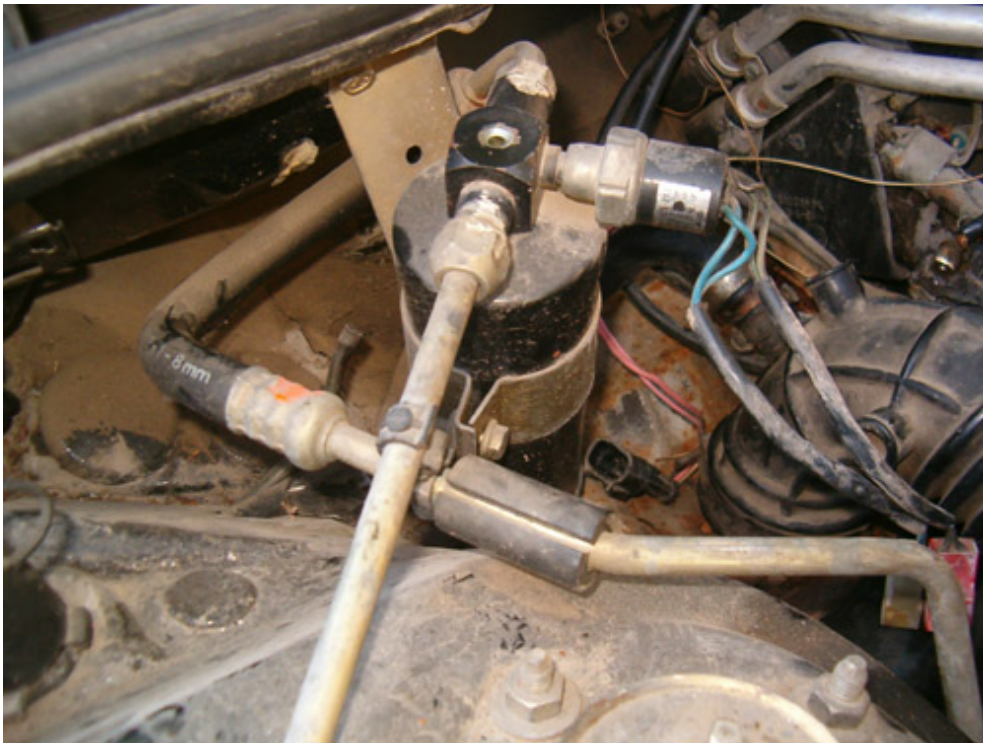
Drier filter and Trinary pressure valve demonstrated

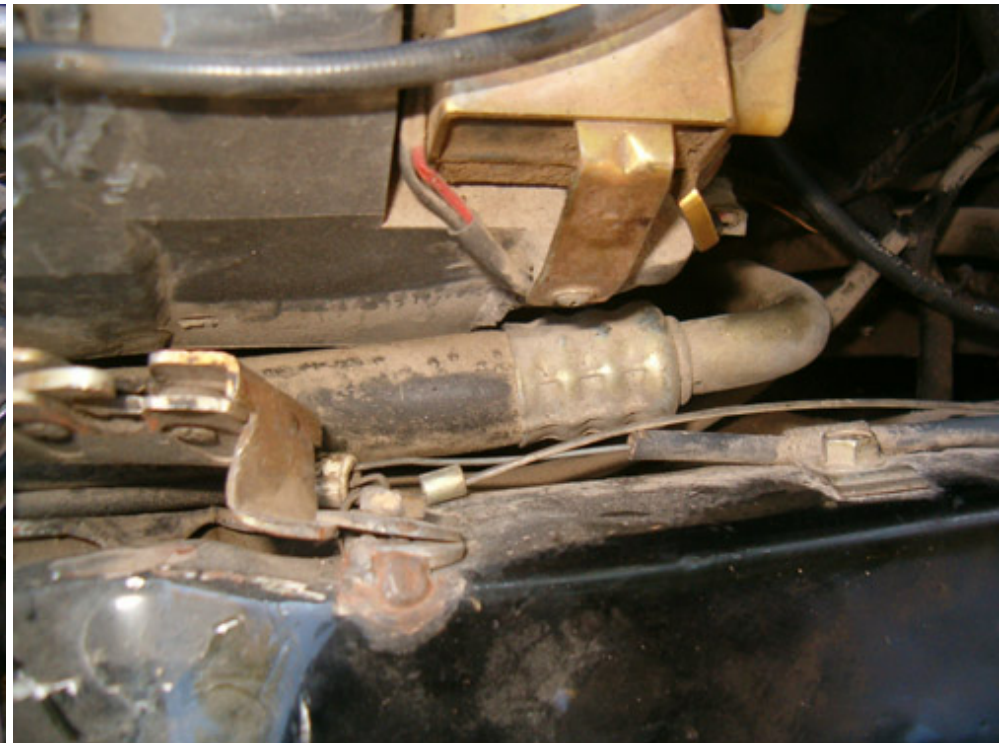
evaporator pipes

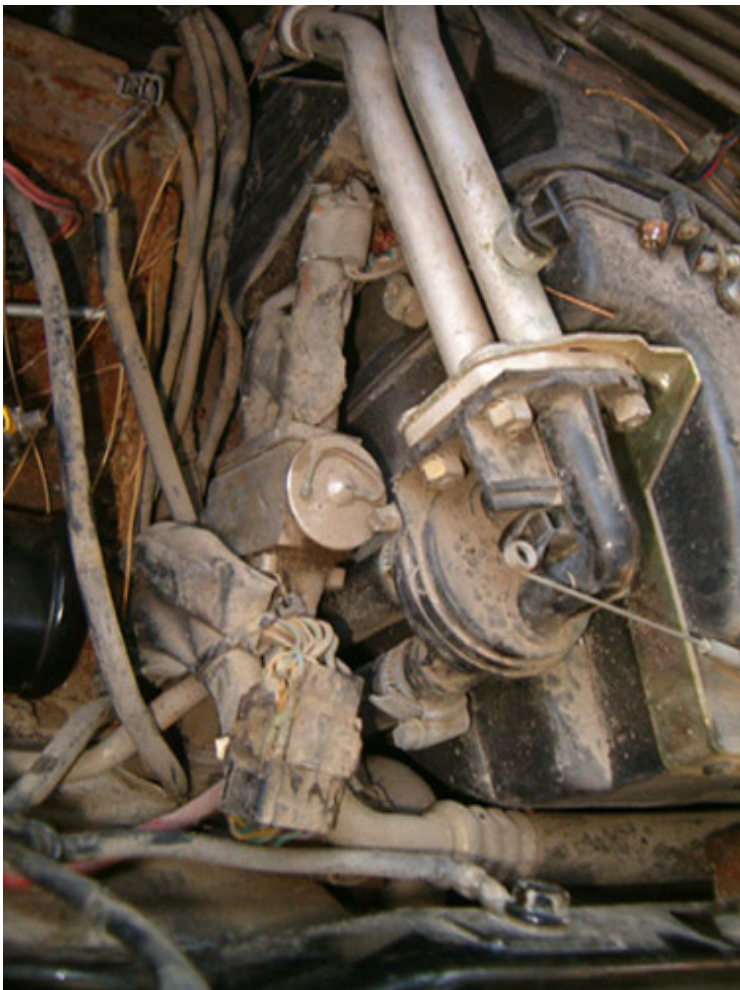
evaporator overview

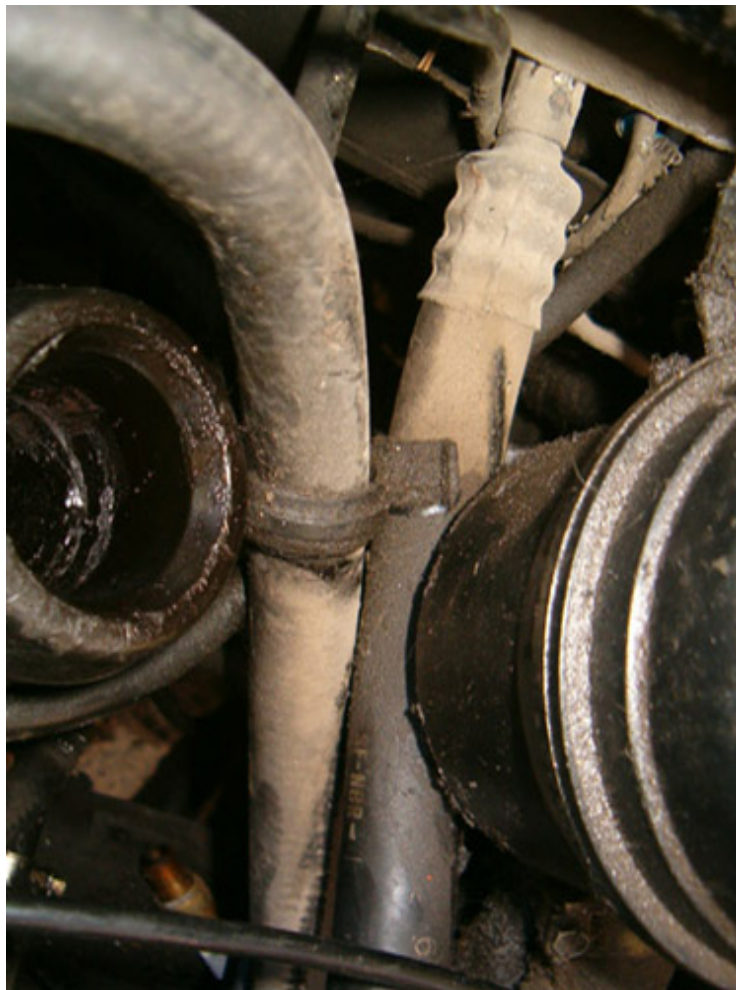
pipes leaving the firewall towards the compressor

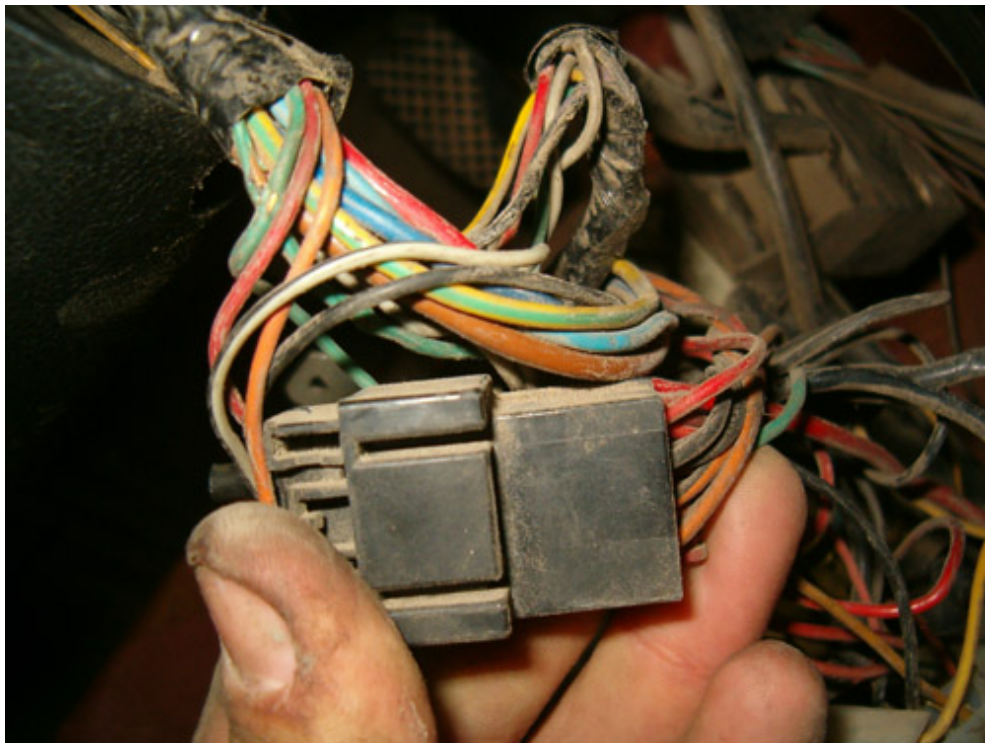
Electrical connections inside the passenger compartment...

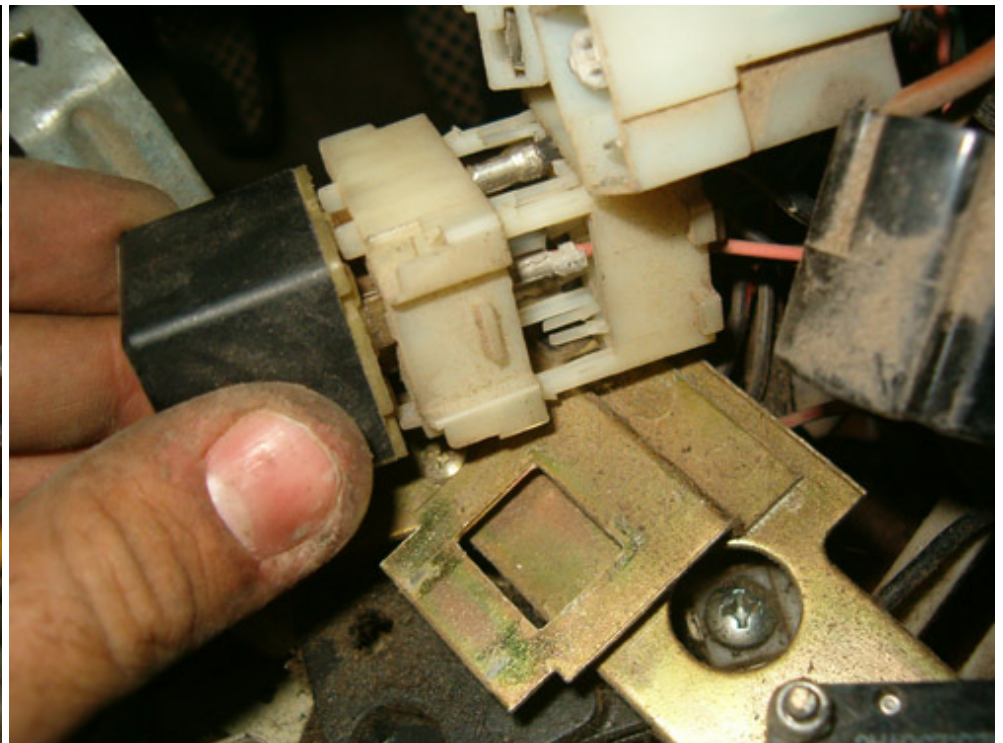
blower motor relay...

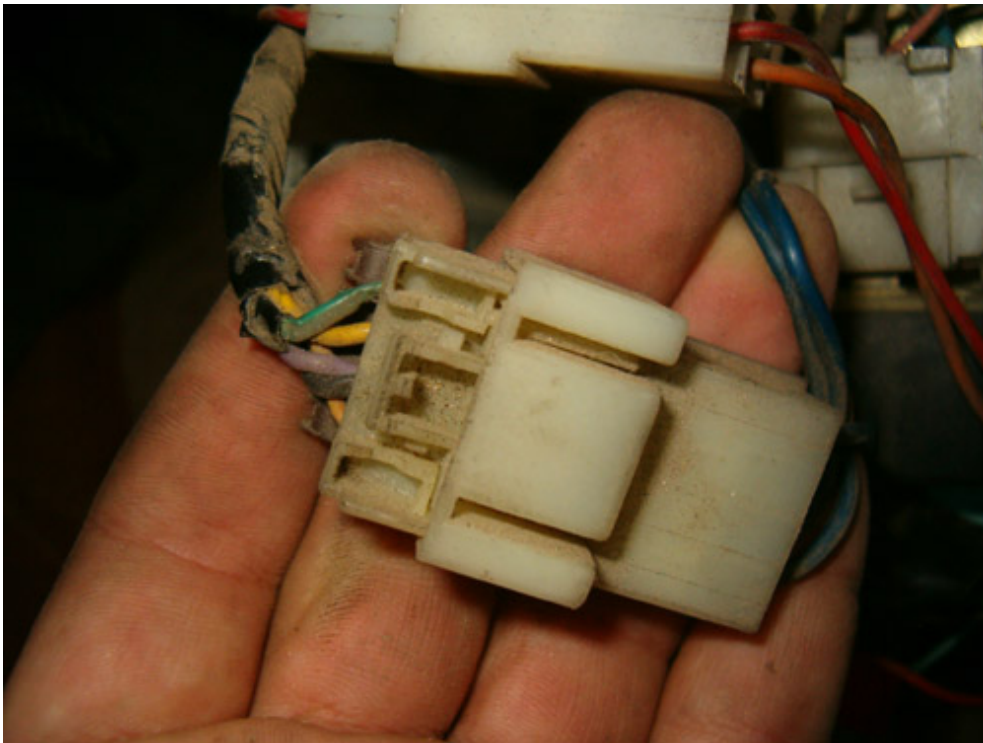
more connectors ...

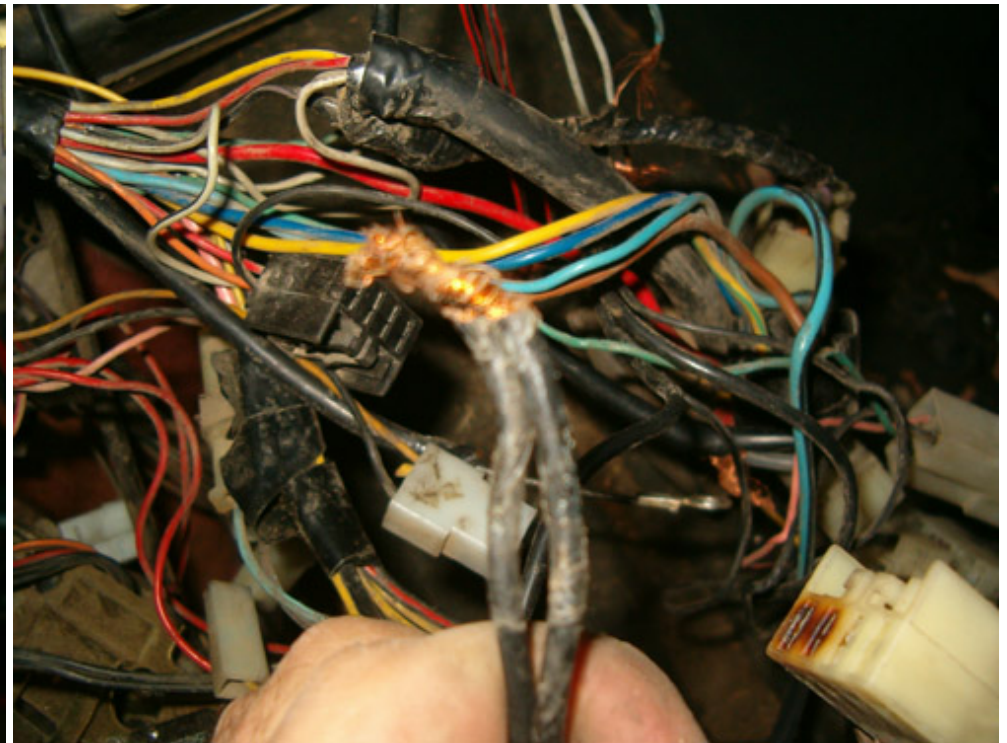
and some dodgy job from the past.
