Evaporator rebuilt

Let's now move on to the most crucial part of our project; rebuilding the evaporator/heater unit. As you will see from the photos the rebuilt is quite challenging. The unit had surely seen better days - the evaporator cover has a big opening on the front and the coolant cut off switch is broken. Let's see what is hidden inside...

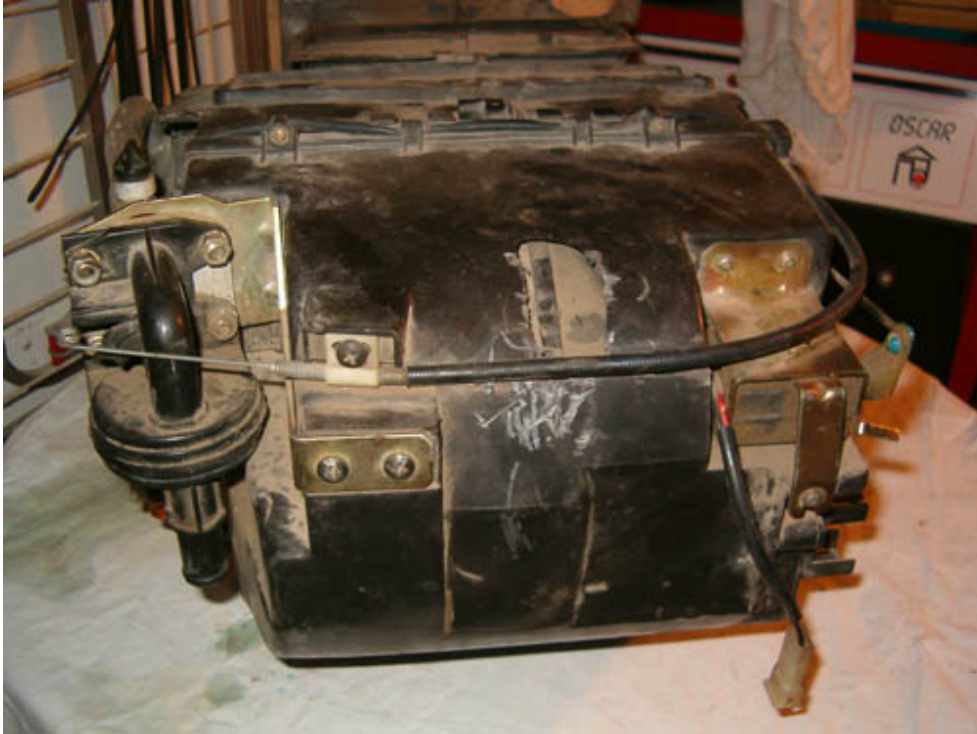
Front view. Notice the big opening and the broken lever of the coolant cut off switch.

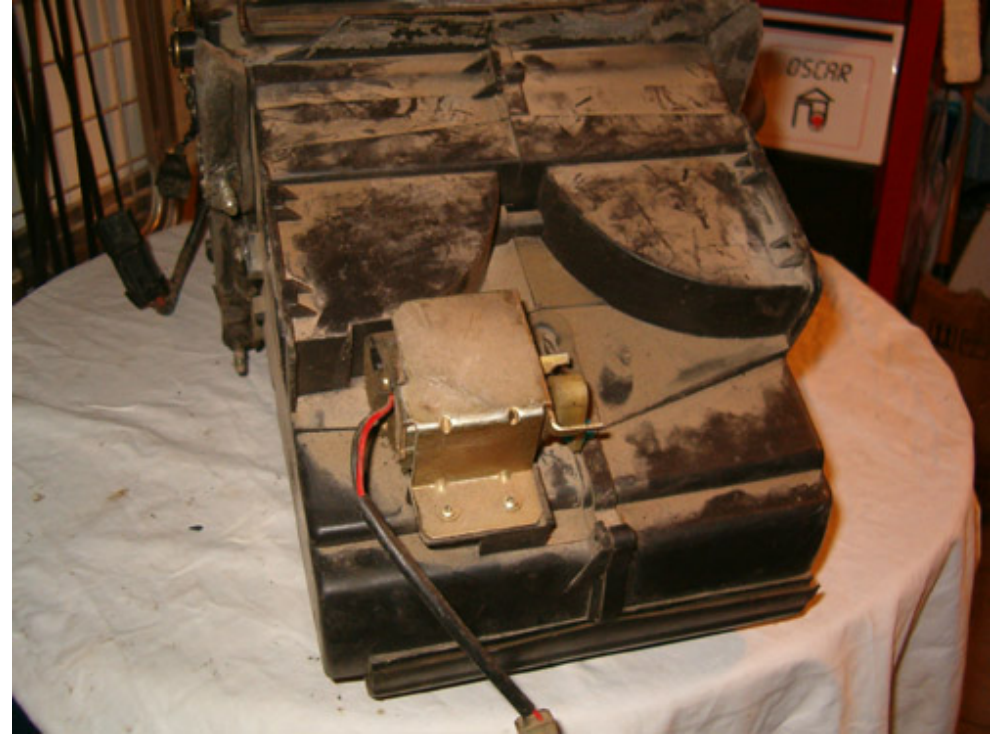
Rear view showing hot/cold air servo motor and air flow direction ducts (feet)

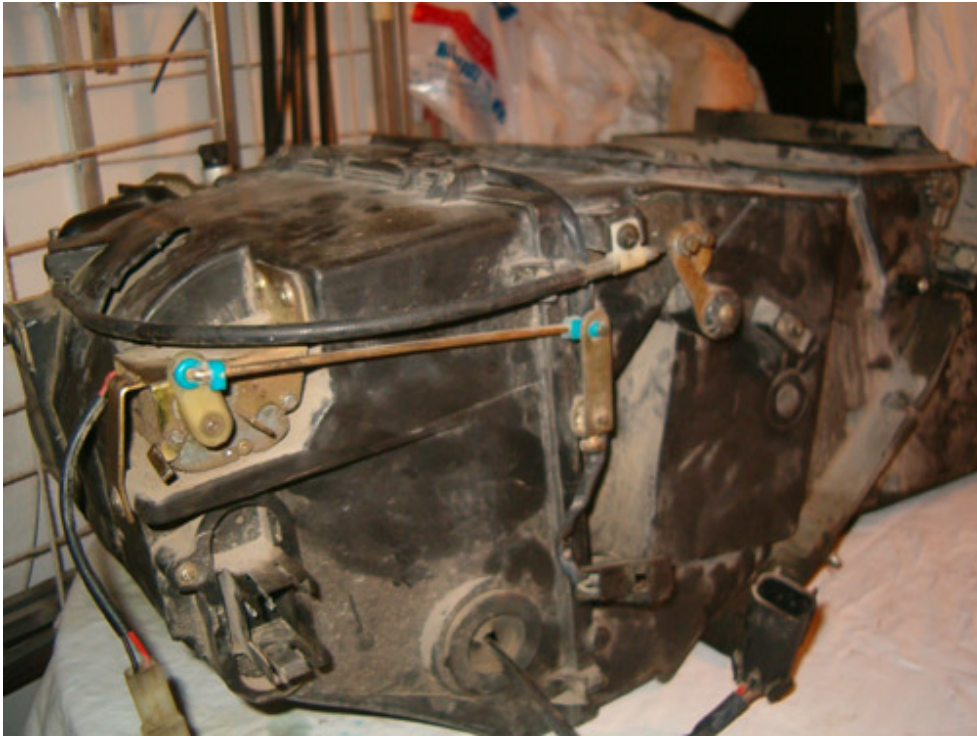
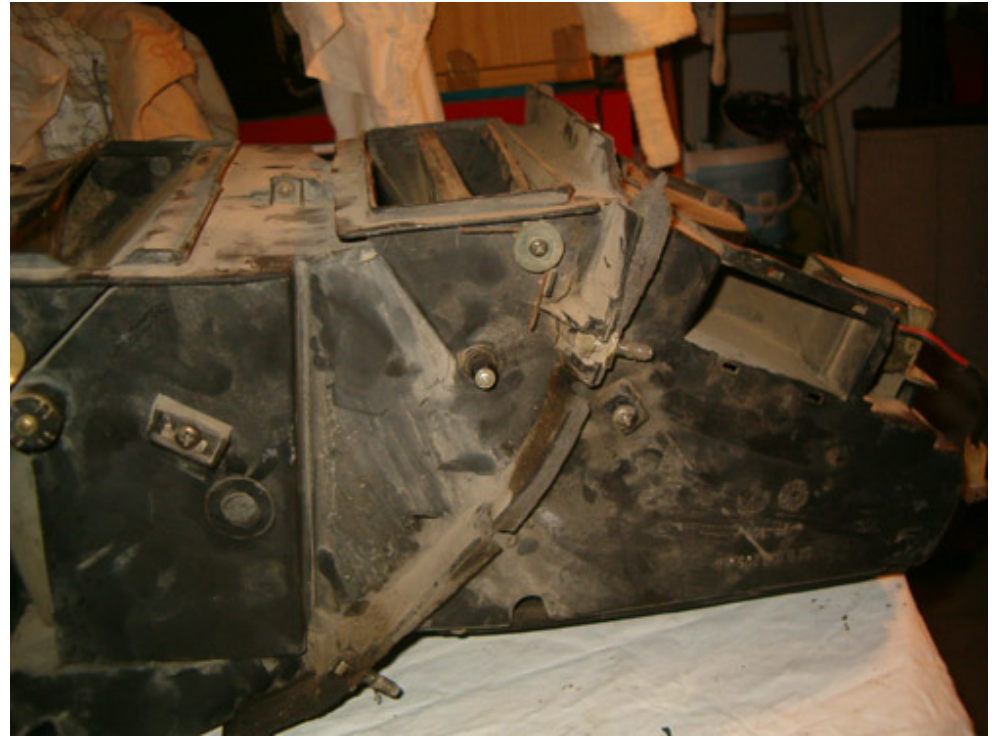
Side views showing servo motor regulating interior/exterior air circulation, blower motor resistor, power connectors, air flow direction ducts.

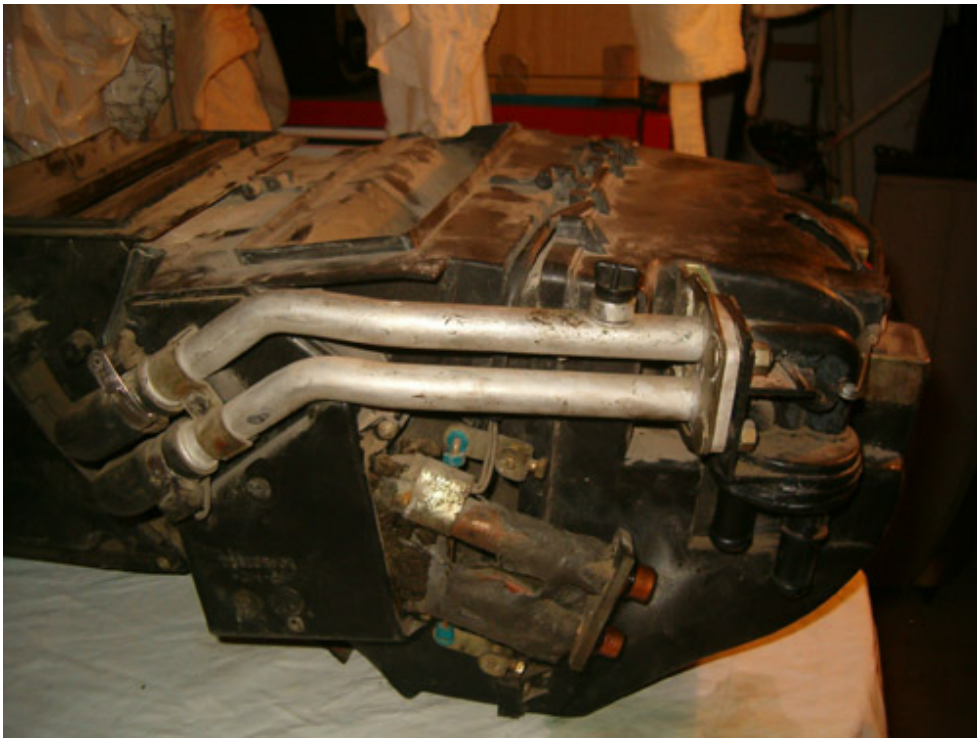
Side view showing A/C and heater piping. Upper pipes are for the heater matrix and lower pipes are for the A/C evaporator.

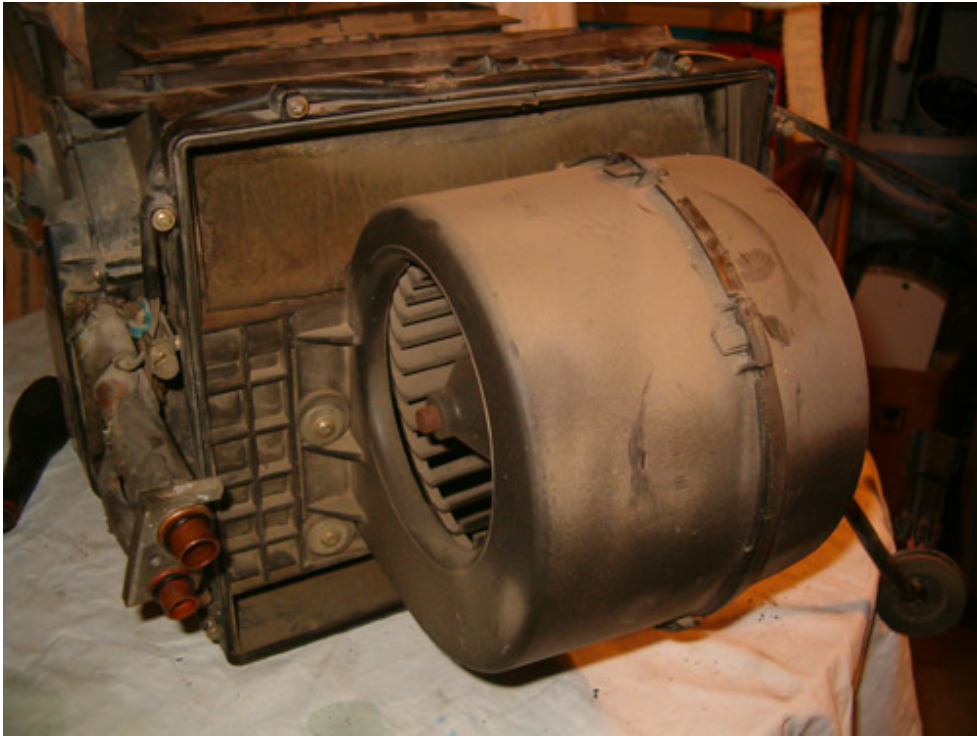
... and a hell of dirt and dust inside

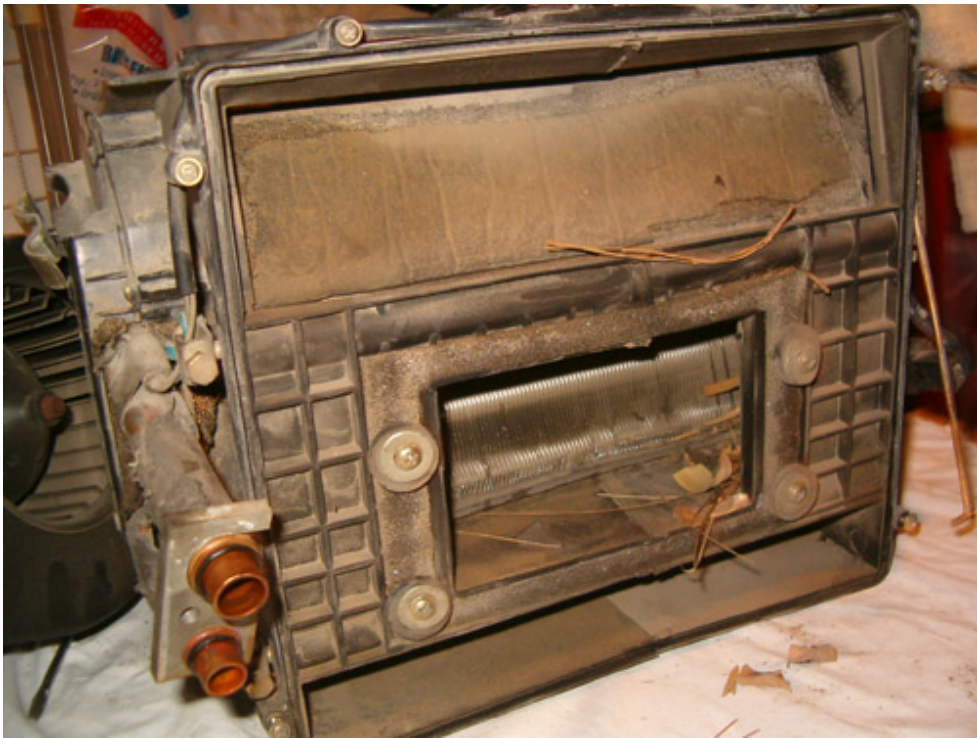
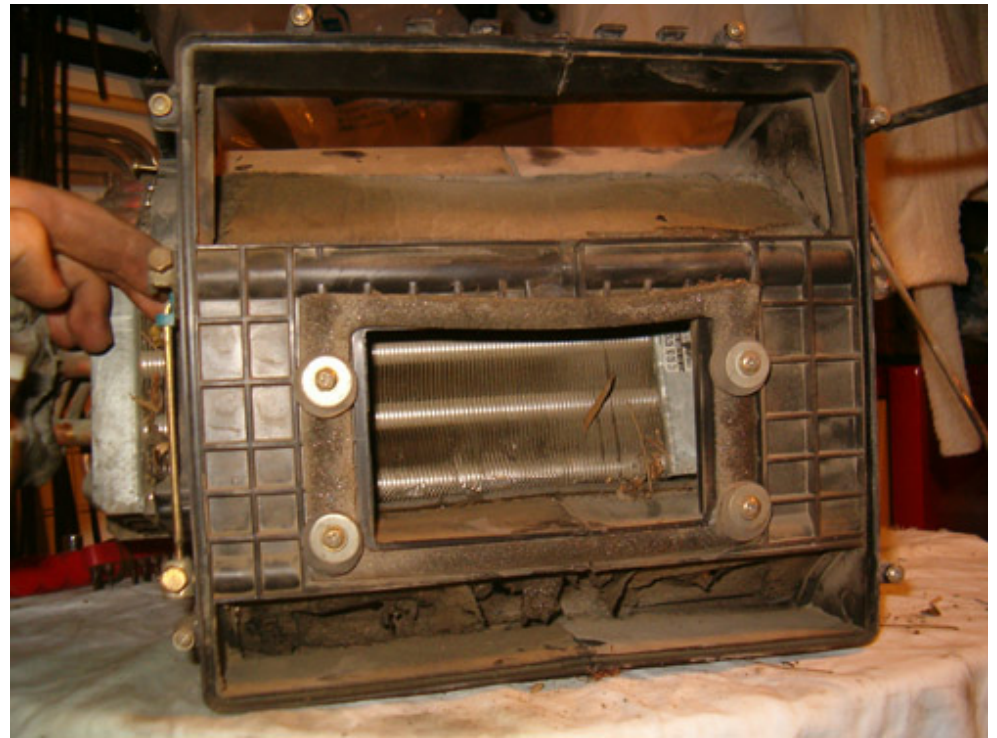
Notice the interior/exterior air circulation flaps. The foam material is collapsing!

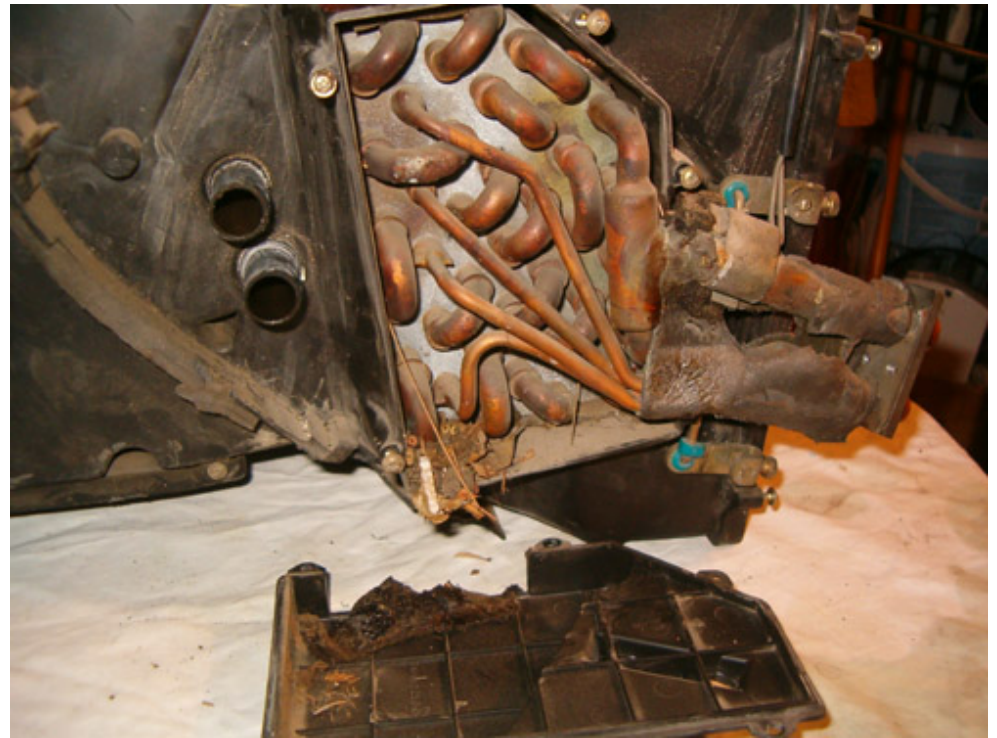
Evaporator piping. This is the part that actually delivers conditioned air; hot Freon in liquid form enters the lower pipe and having removed heat and humidity out of the passenger compartment exits through the upper pipe in gas form.

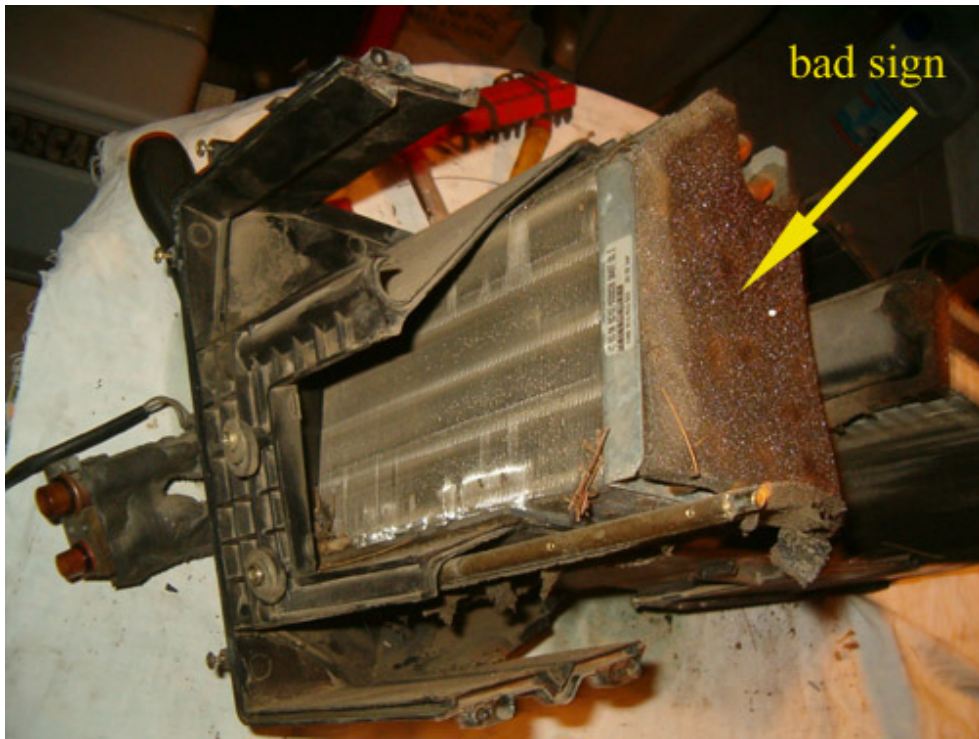
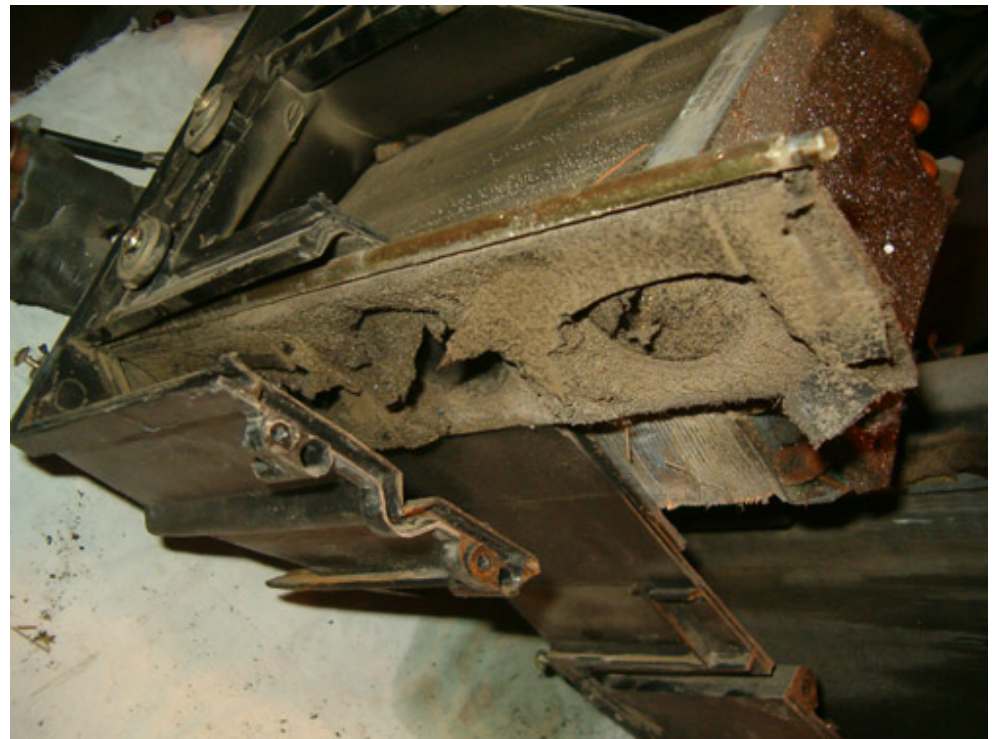
I think I have a pretty hell of a job here...everything is a mess. Notice the dark color of the foam in the right side of the evaporator; wait, this is a bad sign...

It is a wise idea to soak everything overnight in hot water and soap.

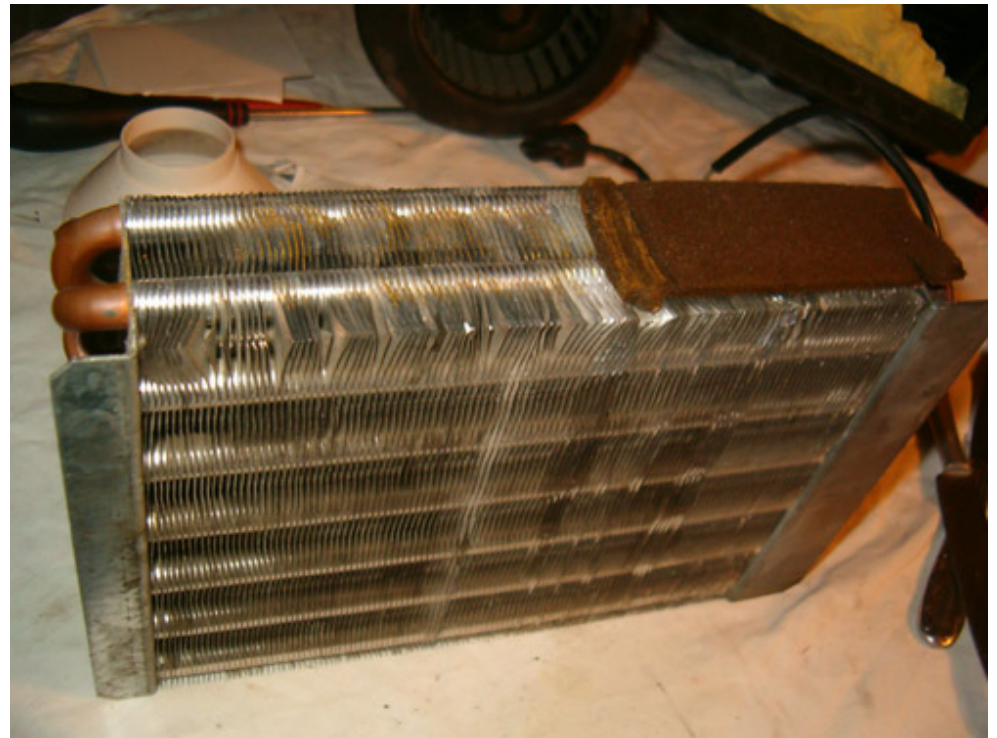
This is the evaporator. The fins surely need to be combed and aligned in a straight line.

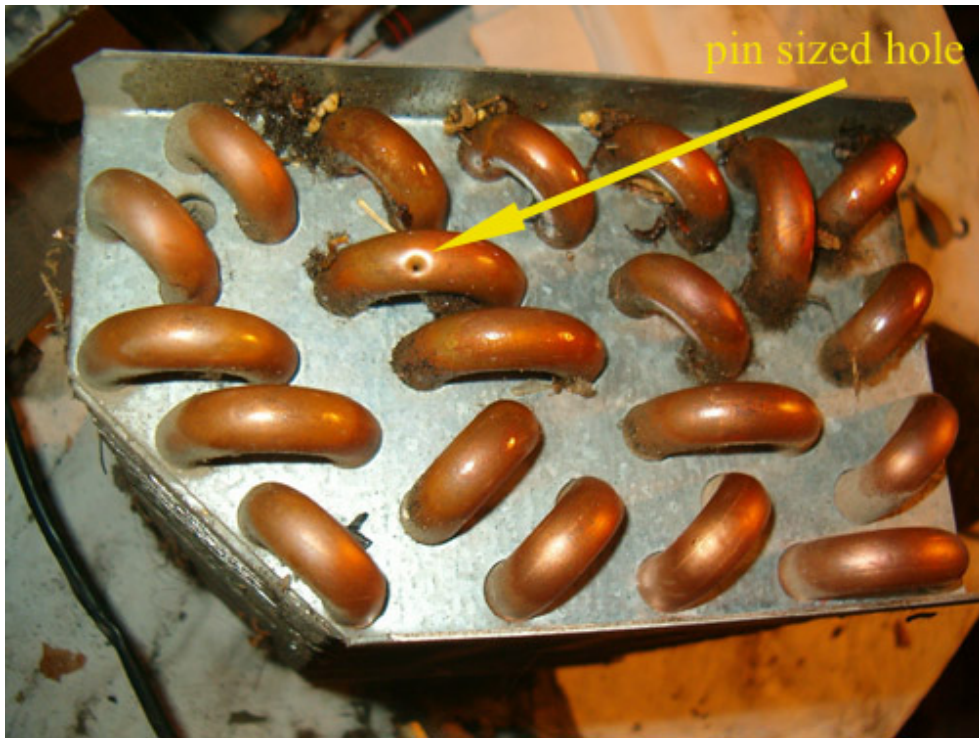
Remember saying about a bad sign? Well this is true; one of the copper lines has a pin sized hole... This is the reason of the dark color on the foam, Freon and oil were leaking...

Fortunately this was easy to repair. A big thanks to my neighbor Bill who had the right gear to solder copper lines!

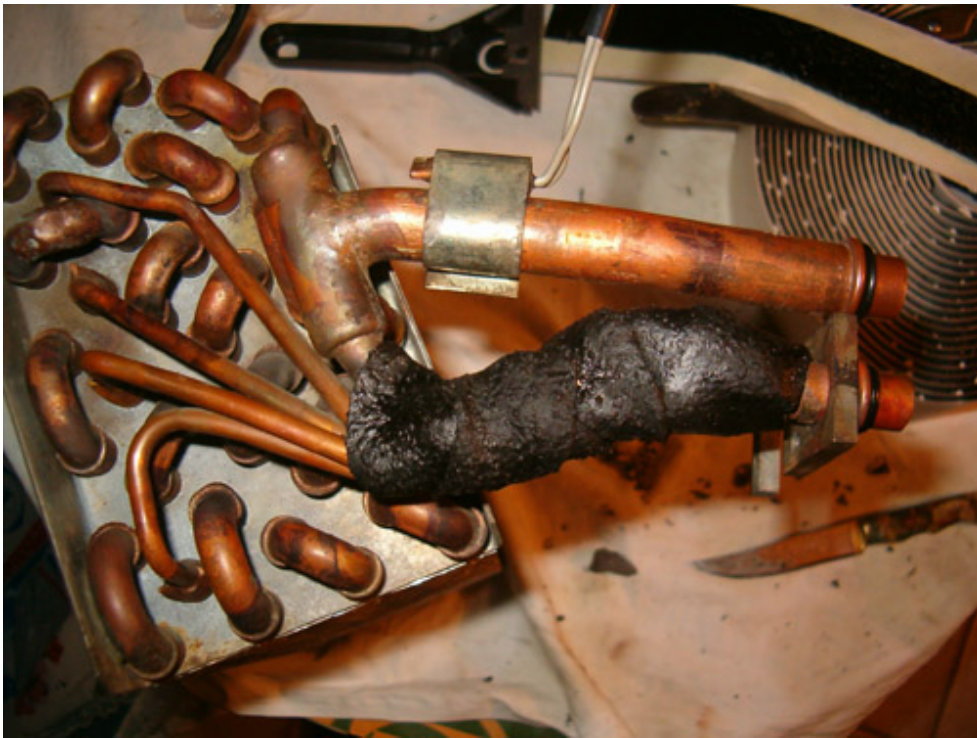
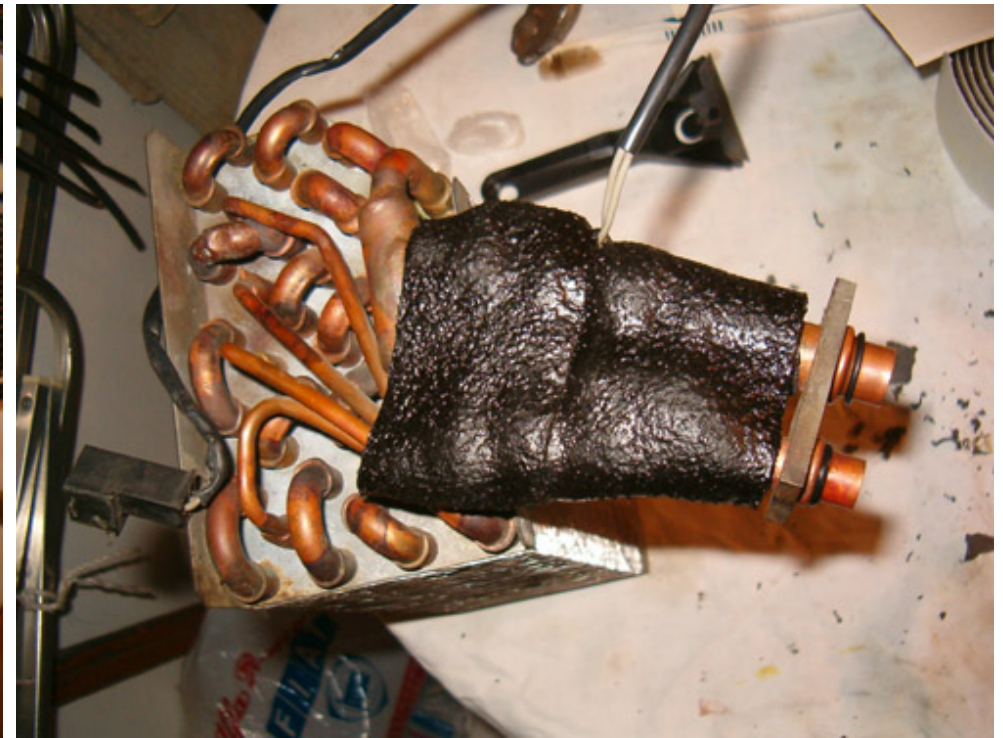
... and wrap the lines with cork tape. A notice here; the sensor you see clamped on the evaporator pipe is the so called Frost Sensor. This sensor gives input to the electronic thermostat when temperature reaches freezing levels in order to seize operation of compressor and condenser fans. Otherwise ice will form on the pipes and evaporator which means Freon has not fully evaporated; this will result in compressor failure because liquid does not compress!

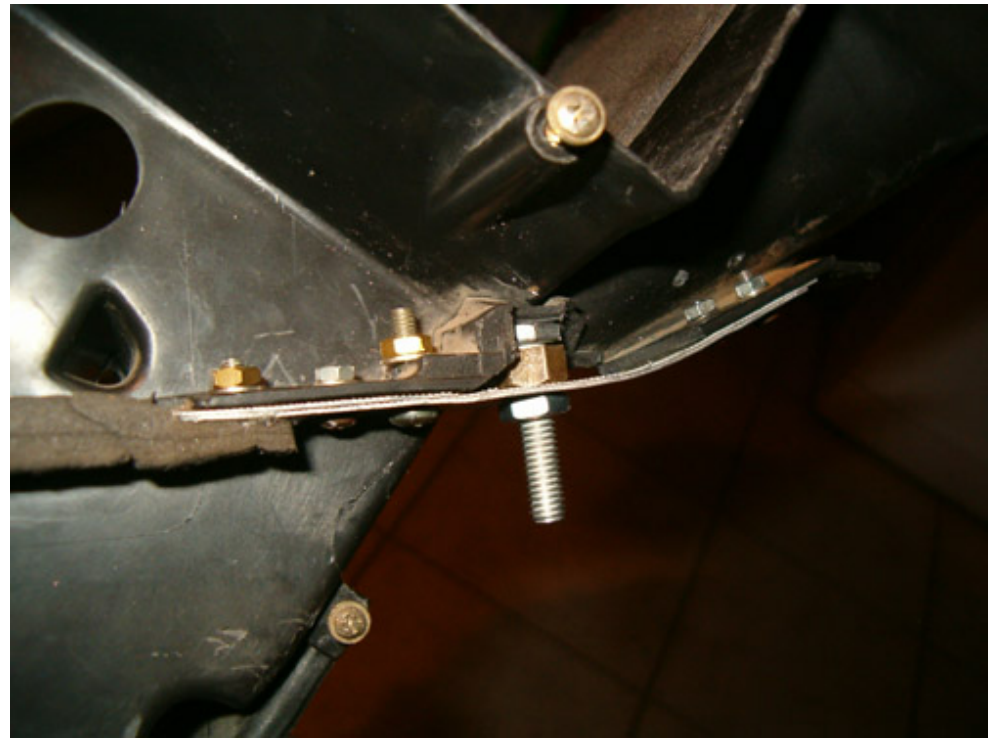
One of the four support points of the unit broke during removal from the donor car, so I had to fabricate one...
