## Freon Charge

## Troubleshooting

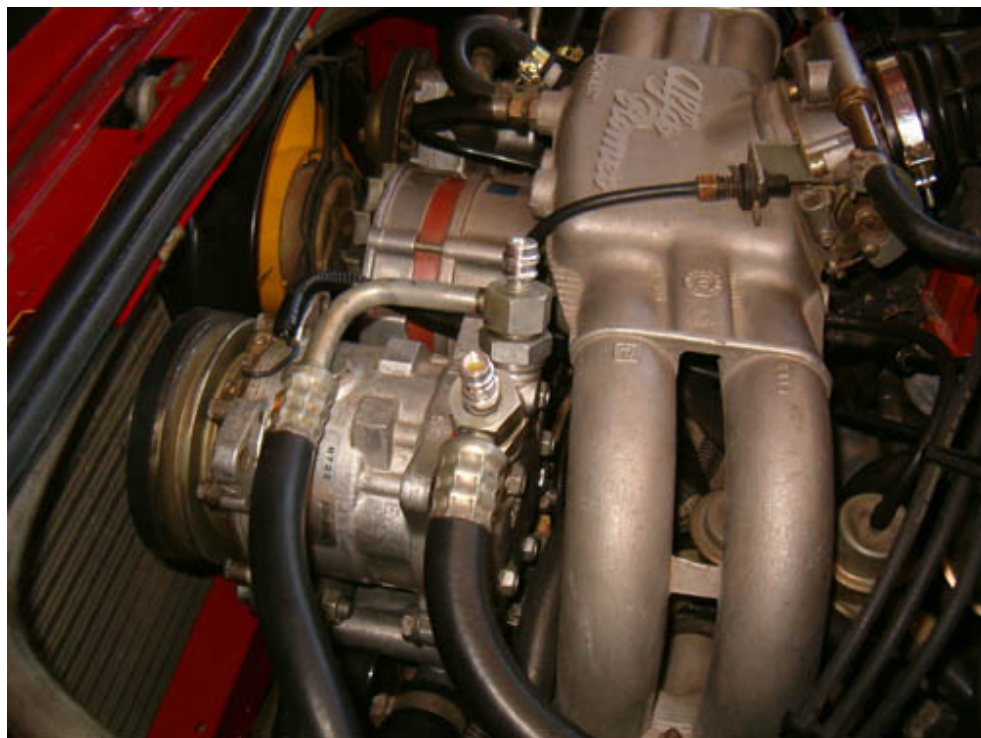
R134a service valves adaptors have been installed on top of R12 valves

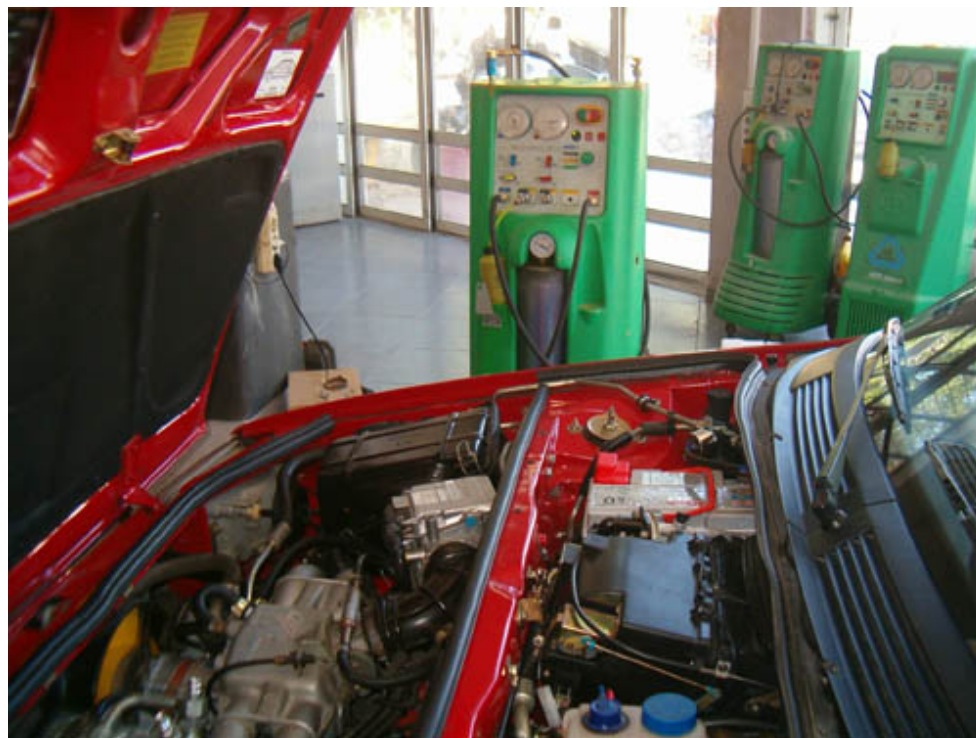
Vacuum/charging machine next to the car ready to do its job.

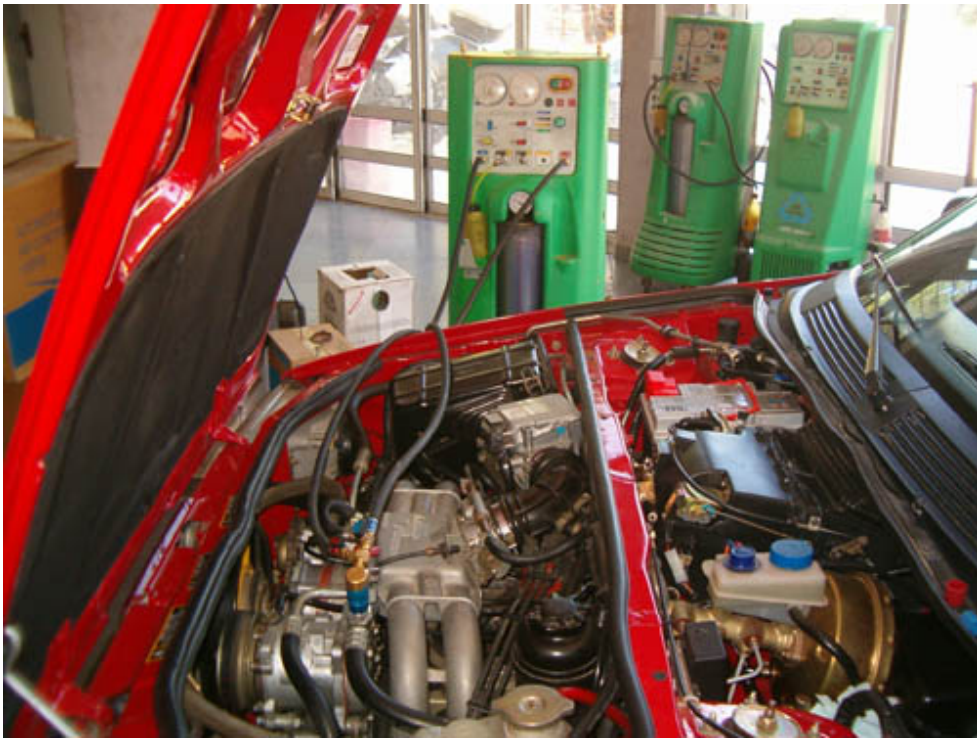
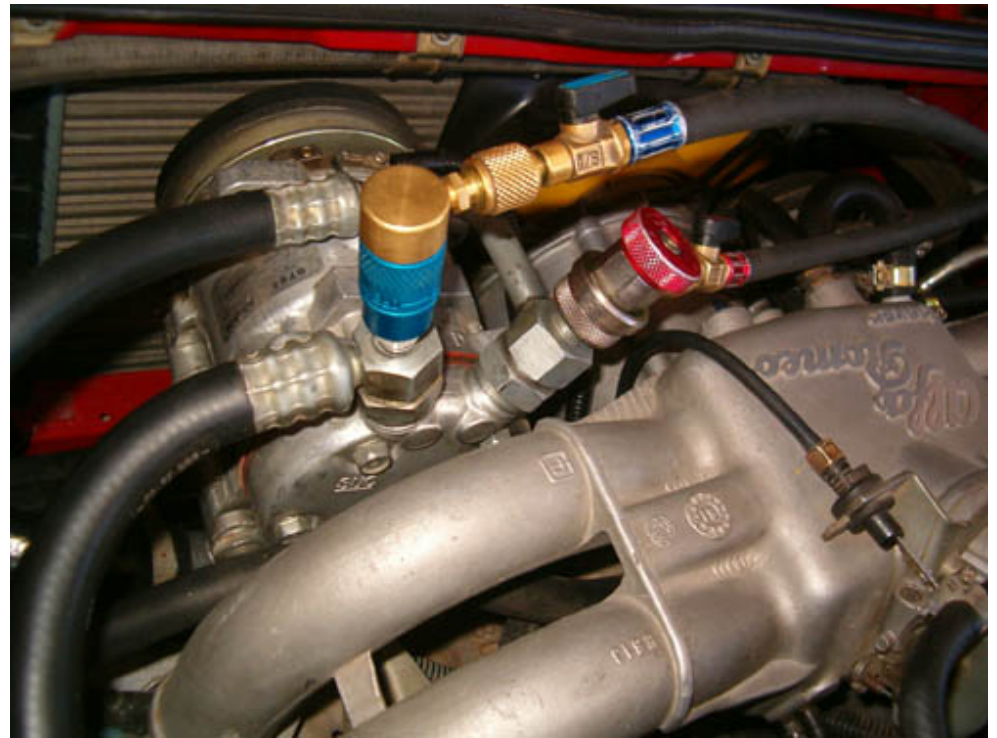
Charging hoses are attached to the compressor ...

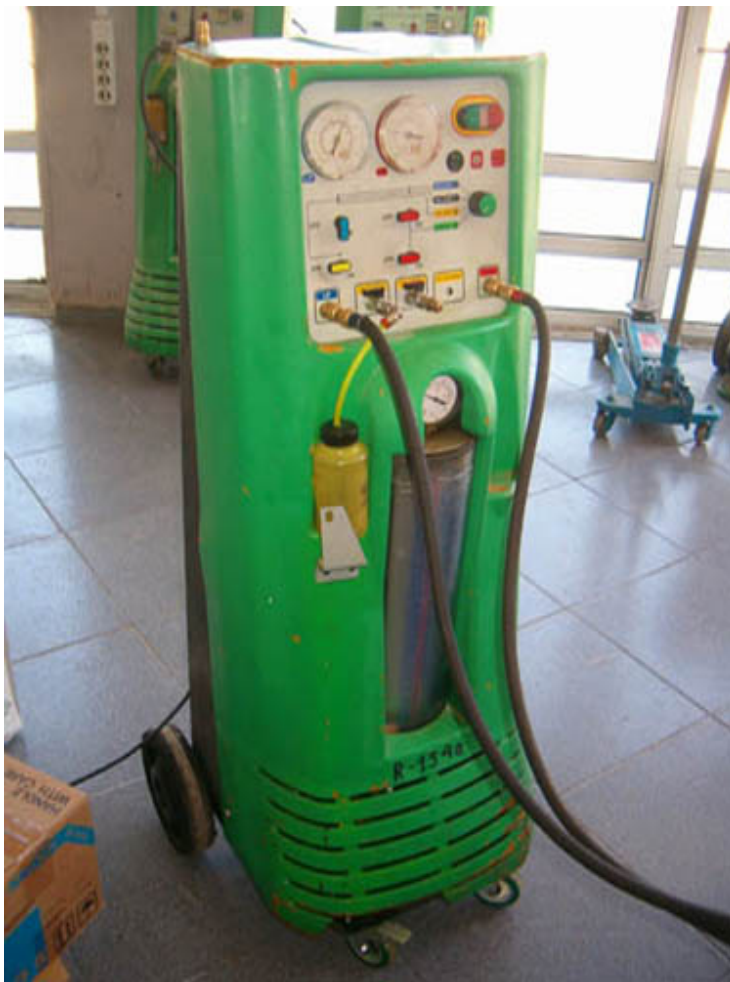
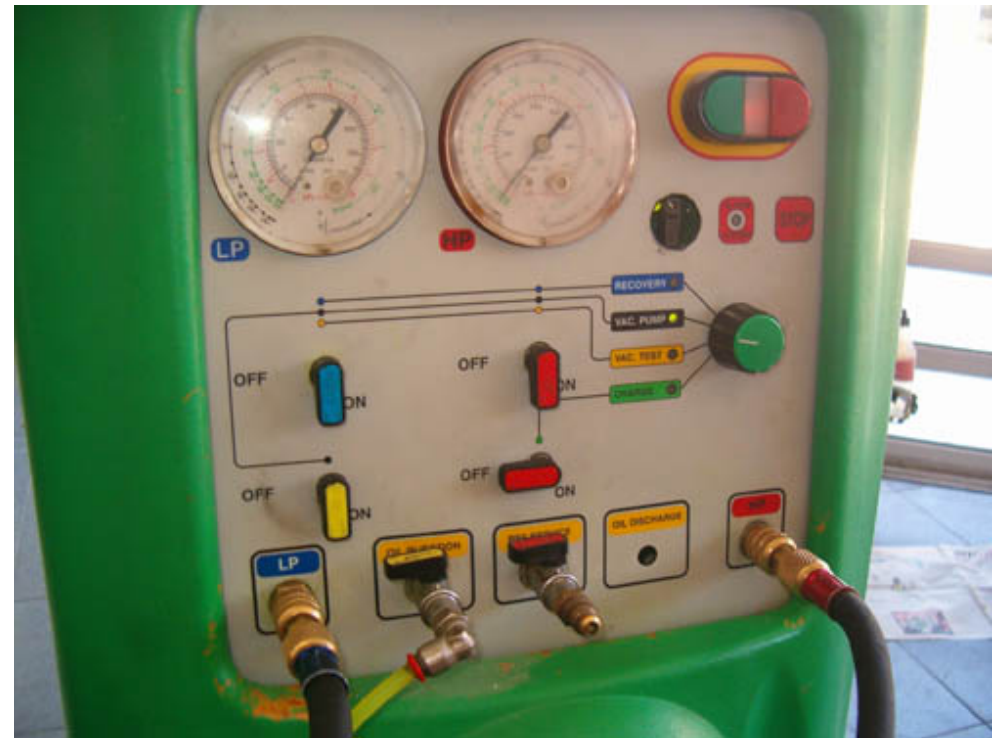
... and vacuum test is initiated; if within the 30 minutes test the gauges remain at 29 mm Hg then the system is considered vacuum tight and we are ready to proceed charging the system with Freon. This vacuum machine is quite "intelligent " to measure ambient temperature and calculate the amount of Freon required in order to charge the system. In my case the system showed no leaks and 650 of refrigerant were added at an ambient temperature of 18 C.

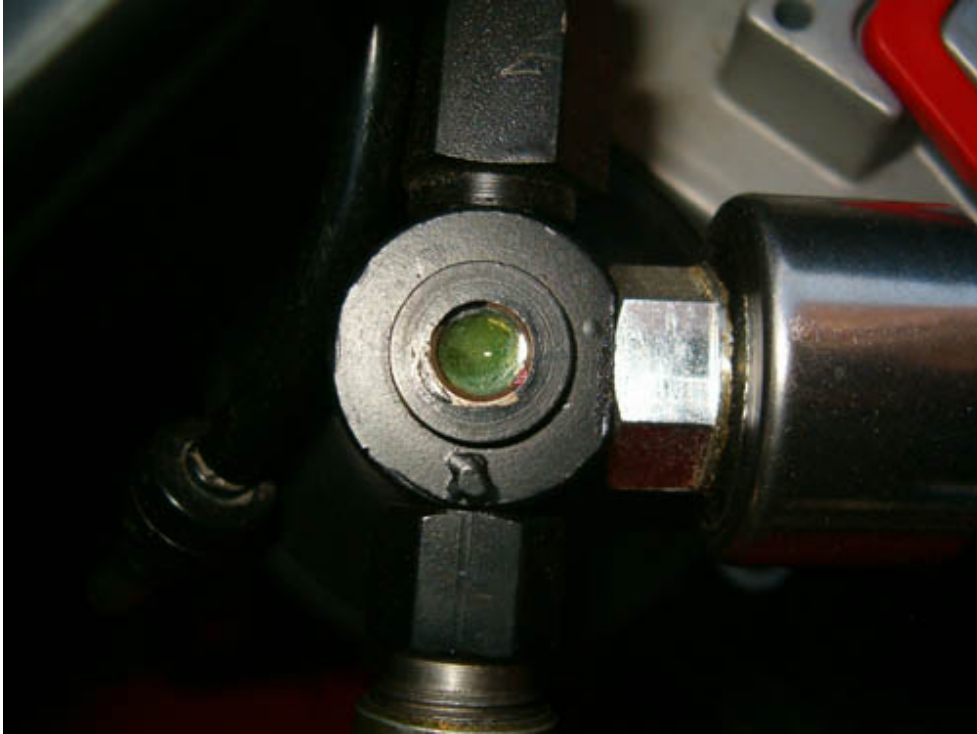
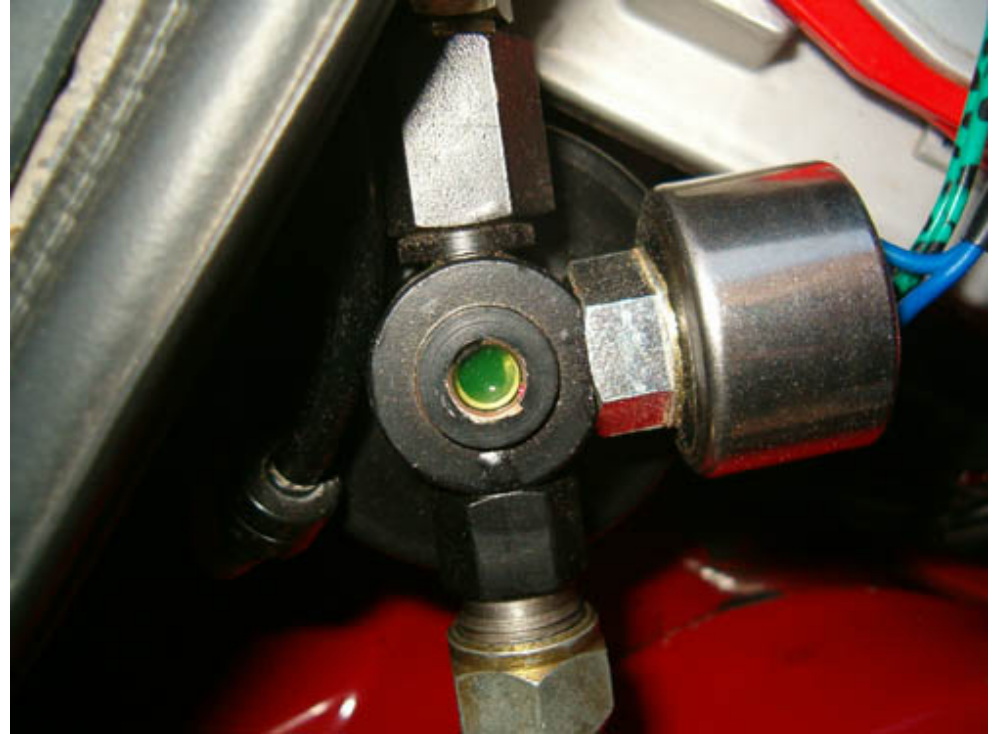
After charging the system with Freon, it was set to operation. An indication of smooth operation is the sight glass of the drier filter. In case you see a continuous flow of liquid then the system is filled with the correct amount of refrigerant. The green color seen on the glass is attributed to the leak detector dye added during Freon charge.

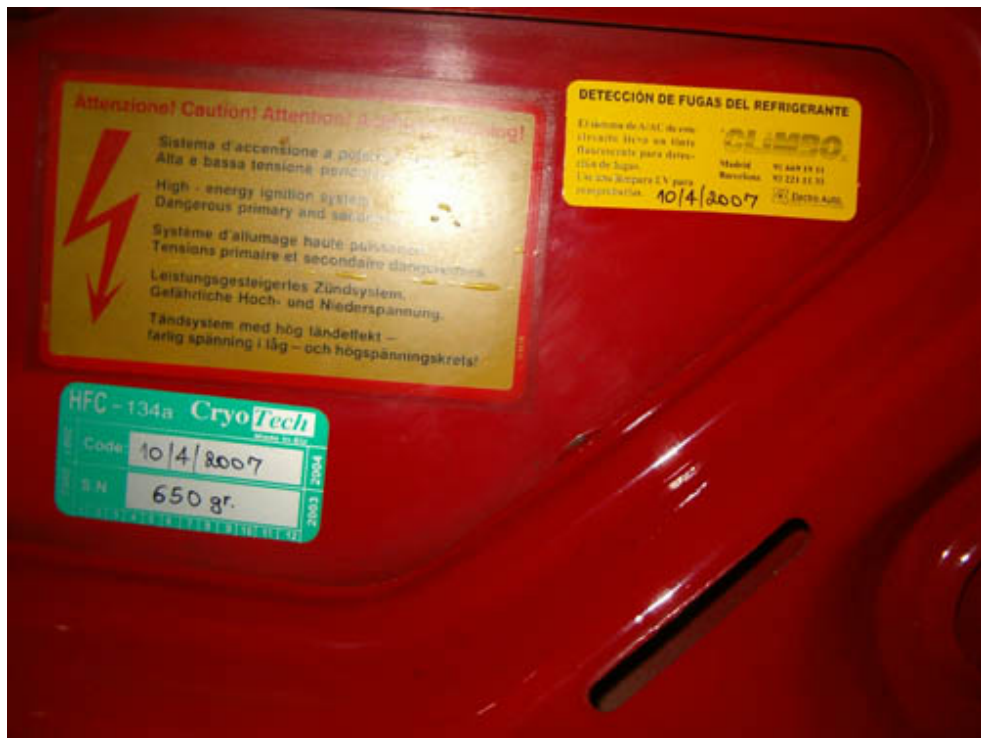
It should be noted that tags should be placed at visible places indicating type of refrigerant and the presence of leak detector dye added to the system.

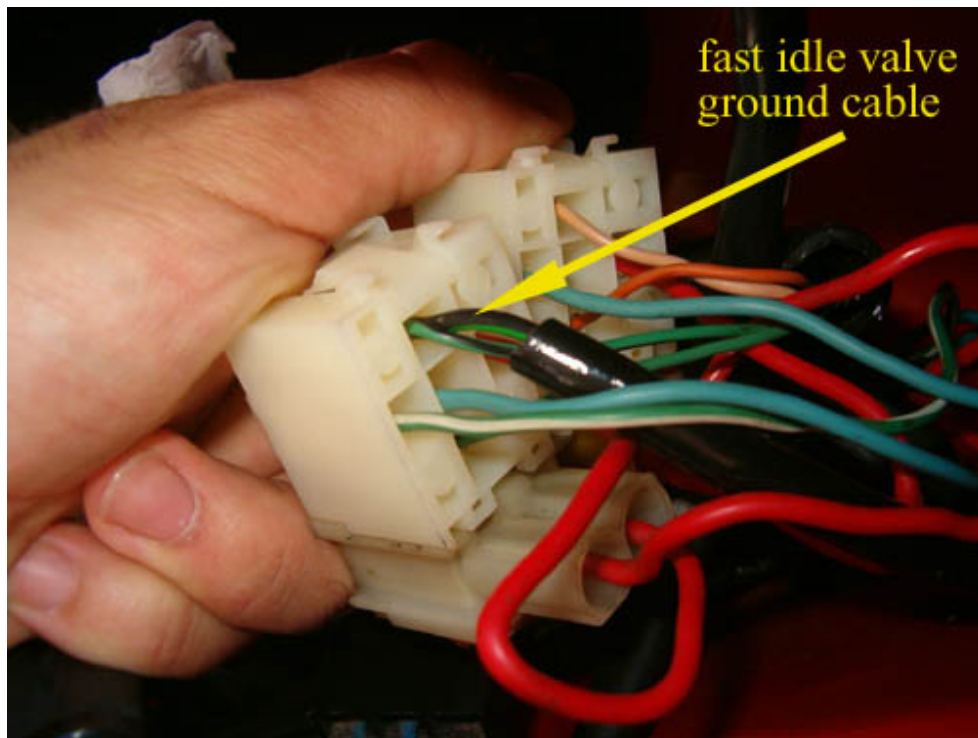
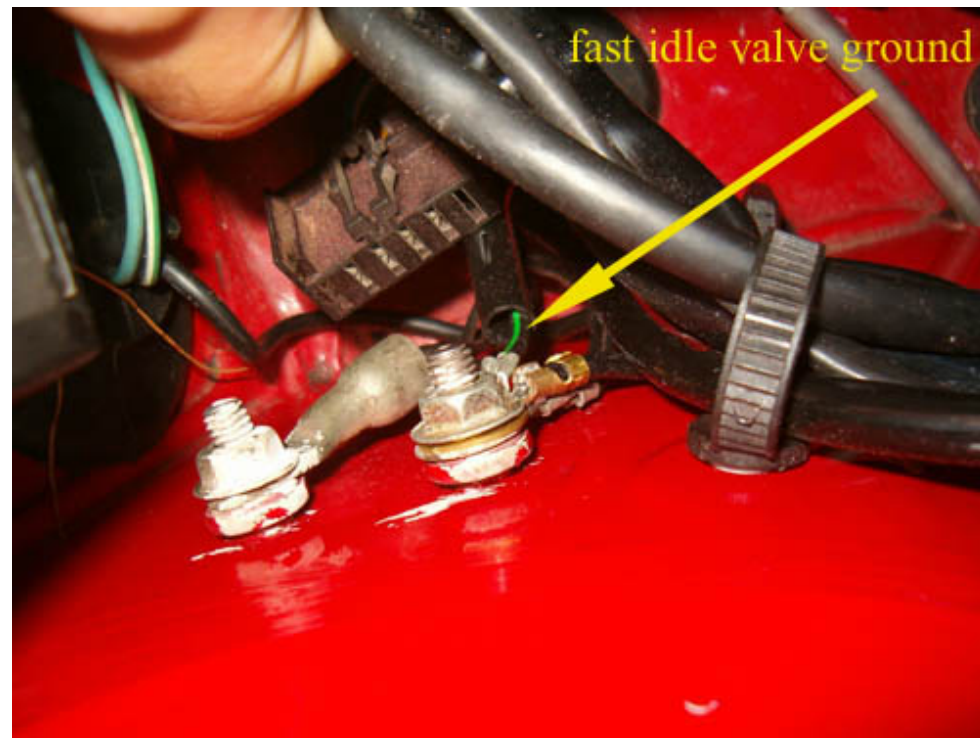
The most frustrating issue was the fact that the A/C wouldn't power on by acting on the switch from the control panel. Since I am not capable of tracking down the source of electrical problems it was solved by the A/C shop. It was quite a straight forward omission by me since there was no electrical connection to ground of the fast idle valve... I should have noticed it during installation; I only attached the positive terminal connector on the junction box. No ground was present on the main harness so there was no way to make ends meet. A ground cable was installed from the fast idle valve connector to the car chassis along with a pair of new relay holders since the old ones had surely seen better days in the past.

However, the lack of this very ground cable is probably attributed to the fact that the donor car featured the Marelli-Weber IAW management system and there might be differences between the last one and L-Jetronic that my car features. Who knows .... the fact is that with this ground cable addition, the A/C works as it is supposed to do, so there is no need to further talk about it.

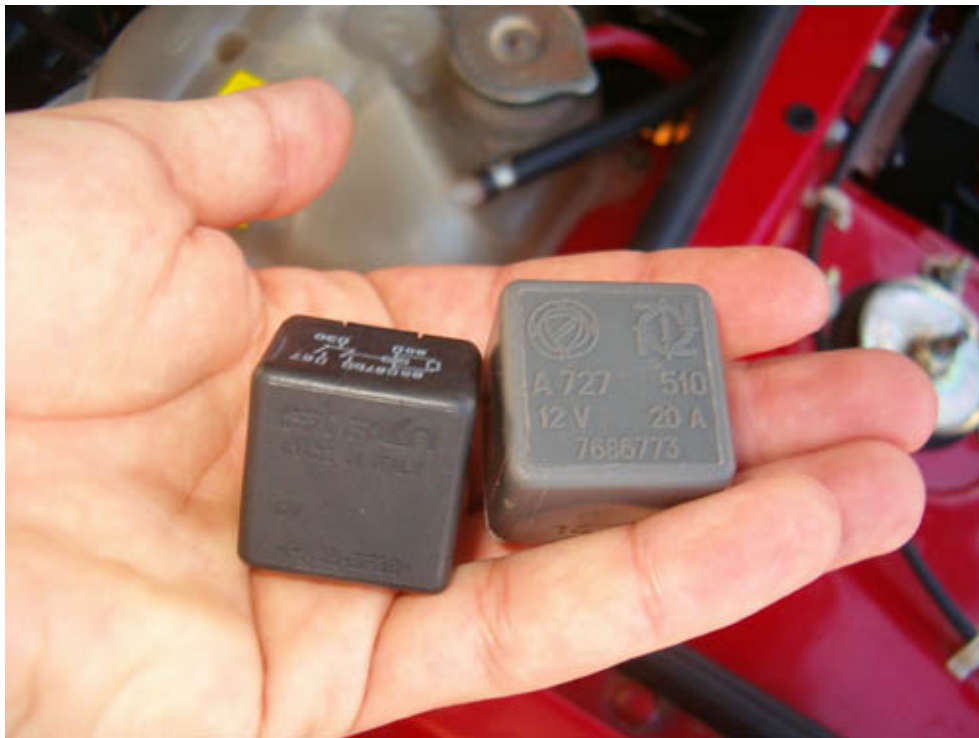
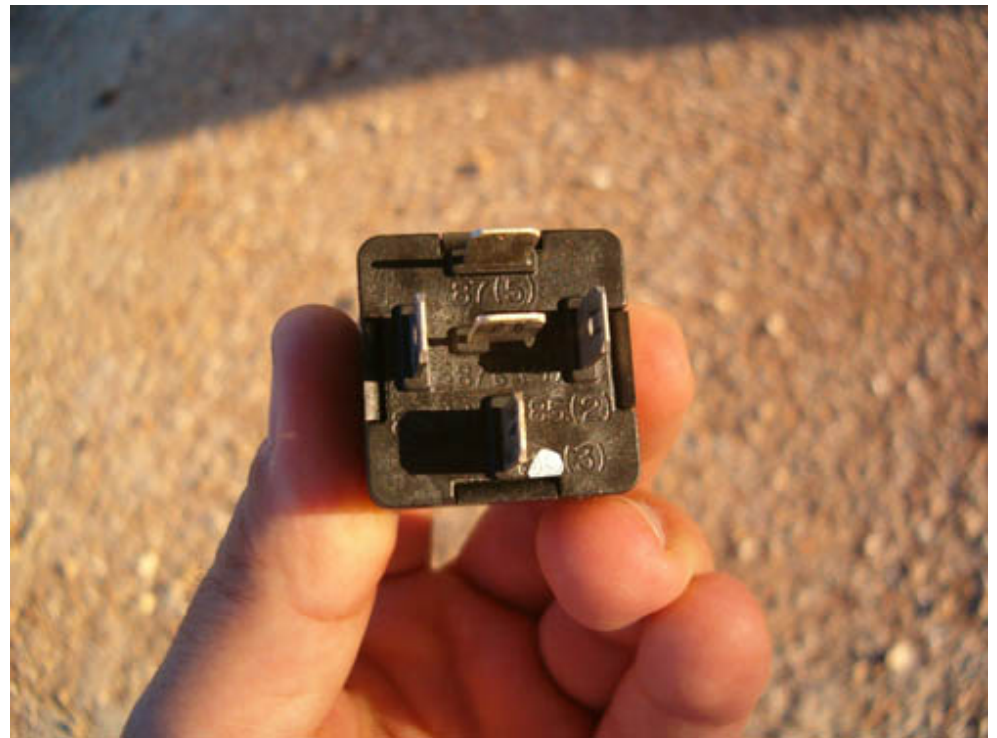
Second problem was the use of an inappropriate relay. The relay intended for compressor/left condenser fan needed to be replaced. Upon switching off the A/C, the fan stopped receiving current but in the mean time still revolving, it was transformed to a power source producing current, until it stopped revolving. This power generated, was finding its way back to the compressor clutch which it turn was delaying to disengage for a few seconds. It was a typical issue of reverse current and it was solved by using a relay of the same type (20A) but its terminals designated as 87a and 87b in contrast to the original one which featured two 87 terminals. Looks like the e-Per catalogue needs some error correction since I had ordered the relays based on it...

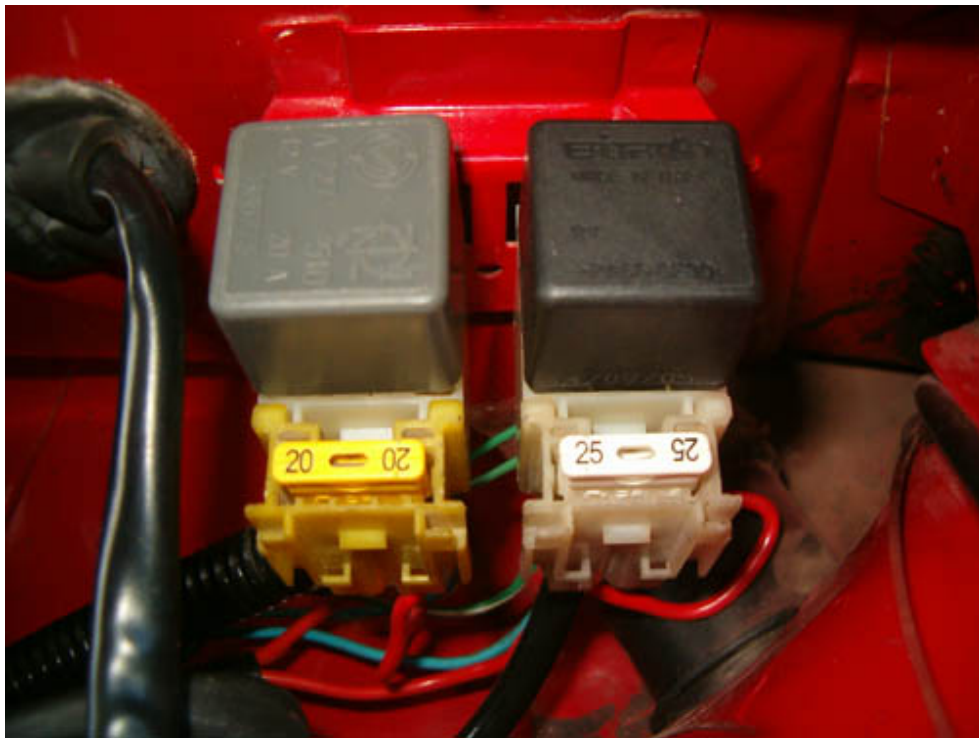
So, relays are back for good at their place.

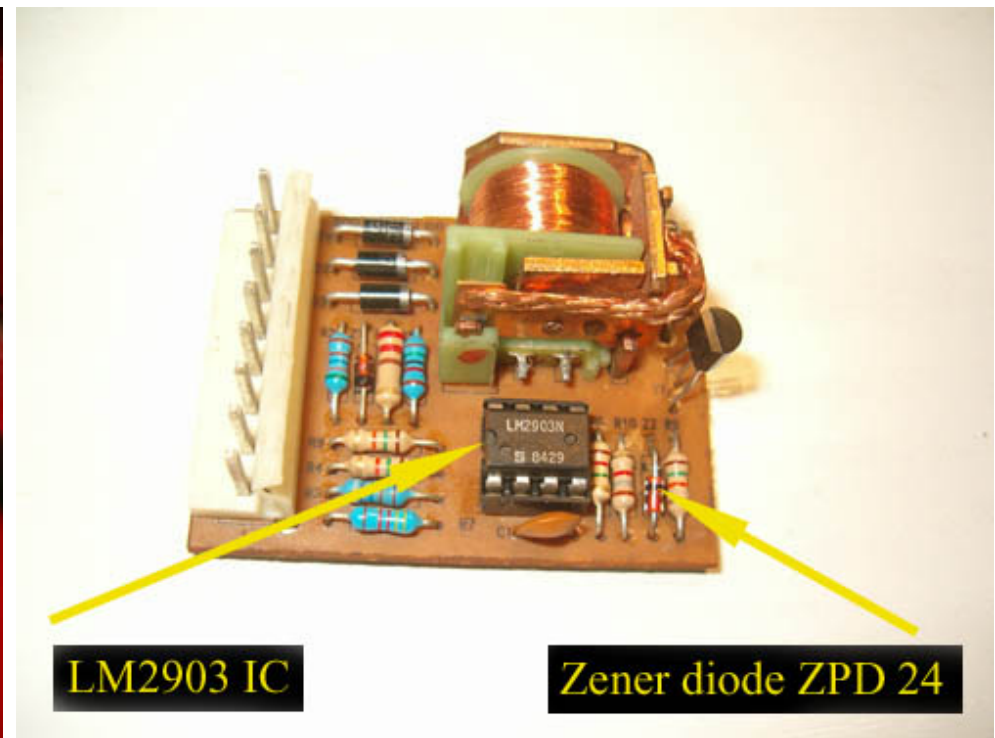
**LM2903 IC**

**Zener diode ZPD 24**

The third problem had to do with the electronic thermostat. This device actually regulates the compressor cycling on and off. This is a very important element of the A/C since it actually protects the evaporator from water freezing and the compressor from liquid Freon suction; both cases lead to expensive A/C failure. In my case the compressor wouldn't cycle on/off as the two electronic elements were burned out. Replacing them solved the problem and the compressor now cycles on and off as it is supposed so.

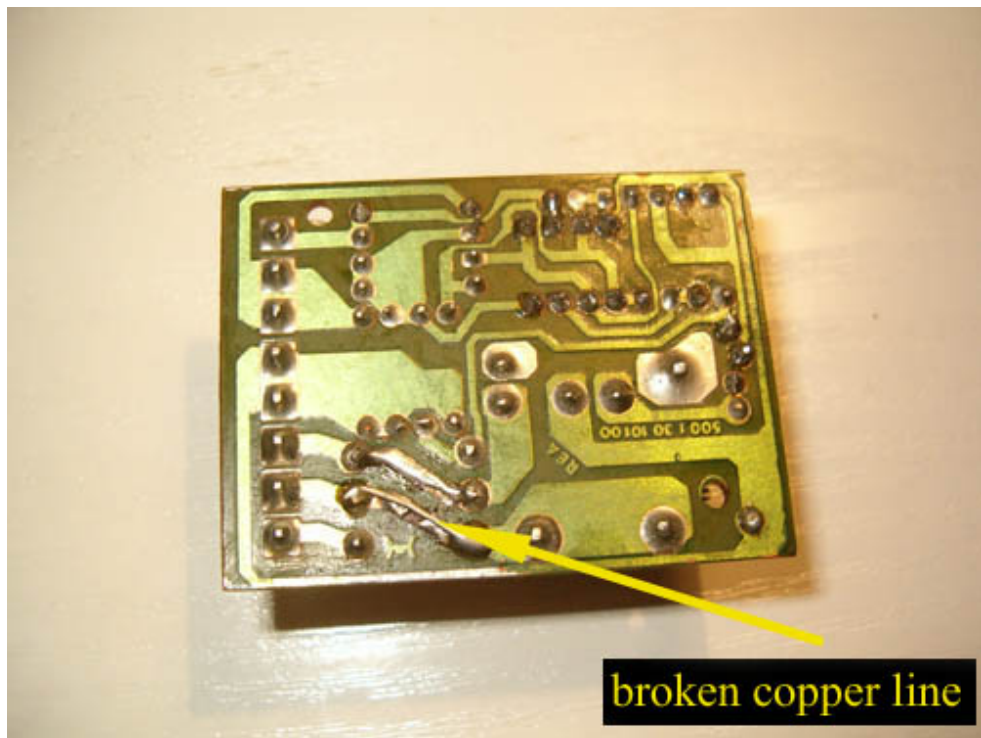
Another smaller problem was a broken copper line on the printed circuit easily solved by connecting the two parts with a small piece of wire.

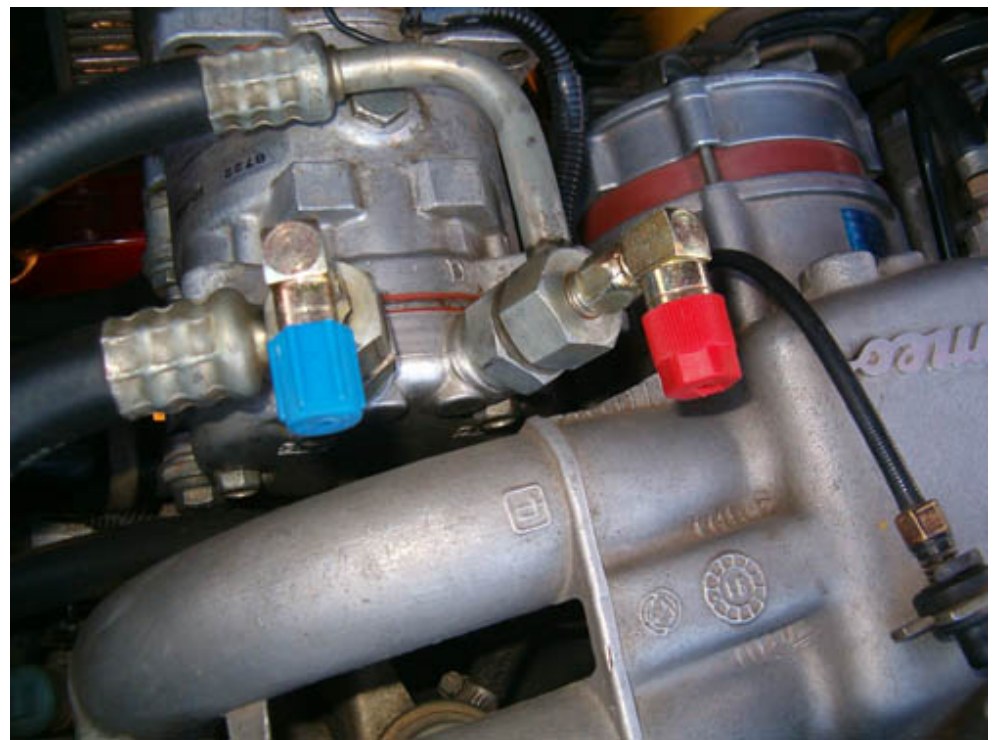
Fourth major problem was Freon leakage from the Discharge port of the compressor and it was noticeable about 20 days after the initial system charge. Performance was getting lower and I had to track down the cause. The check was done at the A/C shop by inspecting the pipe unions with UV light which fortunately didn't return any findings. Having eliminated the Freon hoses unions, the suspects were the service valves; the problem was laying at the Discharge valve pin and it was just a matter to recover the remaining amount of Freon, remove old valve pin and install new service valves on top of the old R12 ones. Doing this cured the problem.

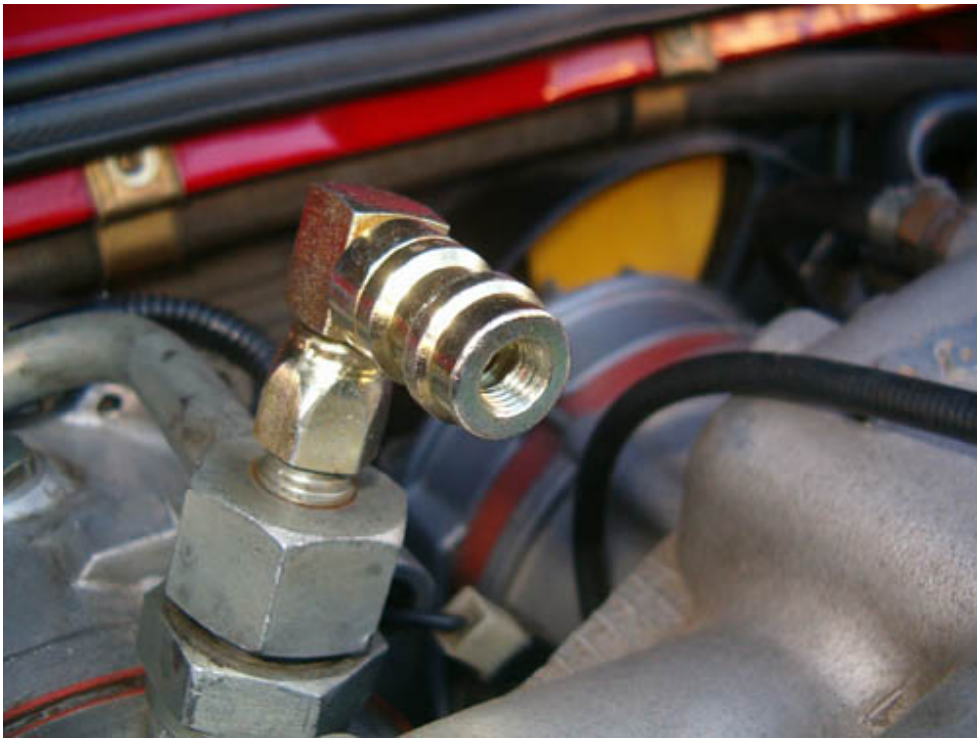
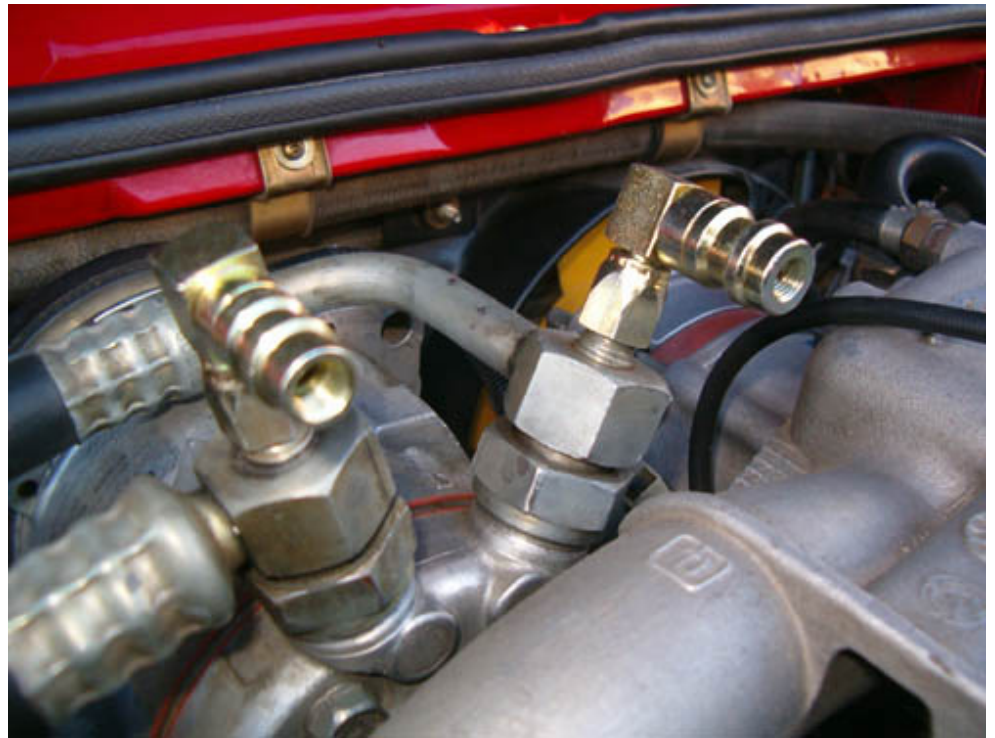
Close - ups of the new service valves
