Ventilation Restoration (Alfa 33 series 907)

Heater Unit Removal

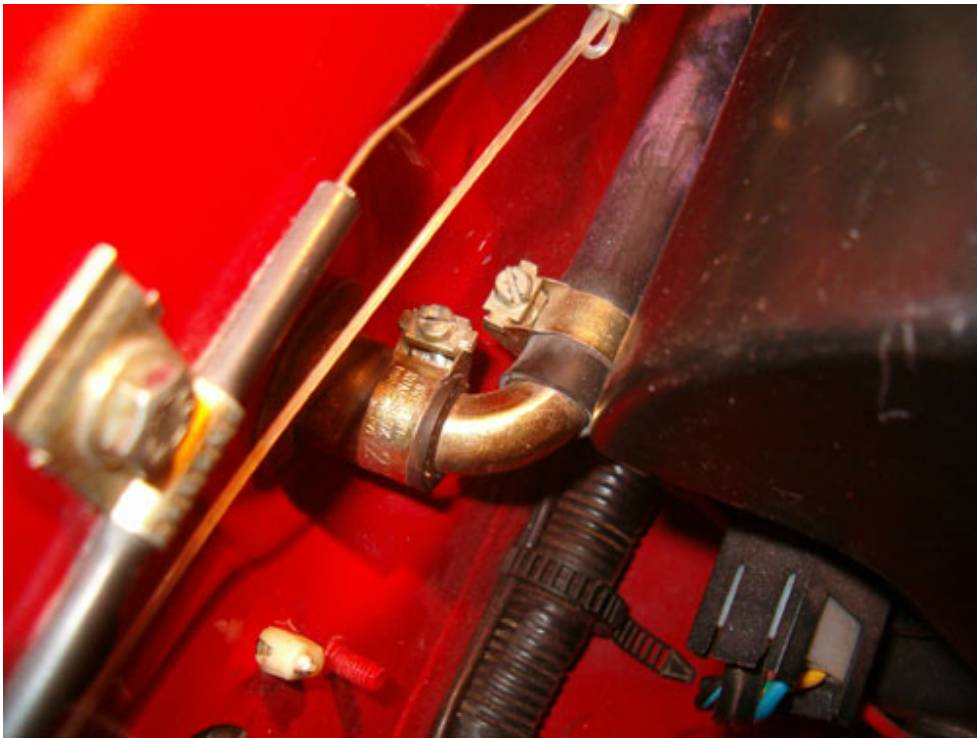
Here you see the 90° metal curve that I will use in order to create the bypass

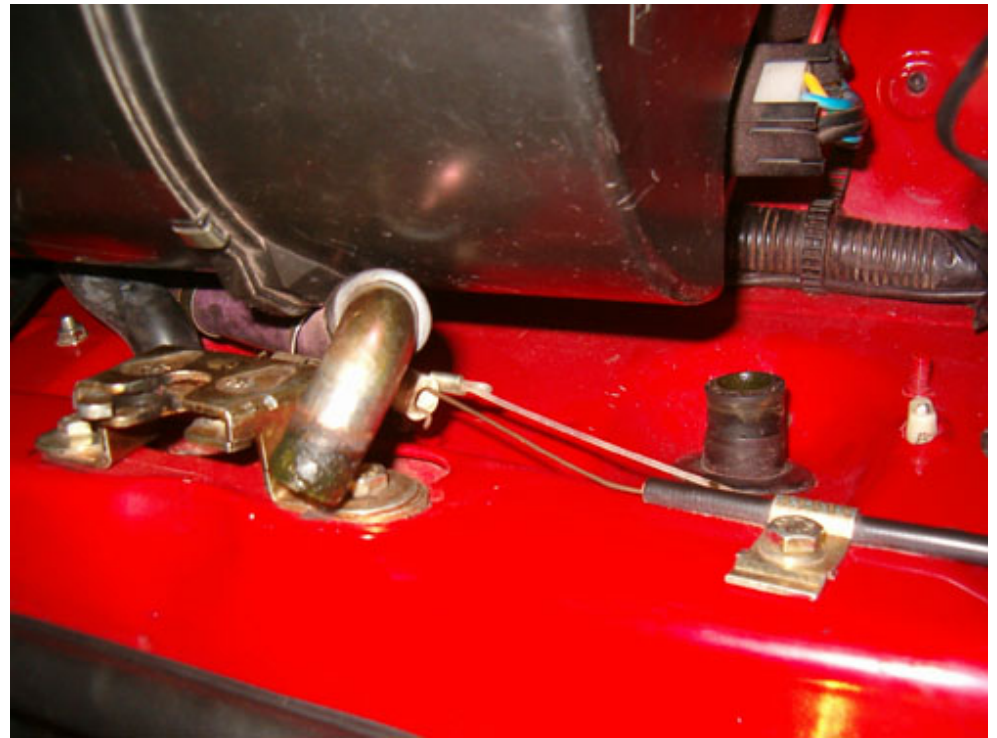
Notice the outlet piping disconnected and barely seen under the hood latch the inlet piping of the heater core.

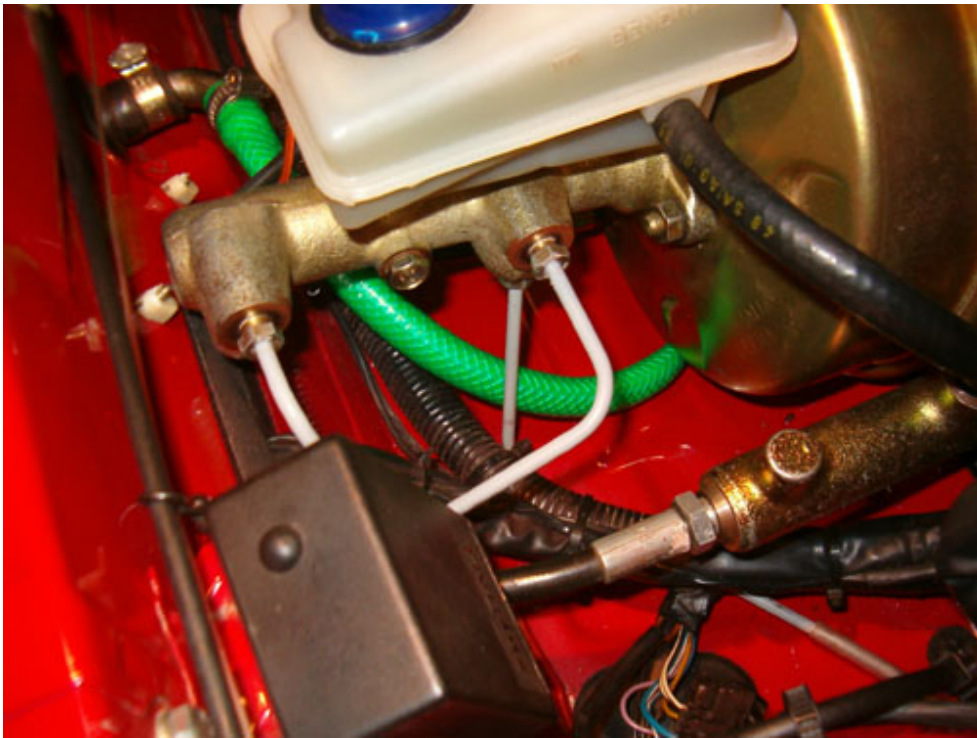
Here is the temporary solution of heater core bypass. In the meantime the vehicle can run with no problem (no heating in the cabin and being December ... brrrr)

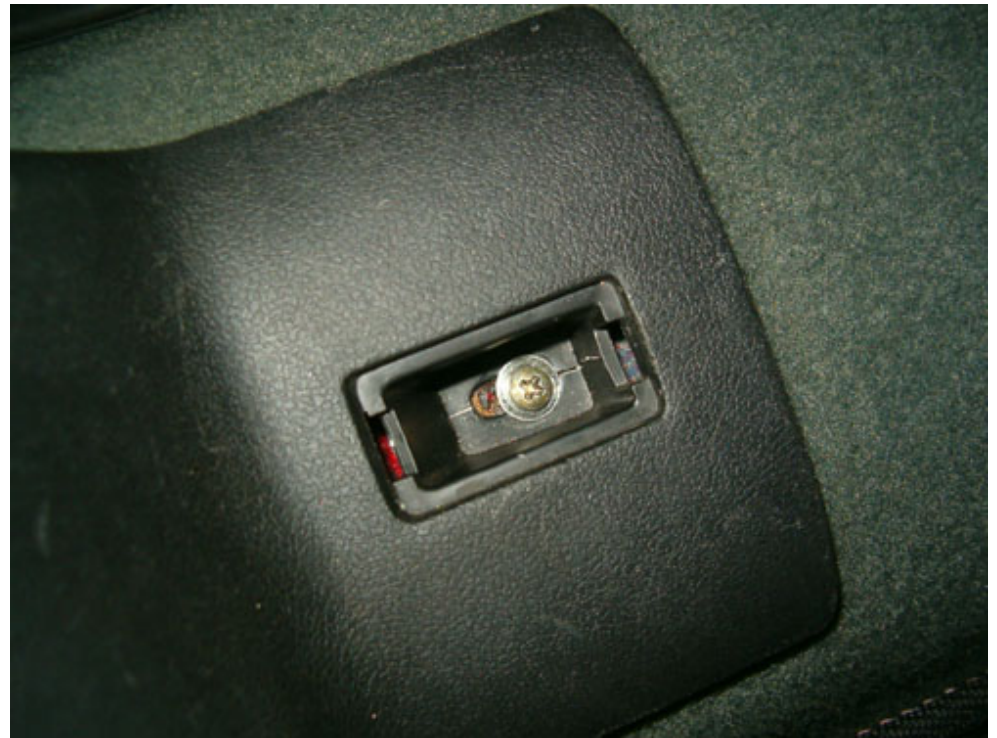
Let's now start disassembly. First job is to disconnect battery negative terminal since we will deal with the electrical system. Remove the handbrake lever decorative box.

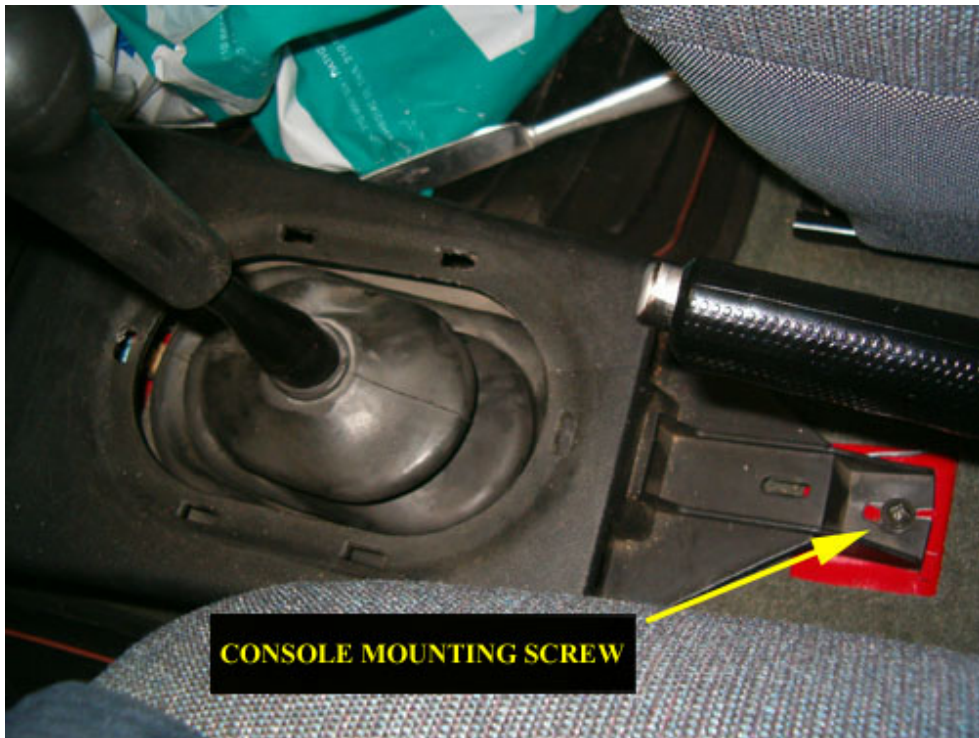
CONSOLE MOUNTING SCREW

Move on to the console. Remove the designated screw ...

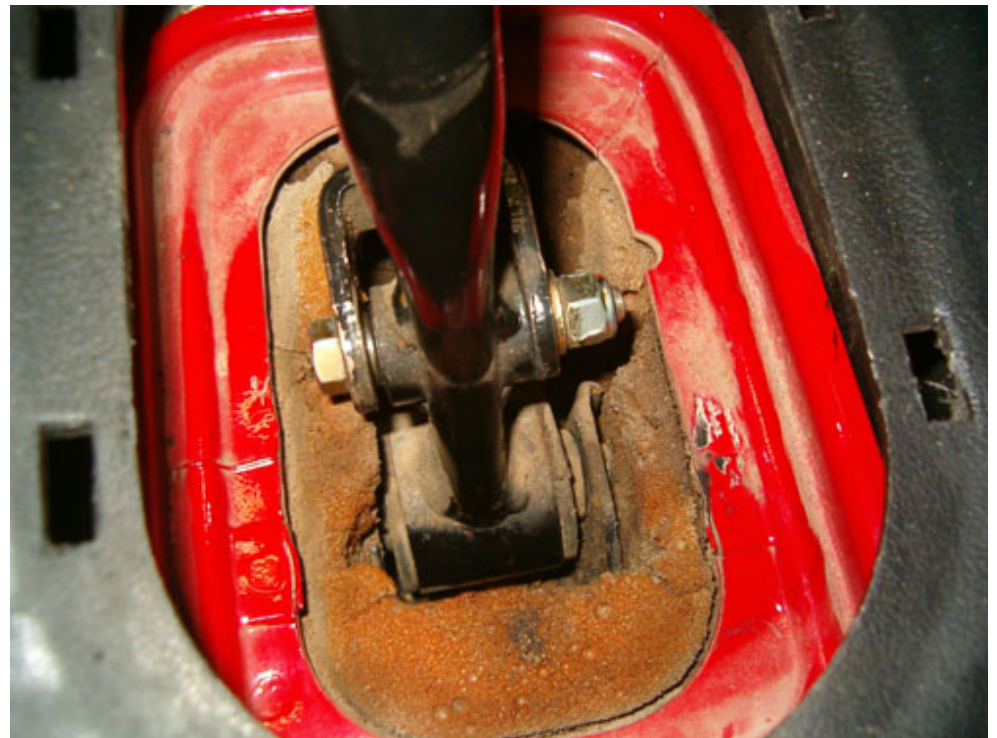
... and then the gear stick mounting screw (11 and 12 mm key)

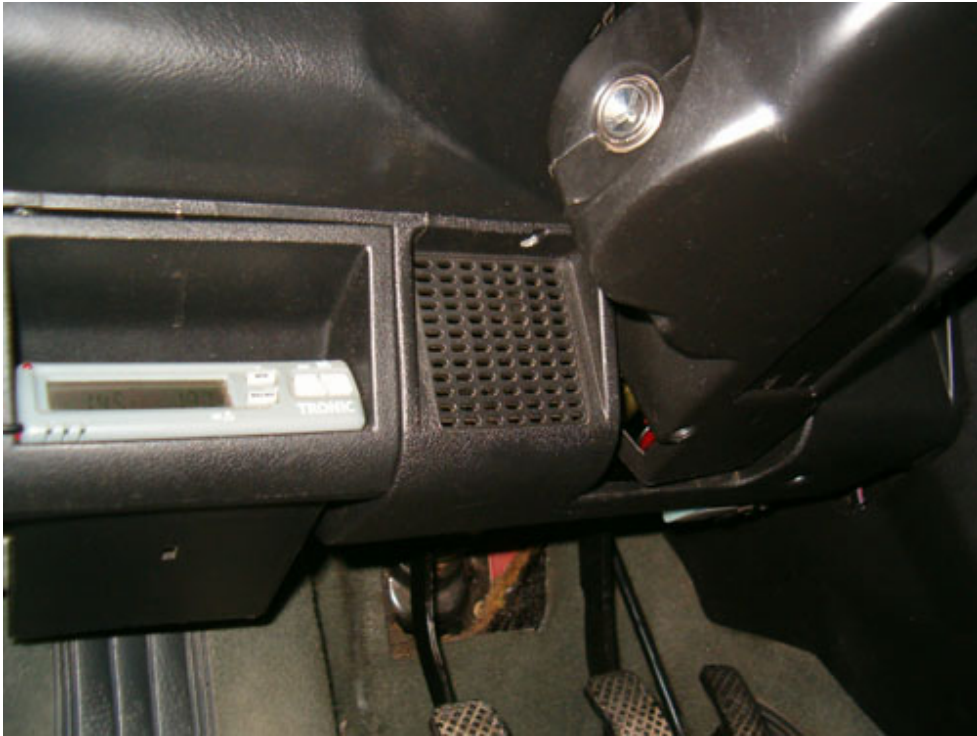
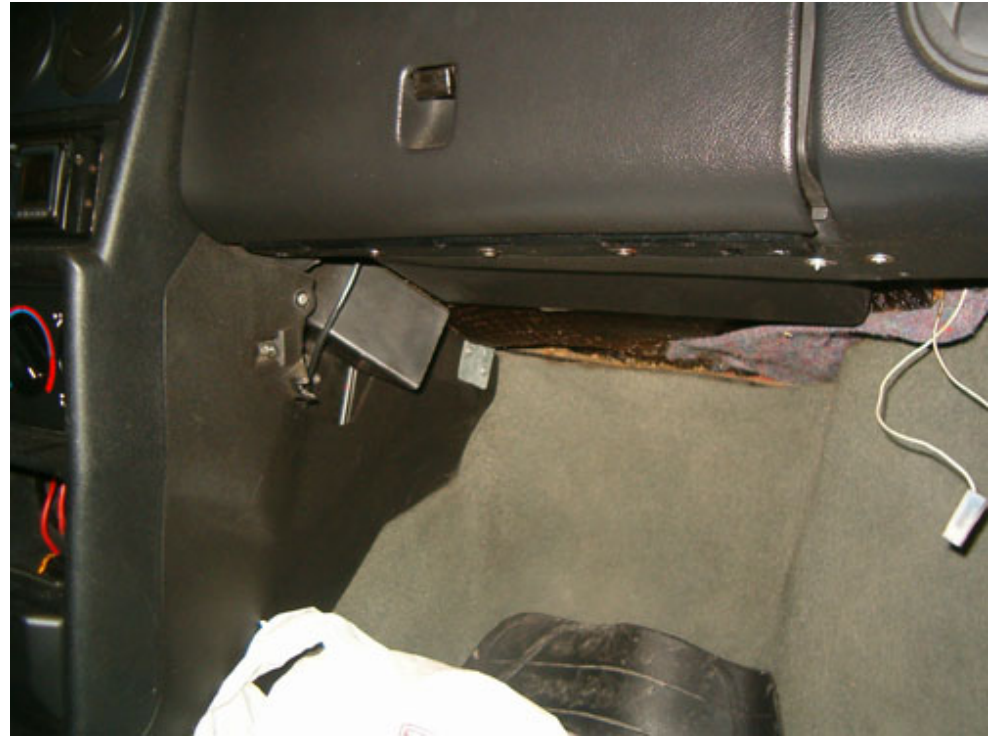
Move on removing the speaker assembly both sides

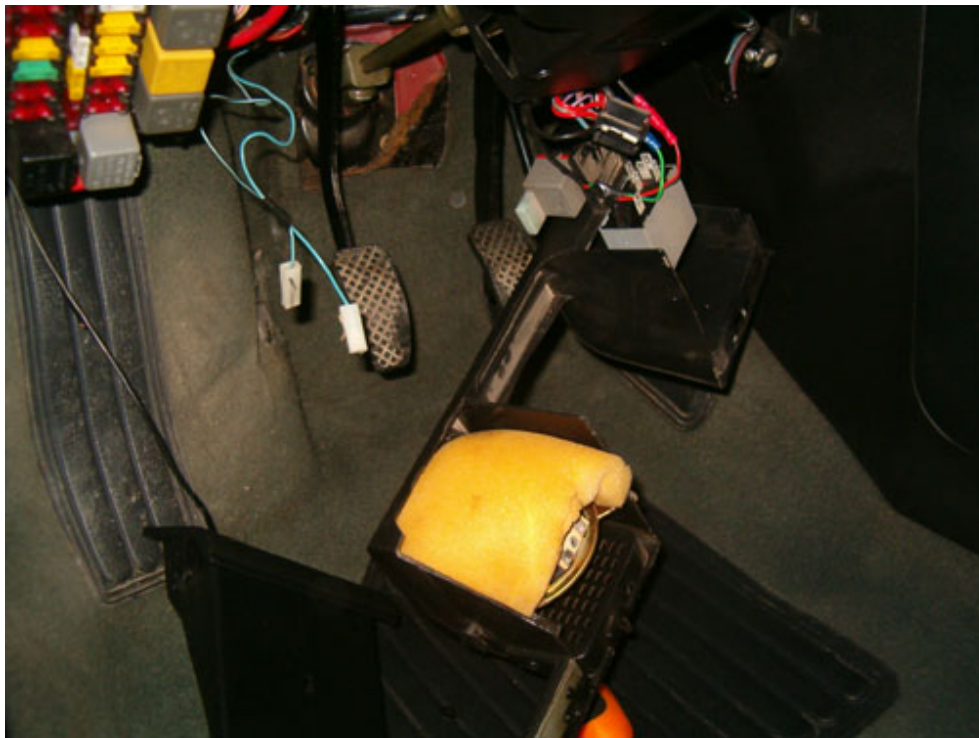
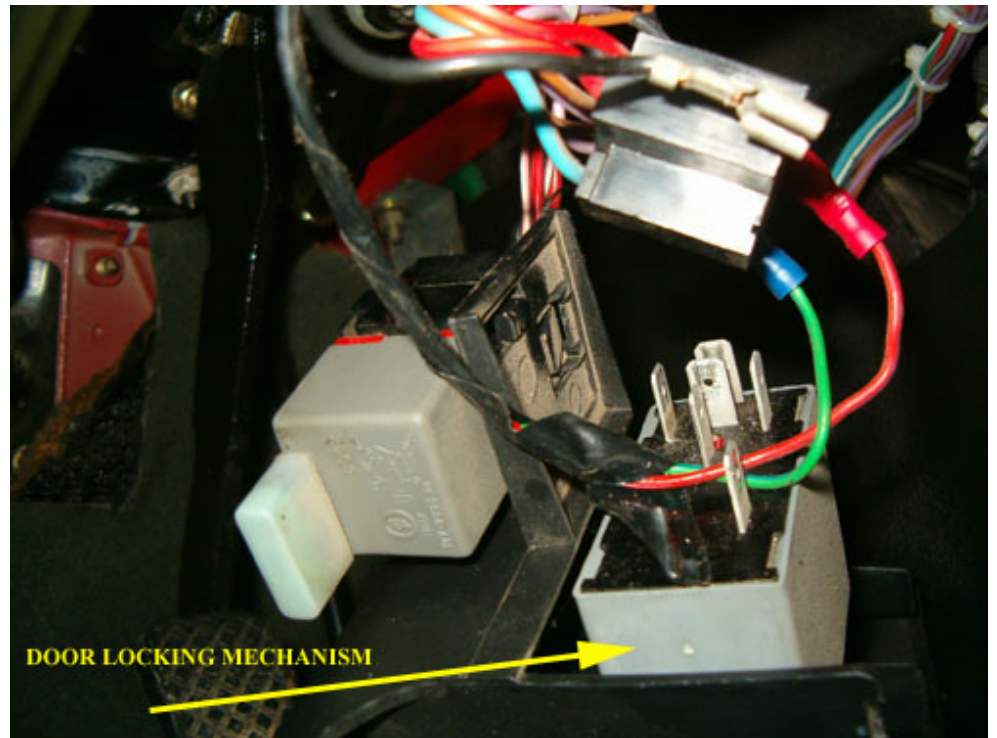
Disconnect speaker leads and the door locking mechanism connector ...

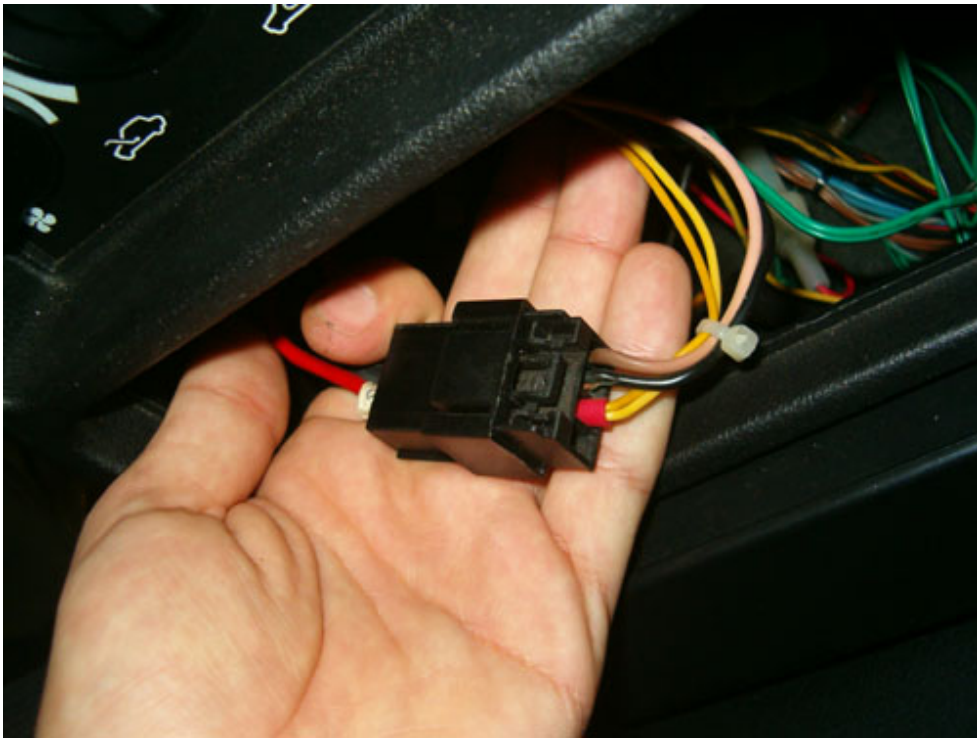
... and heater power supply connector.

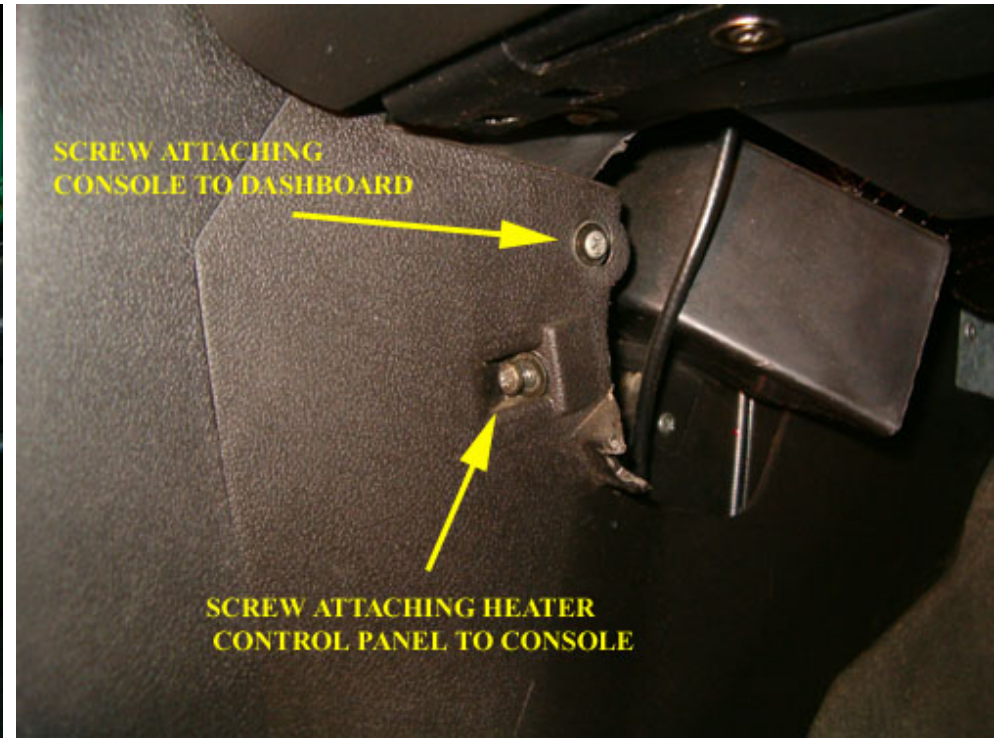
Now let's move on to the mounting screws for the dashboard and heater control panel

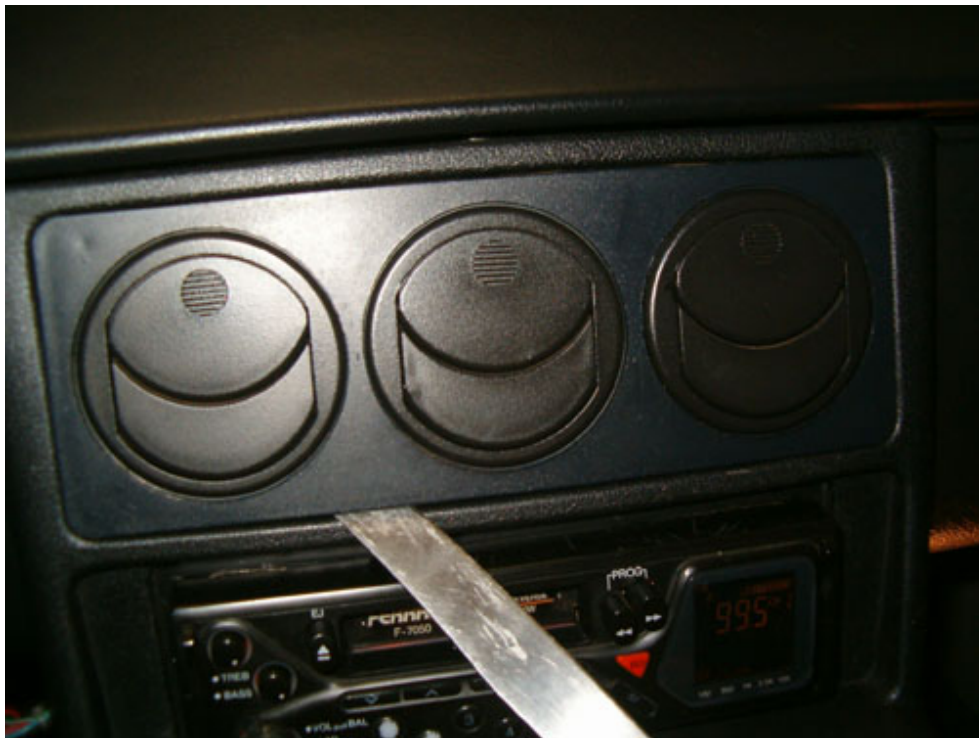
Use a blade to remove the fascia panel. Take it easy as this breaks easily!

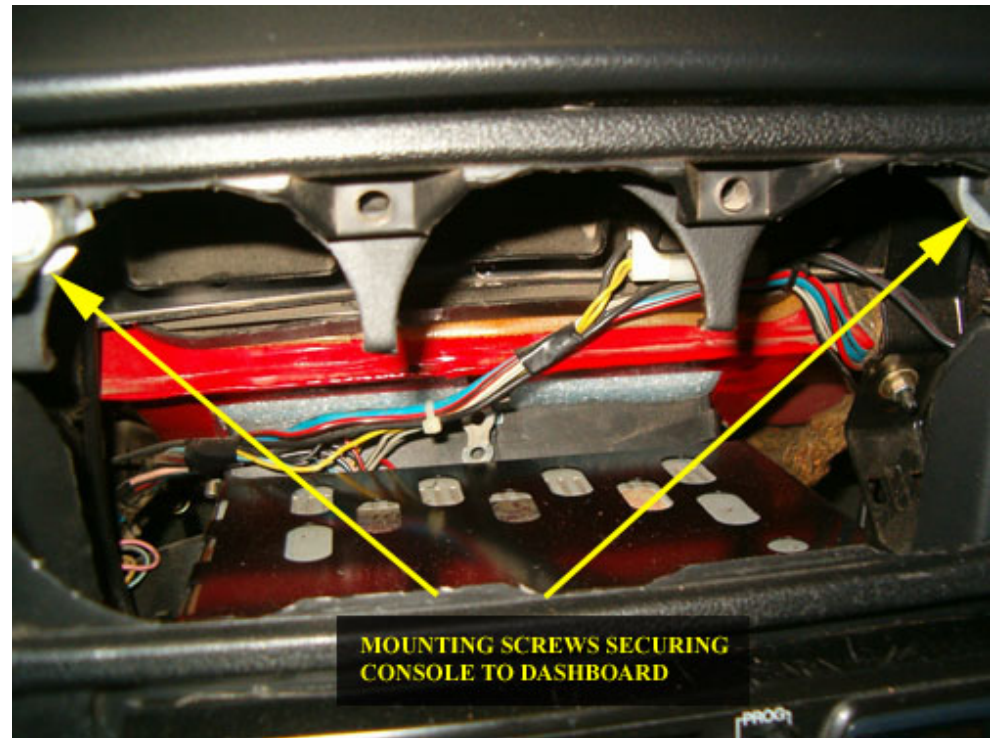
Undo the mounting screws designated. Not shown in the picture are the 3 ducts routing air to the face

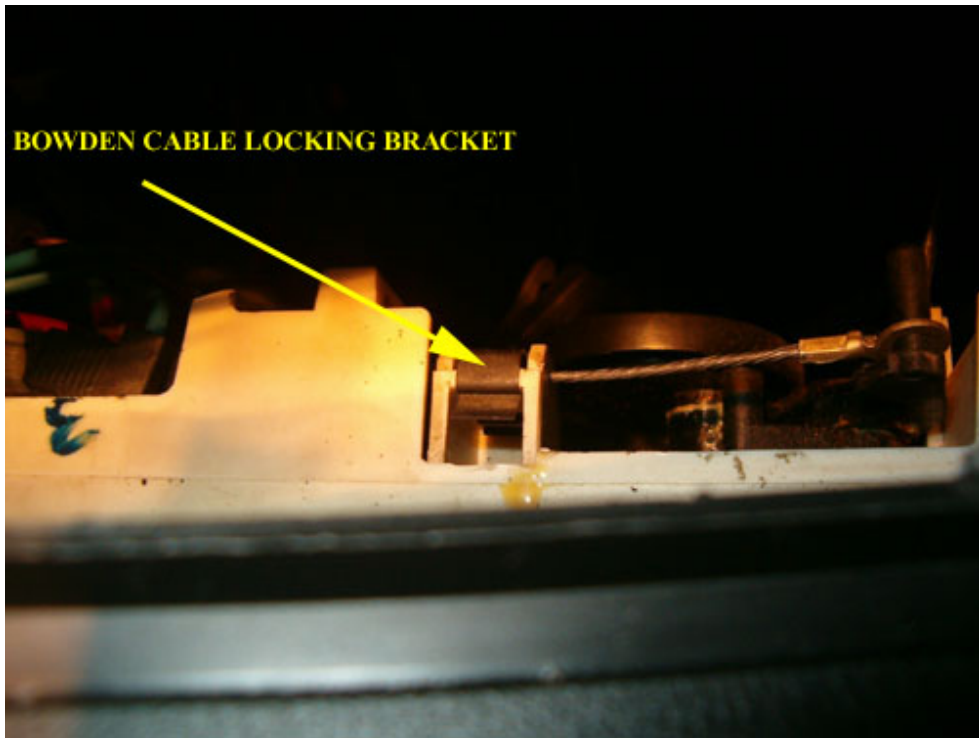
Go on releasing the bowden cable locking bracket ...

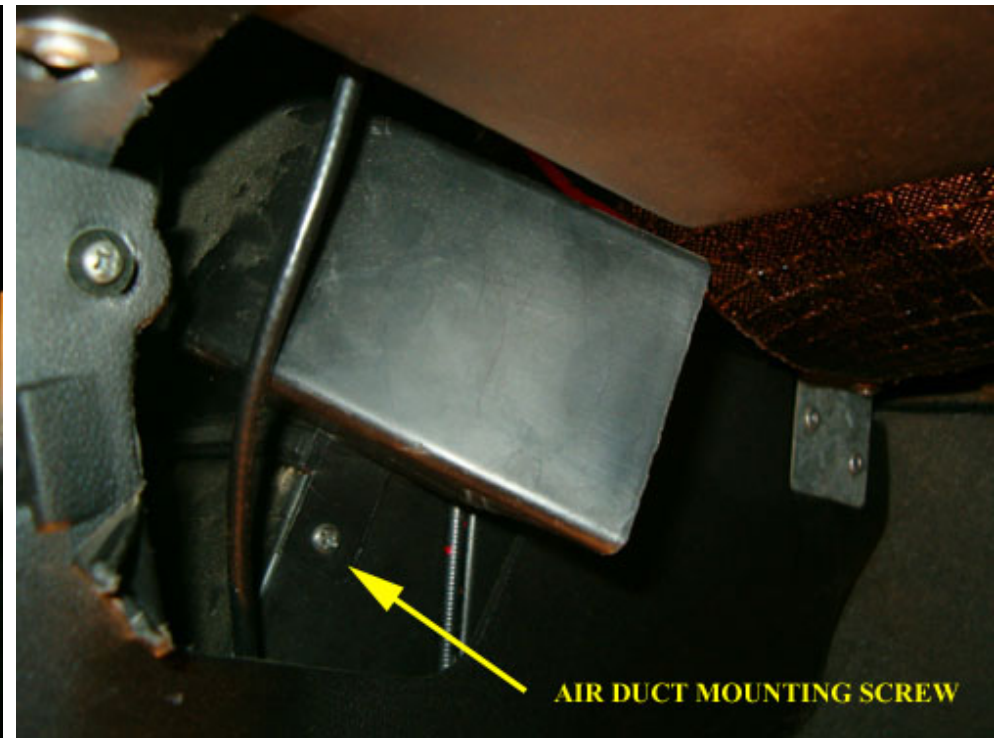
... and the air duct mounting screws. This duct routes air towards the floor or passenger feet

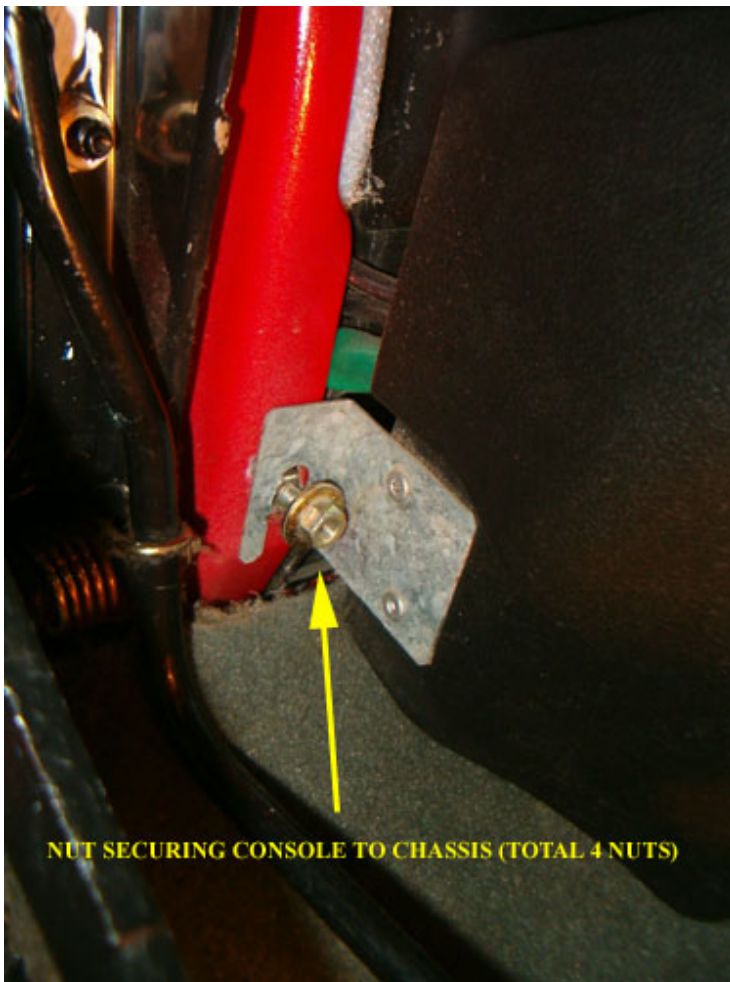
Finally undo the four nuts securing console to chassis (2 per side)

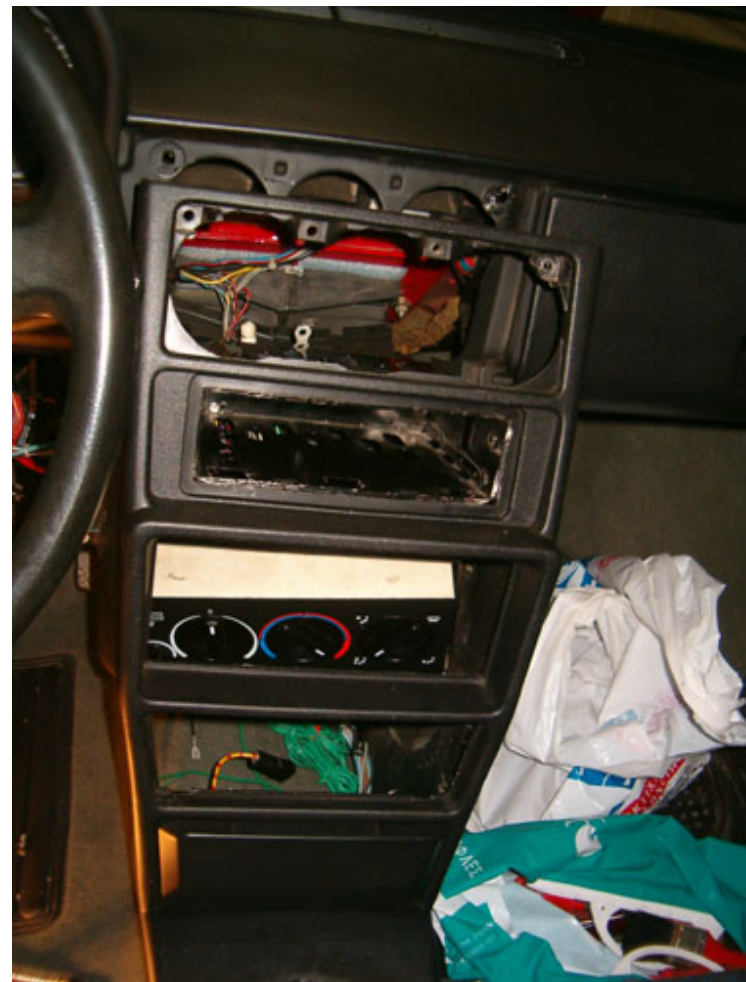
Having disconnected the cigar lighter and ashtray lights slide carefully the console until it is out
