Ventilation Restoration (Alfa 33 series 907)

Heater Unit Disassembly

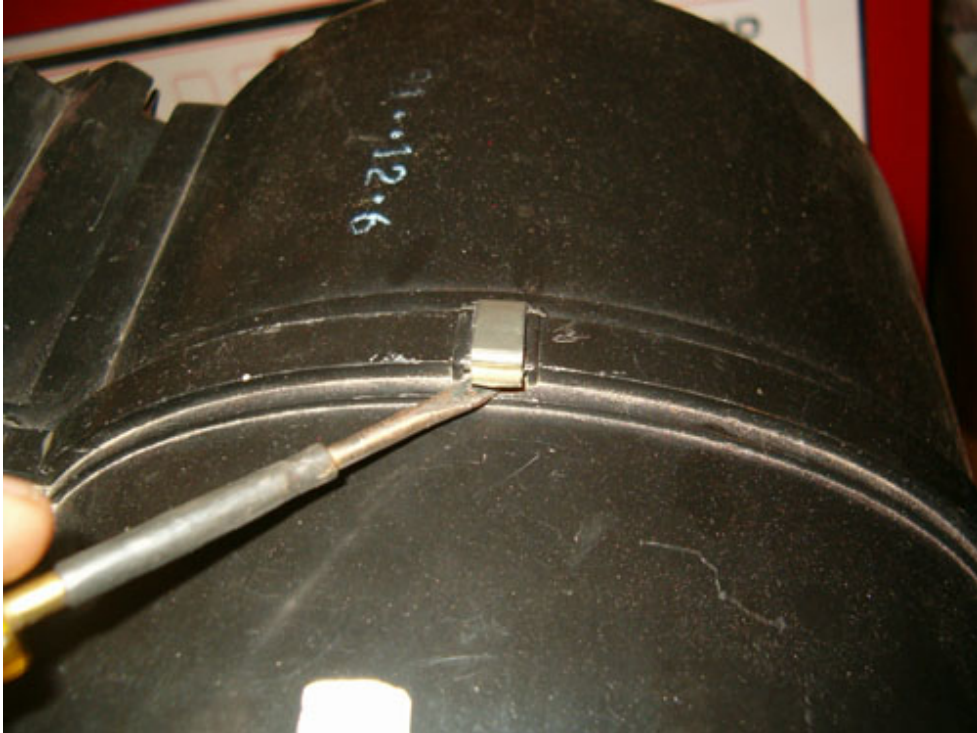
Now that the heater is on the bench let's move on dismantling it. Release locking seals ...

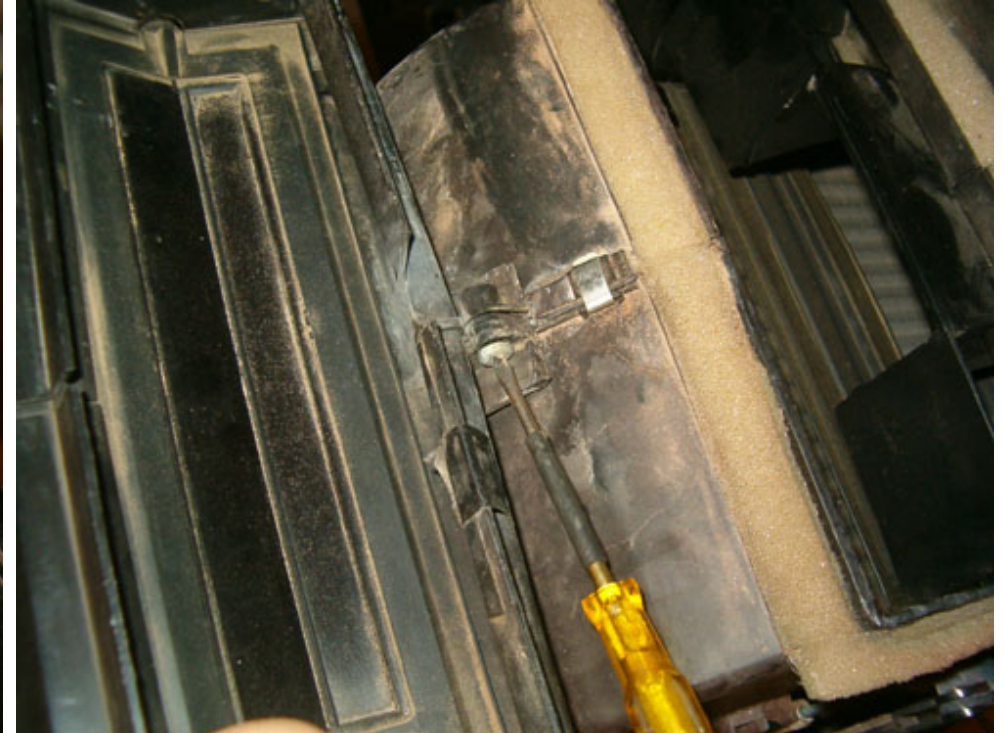
... undo screw keeping blower motor covers

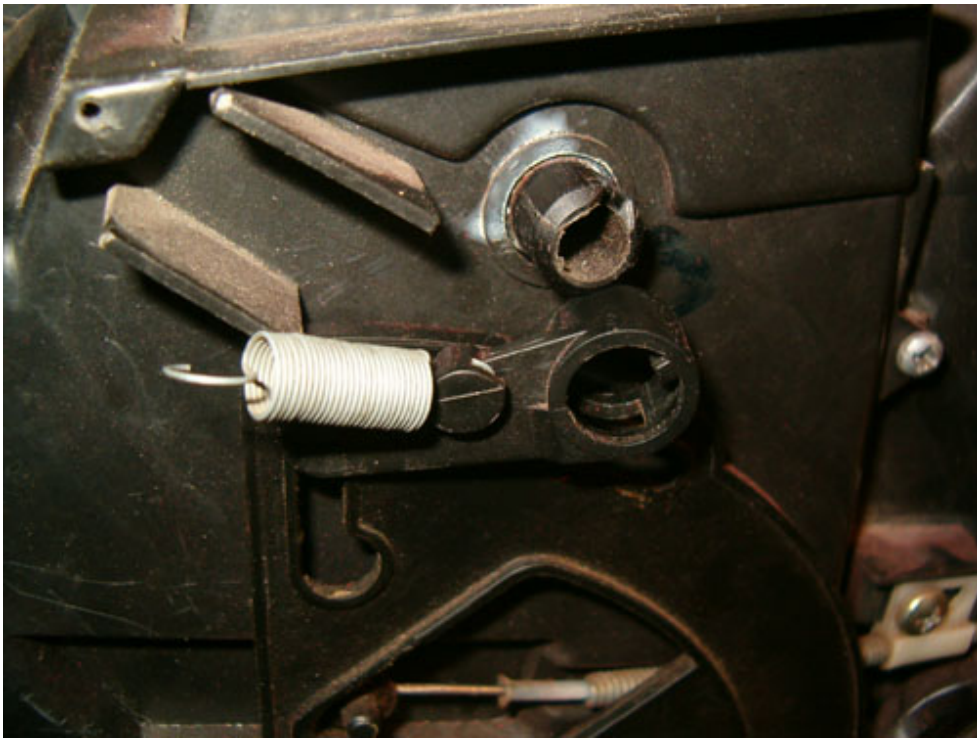
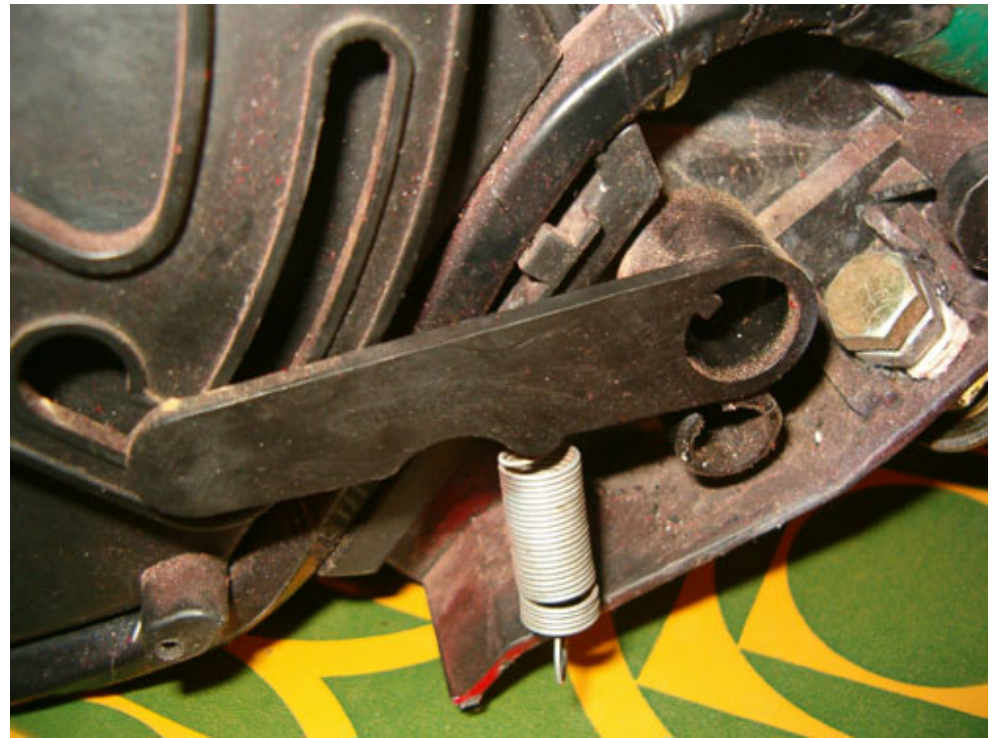
Release retaining springs and duct levers

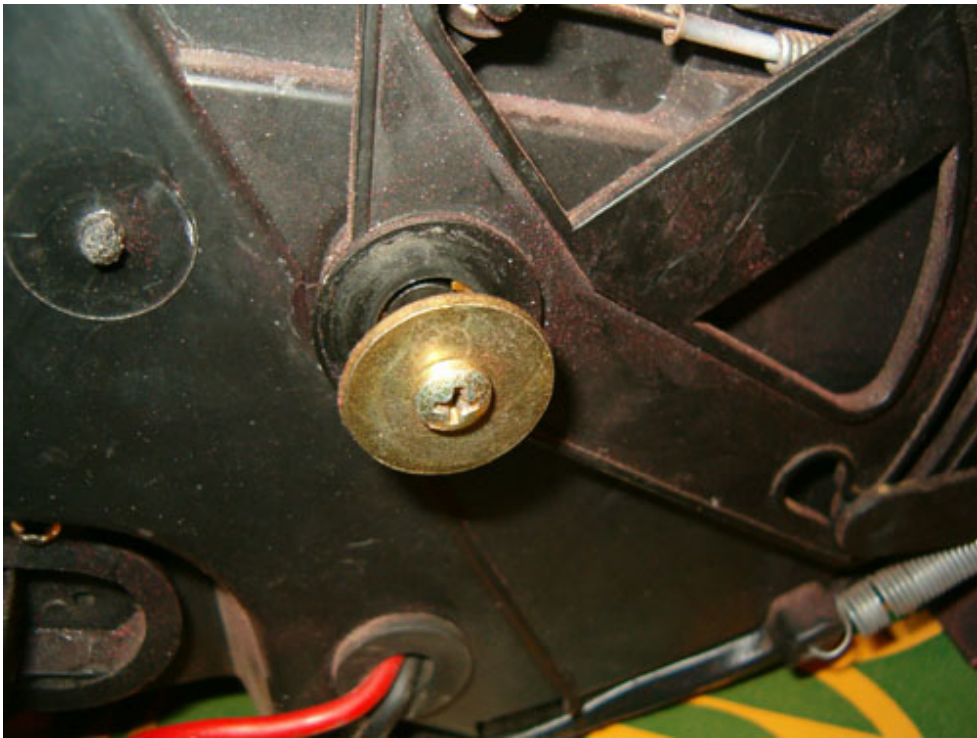
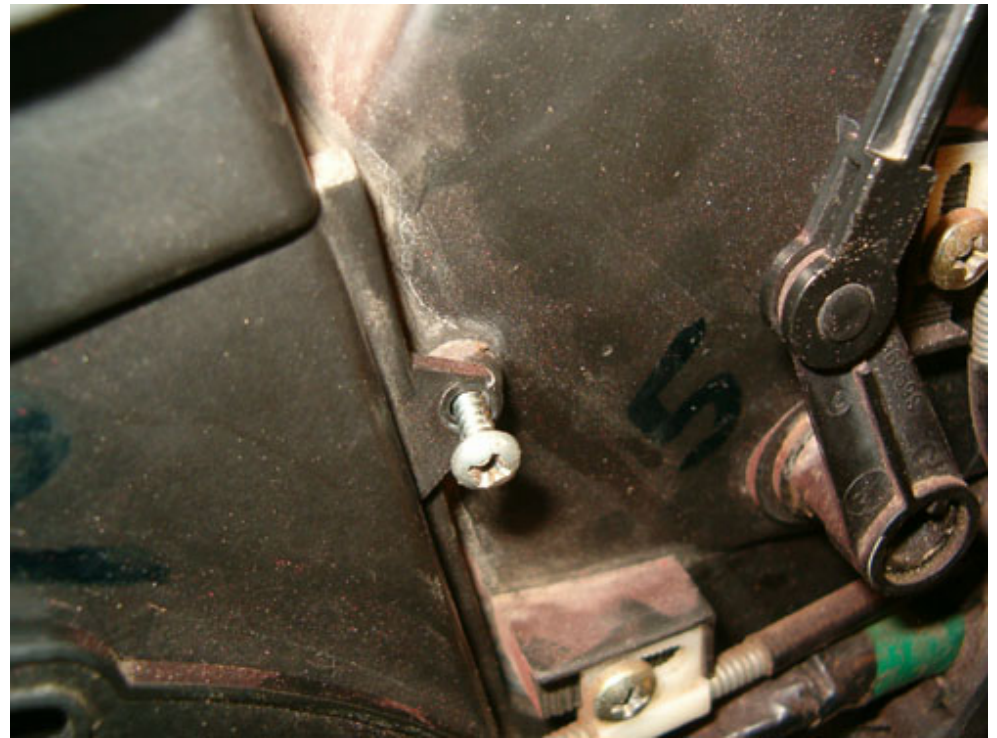
Release screw securing bowden cable assembly and blower motor cover retaining screw

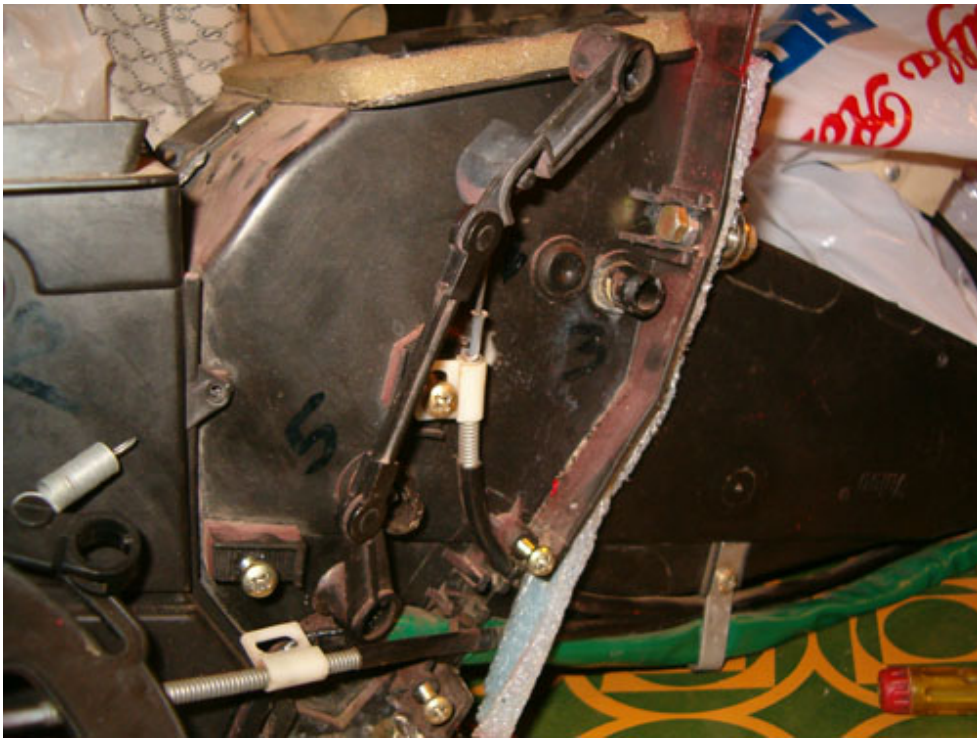
This is how it should look in order to remove covers

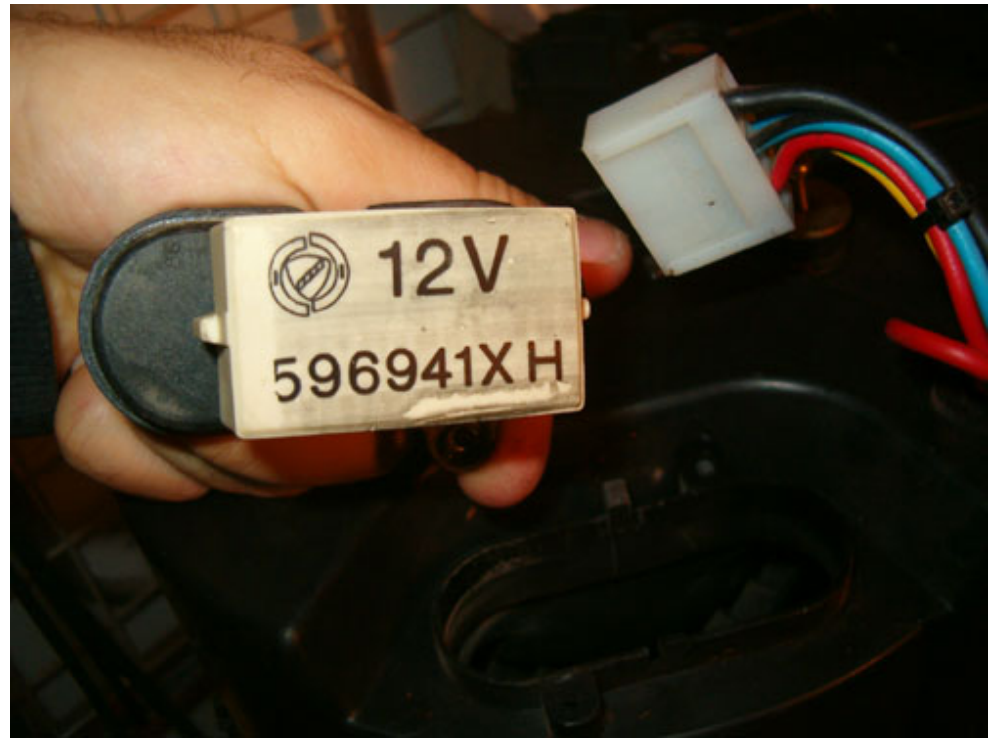
Carefully extract blower motor resistor. This device ensures three motor speeds at your blower - be extremely careful as it is ceramic and breaks easily. In case your blower motor lacks of three speeds, then it is high time you replaced the resistor.

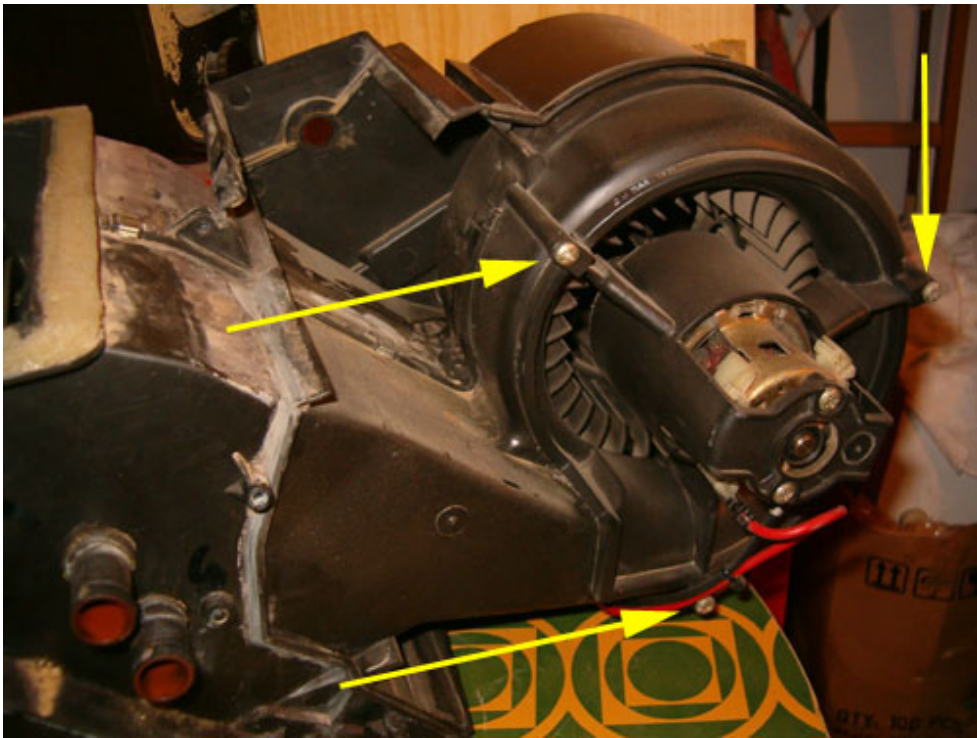
Blower motor revealed - extract it releasing the three designated screws ...

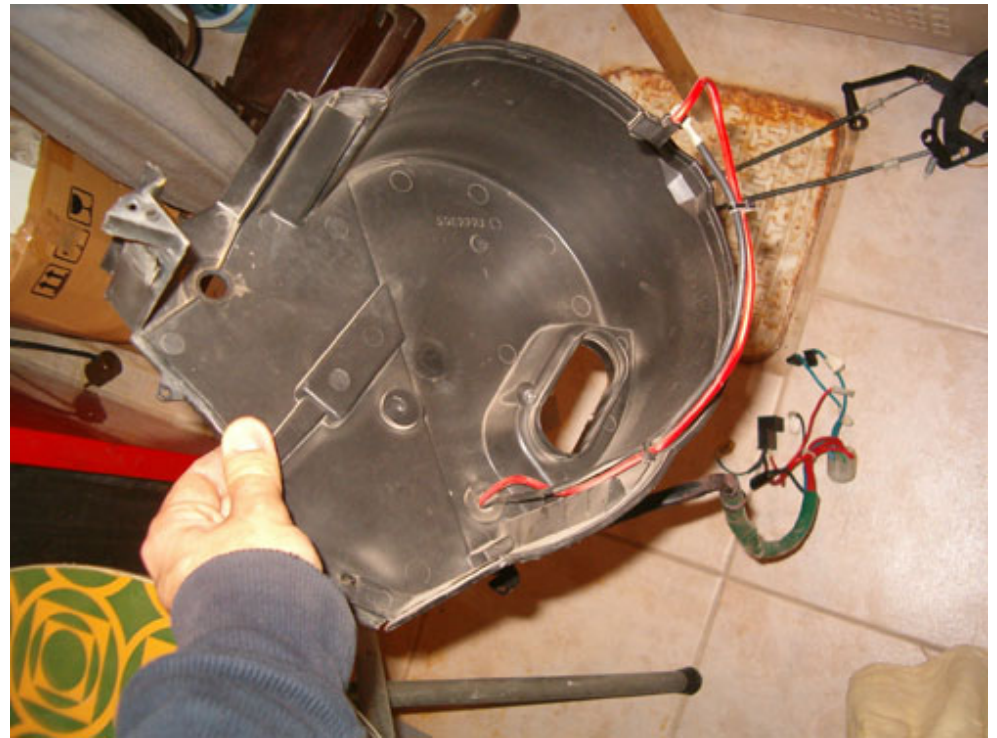
... and wiring harness along with the cover extracted.

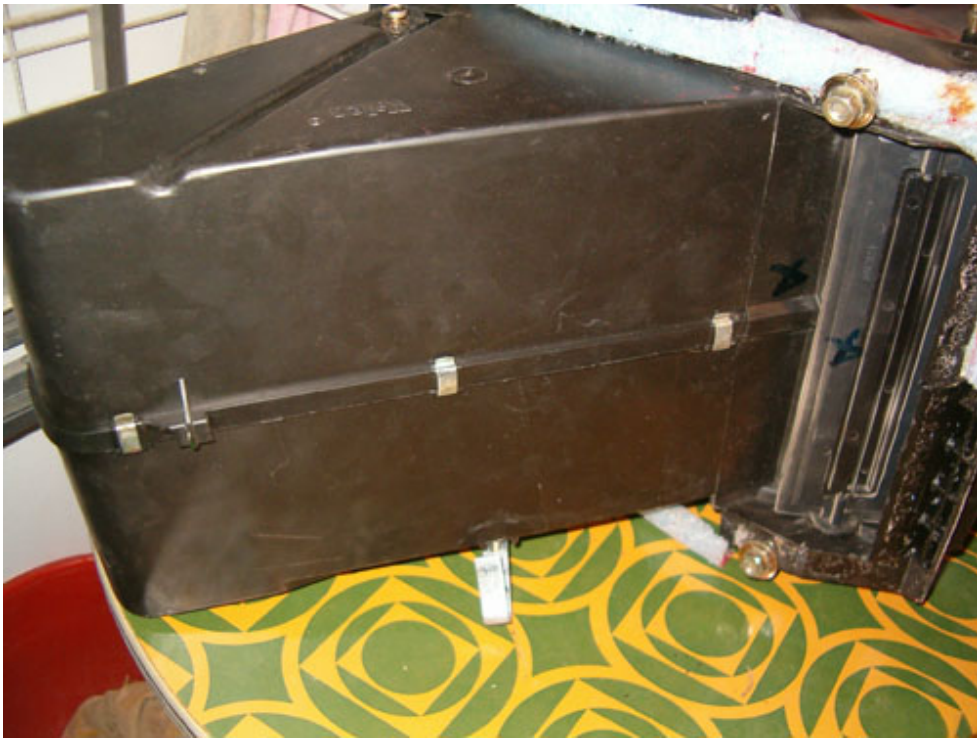
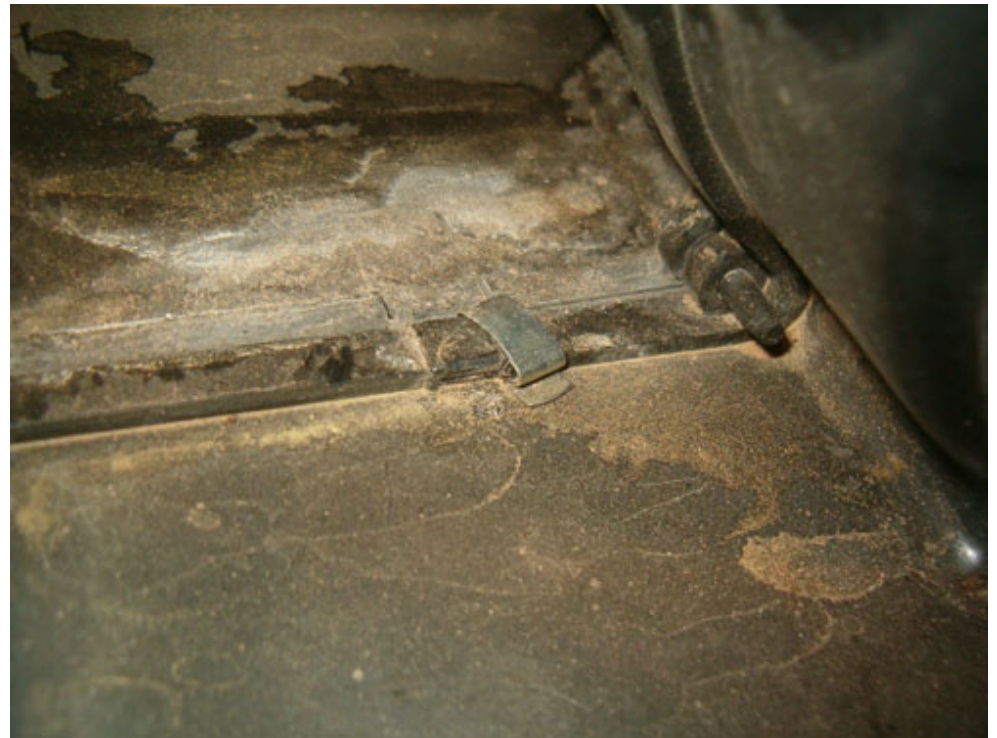
Let's now move on digging out the heater core. Release the remaining locking seals.

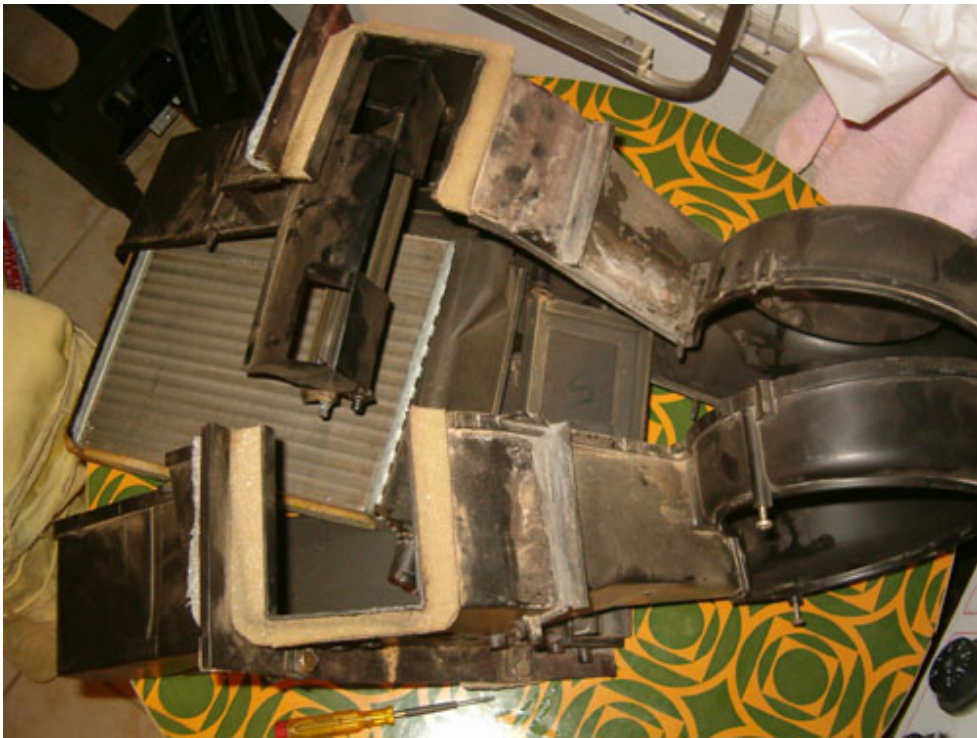
Heater assembly is finally taken apart.

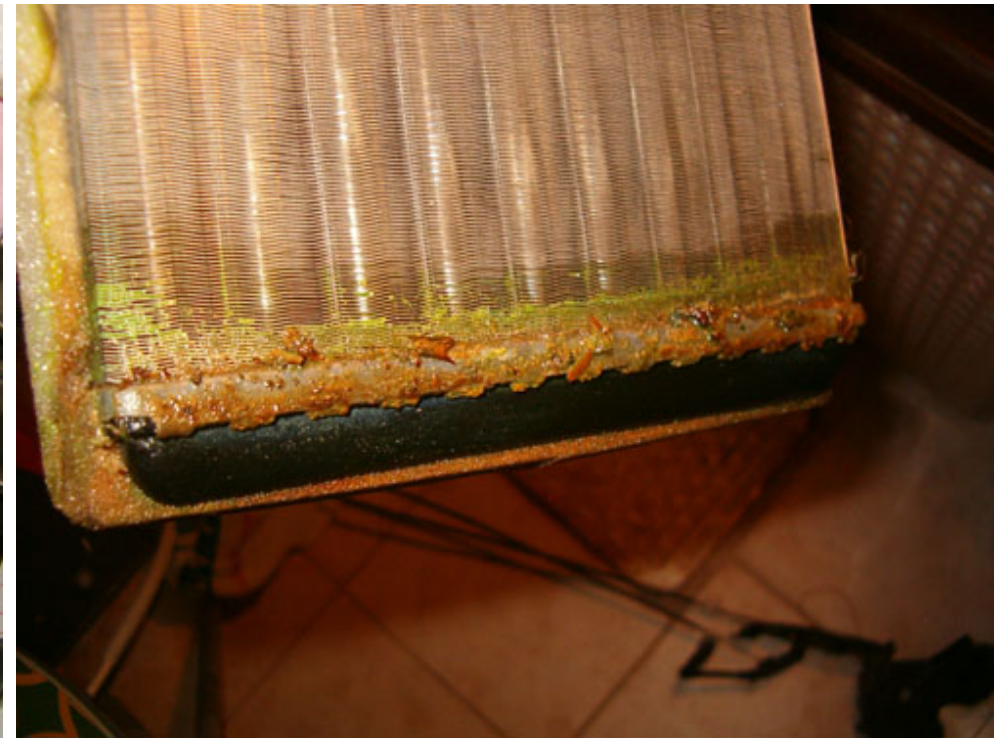
Here the problem is revealed. A fully leaking heater core ...

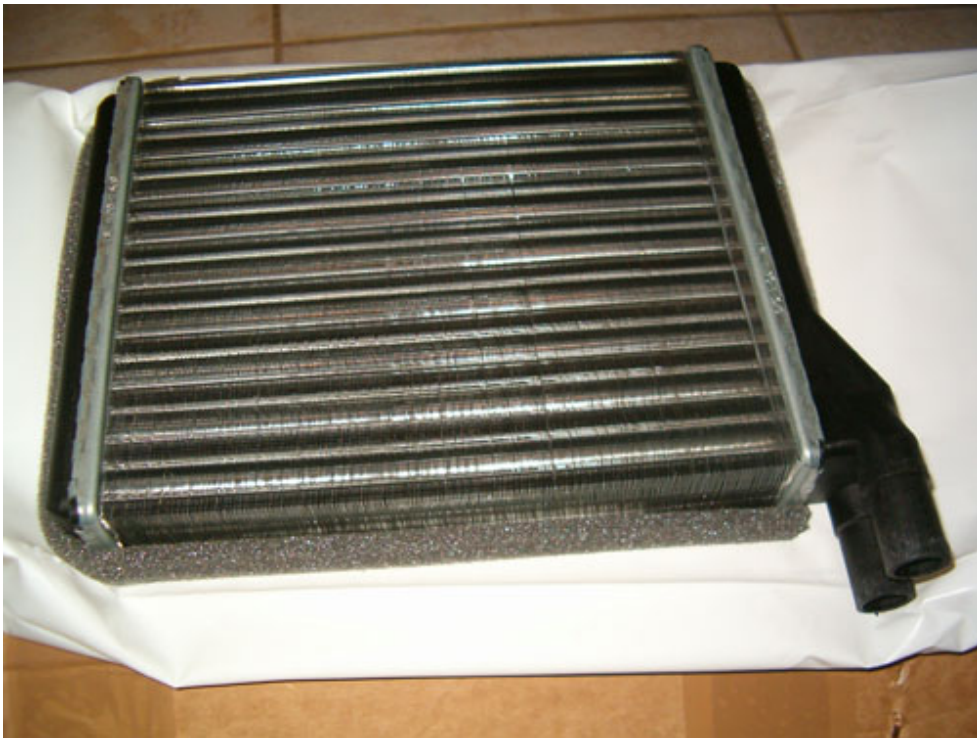
... and the new one out of the package.

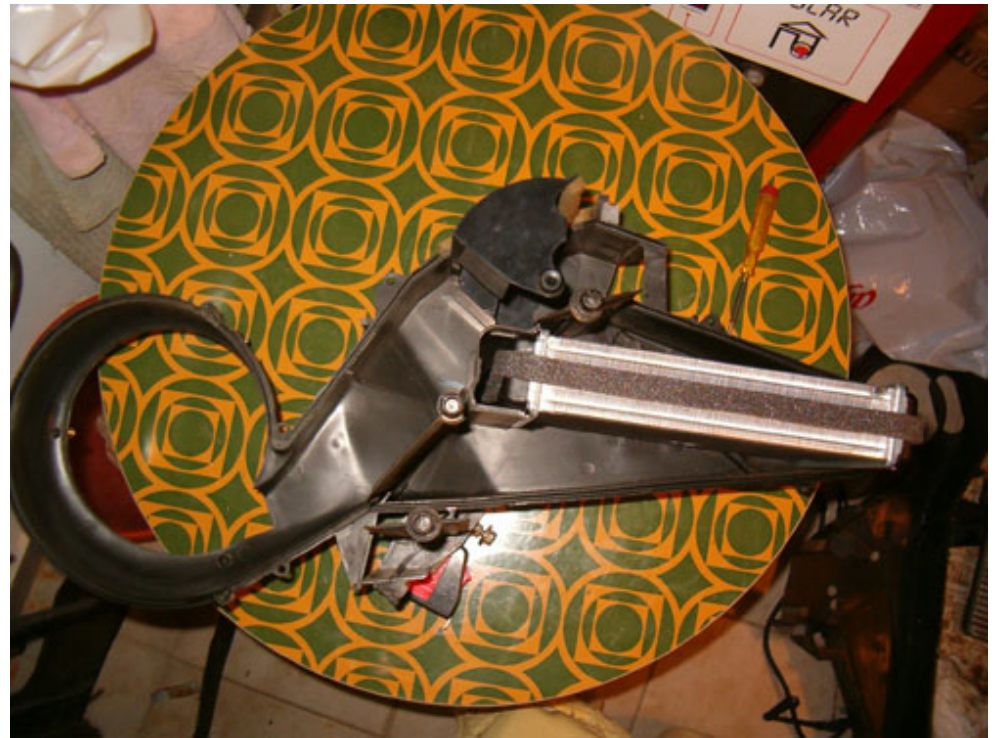
Install the new one as pictured.

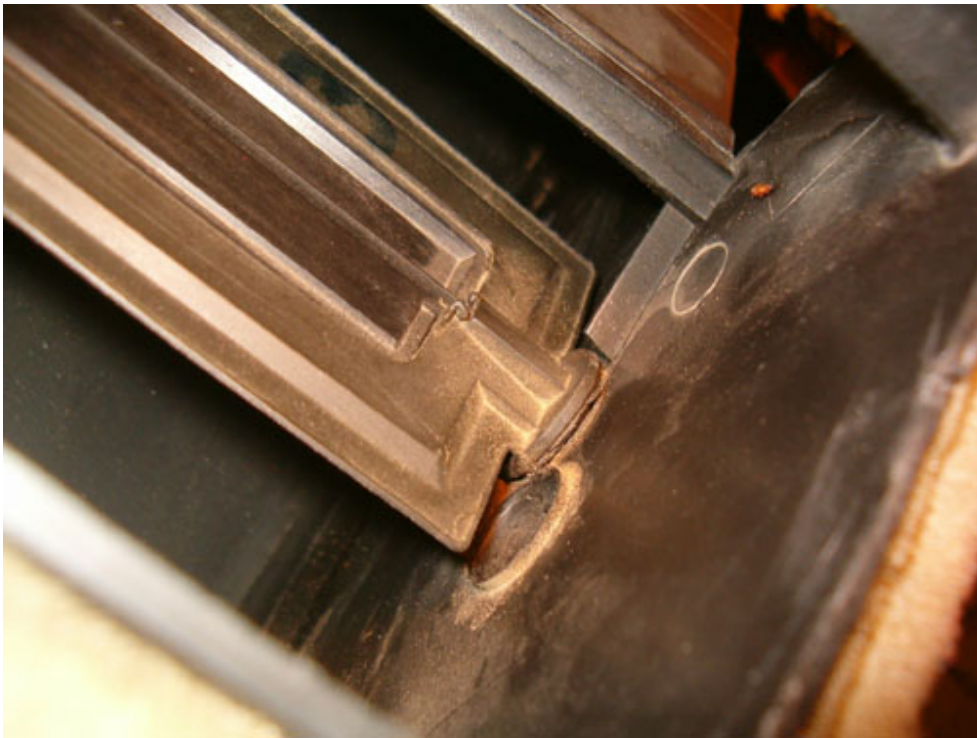
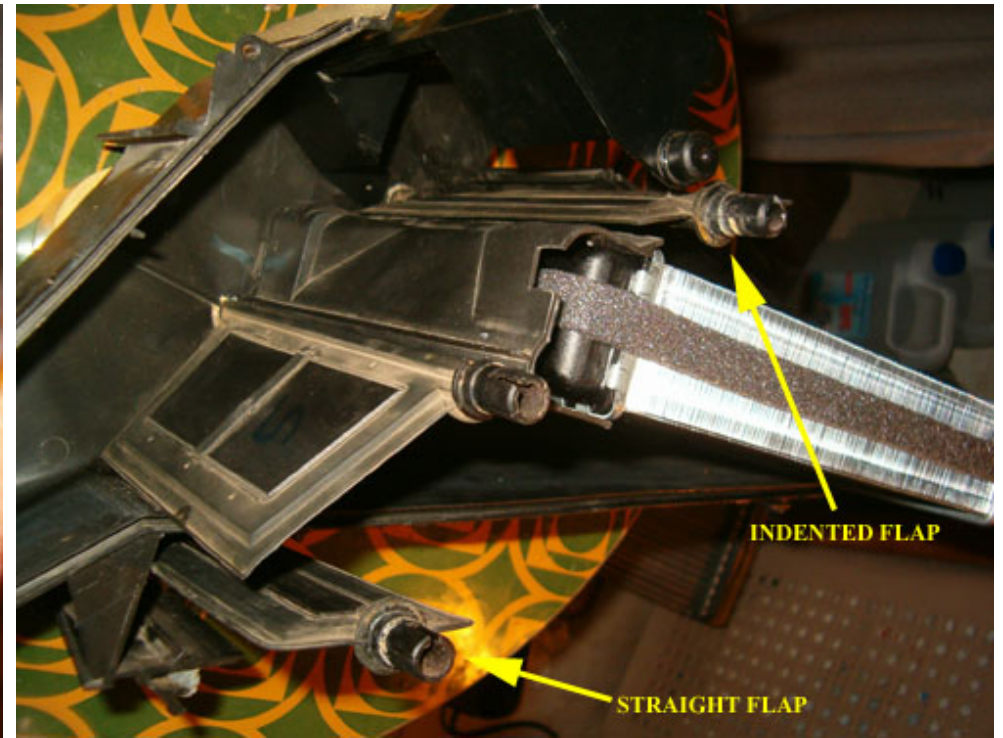
Do not mistake the flaps. The indented one shown in the picture is suited for the upper portion just above the heater core.

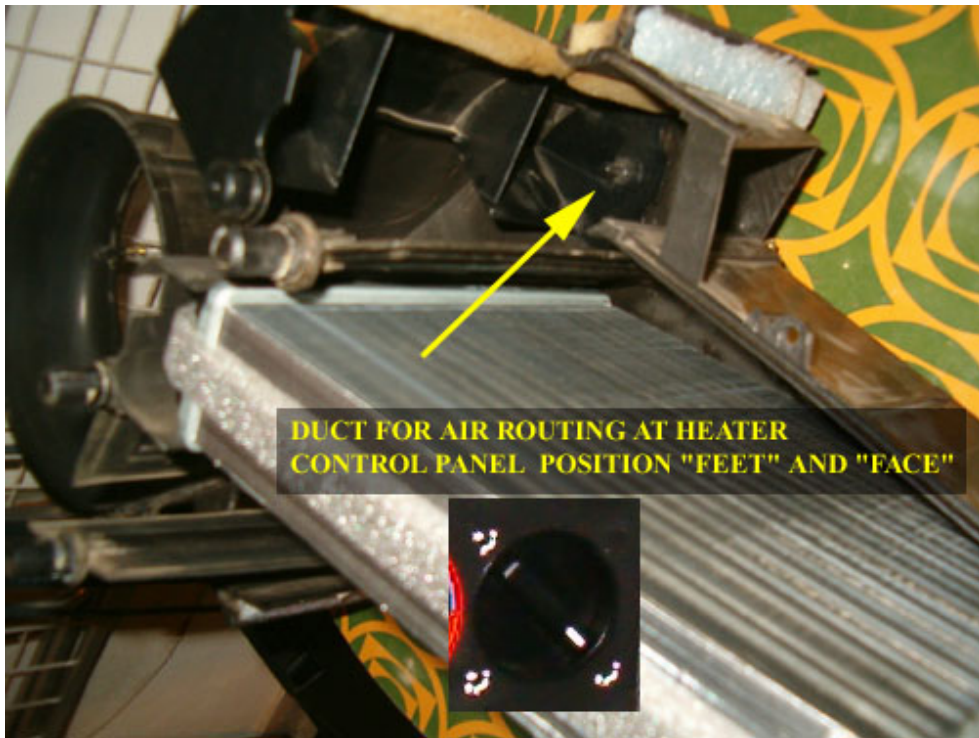
The duct shown above regulates the air aimed at the "feet" or "face". The end of the bowden cable on the demonstrated panel goes to the tip of the duct shown by the arrow

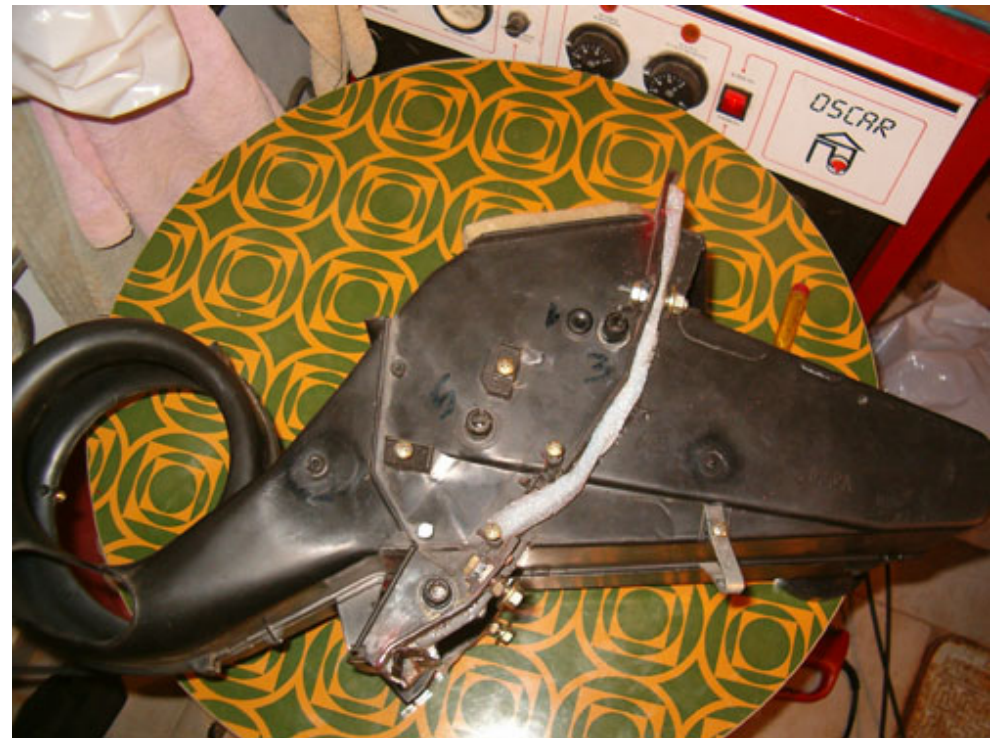
Assemble the two halves and secure them with the locking seals.

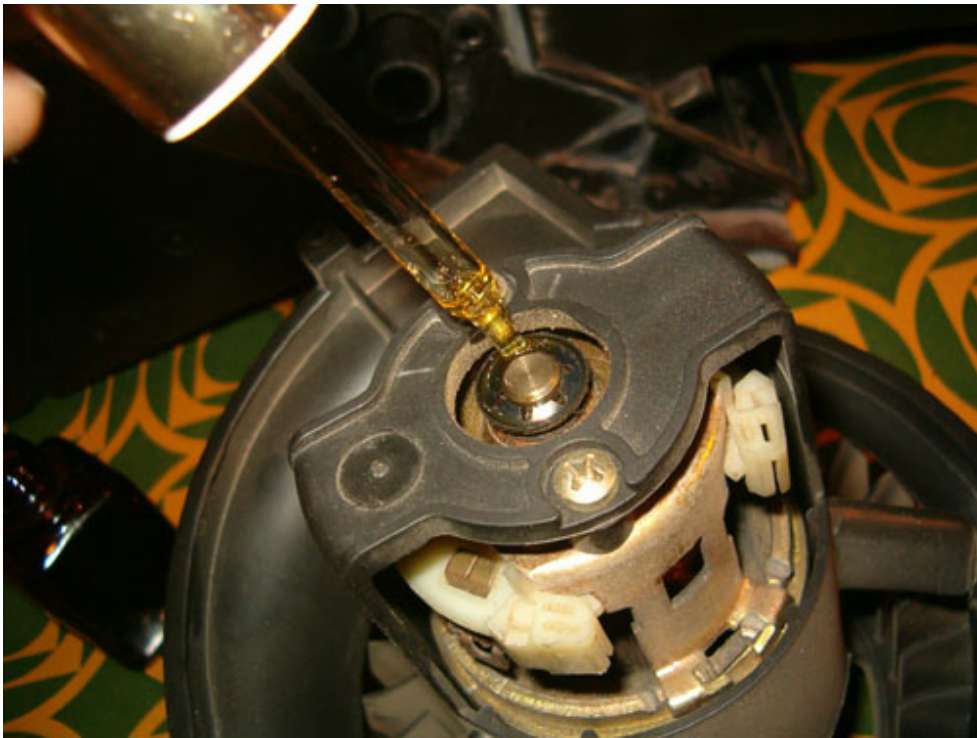
Why not lubricating the motor ...

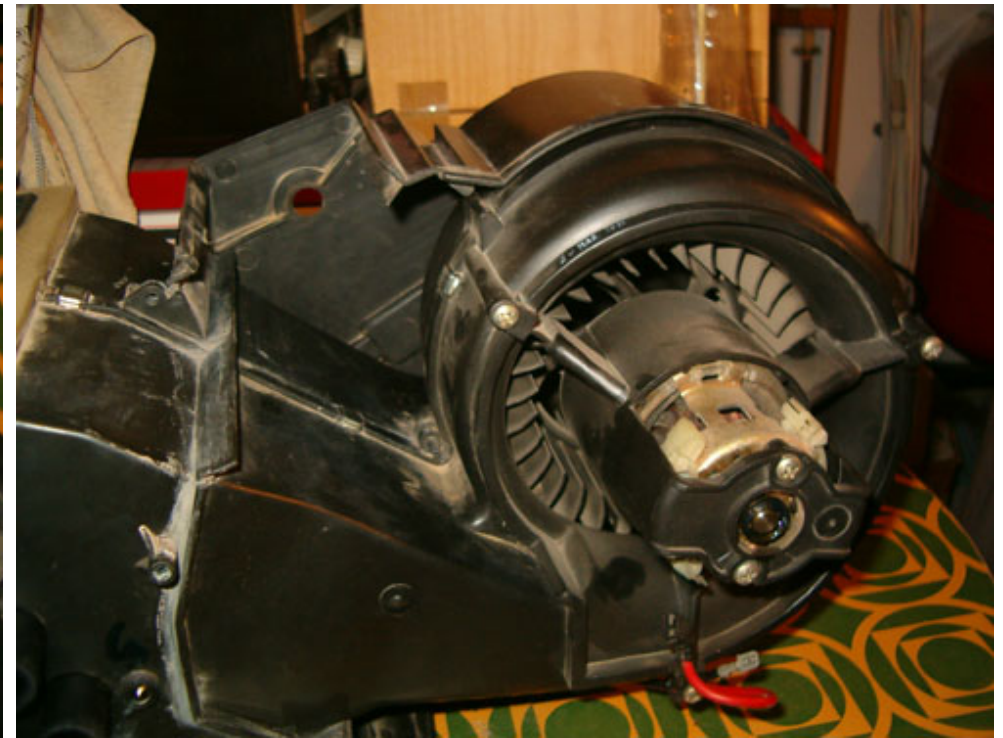
attach it to the heater body and reconnect power leads

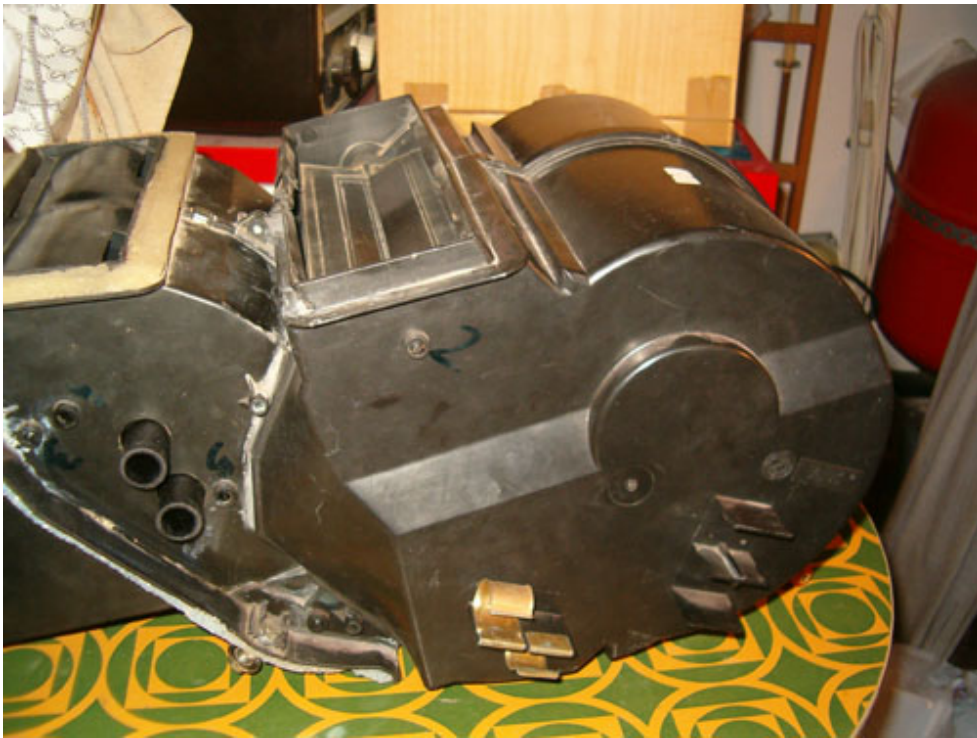
Restore the blower motor covers ...

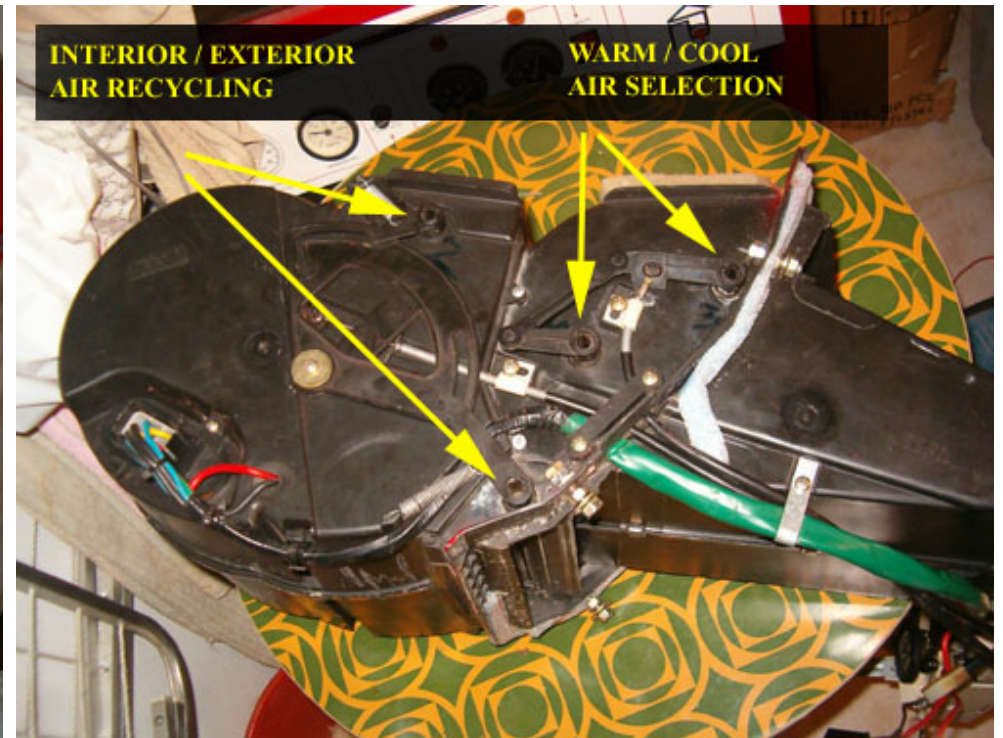
... and restore bowden cable along with the respective levers. There is no chance to mistake the cables or levers as these fit only one way.

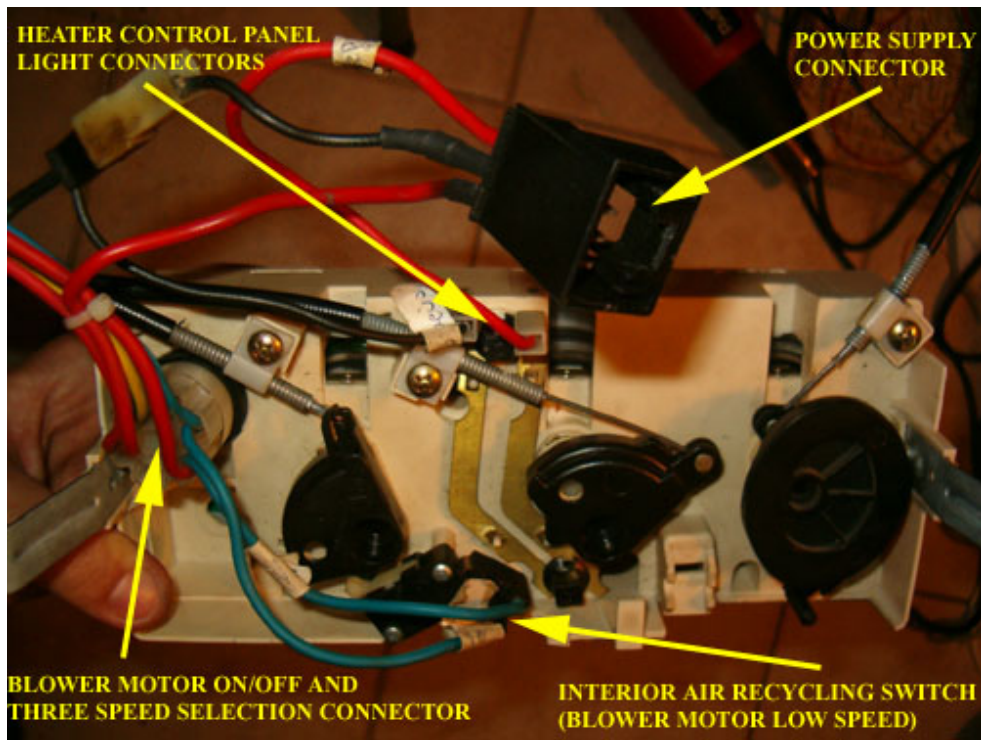
This view is very helpful in order to know the exact connections of every single lead.

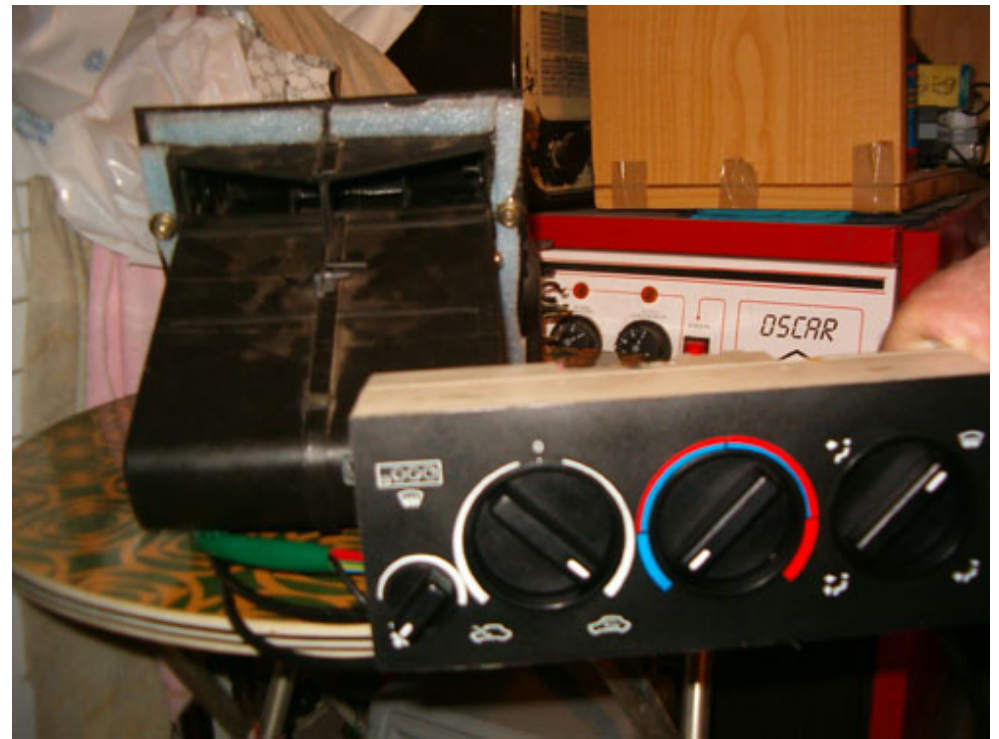
The heater unit is ready to be installed on the car.
