Ventilation Restoration (Alfa 33 series 907)

Heater Unit Refitting

1991 Alfa 33 1.4 IE

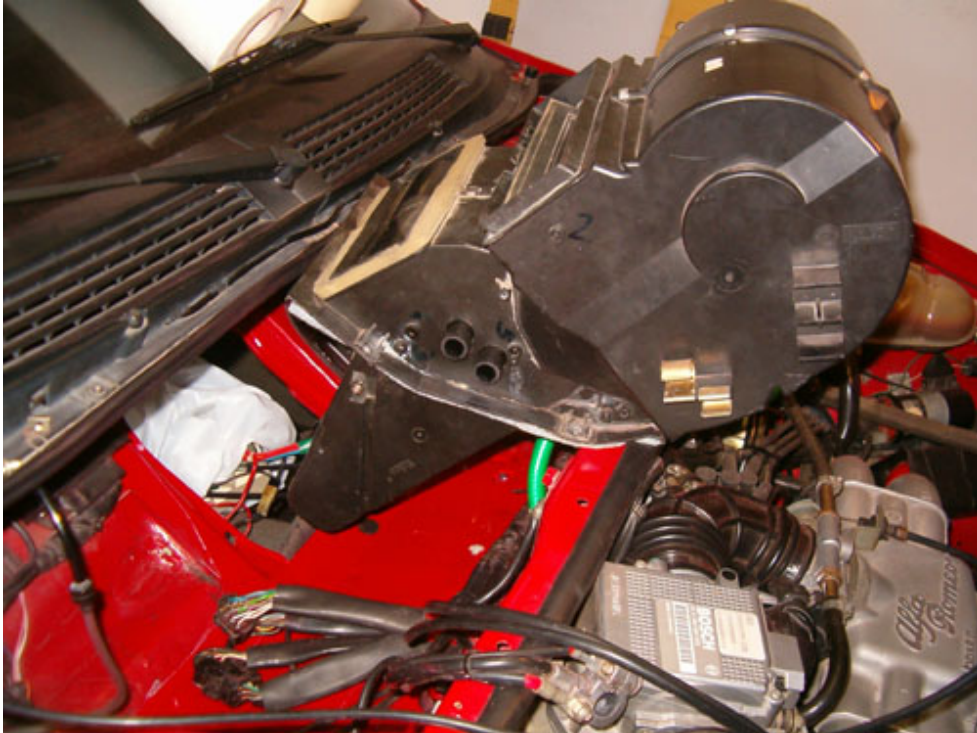
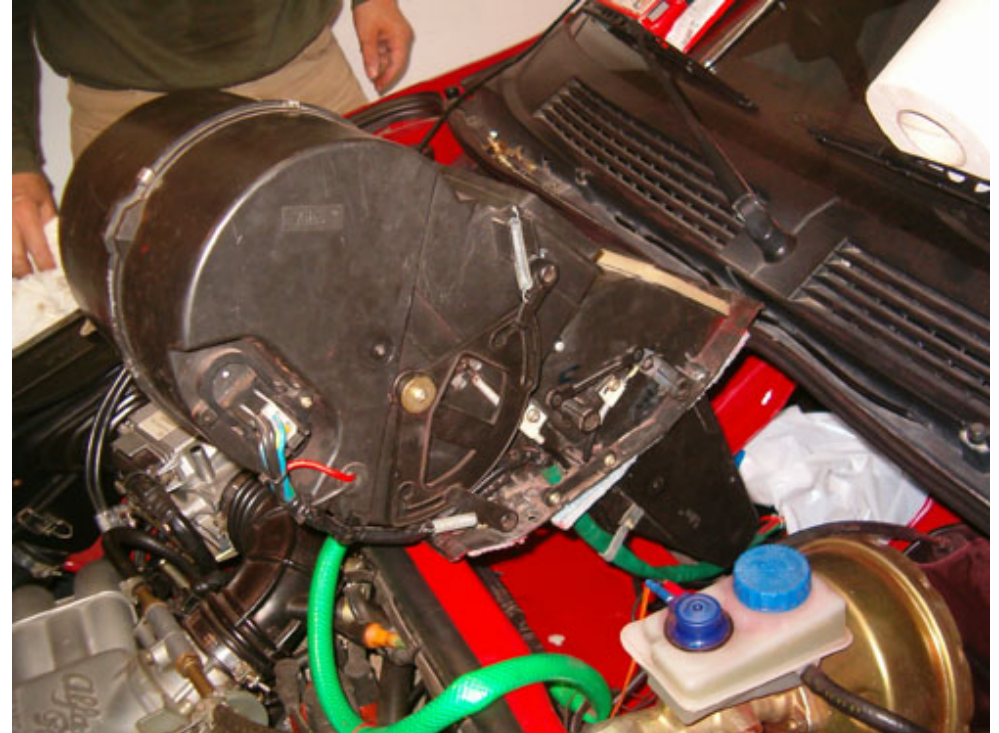
Install heater unit by sliding it slowly and carefully in the bulkhead window. It would be handy to have an assistant sliding in the unit and the other person directing it from the interior; work methodically during refitting so that nothing is overlooked and possibly misaligned.

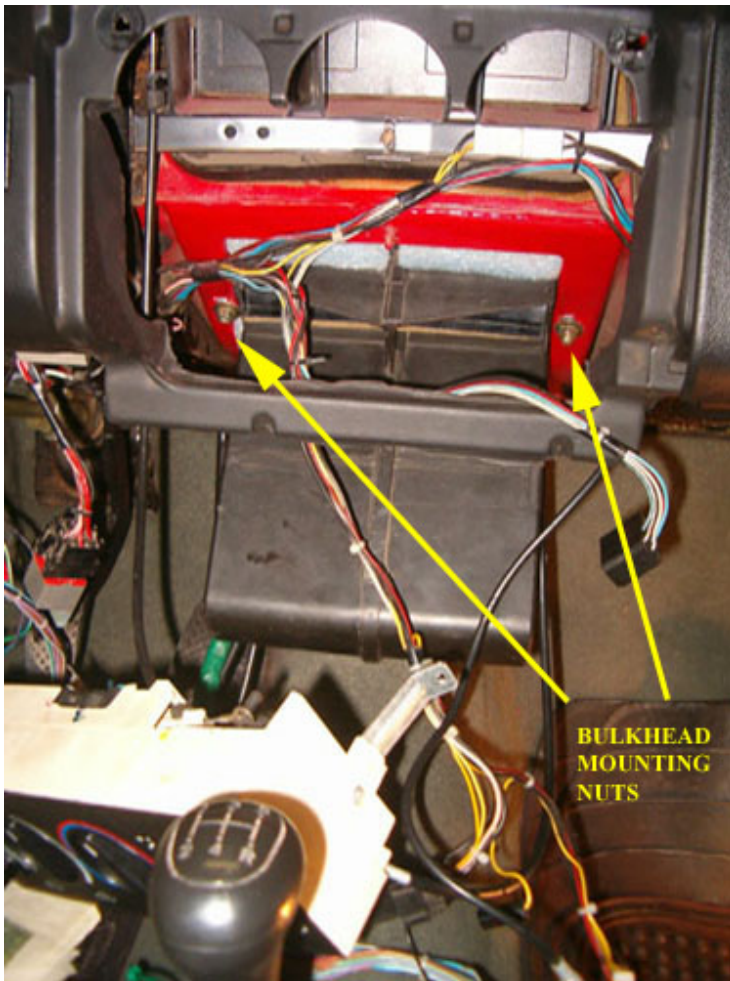
Mount the designated nuts (total 4)

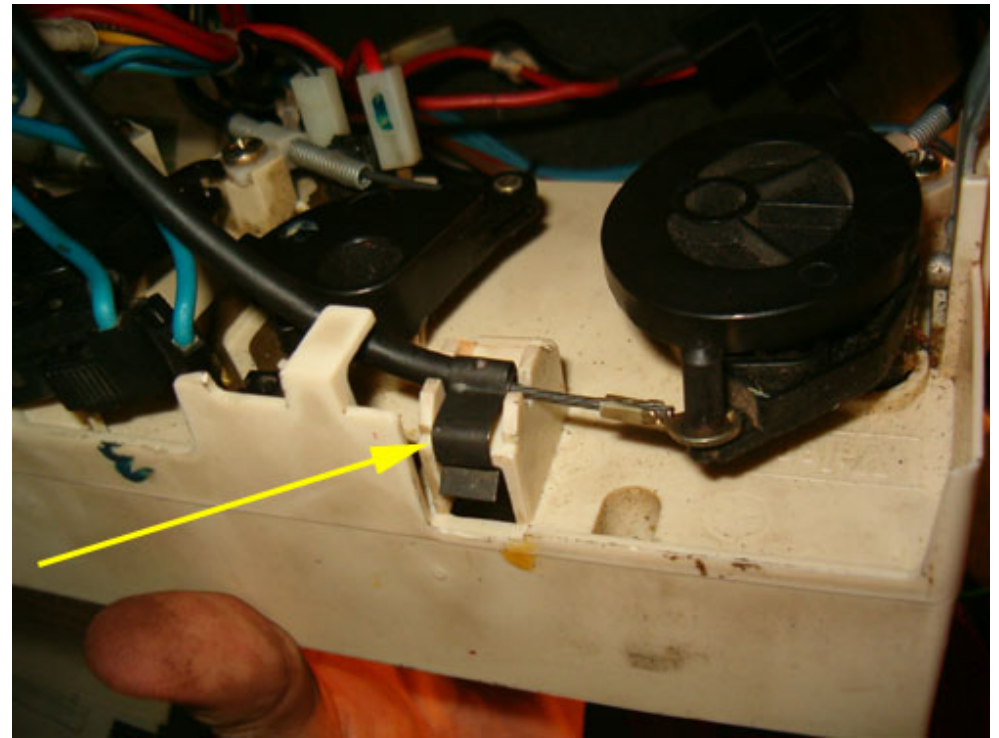
Restore the locking bracket ...

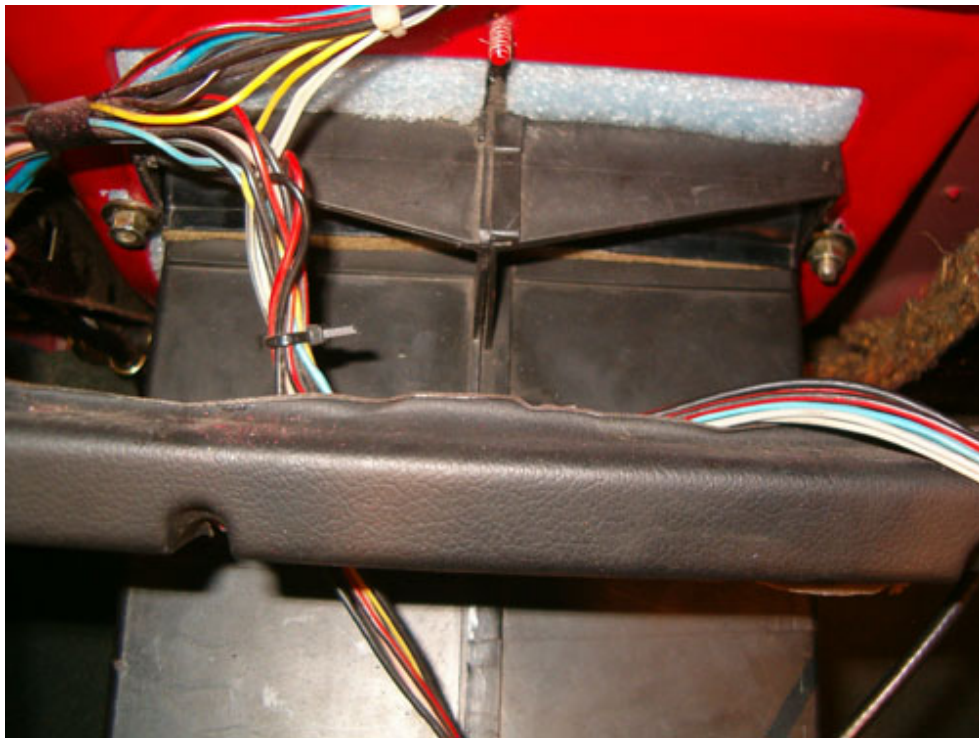
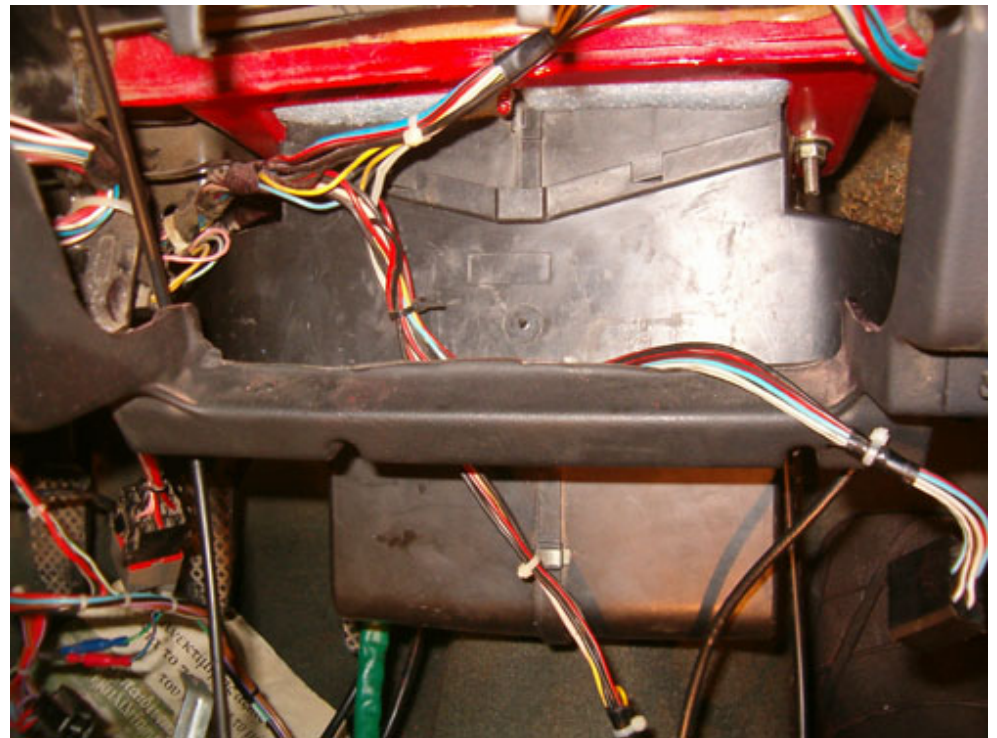
... restore air duct

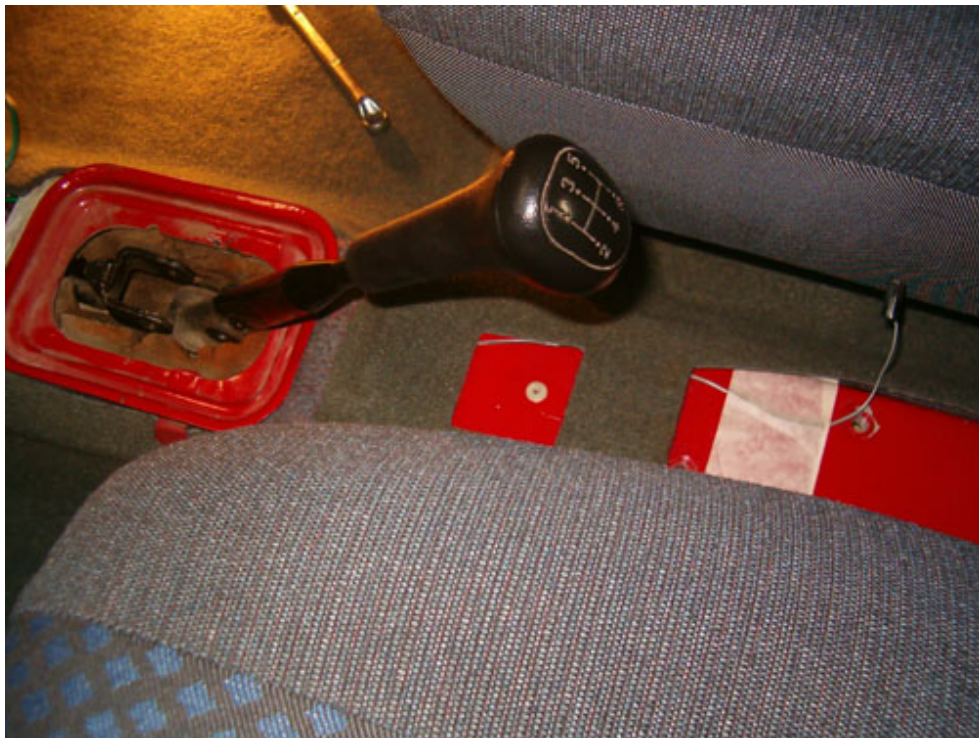
slide back the gear stick so that you have enough clearance to slide in the console.

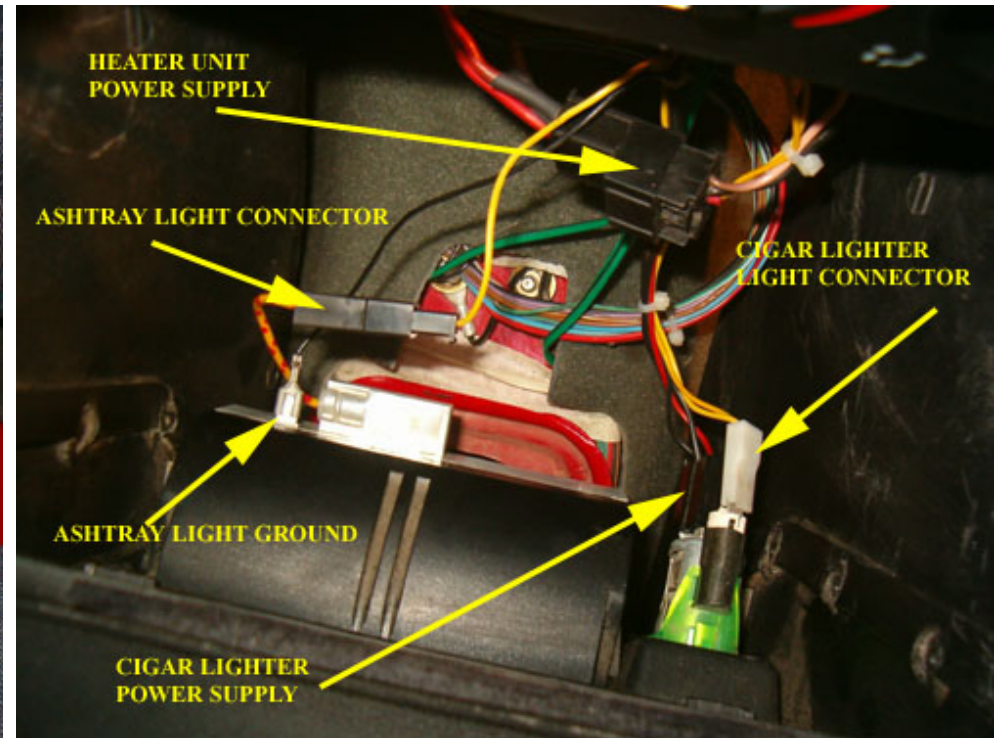
Restore power supply connectors ...

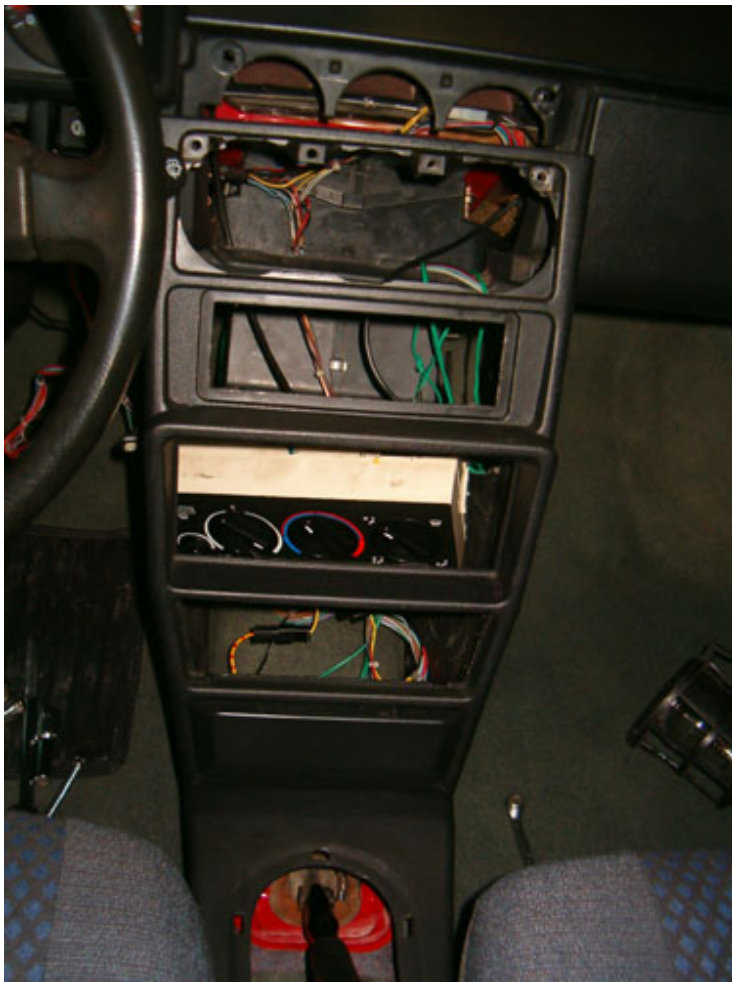
... console merely sits in place

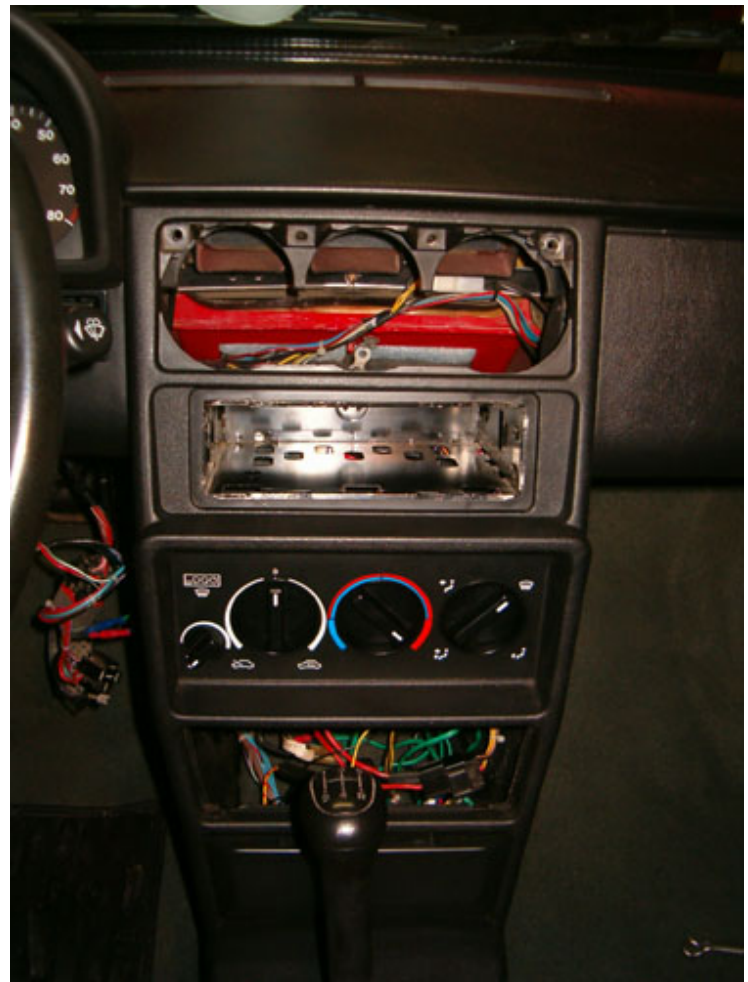
... console sits exactly in place!

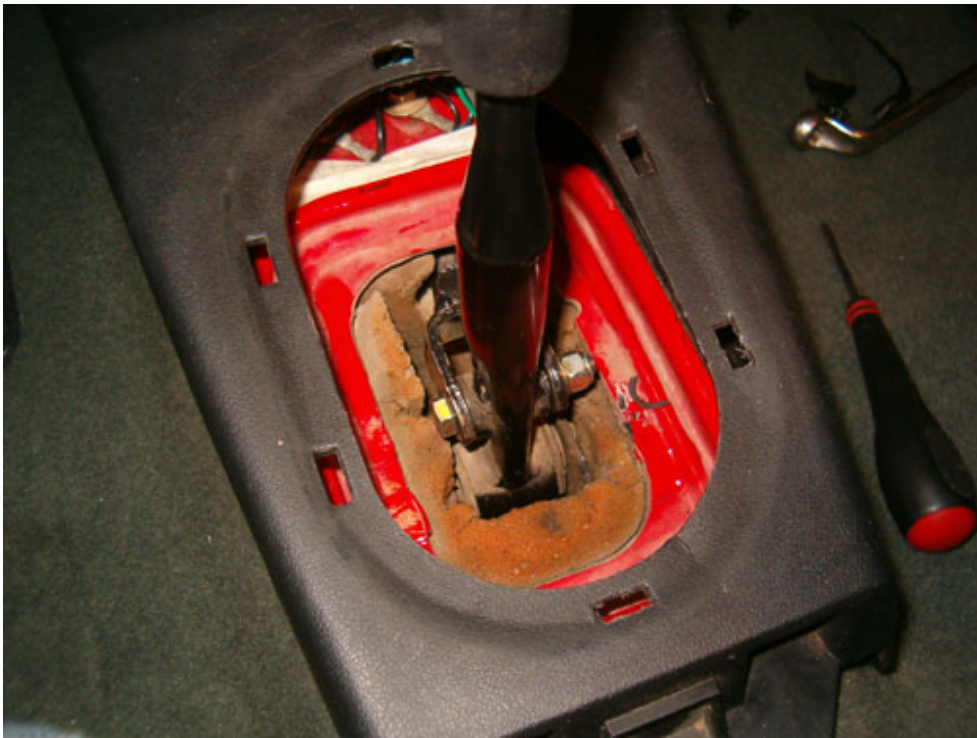
restore gear stick mounting nut ...

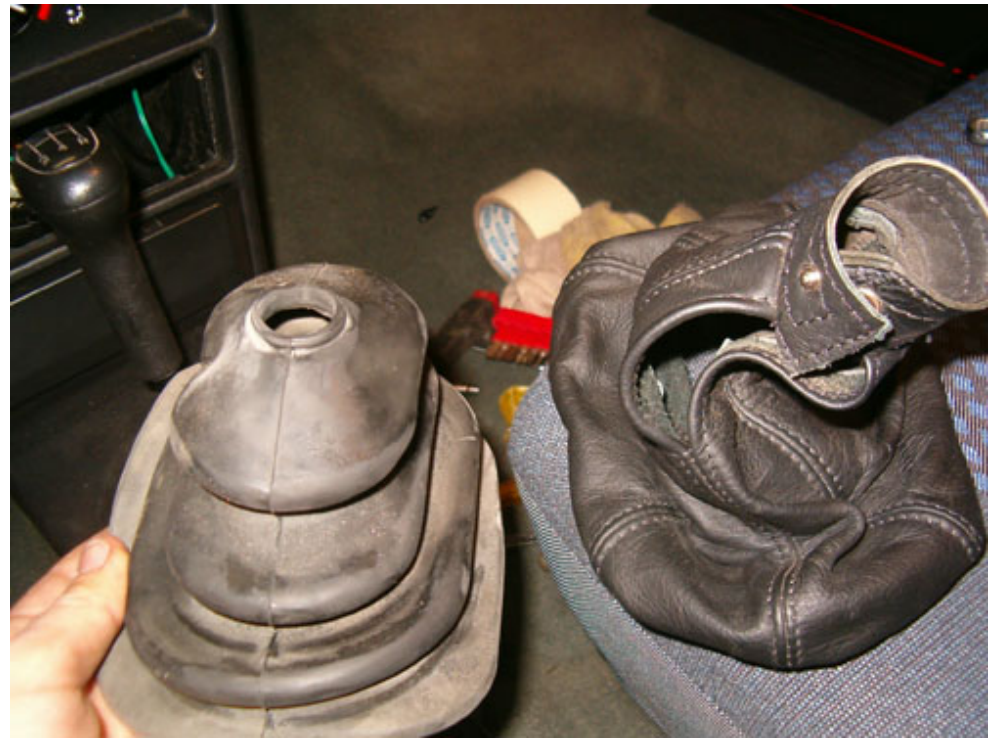
... and the respective bellows and leather cover.

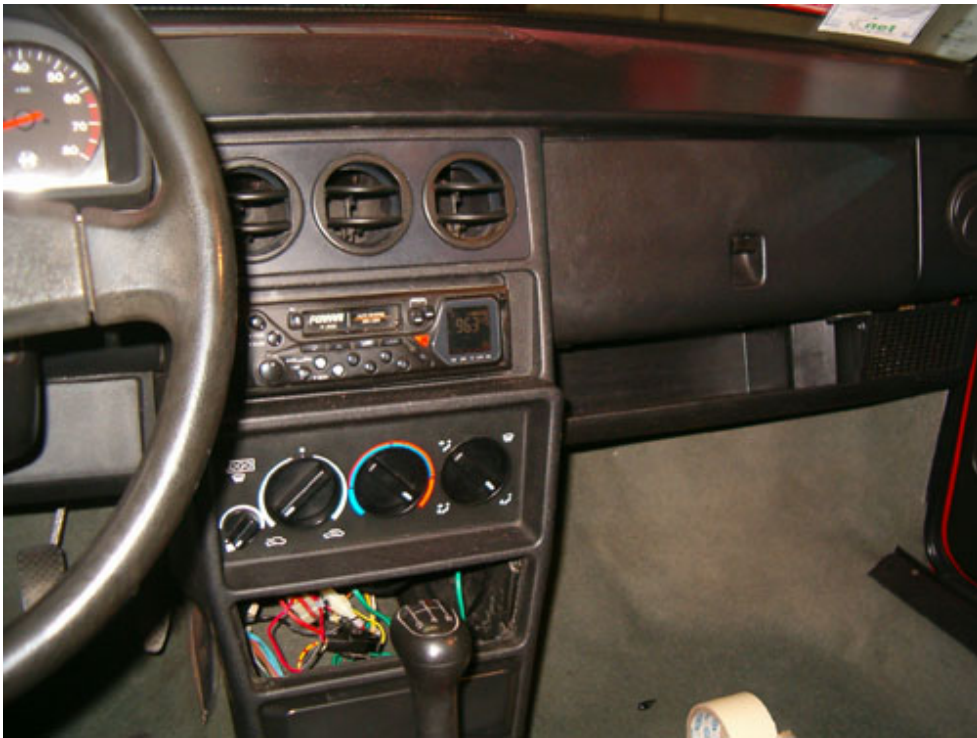
Don't forget to restore the speaker covers ...

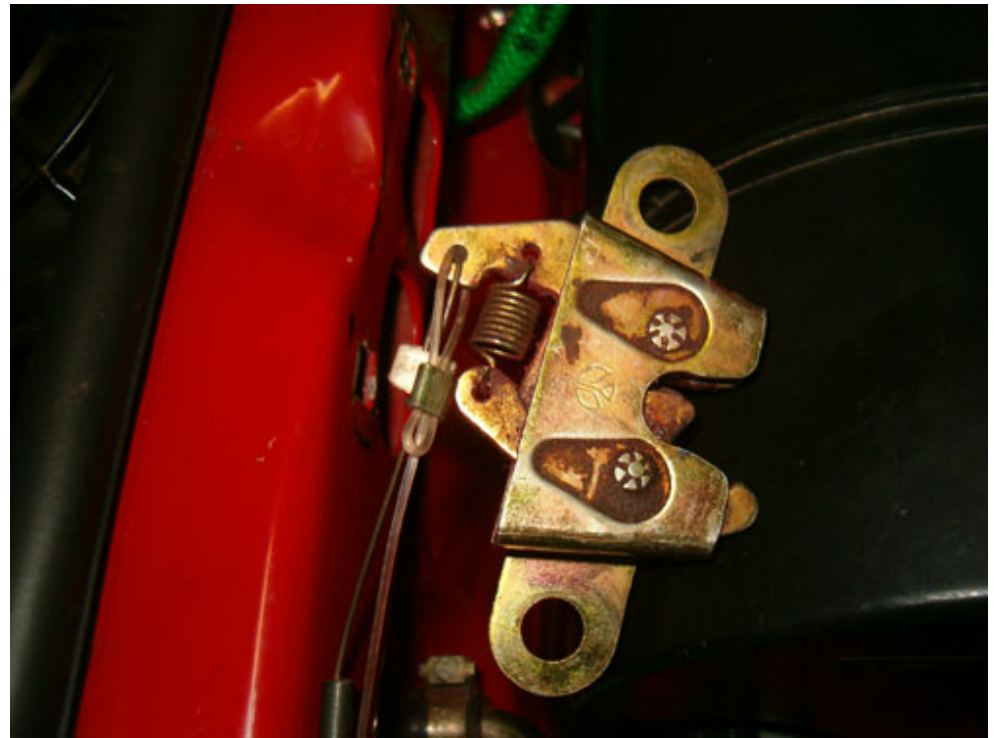
... and the hood latch mechanism

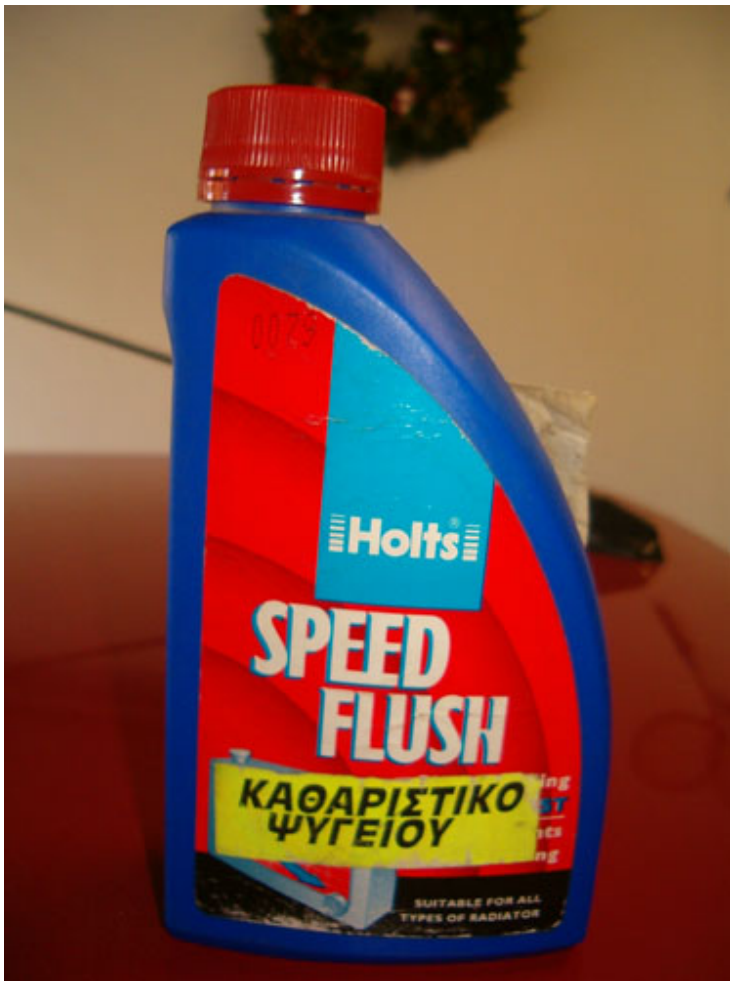
It is now time to flush the rust out of the cooling system. Instructions of the liquid specify to flush old coolant, fill in plain water and add the cleaning fluid. The motor should run at high revs so that the fluid circulates everywhere in the engine block. Highway driving is proposed.

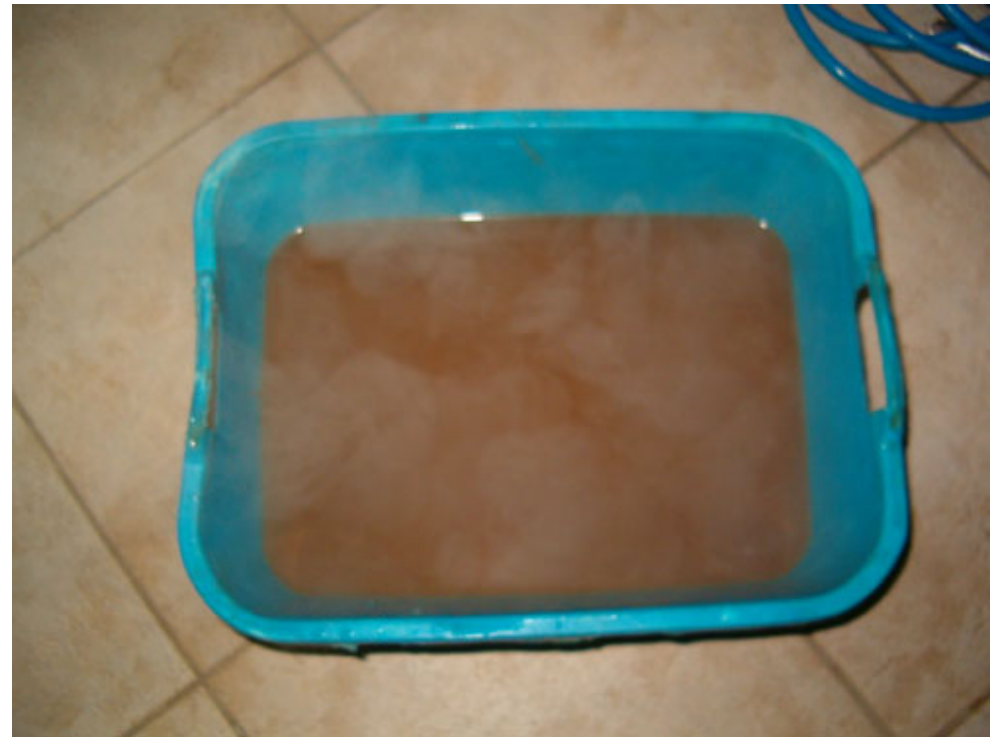
This is not old coolant. It used to be plain water with the flushing liquid having done its miracle. All the crud is out of the cooling system.

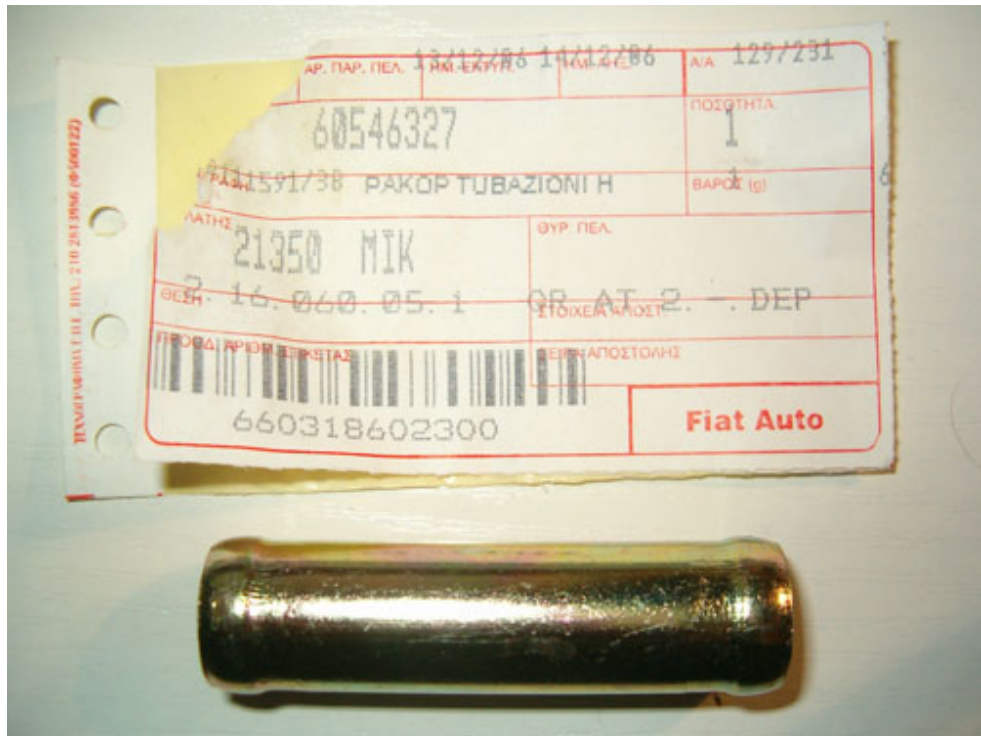
New connections for the cooling hoses. Some of them have been substituted by plastic ones. The good point is that they will not rust ... but over time they may probably harden and tend to break. However, only time will tell ...

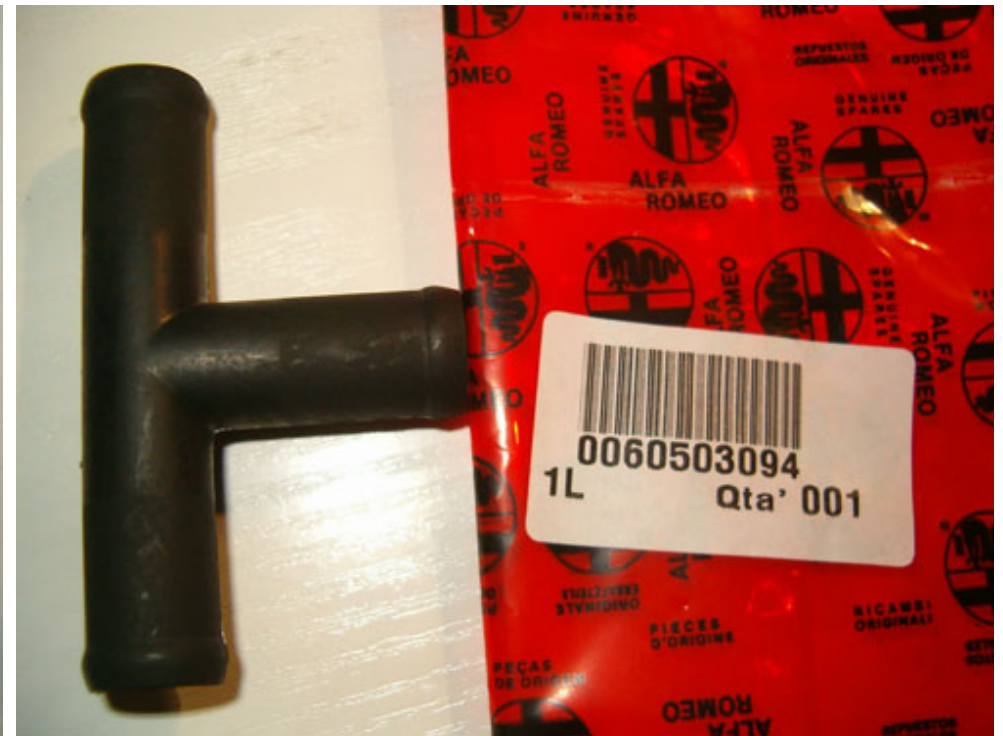
T shaped connection with equal diameter edges

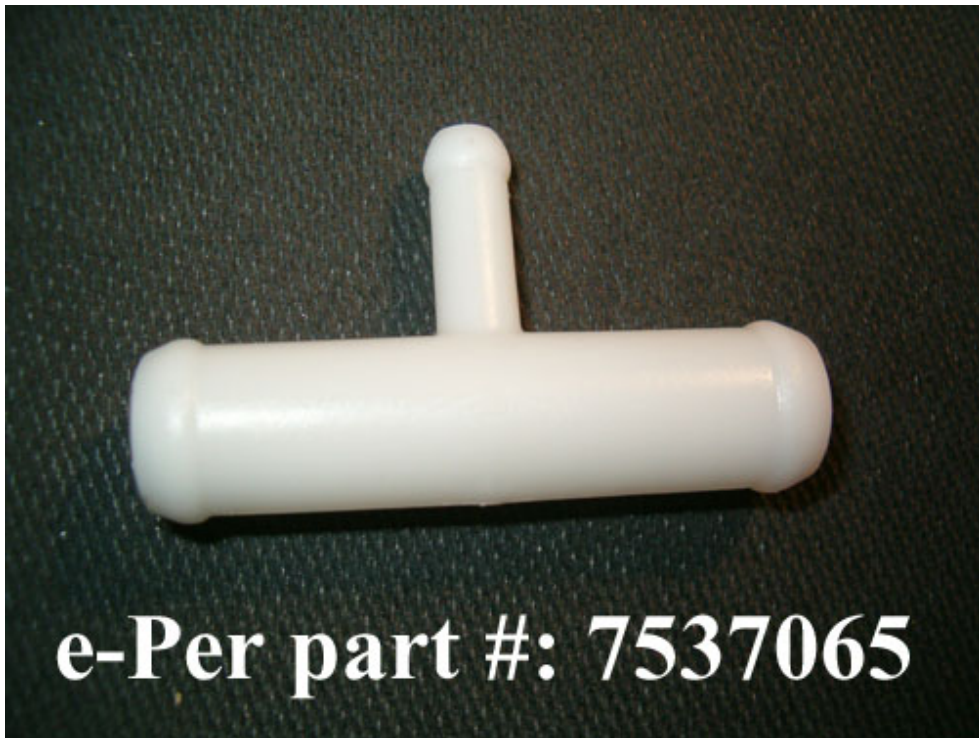
e-Per part #: 7537065

T shaped connection with small sized upper edge. This is used for the junction of the thermostat - intake manifold - heater hoses.

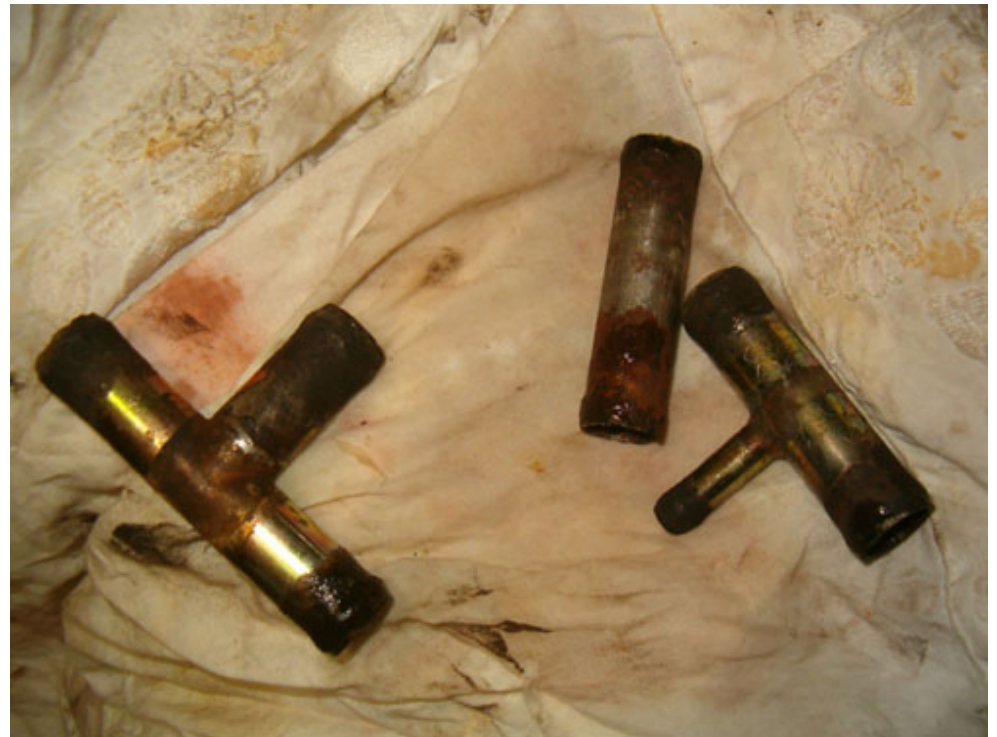
Old ones rusting ...

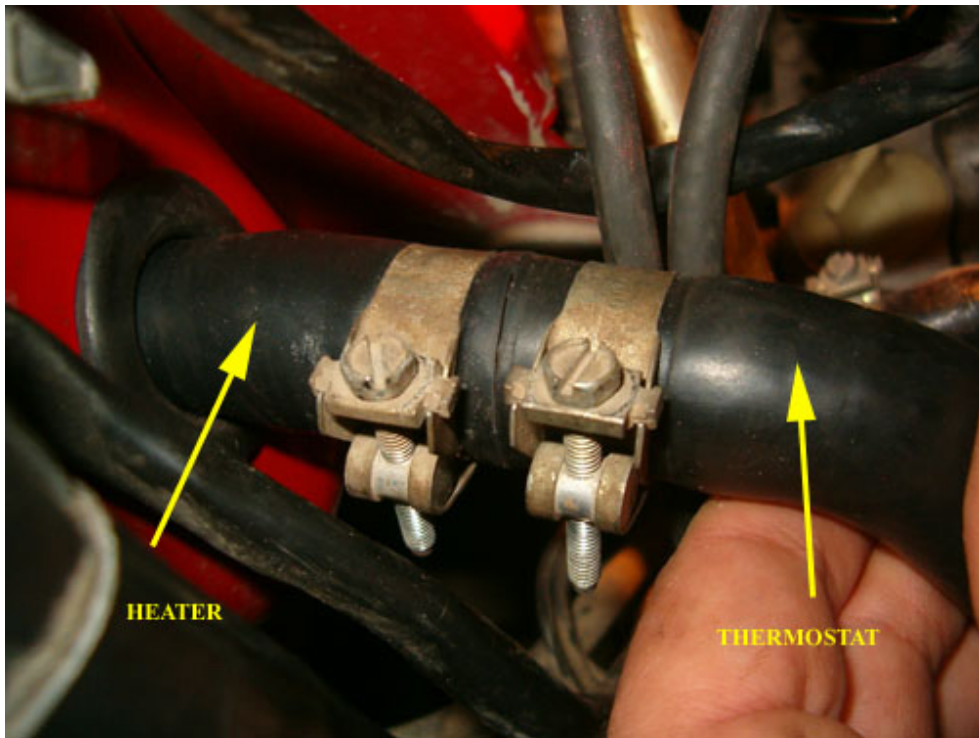
HEATER

THERMOSTAT

The metal connection (60546327) fits in the above junction ...

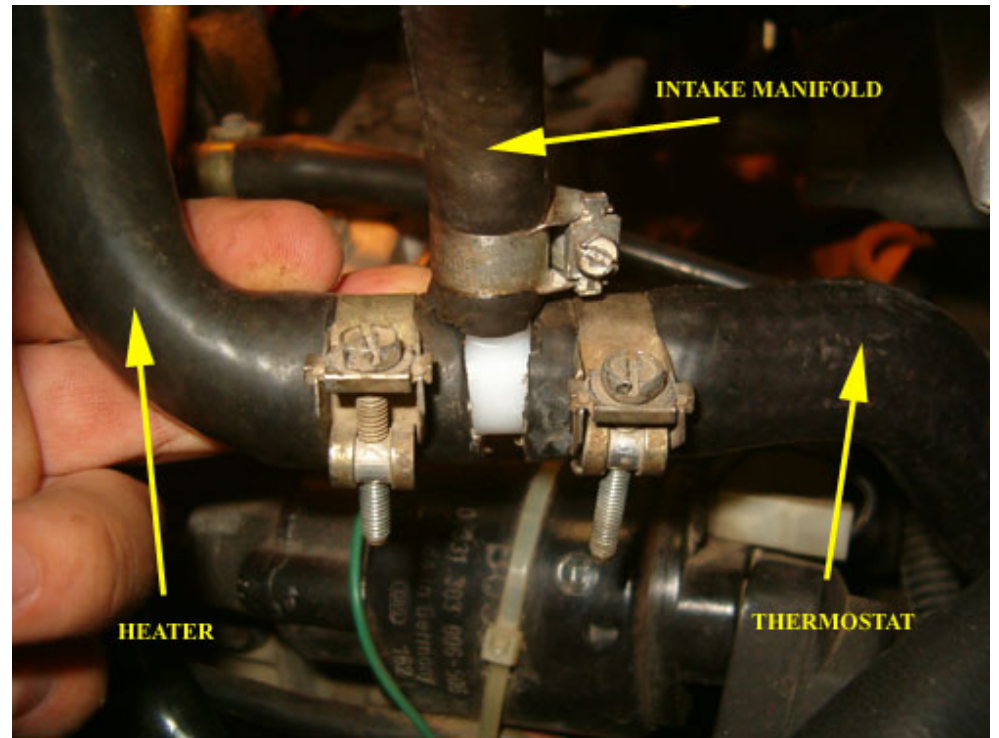
INTAKE MANIFOLD

HEATER

THERMOSTAT

... and plastic connection (7537065) as demonstrated above

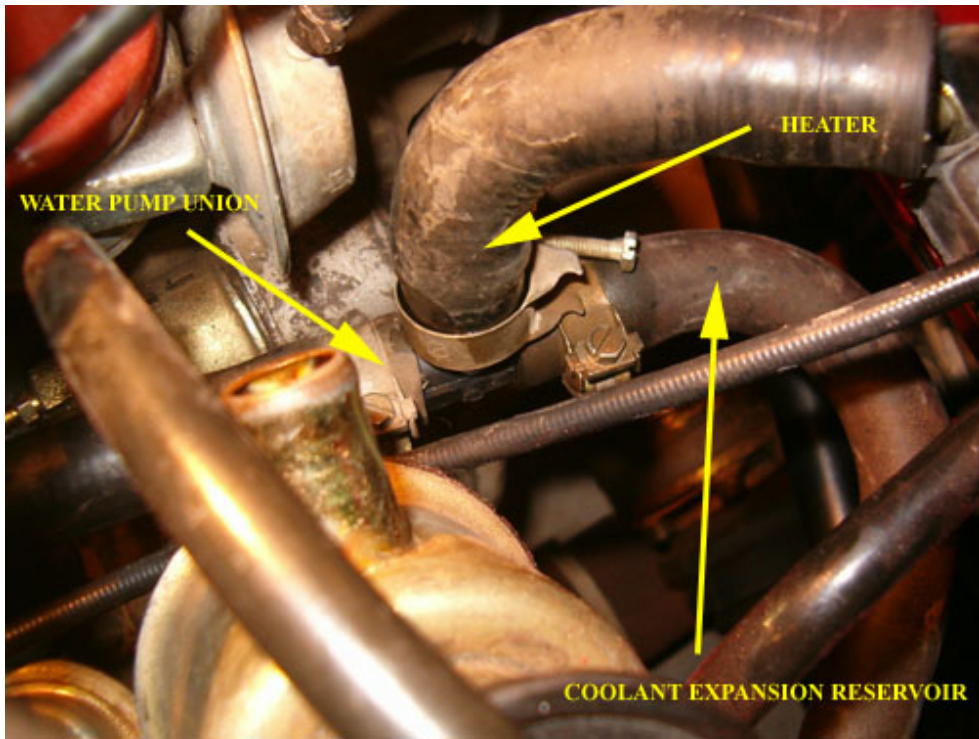
and the remaining connection as shown

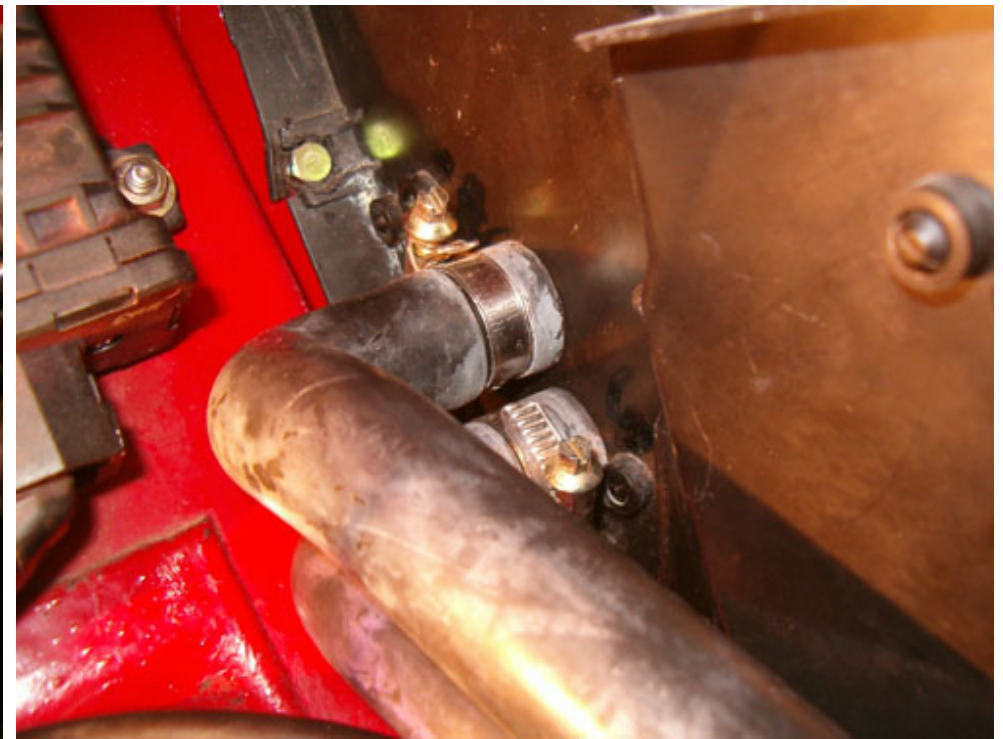
Restore heater core supply hoses ...

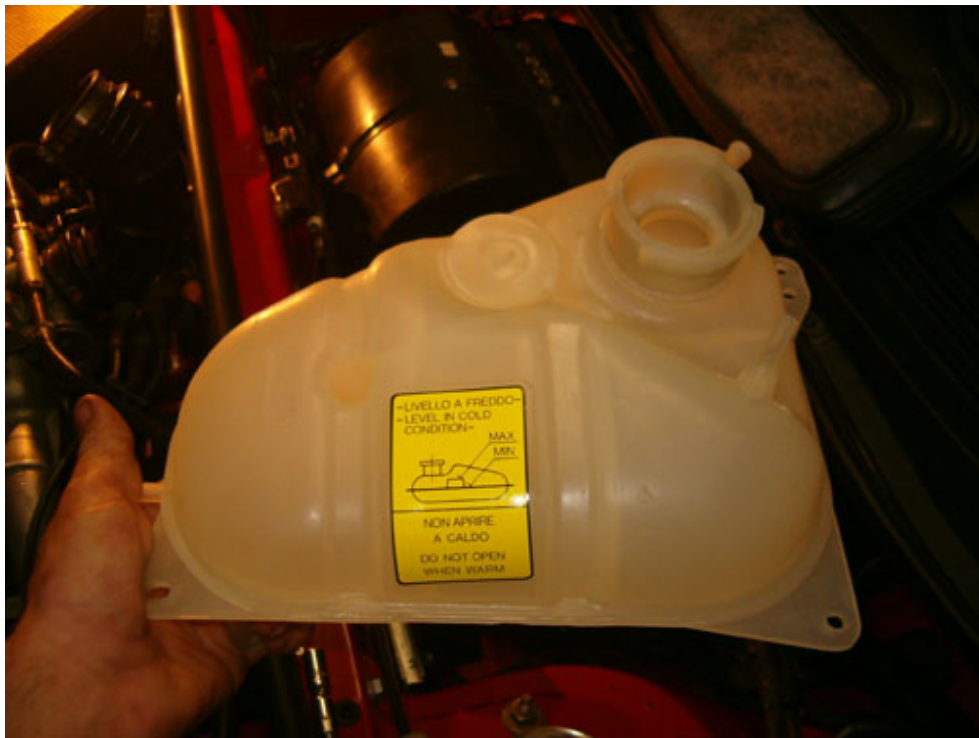
...and install new reservoir expansion tank. The previous one contained so much rust deposits that coolant level could not be distinguished!

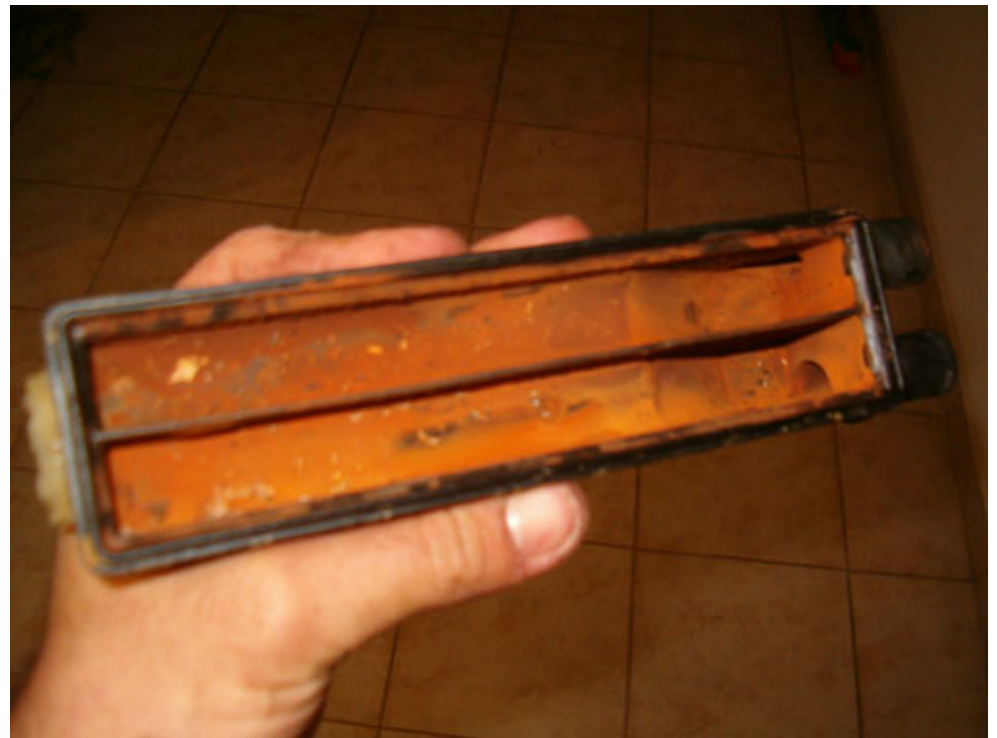
Here you can get the idea of rust inside the cooling circuit. This is the side tank from the old heater core.

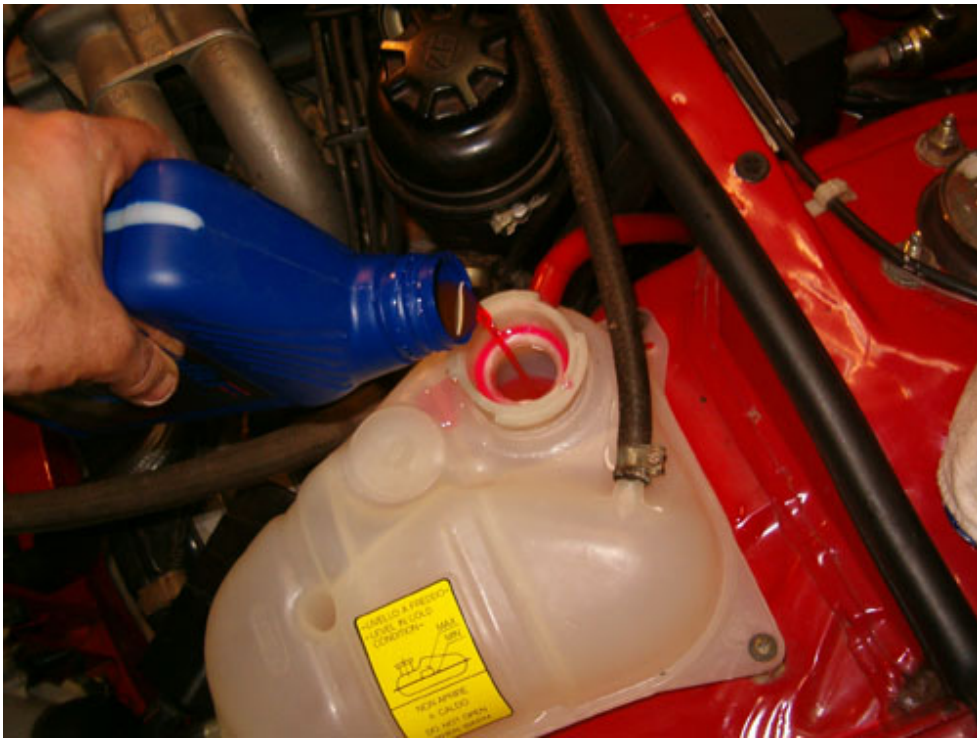
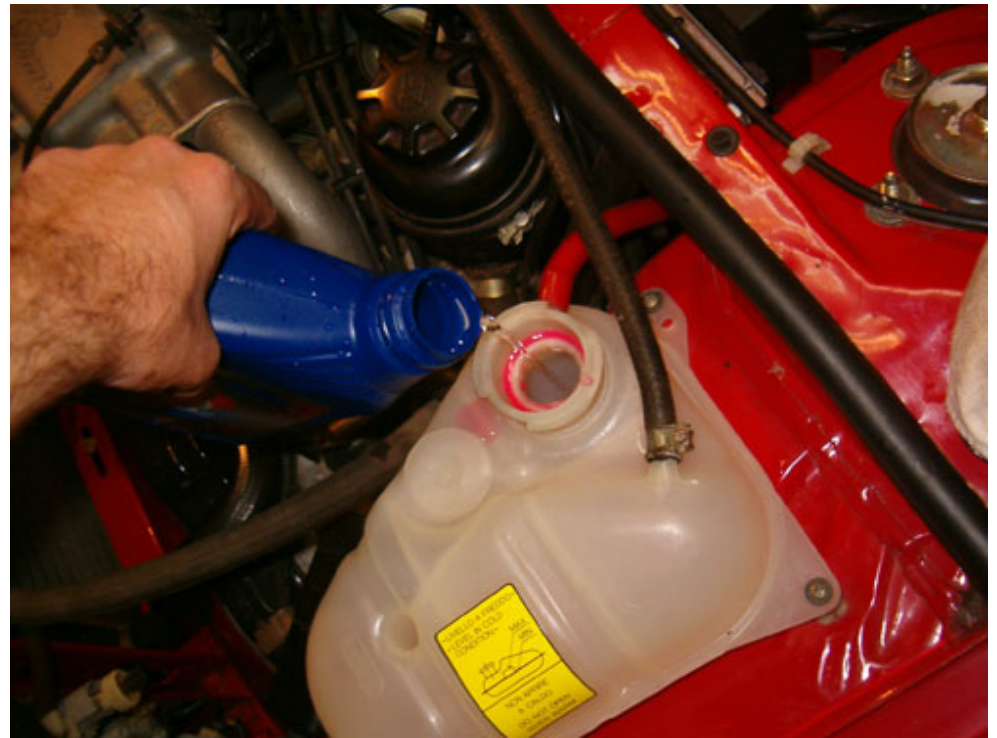
Finally fill in the circuit by adding 50% coolant and 50% diluted water. Squeeze lower and upper radiator hoses in order to expel air locked inside the cooling circuit

Fire up the motor, and let it run at normal running temperature until thermostat opens and the fan kicks in.

Check heater operation; it is common for heater cores not fully working at initial coolant fill as airlocks are formed inside. You may also take the car for a drive so that engine works on street conditions. Then check again coolant level and top up if level is lower than designated.
