Suspension Maintenance

This time we will attempt to maintain the suspension of our Alfa 33. This manual features a ground up repair including new springs all around as the car appeared to be sitting slightly tilted from the drivers side.

1991 Alfa 33 1.4 IE

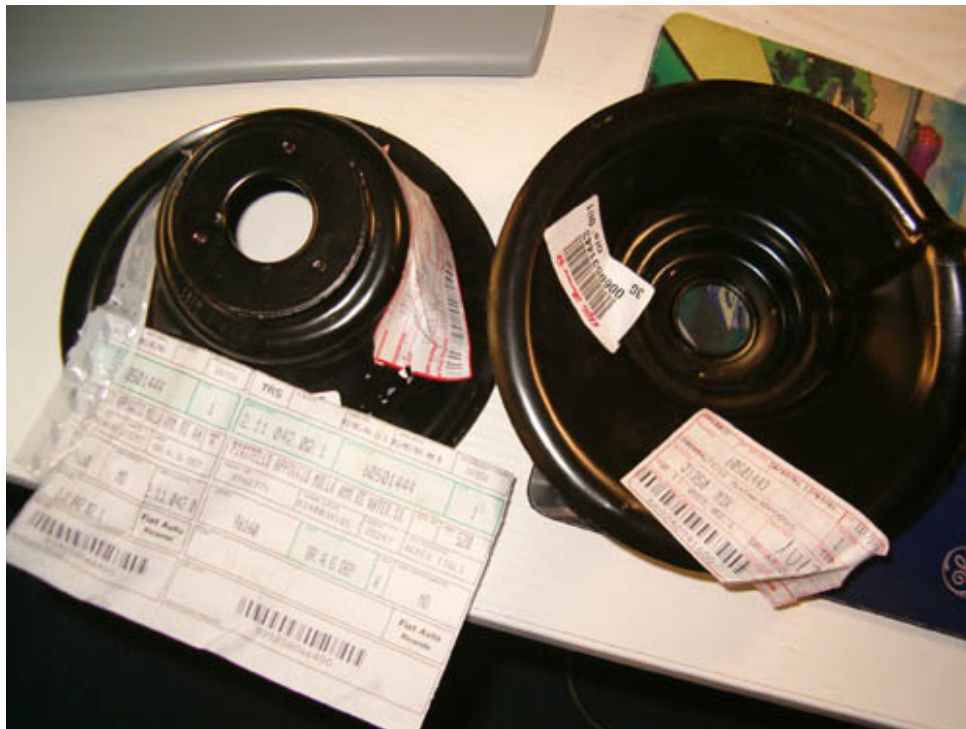
These are the lower spring plates - here a problem exists as there is product shortage for the right side plate (60501444) and I was lucky to find one from France. My parts dealer did a nice trick to declare my car as being off the road due to suspension problems and the part was finally found after ... 3 months!

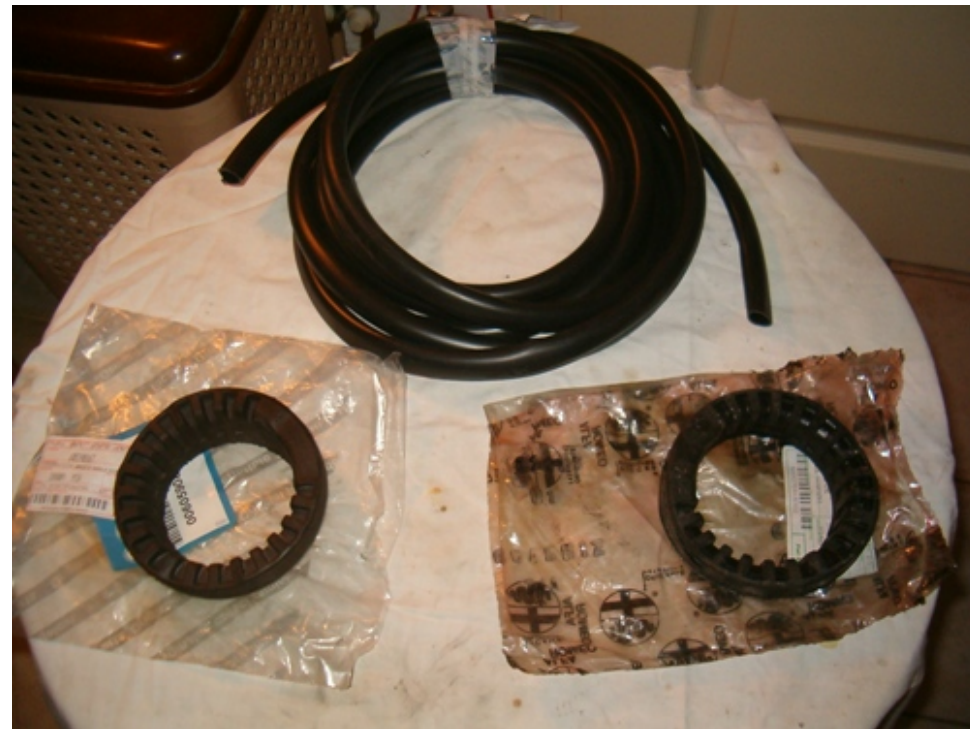
Here you can see the rubber spring hose that actually wraps around the first turn of the front springs and the rear thrust rings fitted between the shock tower and the springs. The rubber hose is sold per meter. To my surprise the right thrust rubber ring, featured an unusual product code which after some research it proved to be the Alfasud part number! This is what is called New Old Stock parts!

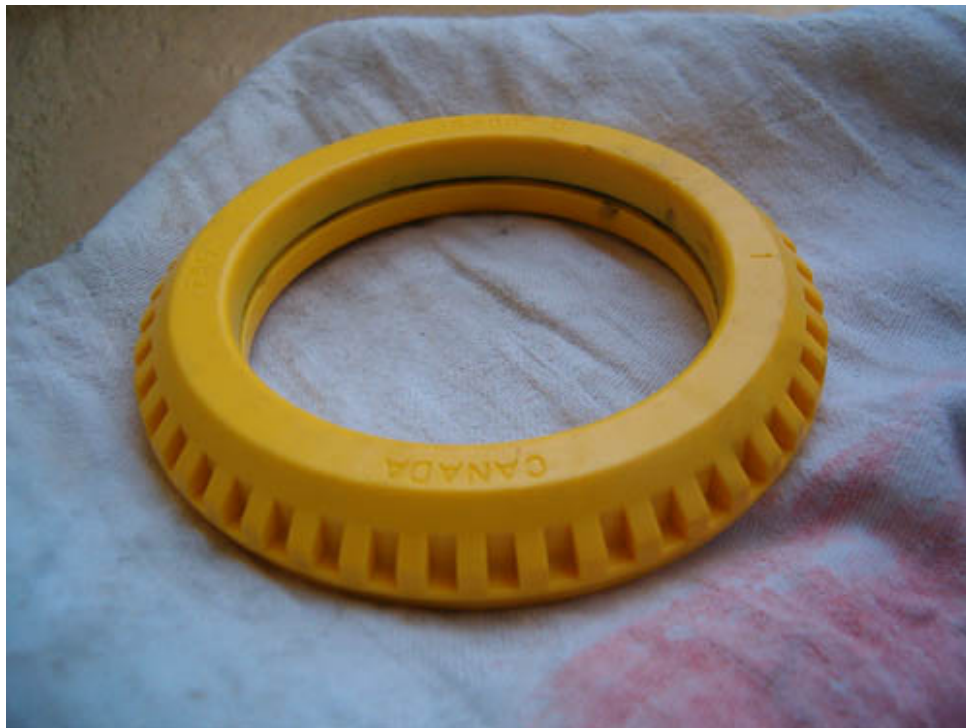
This is the notorious strut pan bearing that is prone to wear. Actually this bearing holds the weight of the front part of the car plus the tension of the suspension.

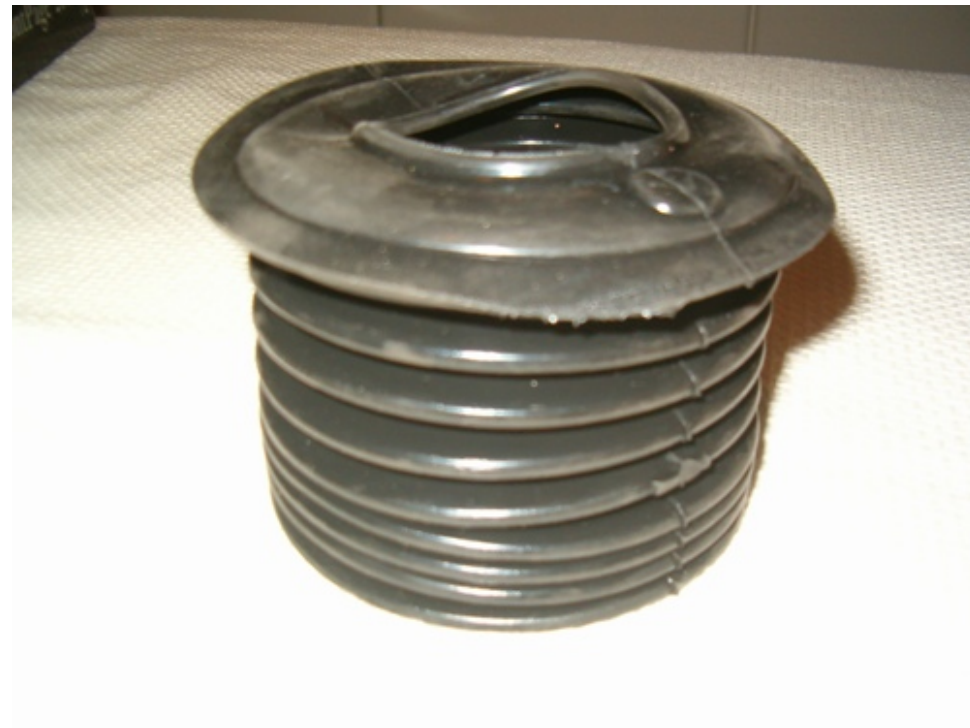
Not much to say about the boots of the strut. These boots, strut pan bearings and lower spring plates are common parts with the Alfa 164.

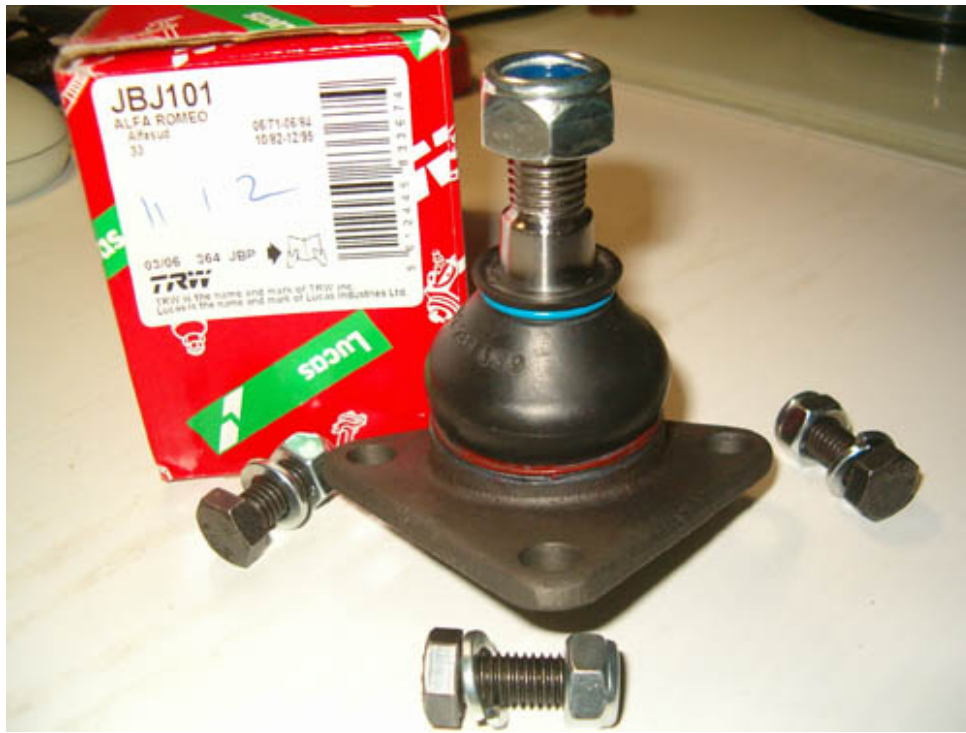
Here you can see the lower ball joint of the suspension. It is a TRW product NOT found in AR parts dealers. Note that the original semi-trailing link has the ball joint tied together with big blind rivets which were cut away when I had the ball joint replaced for the first time.

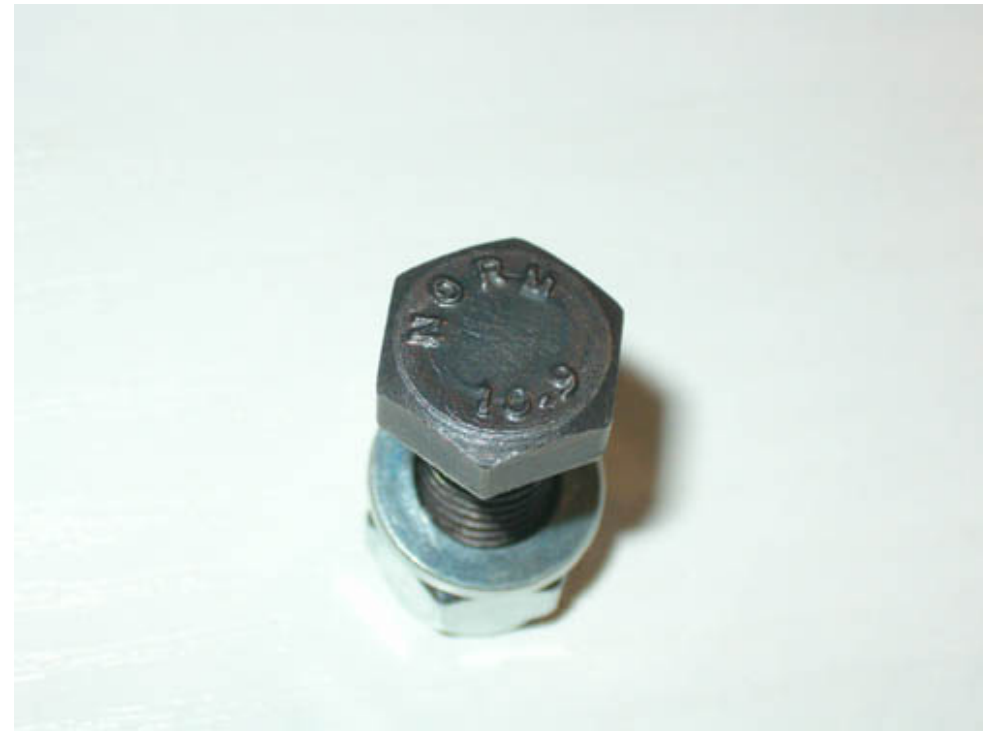
A close up of the bolts used in the repair kit. It is the most hardened steel (rated 10.9) so there is no need to worry for its effectiveness.

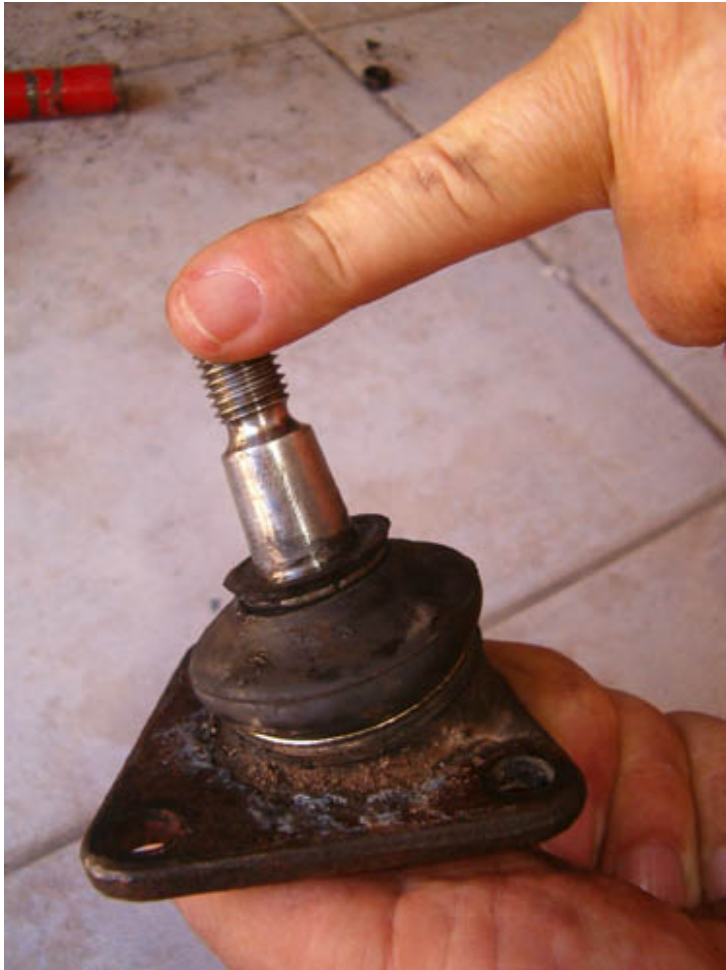
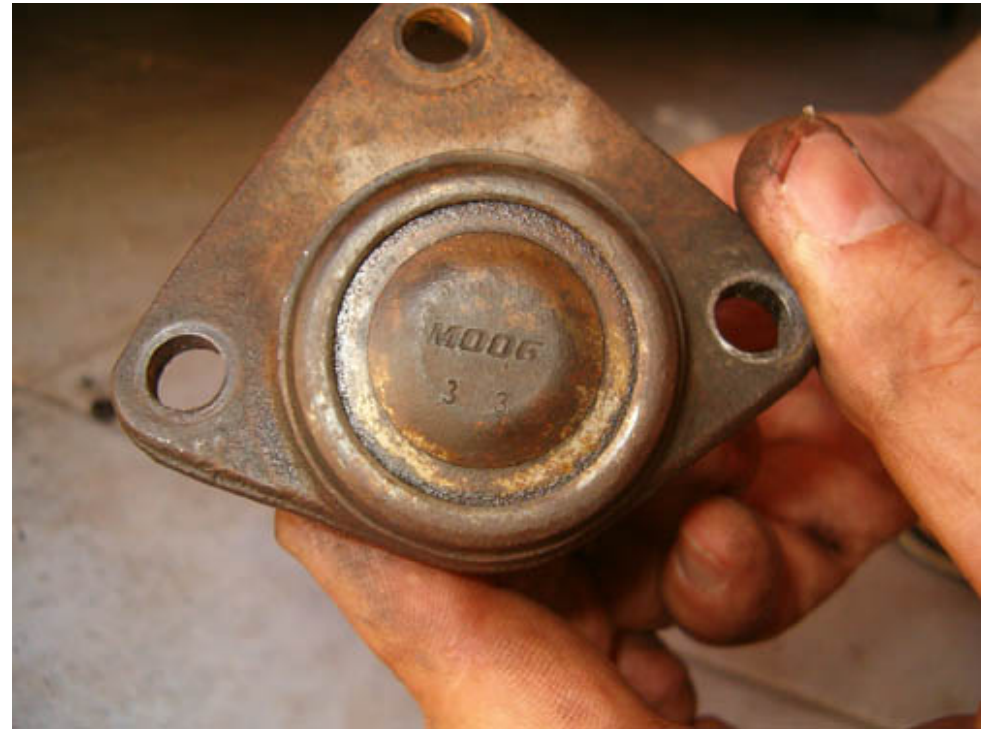
Notice the extend of wear as you can move the pin easily with your little finger.

I wouldn't recommend you to use MOOG ball joints ... It lasted only 2 years but who guarantees that the new one will live longer? The funny part of the story is that the original lower ball joint lasted for 13 years without any inner wear ... the boot was the one that gave off the spirit; that's why I had them both replaced.

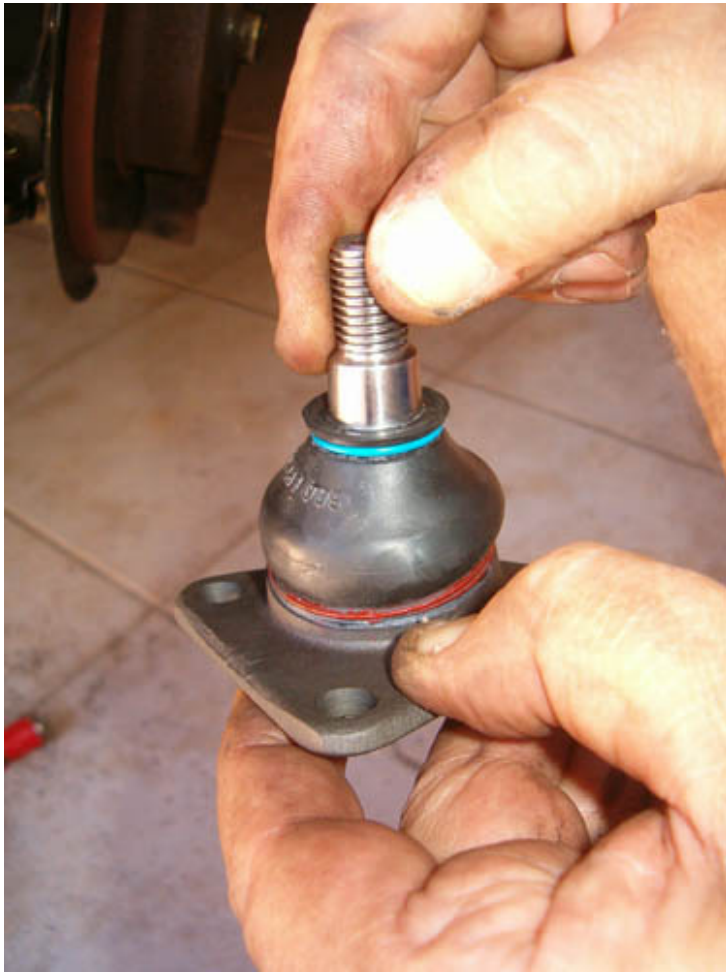
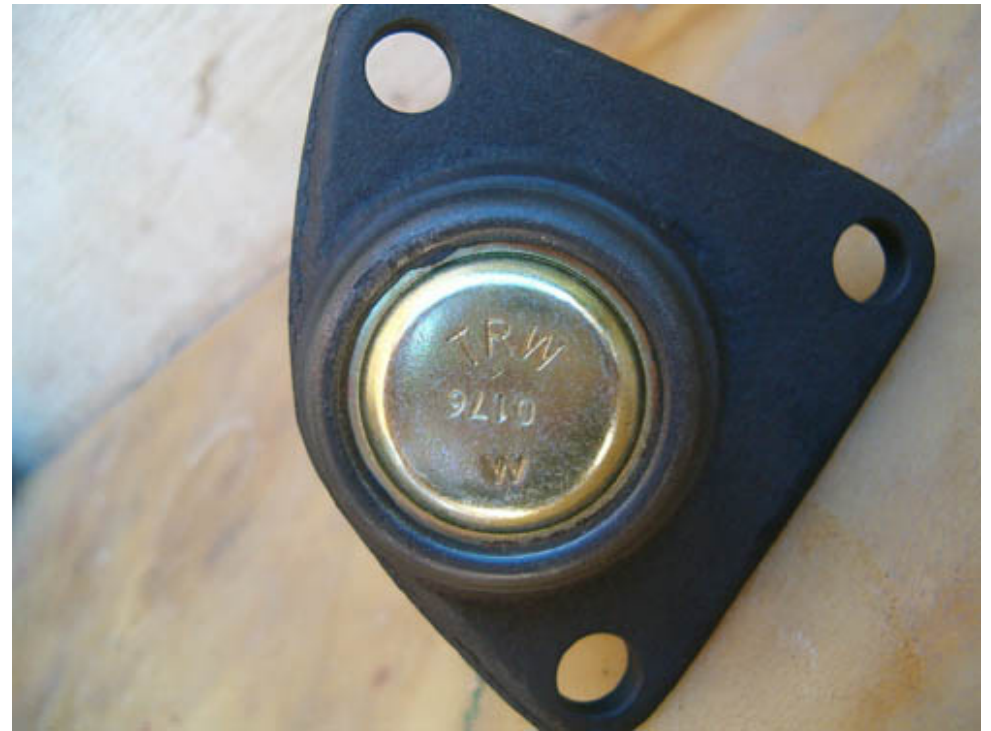
This is the new one where the pin wouldn't move no matter how hard I tried!

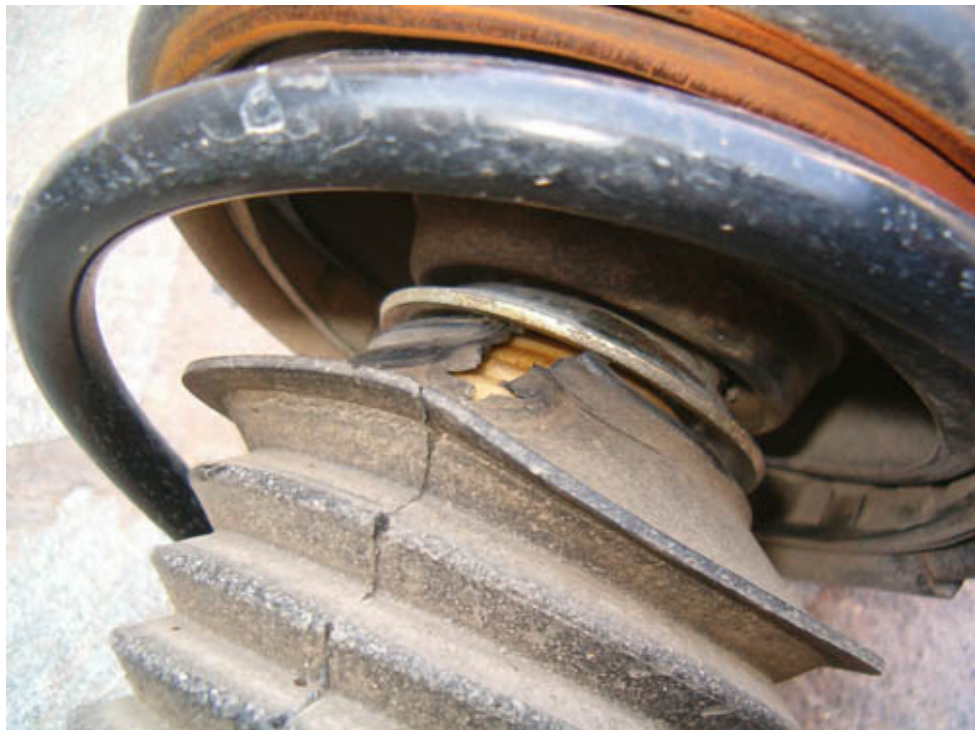
rubber boot is completely shot

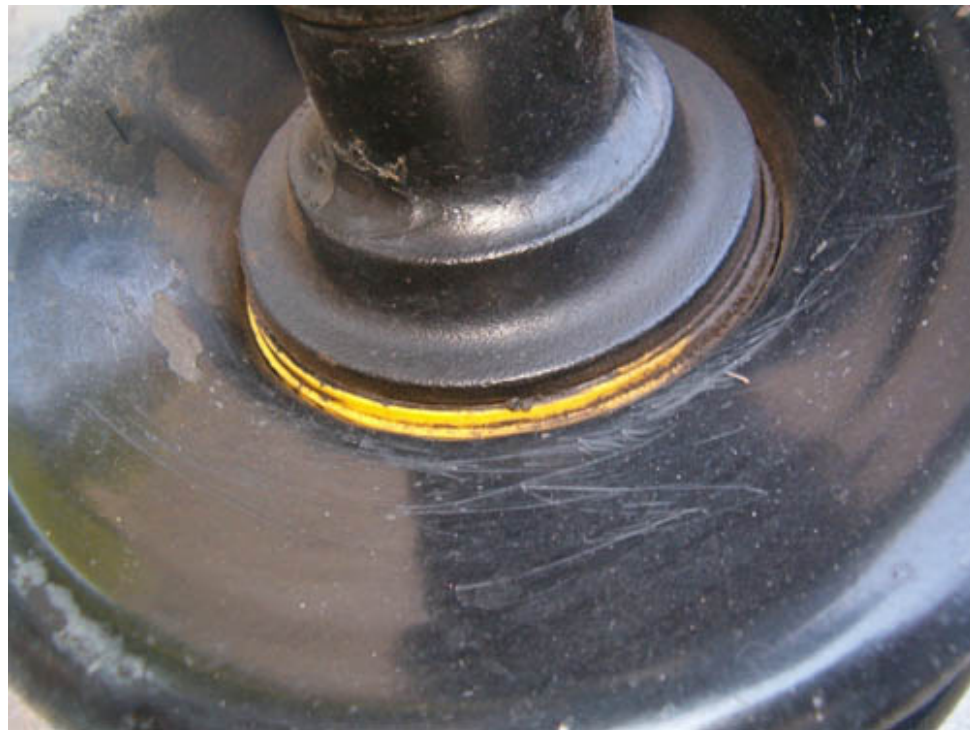
strut pan bearing doesn't look that bad ...

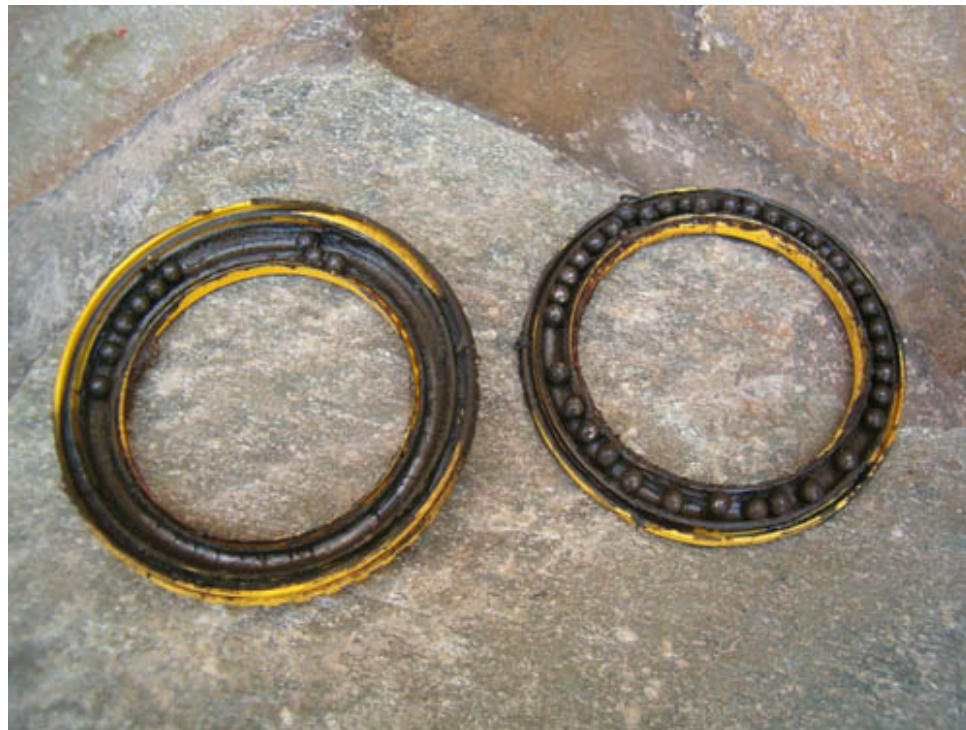
in fact it is collapsing...

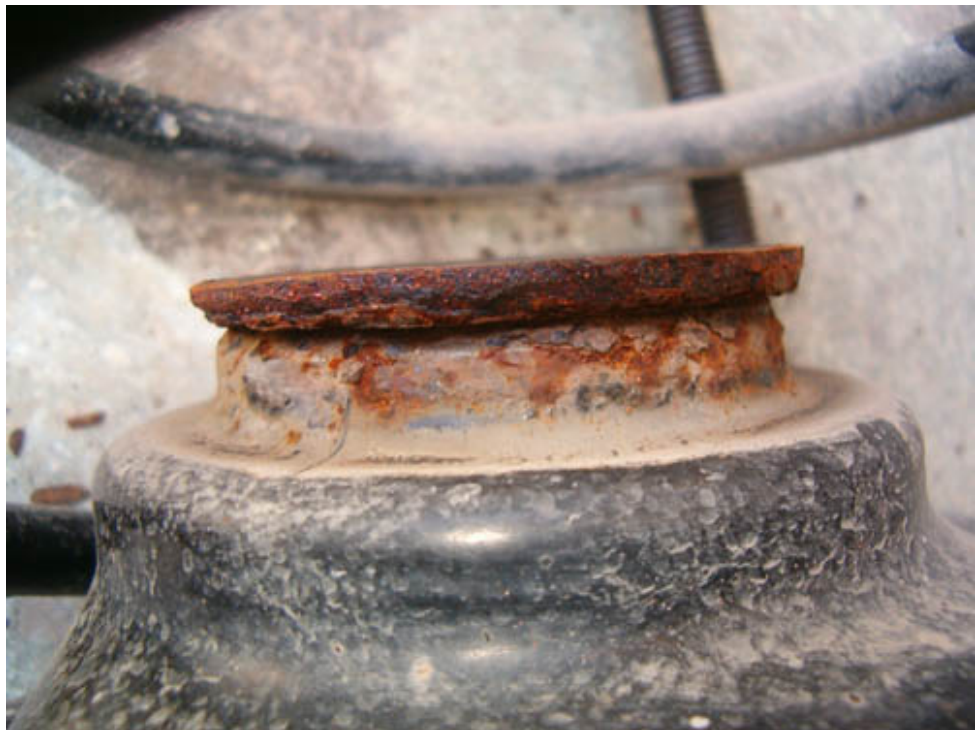
... and lower spring plate rusting away

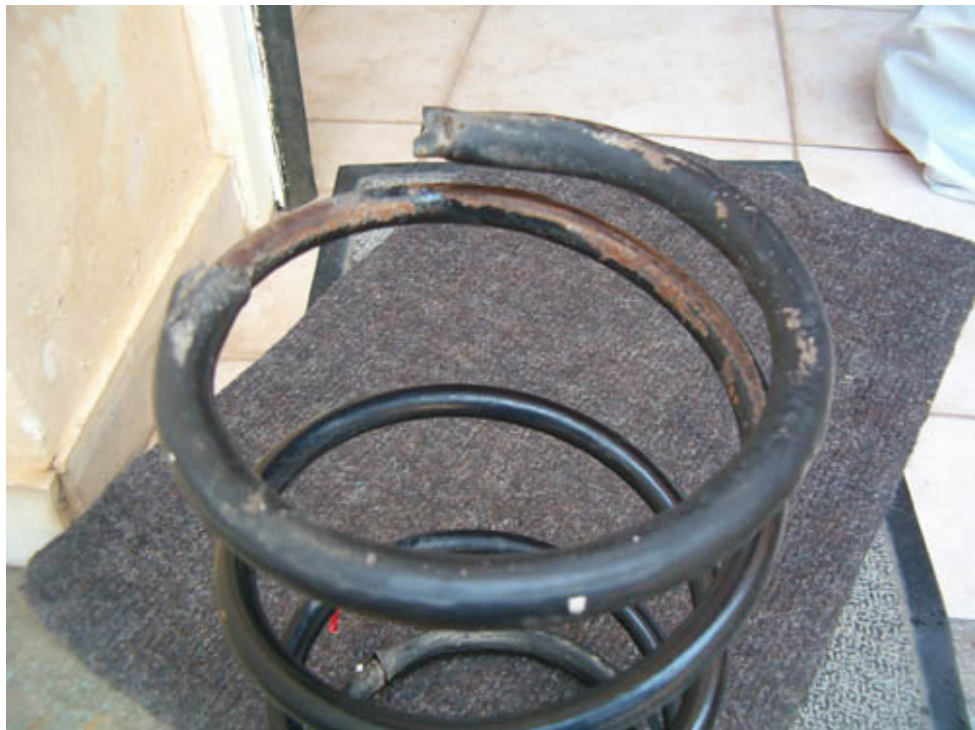
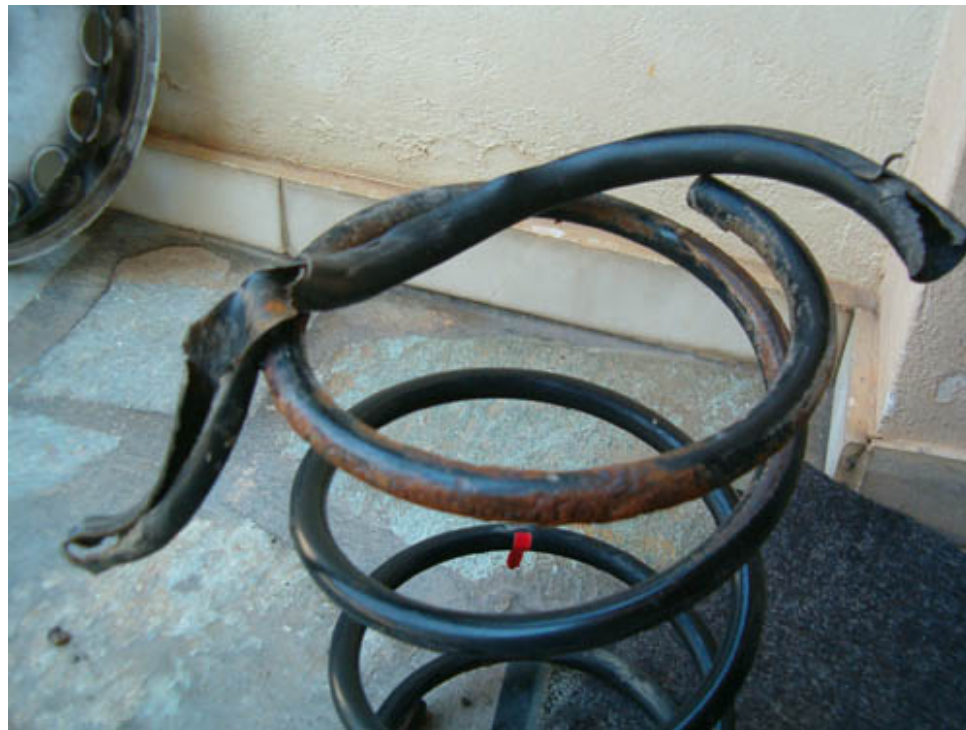
See the extend of corrosion on front springs and the wear on the rubber hose ...
