## Windscreen removal, maintenance and installation

1991 Alfa 33 1.4 IE

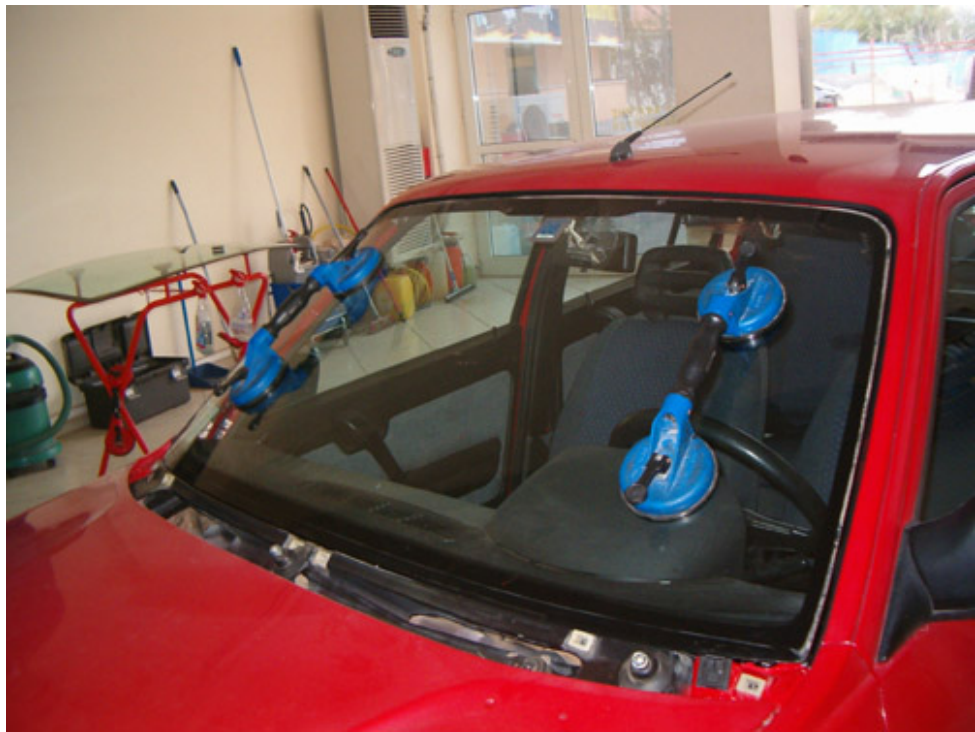
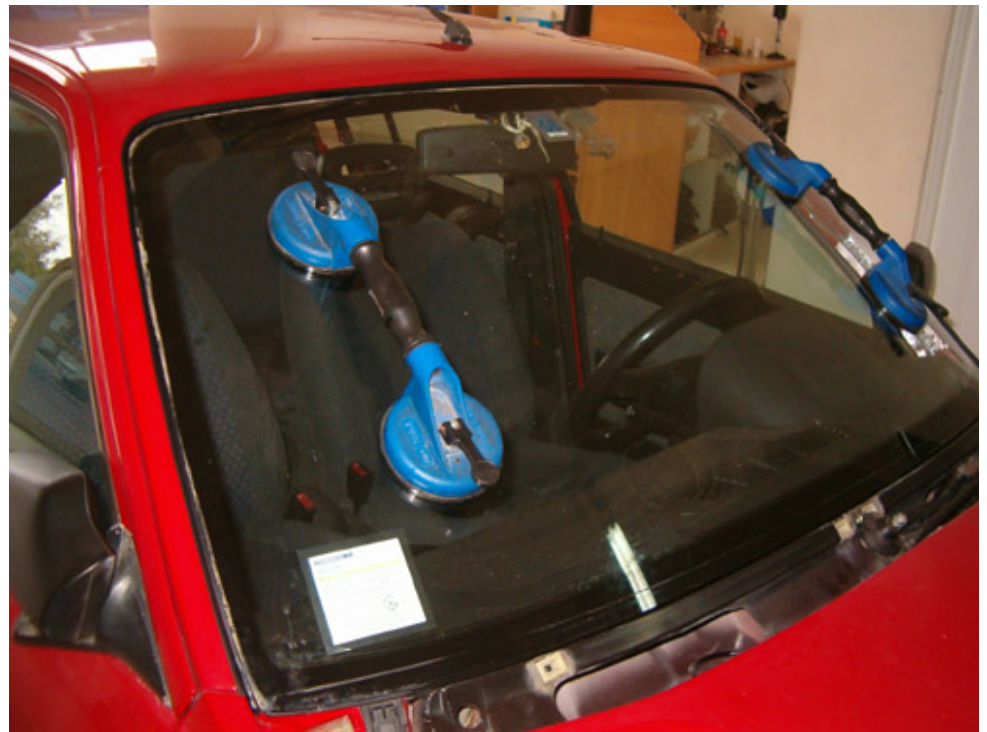
The suckers are now doing a nice job. Michael and his father are merely installing the windscreen.

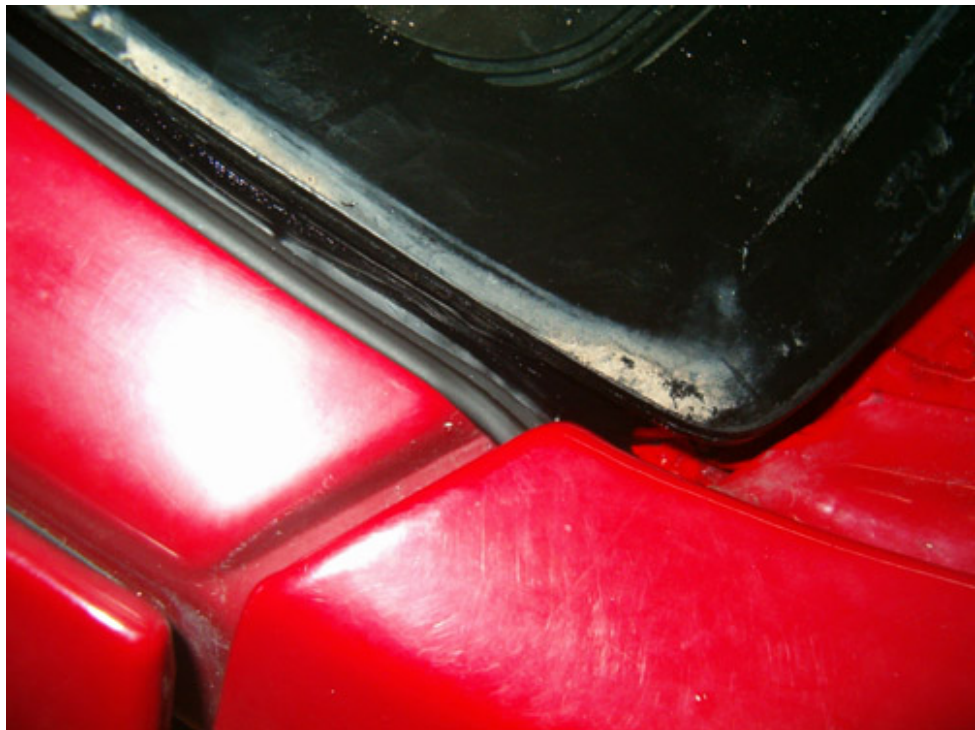
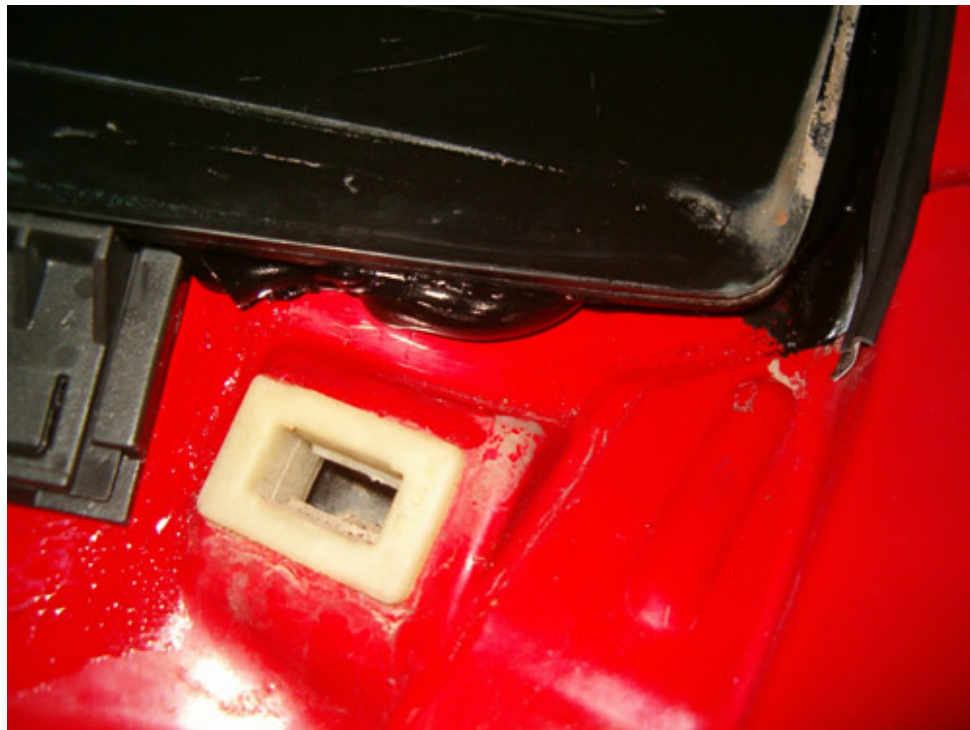
The windscreen gaps around the frame are now adjusted and the plastic stops on the bottom of the frame are locking the final position of the windscreen

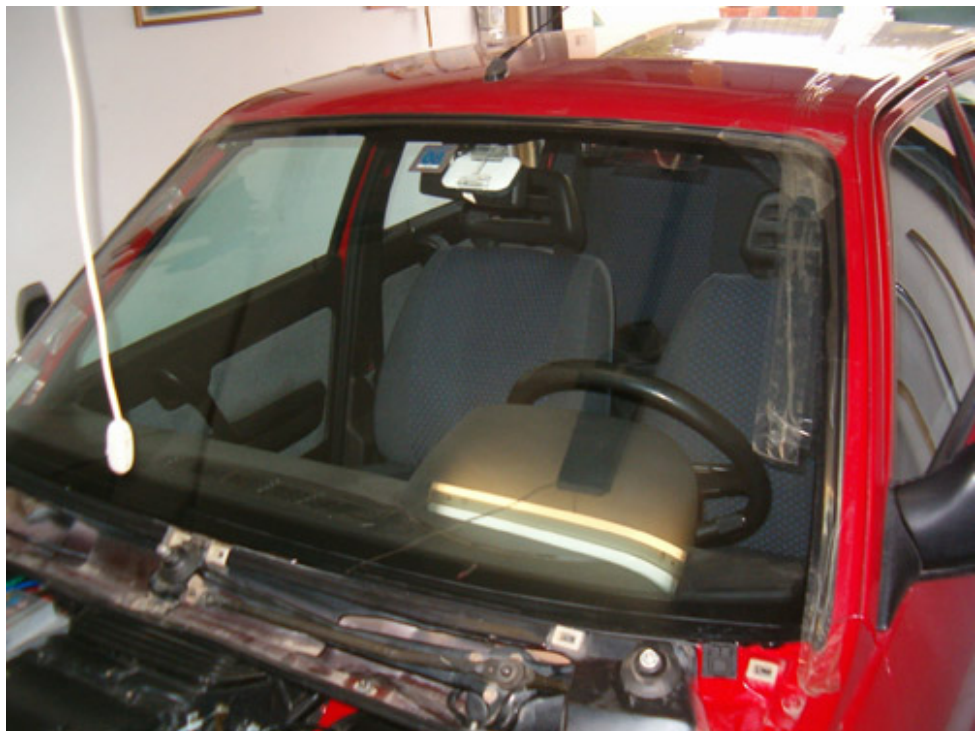
Michael is applying the final finish of windscreen glue to the gap and the decorative rubber strip is finally installed

In order to be safe than sorry, adhesive tape has been used in order to keep the windscreen fixed in its position until the glue dries. After 3 hours from fitting, the vehicle can be normally used with no problem whatsoever.
