## **Inner Wheelarches & Luggage Compartment Maintenance**

1991 Alfa 33 1.4 IE

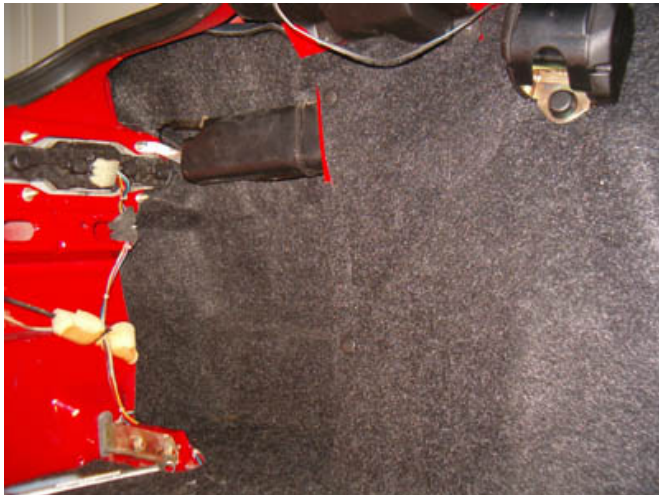
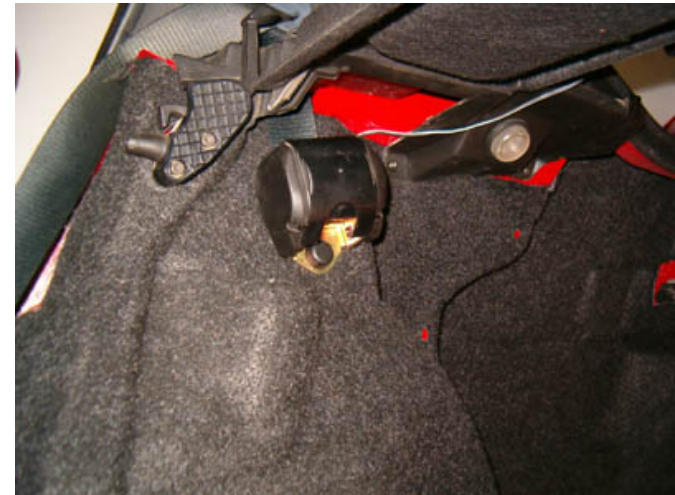
It is now time to clean both wheel arches. It is a job that needs to be done with patience since every bit of dirt must be removed. Again use sponge, brush, toothbrush for the difficult spots and plenty of soap. The middle photo shows the area of problems ... water is coming in from the topmost part of the vertical cylinder and finds its way to the luggage compartment. Note two pieces of rubber material coming out of the upper cylinder part; the left sits much lower compared to the right one. This is the reason of troubles; misaligned factory sealing. This material in excess will be removed and sealed on top.

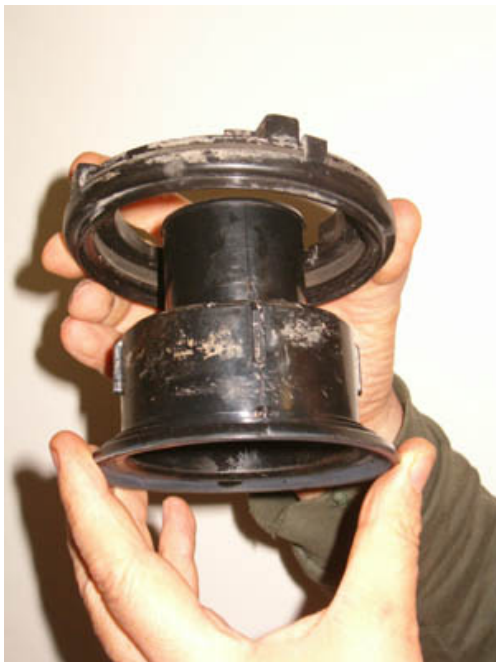
... and rusted inlet. Note that the inlet assembly (spring & door) are NLA items (No Longer Available); so it would be wise to clean out rust and preserve it as much as possible.

After cleaning out the filler neck and ring, a small demonstration of the way it attached to the body.
