Dial/Dashboard Bulb Replacement

1991 Alfa 33 1.4 IE

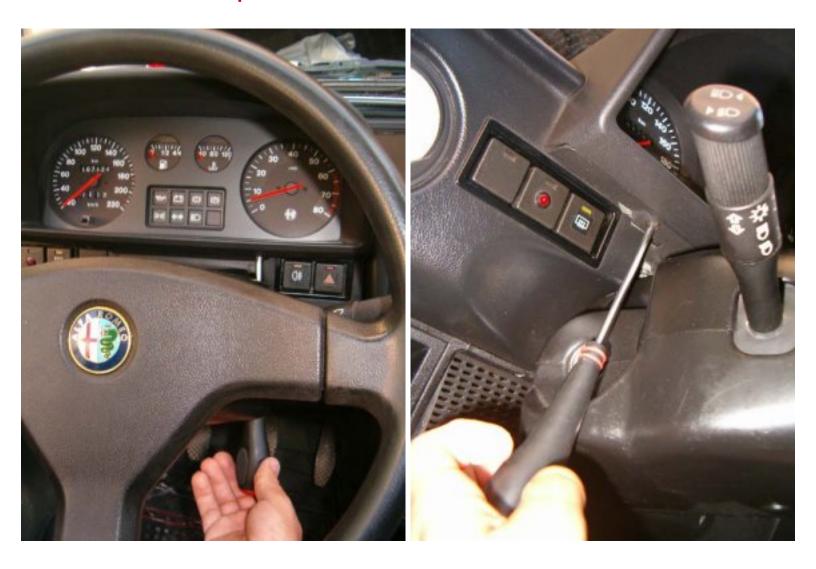
First undo the two screws that hold the dashboard's shell in place.

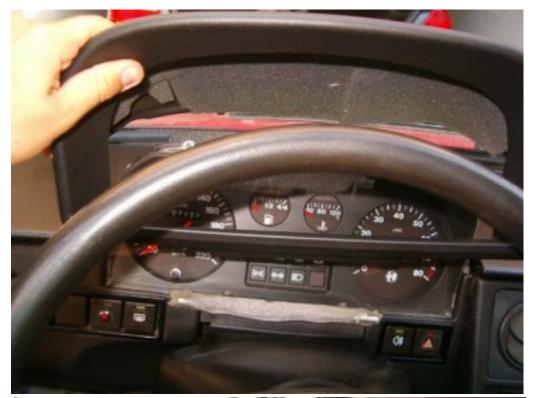
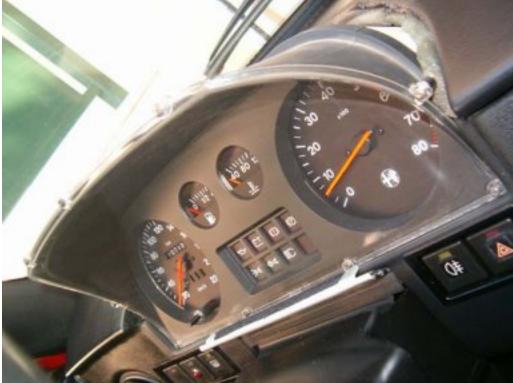
Now lift the shell carefully so as not to break the two holders on the back of the shell. Actually these two holders are the rear support of the shell and if broken the shell cannot remain fixed in position ... meaning rattles!

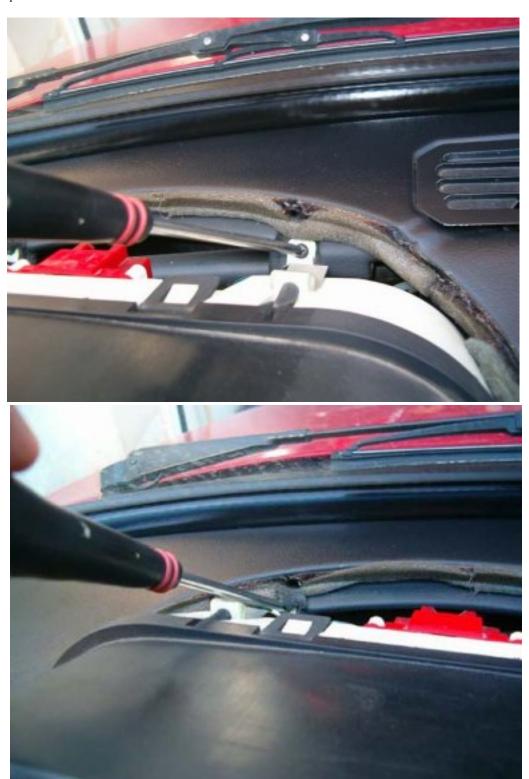
Undo the two screws that hold the instrument panel to the console. These are the first pair of screws that must be removed; the other pair is located on the base of the panel which will be described later on.

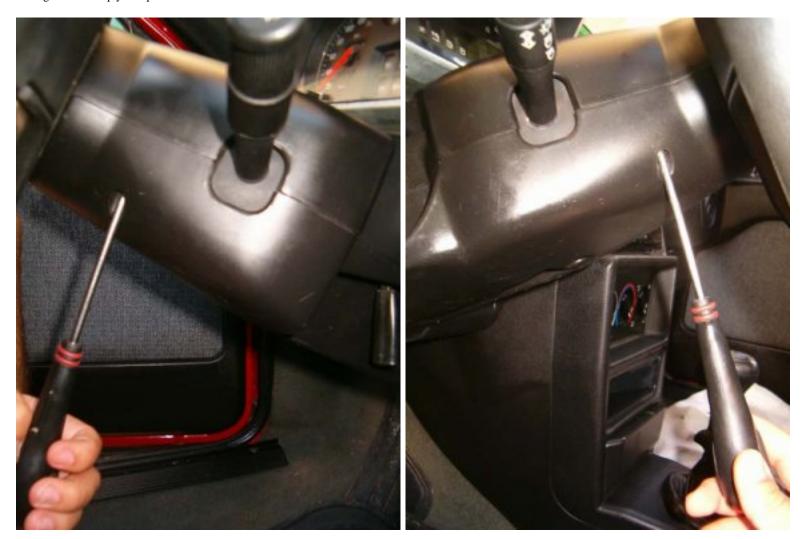
It is now time to remove the steering column cover. It is held in place by 6 screws pretty long on their threads ... so be prepared!

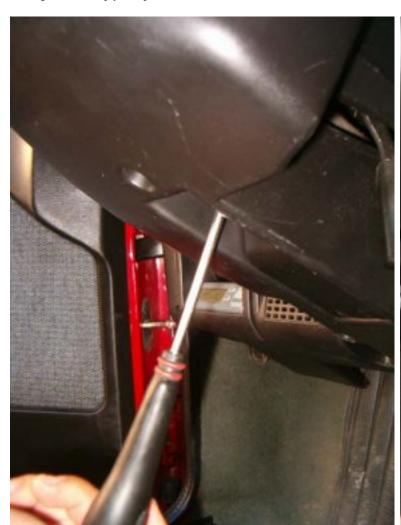
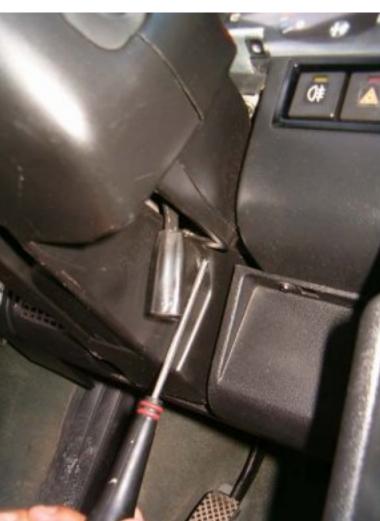
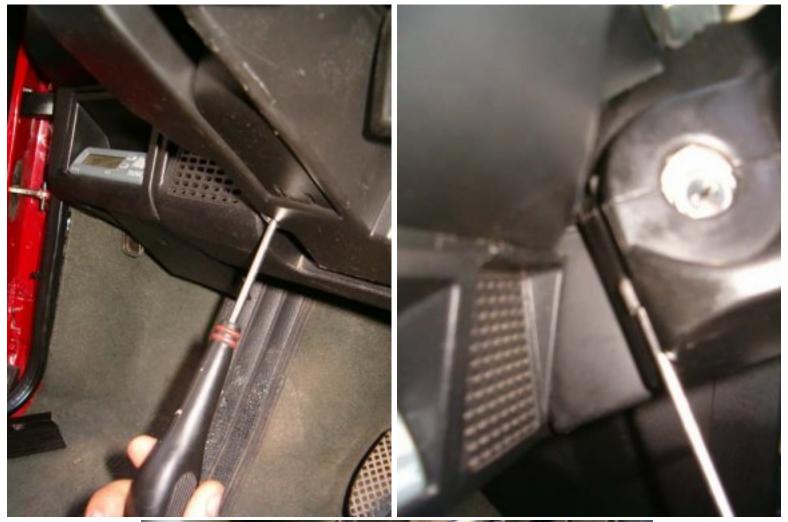
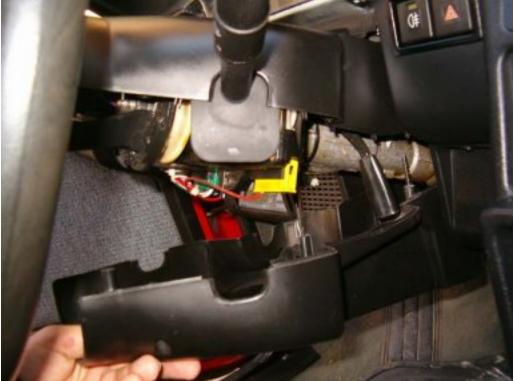
At last the screws are out and the lower part has come off ...

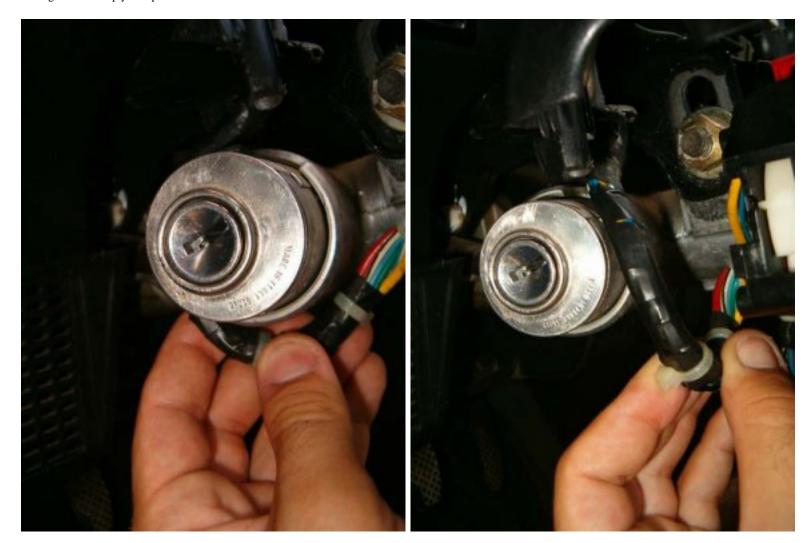
In order to remove the upper part of the cover move to the left the cable harness passing under the steering lock, as shown on the pictures above.

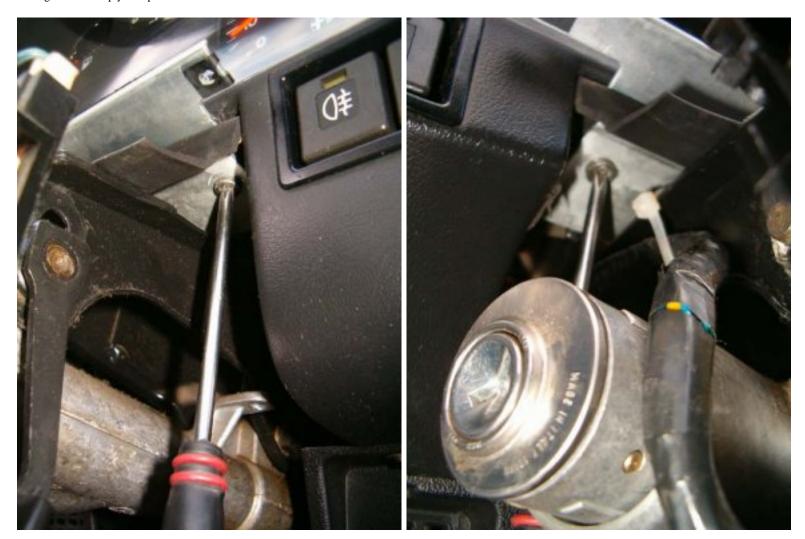
Now that there is space in the room, undo the second pair of screws that hold the instrument panel to the console

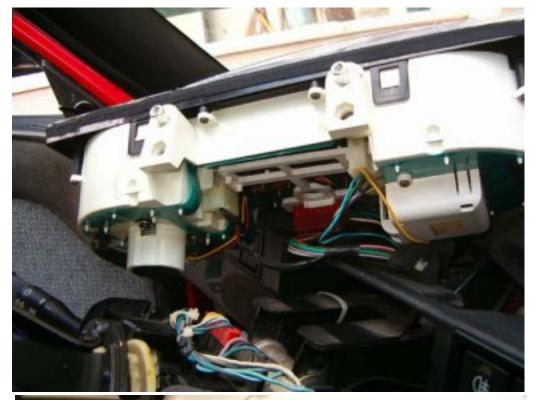
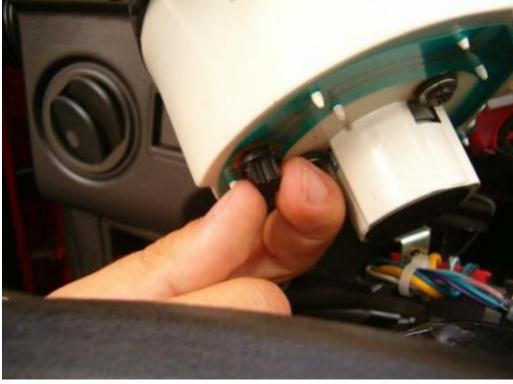
Here is the panel turned upside down ...

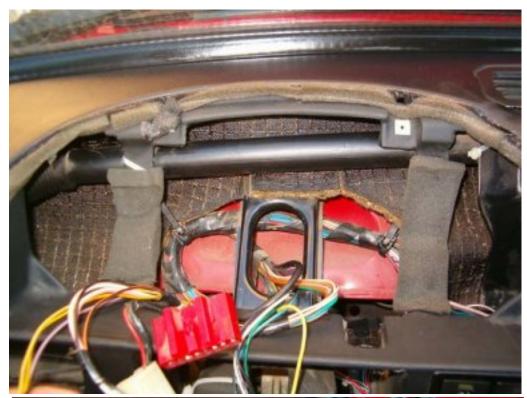
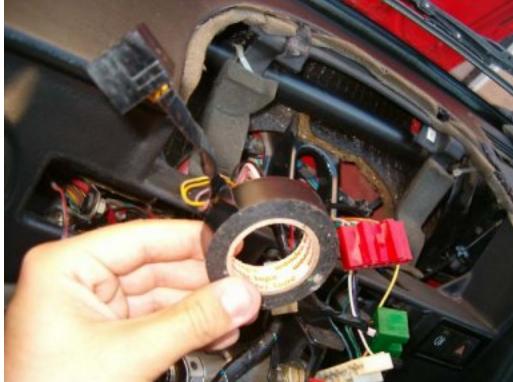
It is a good time to tidy the place ... electrical tape for keeping together every cable harness

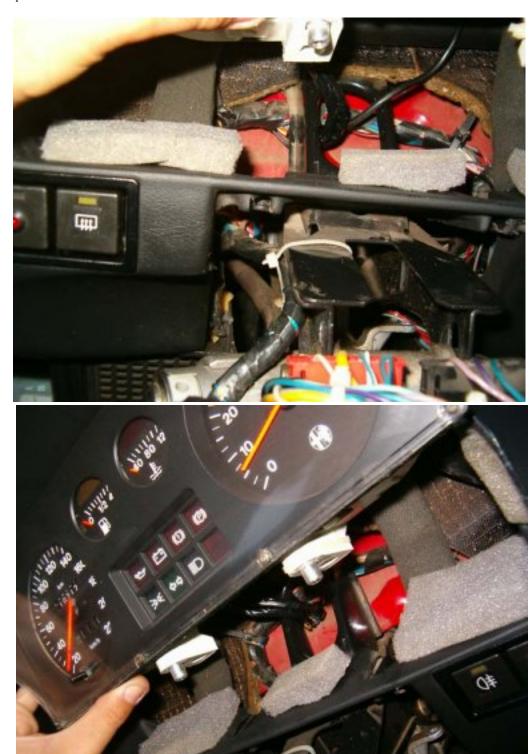
Everything 's ready for reversing the removal procedure ...it is a good idea to place foam sponge in places where rattles can be experienced. Foam sponge from packaging is suitable for such applications being flexible and easily cut with a blade cutter. Notice the lower area of the instrument panel that will be lied on the foam.
